Structures Technical Memorandum 361

**AIRCRAFT FATIGUE - WITH PARTICULAR EMPHASIS ON  
AUSTRALIAN OPERATIONS AND RESEARCH**

J.Y. MANN

APRIL, 1983

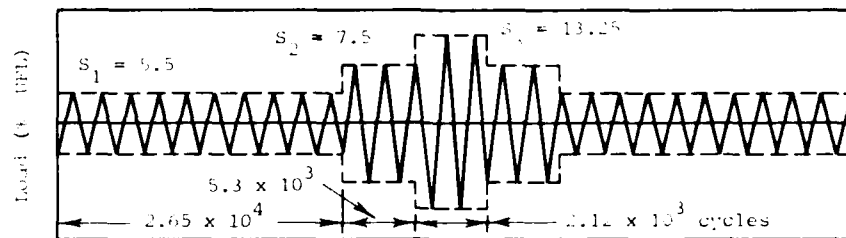
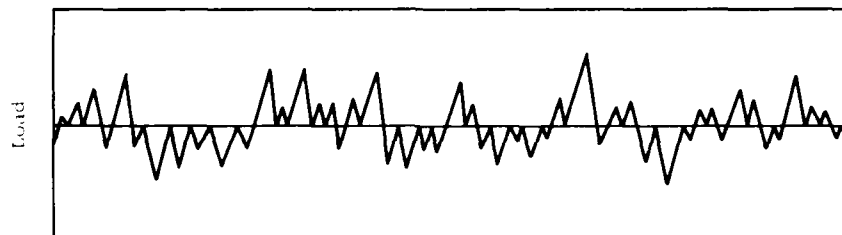
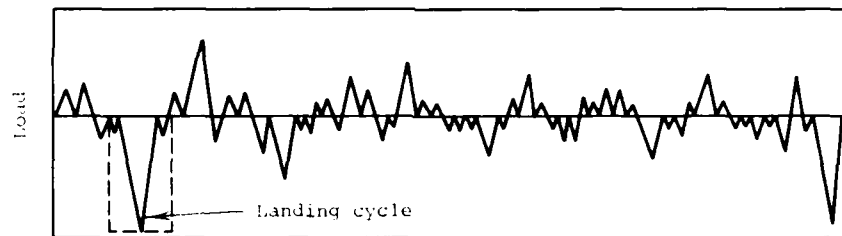
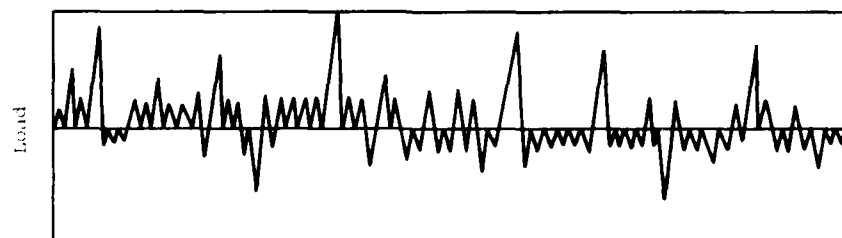
FIG. 11 EXAMPLES OF VARIOUS MULTI-LOAD-LEVEL SEQUENCES USED DURING MUSTANG WING INVESTIGATIONS

(a) Program block 3-load-level test (vibration rig)

(b) Typical random gust load sequence (hydraulic rig)

(c) Typical ground-air-ground cycle/gust load sequence (hydraulic rig)

(d) Typical manoeuvre load sequence (hydraulic rig)
