TECHNICAL REPORT, HL-83-9

# BLOOMINGTON SPILLWAY NORTH BRANCH POTOMAC RIVER MARYLAND AND WEST VIRGINIA

Hydraulic Model Investigation

Prepared for U. S. Army Engineer District, Baltimore  
Baltimore, Md. 21203

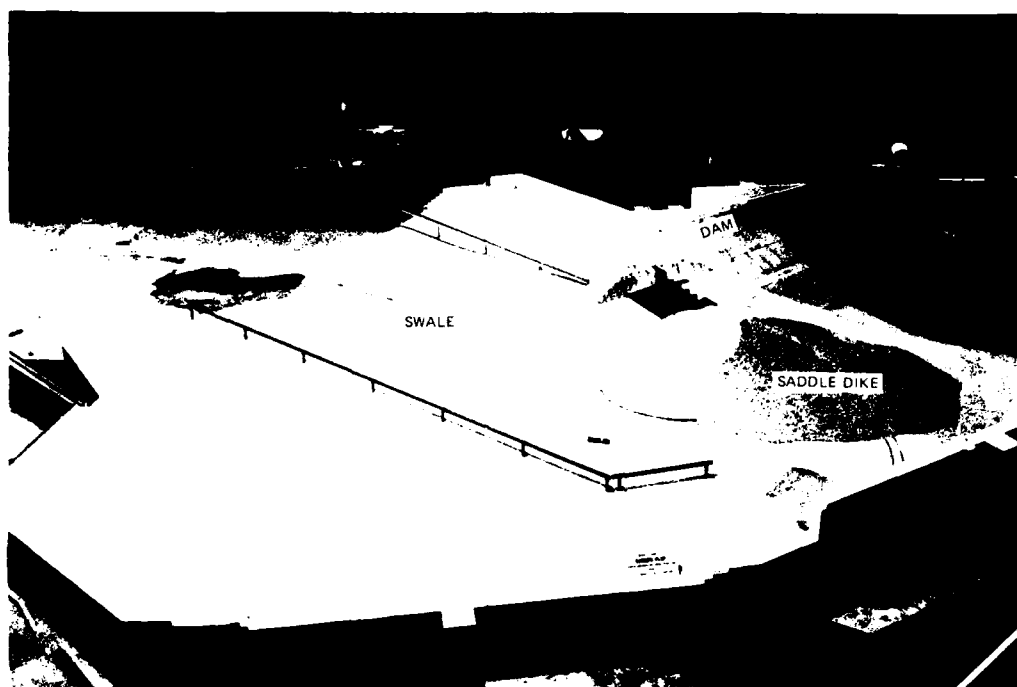
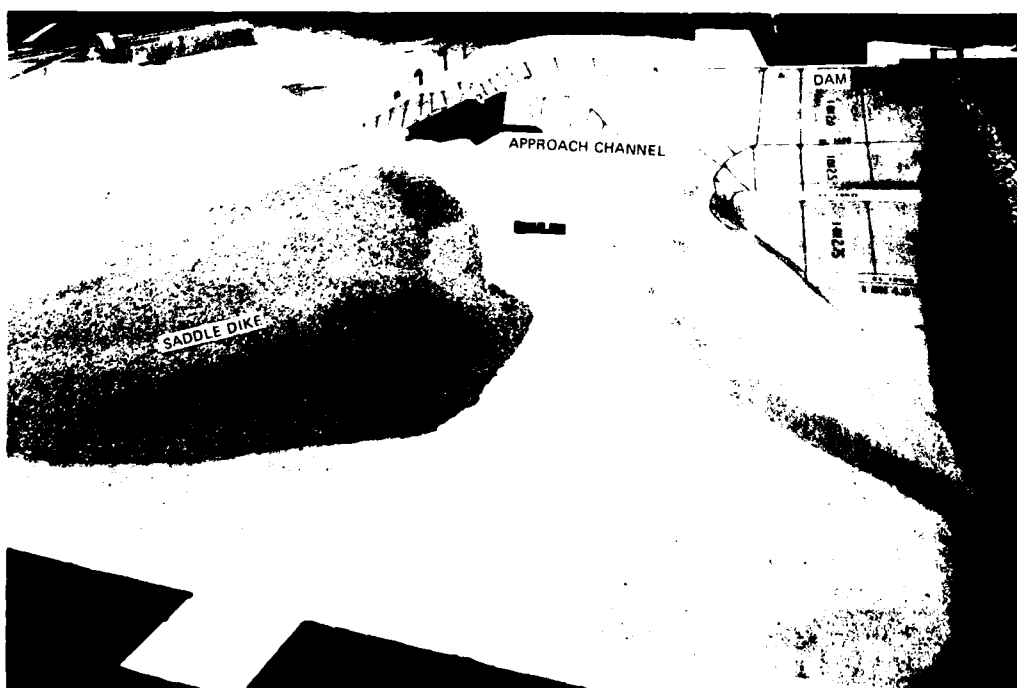
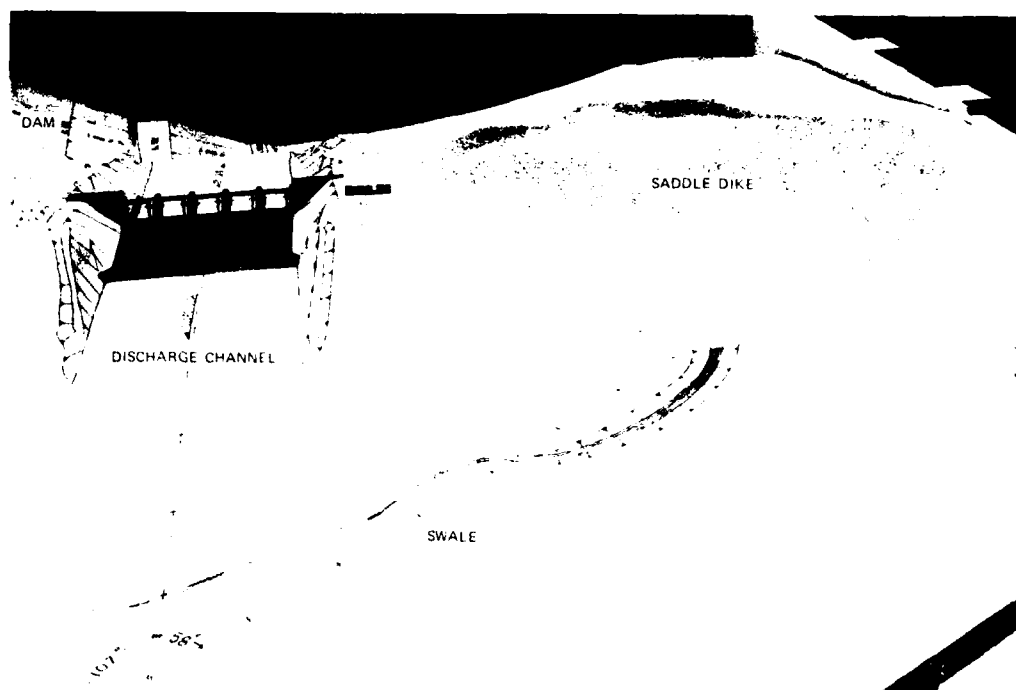
Figure 2. The model (Continued)

a. General view

b. Spillway approach

c. Spillway exit

d. Discharge channel

3. The excavated portion of the approach channel (Figure 2b) is about 250 ft long with an unpaved channel of exposed sandstone. A 25-ft-long concrete apron is provided upstream of the ogee weir at el 1455.0. The approach channel bottom has a downward slope of 1 percent in the upstream direction. Approach channel sides are sloped 2V on 1H in the existing material. The earth-fill saddle dike (Figure 2a) has a top elevation of 1514.0 and its downstream toe is protected up to el 1430.0 by stone with a maximum diameter of 3 ft. The earth-fill dam has a top elevation of 1514.0 (Figure 2).

7. A 1:60-scale comprehensive model (Figure 2 and Plate 1) was constructed to reproduce all topography and structures including a 900-ft length and 1,200-ft width of approach, spillway, dam, dike, discharge channel, and swale from the toe of the saddle dike to a point about 2,000 ft downstream. The approach and overbank areas were molded of sand-cement mortar to sheet-metal templates and were given a brushed finish. The weir crest, tainter gates, crest piers, and nonoverflow sections of the dam were constructed of metal. The saddle dike (Figure 2) was constructed of loose stone simulating a maximum diameter ( $d_{100}$ ) of 3.0 ft. The model was designed to permit tests with a fixed or movable overburden simulated in the exit area (swale).

11. The model reproduced the approach area for a width of 1,200 ft and a distance of 900 ft upstream from the spillway (Plate 1 and Figure 2a). Approach flows, controlled and uncontrolled, up to the design discharge of 178,000 cfs were evaluated.

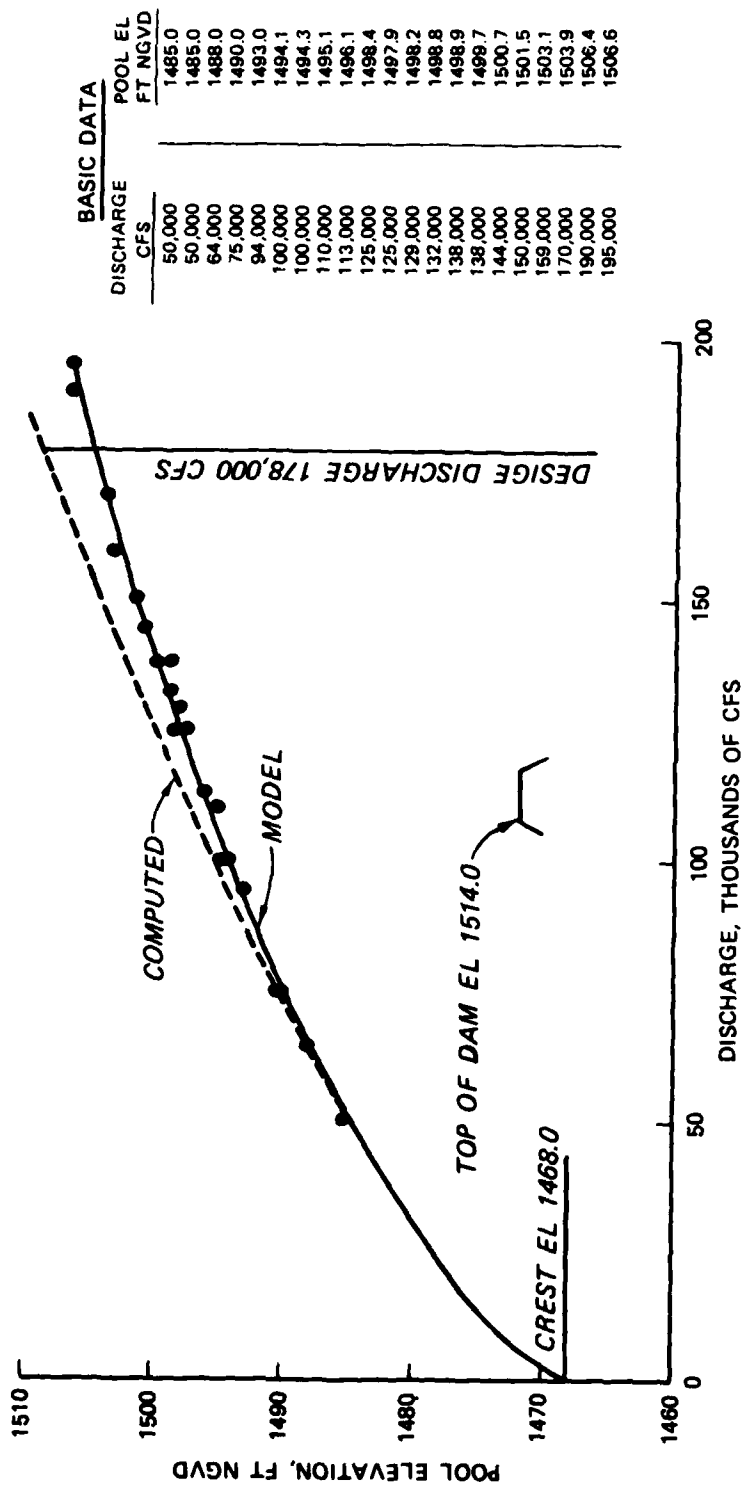
Figure 3. Spillway rating curves for uncontrolled flow

COEFFICIENTS FOR DESIGN HEAD OF 40.9 FT  
 PIER CONTRACTION,  $K_p = 0.013$   
 ABUTMENT CONTRACTION,  $K_d = 0.17$   
 DISCHARGE,  $C = 3.56$

The crest profile is shown in Plate 3. The computed and model flow rating curves and basic model data are shown in Figure 3. Coefficients used for computation of the computed curve are also listed in Figure 3. The model rating curve indicated that the spillway would pass the design flood of 178,000 cfs at a pool elevation 4.0 ft less than that computed. Controlled and uncontrolled flow rating curves are plotted in Figures 4 and 5. Controlled flow discharge coefficients,  $C_g$ , are plotted versus gross head on the gate,  $H_g$ , in Figure 6. Basic calibration data for controlled flows are tabulated in Table 1. No severe flow contraction at the spillway abutments or piers was observed. Vortices occurred occasionally immediately upstream from each tainter gate (Photo 2). These vortices had no significant effect on hydraulic performance. During uncontrolled or controlled flow releases, no random or periodic surging of flow was observed upstream of the spillway piers or abutments.

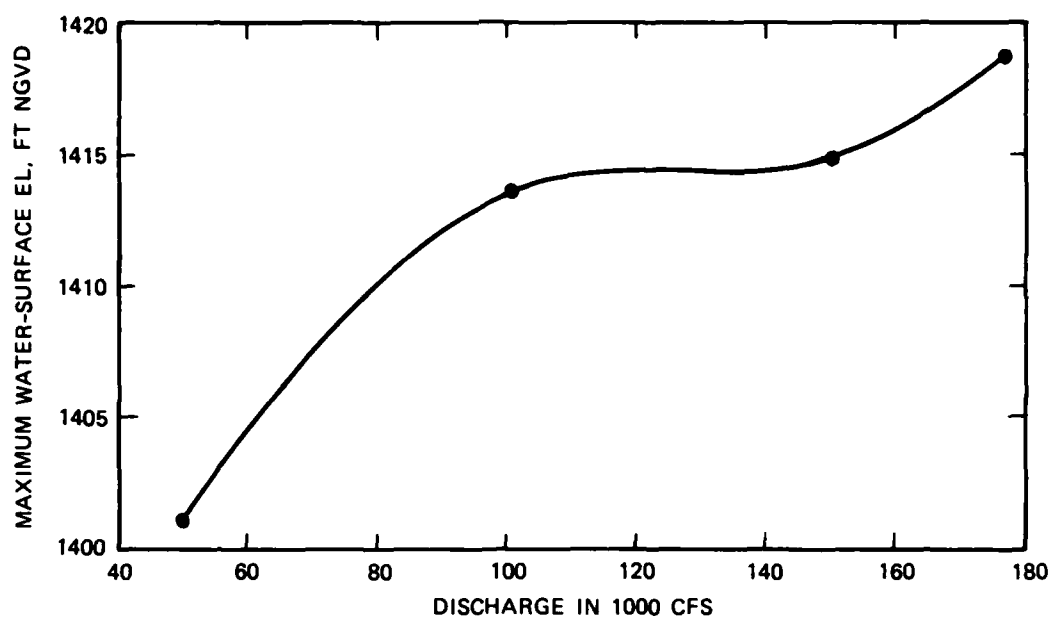
Figure 8. Fixed overburden, maximum water-surface elevation in return flow toward dike

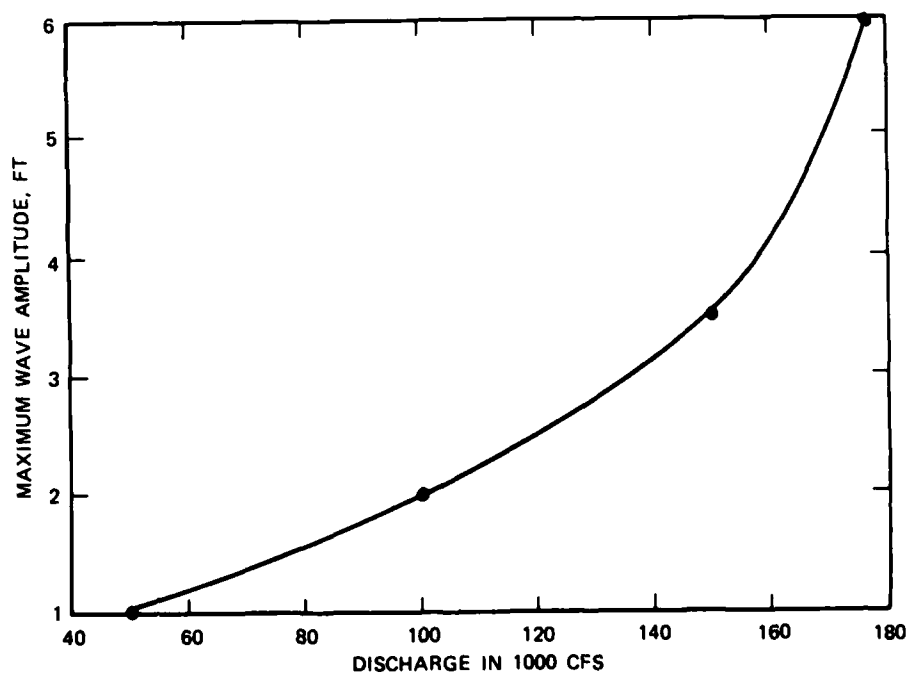
Figure 9. Fixed overburden, maximum wave amplitude in return flow toward dike

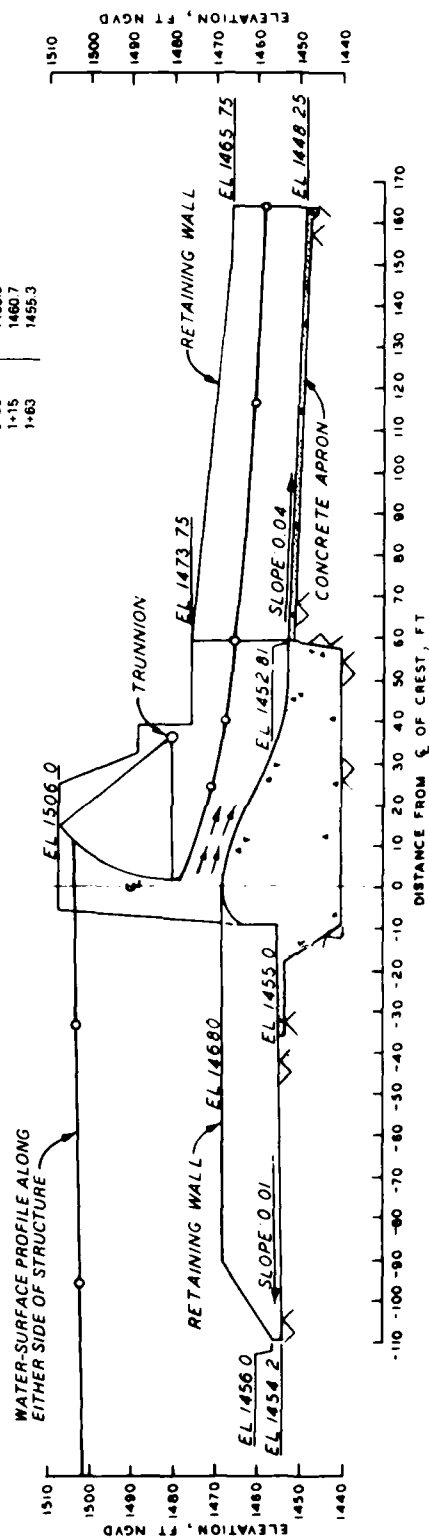
TEST CONDITION  
 $Q = 65,000$  CFS  
 $G_0 = 100$  FT

WATER-SURFACE PROFILE  
 DISCHARGE 65,000 CFS

14. Water-surface profiles through the spillway were similar on each side of the spillway and are plotted for various discharges in Plates 10-13. At the maximum flow, the water surface contacted the gate trunnion and overtopped the upstream end of the downstream training walls (Plate 13). Flows above 150,000 cfs splashed over the top of the upstream end of each training wall and produced a flow in the downstream direction along the backside of each training wall. Water splashing over the walls at a discharge of 178,000 cfs produced a maximum insignificant flow rate of about 10 cfs along the backside of each wall at the downstream end of the wall.

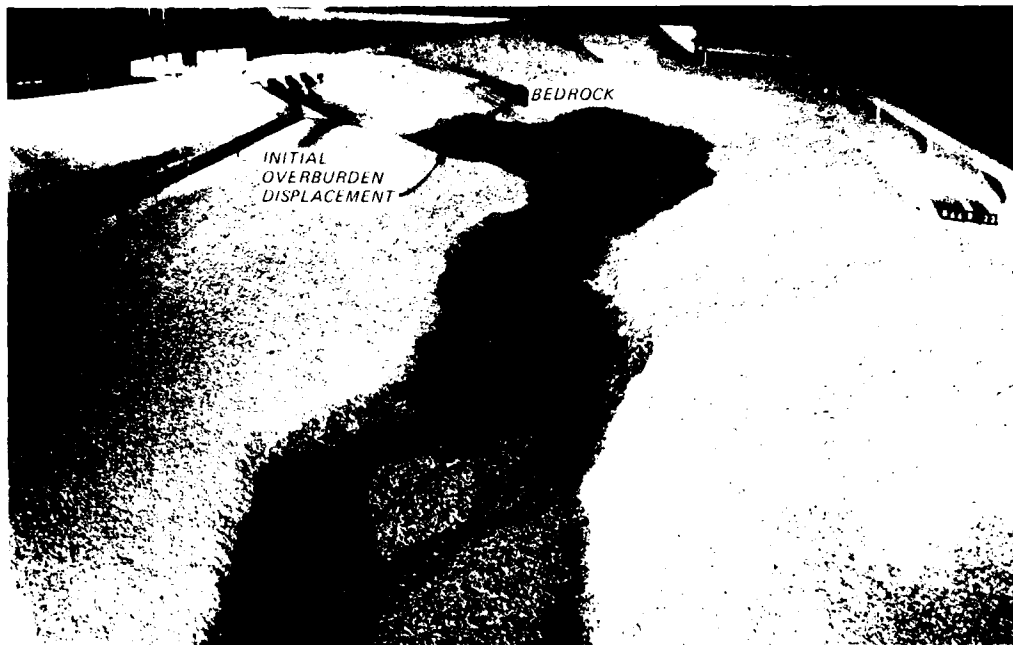
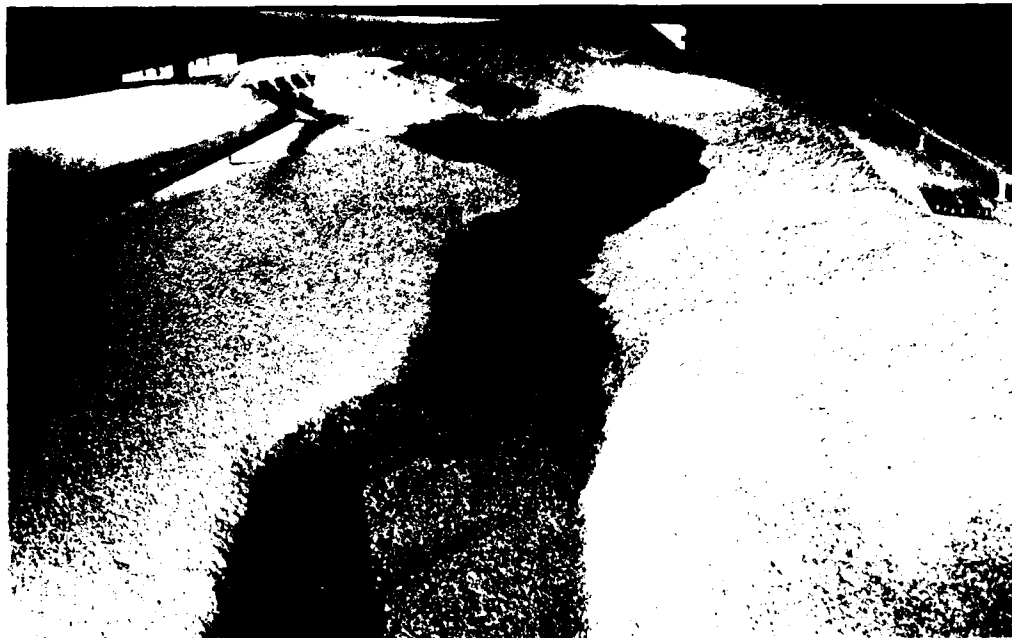
a. Operating

b. Dry bed

Overburden displacement; discharge 10,000 cfs,  $G_o = 2.5$  ft,  
 $H_w = 1500.2$ ; operation time 2 hr

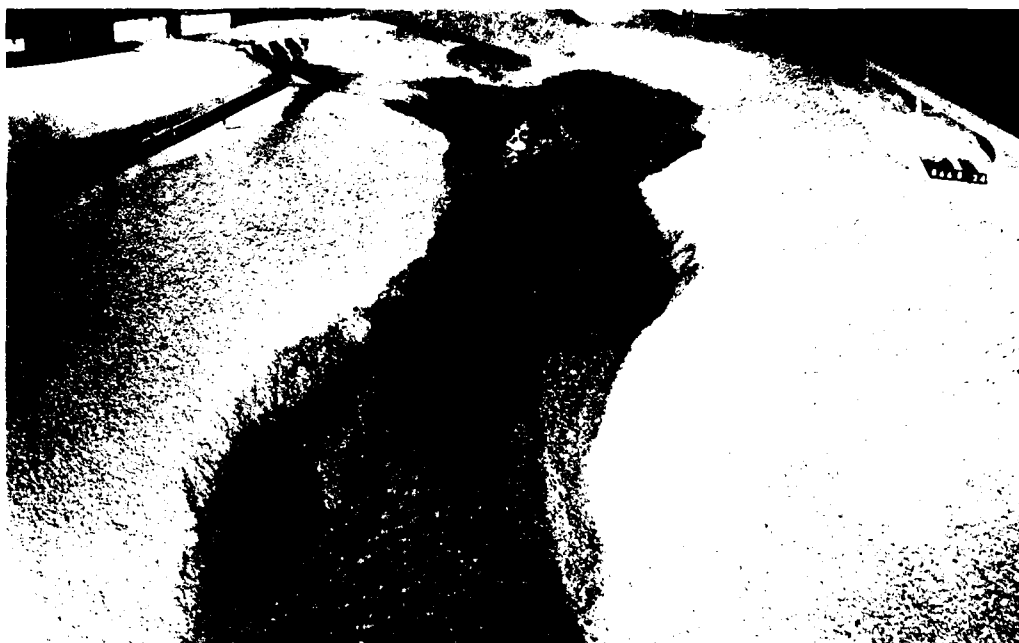
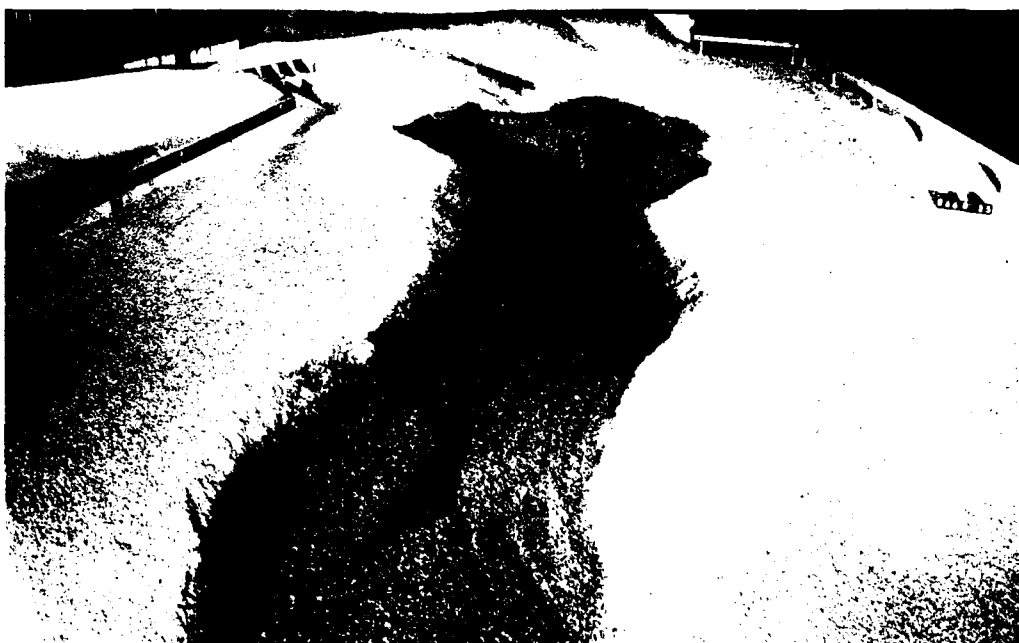
PLATE 27 (Continued)

a. Operating

b. Dry bed

Overburden displacement; discharge 33,000 cfs,  $G_0 = 2.5$  ft,  $H_w = 1500.9$ ;  
operating time, 2 hr at 10,000 cfs and 1 hr at 33,000 cfs

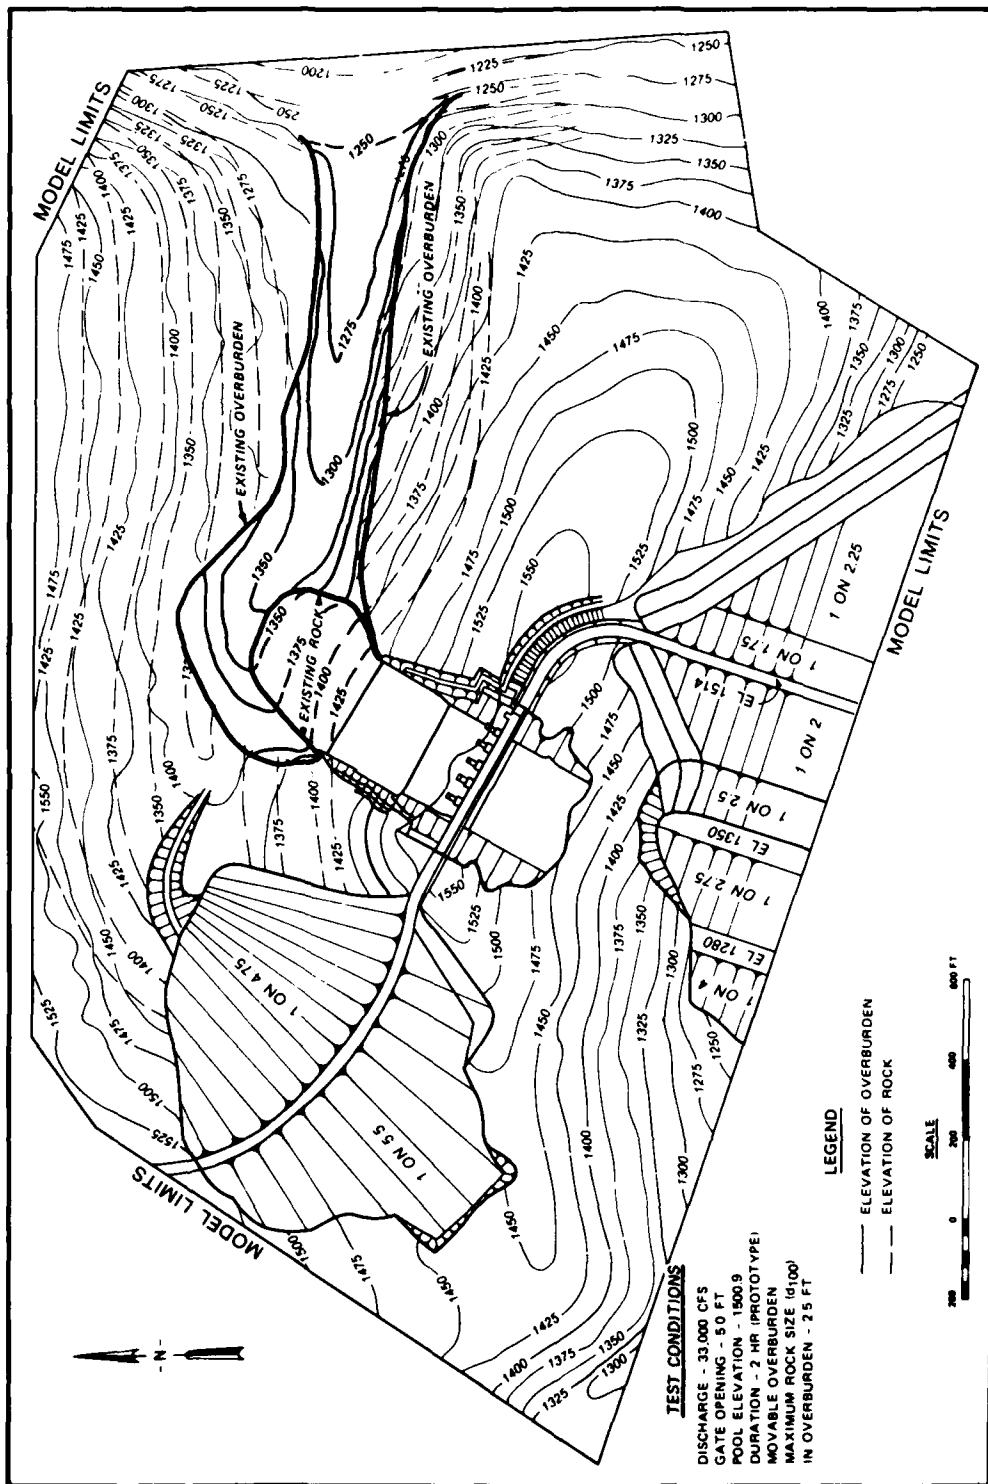
c. Scour characteristics

21. Figure 11 shows the dike and swale prior to flow. The dike consists of loose stone with a maximum diameter ( $d_{100}$ ) of 3.0 ft. The downstream toe of the prototype dike is protected by stone with a  $d_{100}$  of 3.0 ft. Initial displacement of the overburden occurred at the downstream end of the spillway cut. Overburden displacement during and after a discharge of 10,000 cfs for a period of 2 hr (prototype) is shown in Plate 26. Resulting overburden displacement after discharges of 33,000, 65,000, 97,000, and 178,000 cfs is shown in Plates 27, 28, 29, and 30, respectively. A debris dam did not form for any discharge as the scoured overburden was transported through the swale.

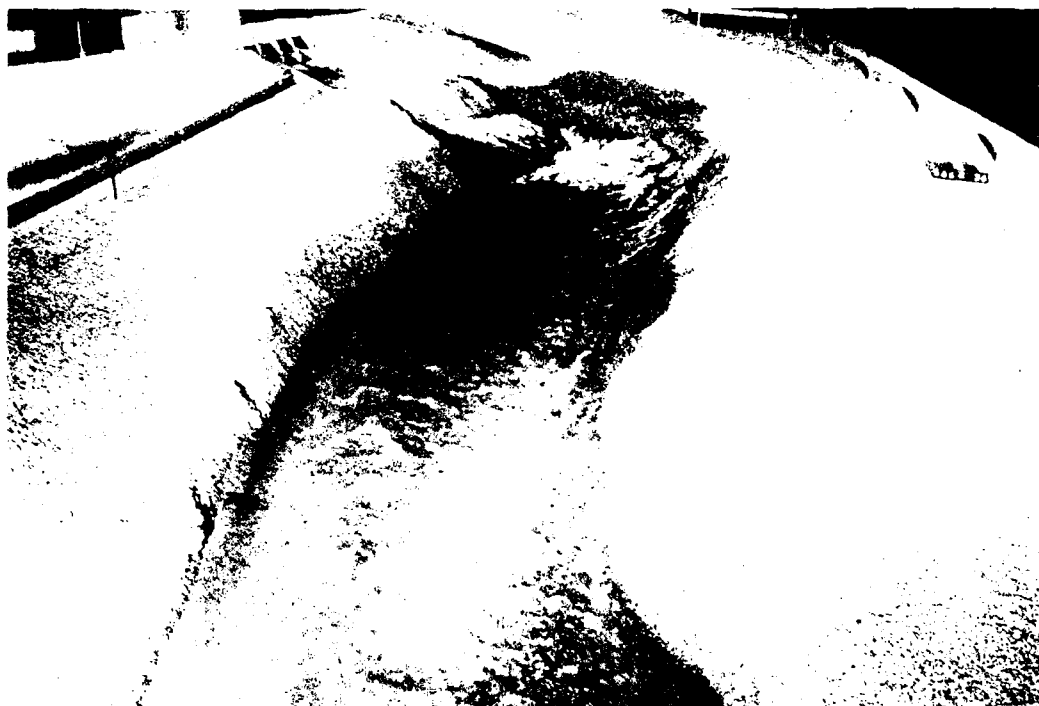
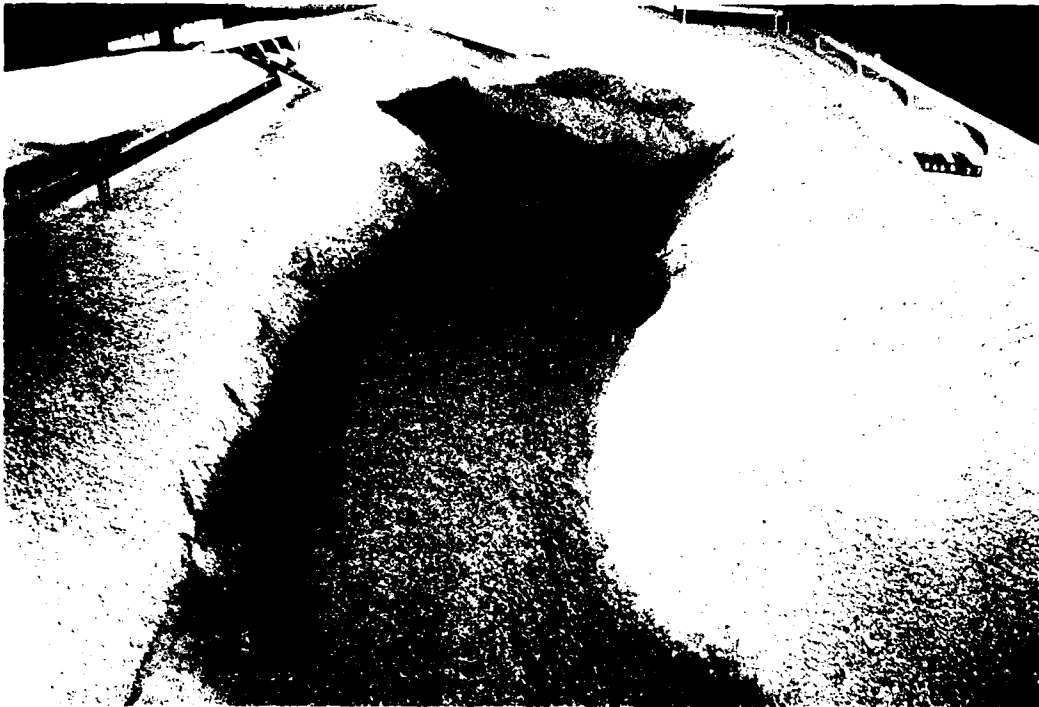
a. Operating

Overburden displacement; discharge 65,000 cfs,  $G_0$  - 10.0 ft,  $H_w$  - 1502.0;  
operating time, 2 hr at 10,000 cfs, 1 hr at 33,000 cfs, and 1 hr at  
65,000 cfs

b. Dry bed

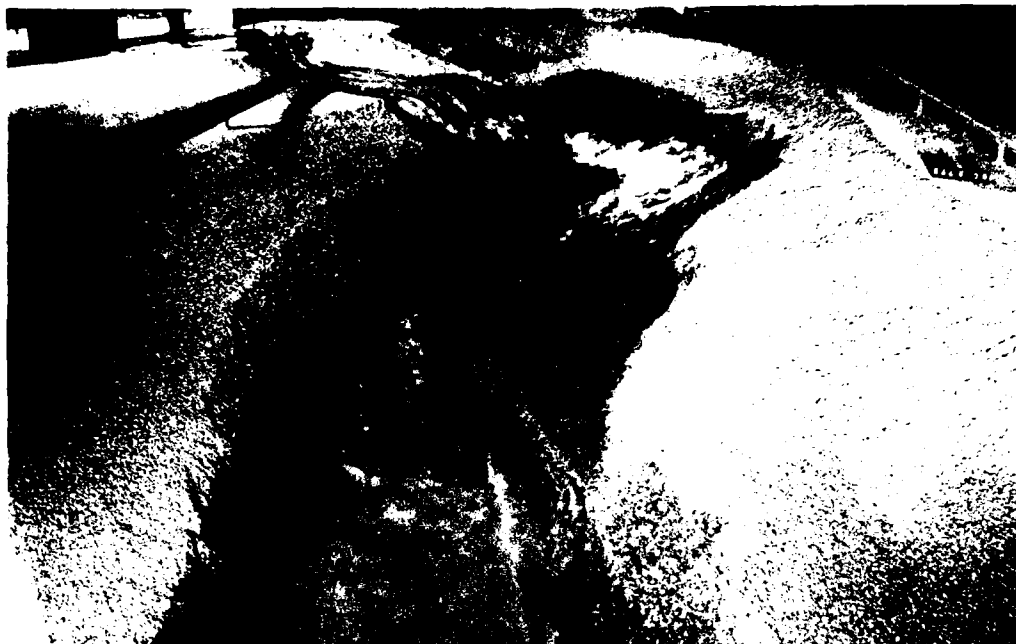
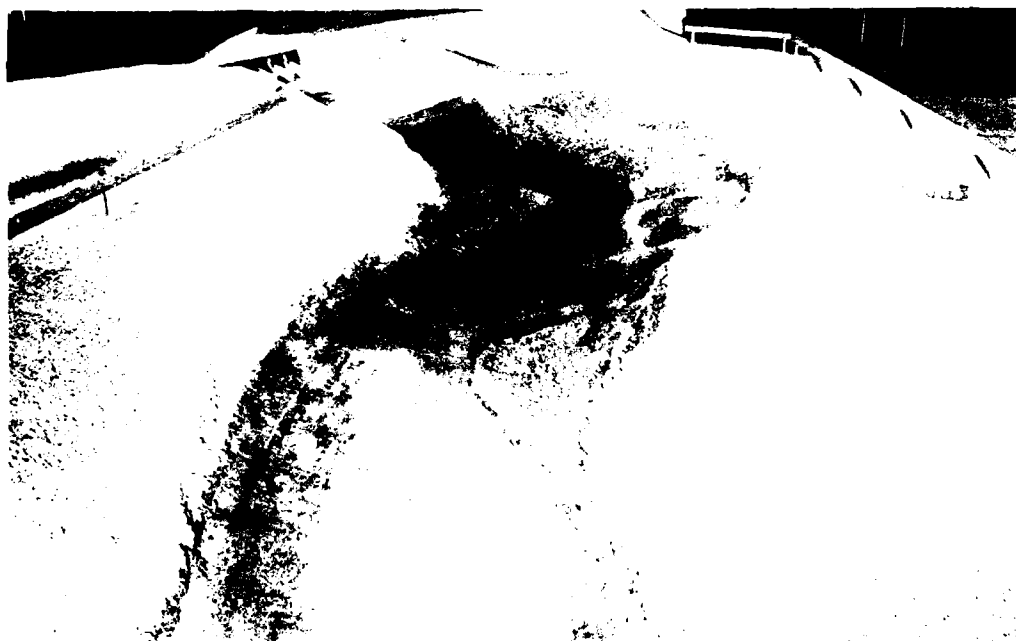
PLATE 29 (Continued)

a. Operating

b. Dry bed

Overburden displacement; discharge 97,000 cfs,  $G_o = 15$  ft,  $H_w = 1504.6$ ; operating time, 2 hr at 10,000 cfs, 1 hr at 33,000 cfs, 1 hr at 65,000 cfs, and 1 hr at 97,000 cfs

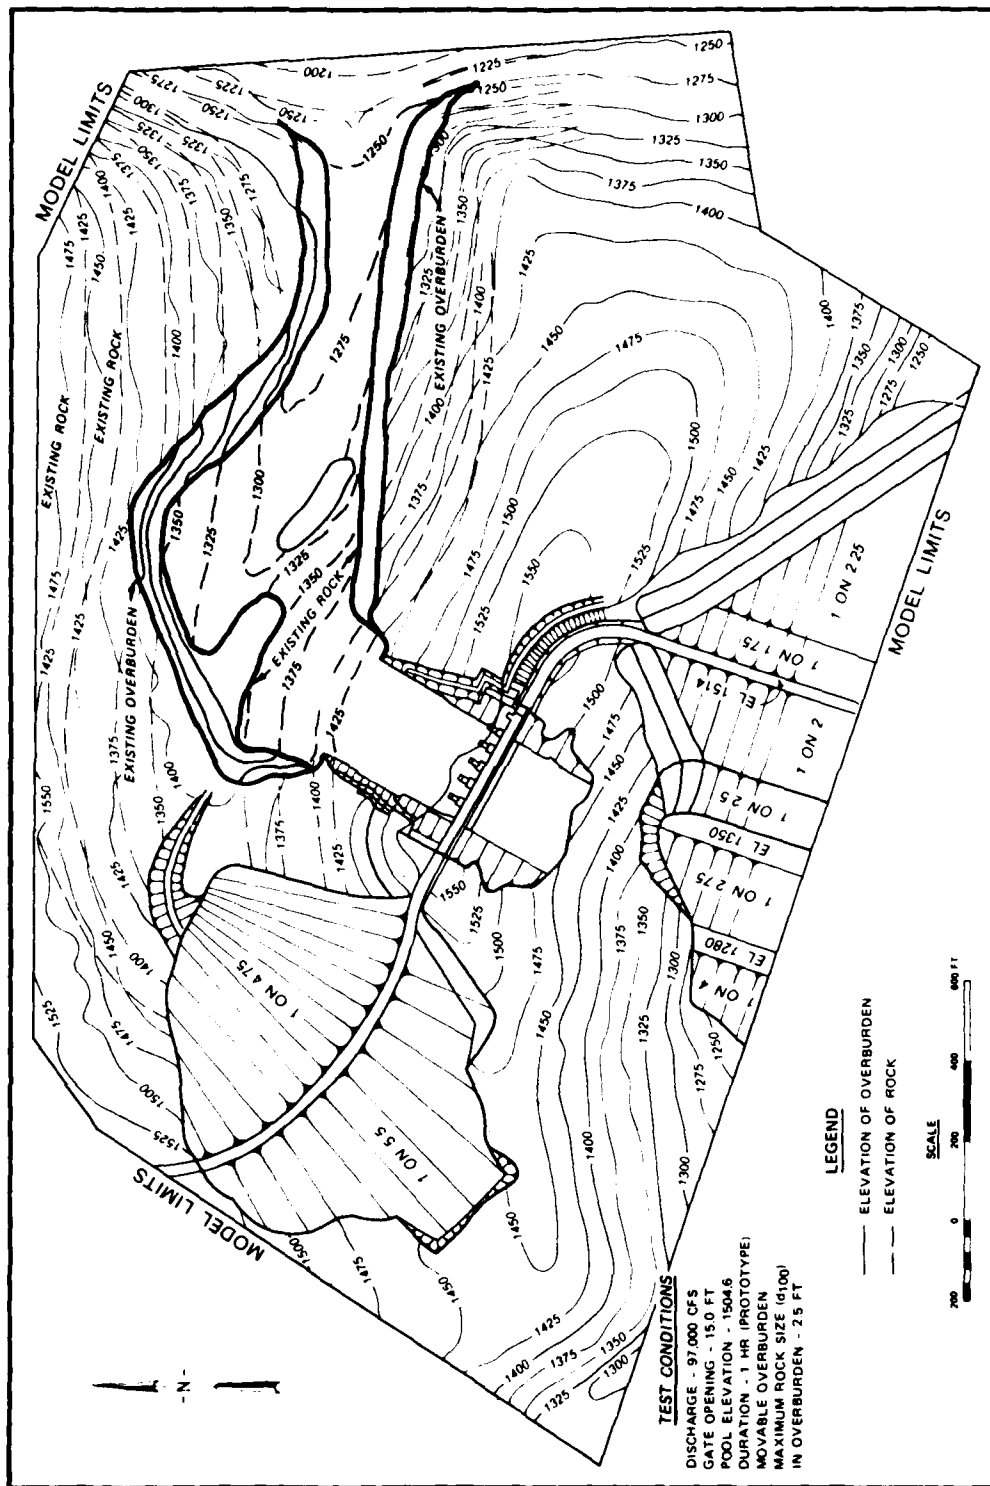
PLATE 29 (Concluded)

c. Scour characteristics
