CR 83.019

NAVAL CIVIL ENGINEERING LABORATORY  
Port Hueneme, California

**ACOUSTICAL BENEFITS RESULTING FROM INSULATION AND  
AIR LEAKAGE CONTROL IN FAMILY HOUSING UNITS**

An Investigation Conducted by  
MANVILLE SERVICE CORP., R&D Center  
P.O. Box 5108  
Denver, Colorado

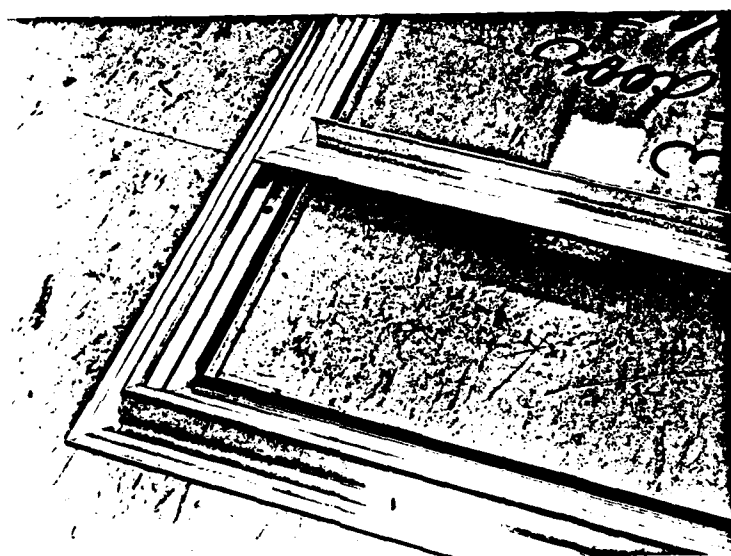
Fig. A7. Storm Window and Frame.

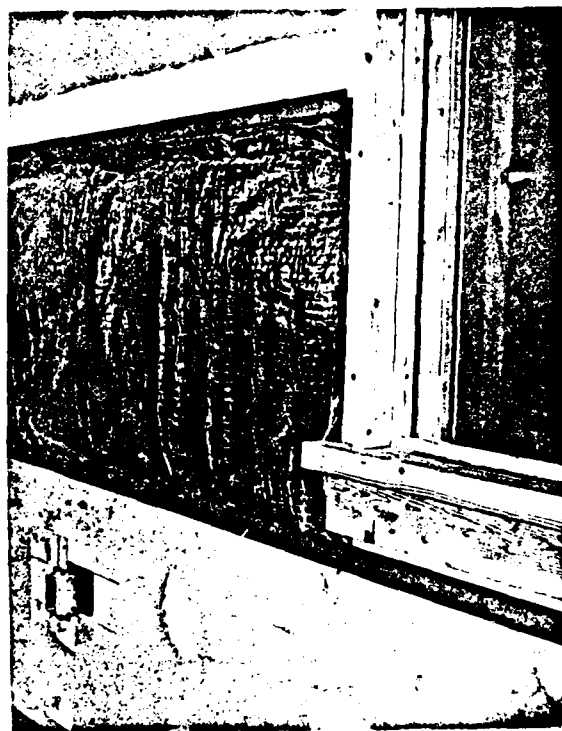
Fig. A8. Additional Insulation Added to Interior Wall Surface.

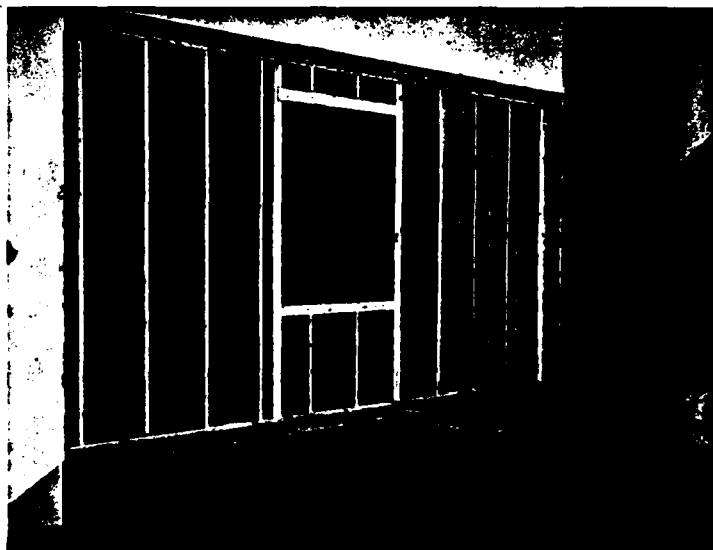
Fig. B2. Basic Wall Framing Viewed From Interior Side Showing Crawl Space.

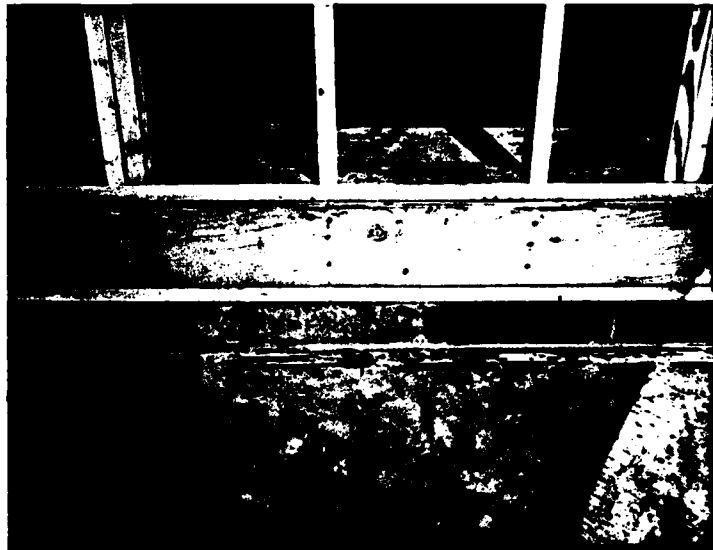
Fig. B 3. Framing of Wall Viewed From Exterior Side Showing Header.

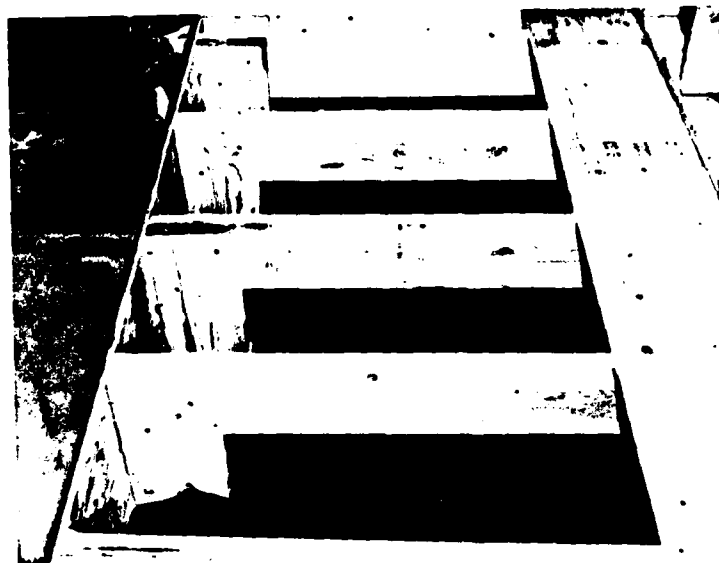
Fig. B4. Crawl Space Framing.

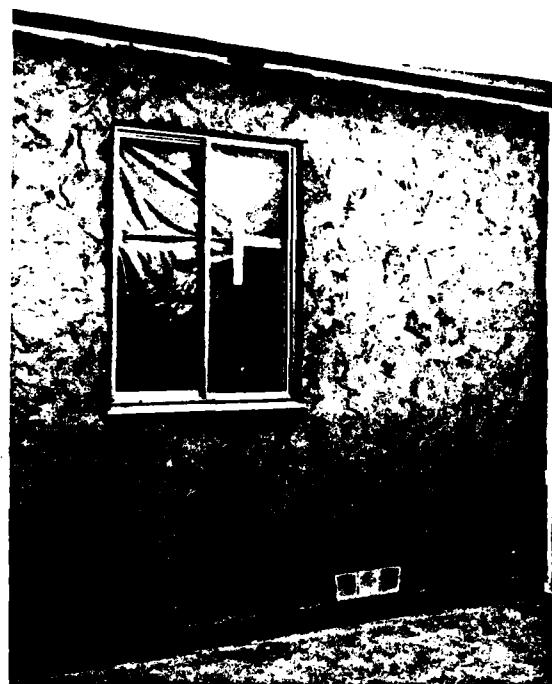
Fig. B5. View of Exterior Showing Prime Window and Crawl Space Vent (Plastic film over window for calibration tests only).

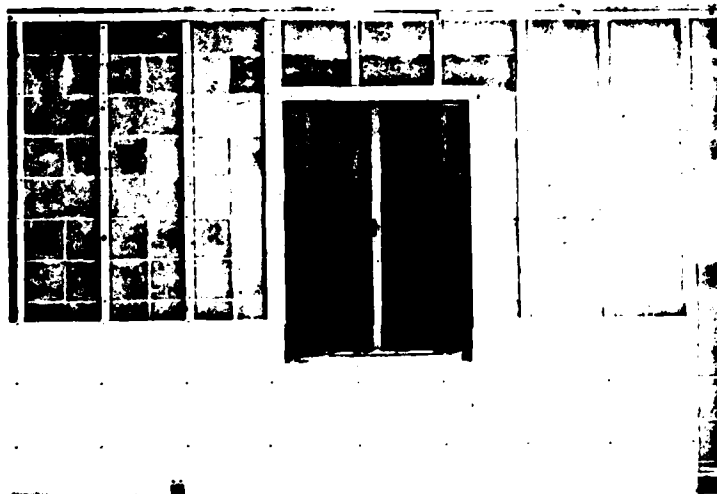
Fig. C4. Interior Surface Showing Wood Furring Strips, Gypsum Board and Steel Sash Window.

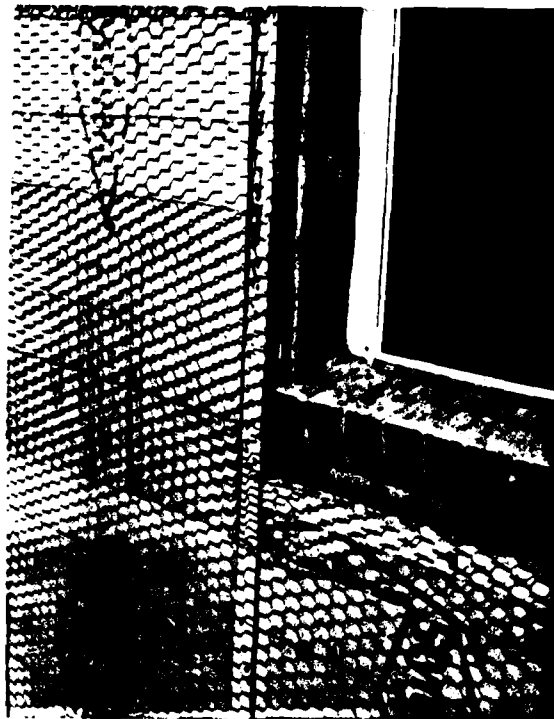
Fig. C8. Detail at Window Showing Installation of 1 1/2" Polystyrene Insulation (Window sill not modified at this point in retrofit).

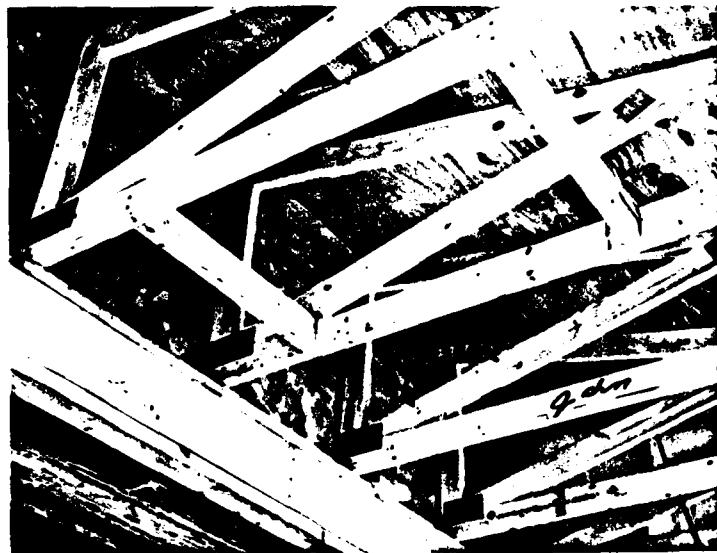
Fig. D3. Wood Trusses in Place Showing Location of Scuttle and Cut-Out for Roof Vent Directly Above Scuttle.

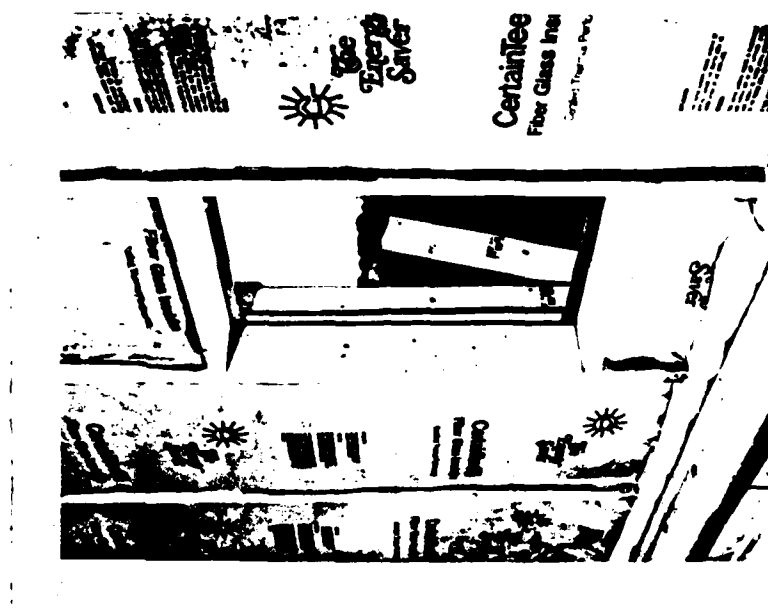
Fig. D 4. Retrofit Dropped Ceiling in Place Showing Detail at Scuttle.

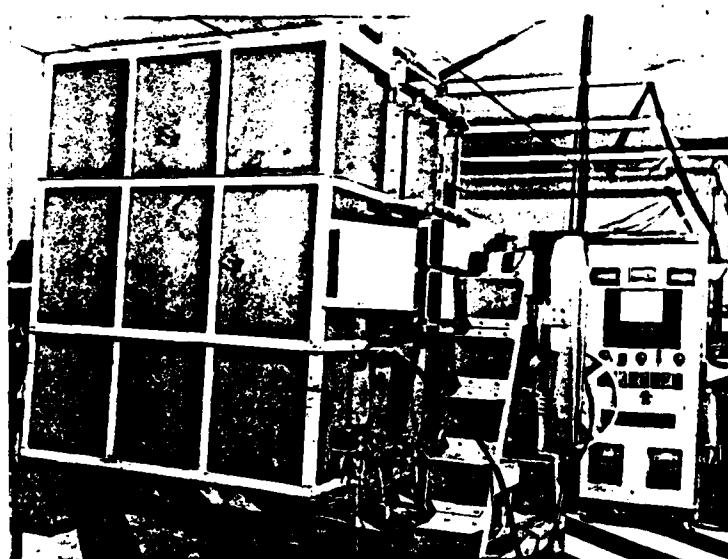
Fig. I2. Guarded Hot Box with Control Panel.
