# NAVAL POSTGRADUATE SCHOOL

## THESIS

THE EFFECTS OF ENVIRONMENT AND DWELL  
ON HIGH TEMPERATURE FATIGUE CRACK GROWTH  
OF 2 1/4 Cr - 1 Mo STEEL

June 1983

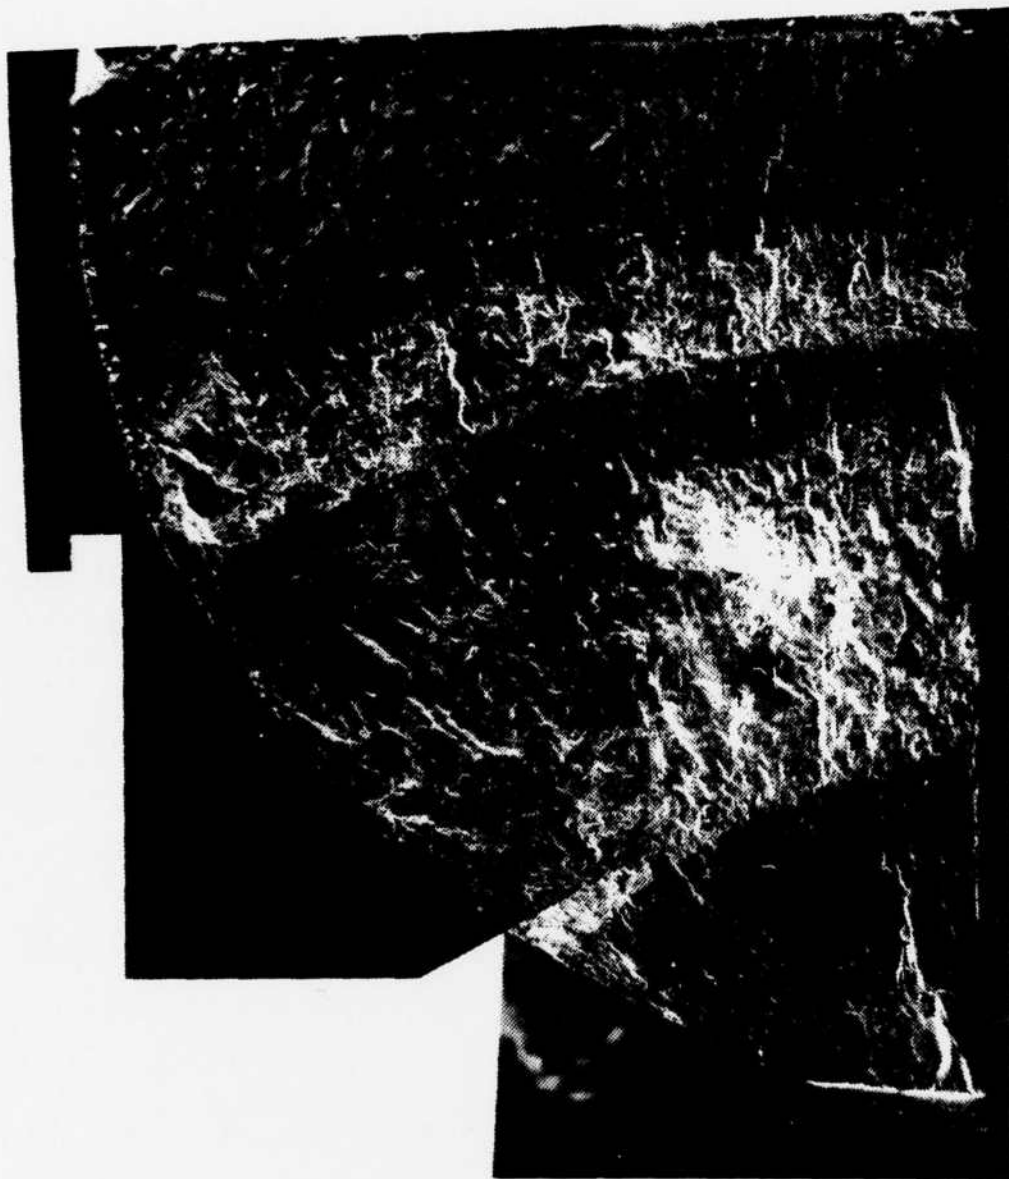
Figure 13. 1/2 Fracture Surface of Normalized and Tempered Material.  
Continuous Cycling in Air (26x). Specimen No. 9.

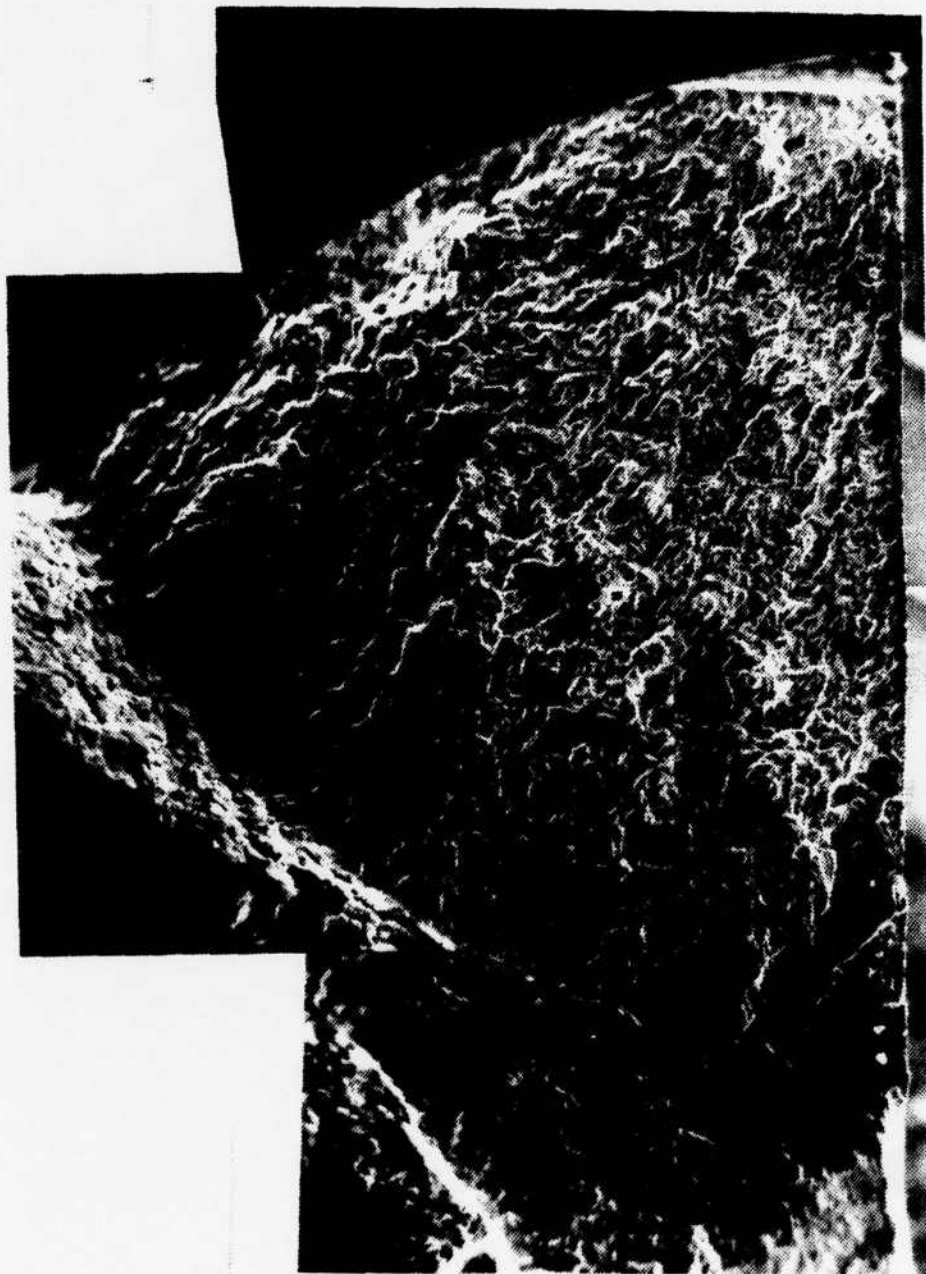
Figure 24. 1/2 Fracture Surface of Annealed Material Subjected to  
1/2 Hour Dwell Periods and Continuous Cycling in Vacuum.  
Specimen No. 6 (31x)

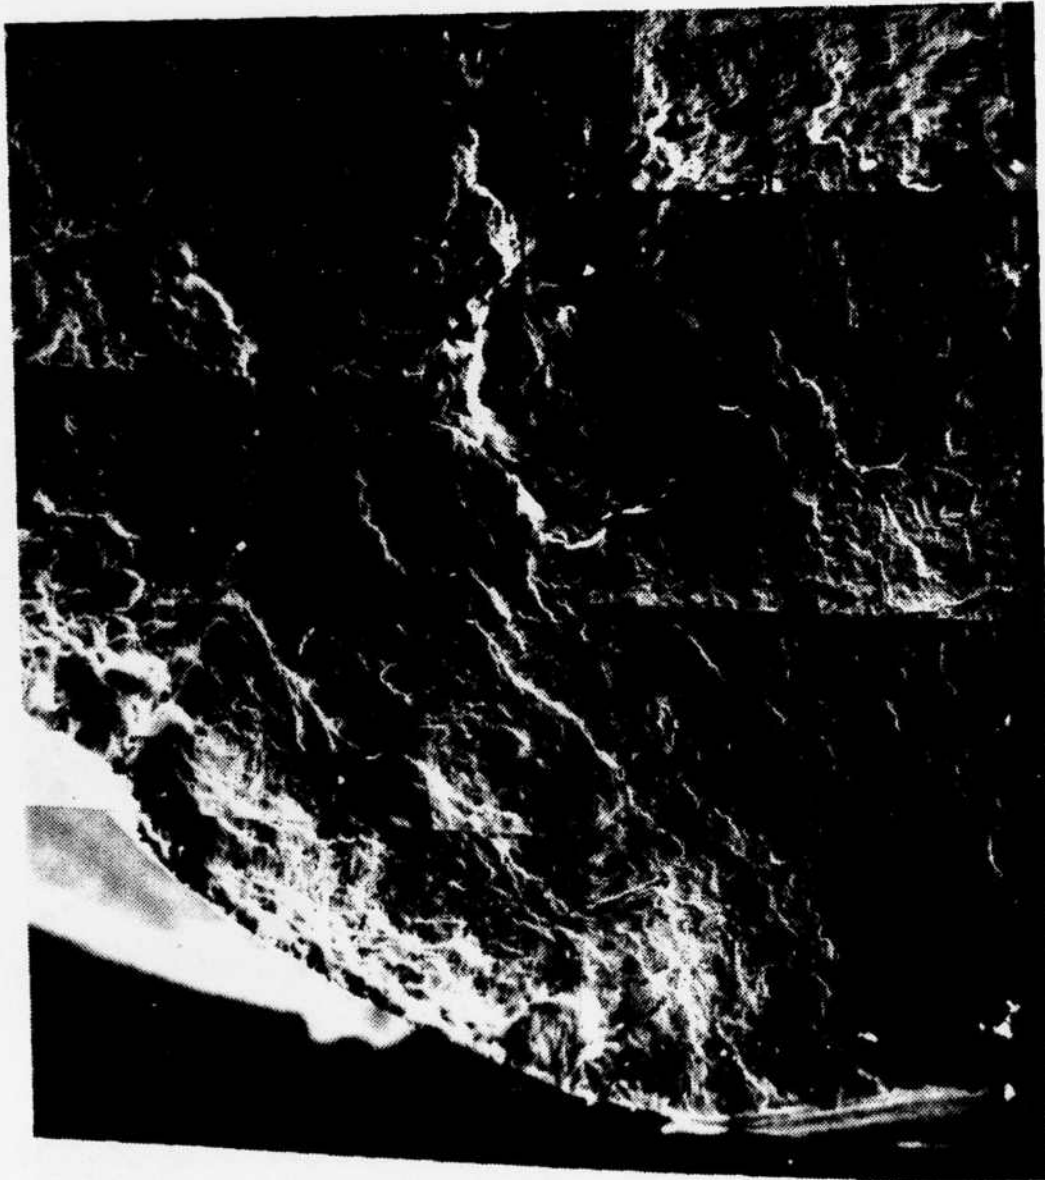
Figure 25. 1/2 Fracture Surface of Normalized and Tempered Material  
Subjected to 1/2 Hour Dwell Periods and Continuous Cycling  
in Vacuum. Specimen No. 12 (28x)

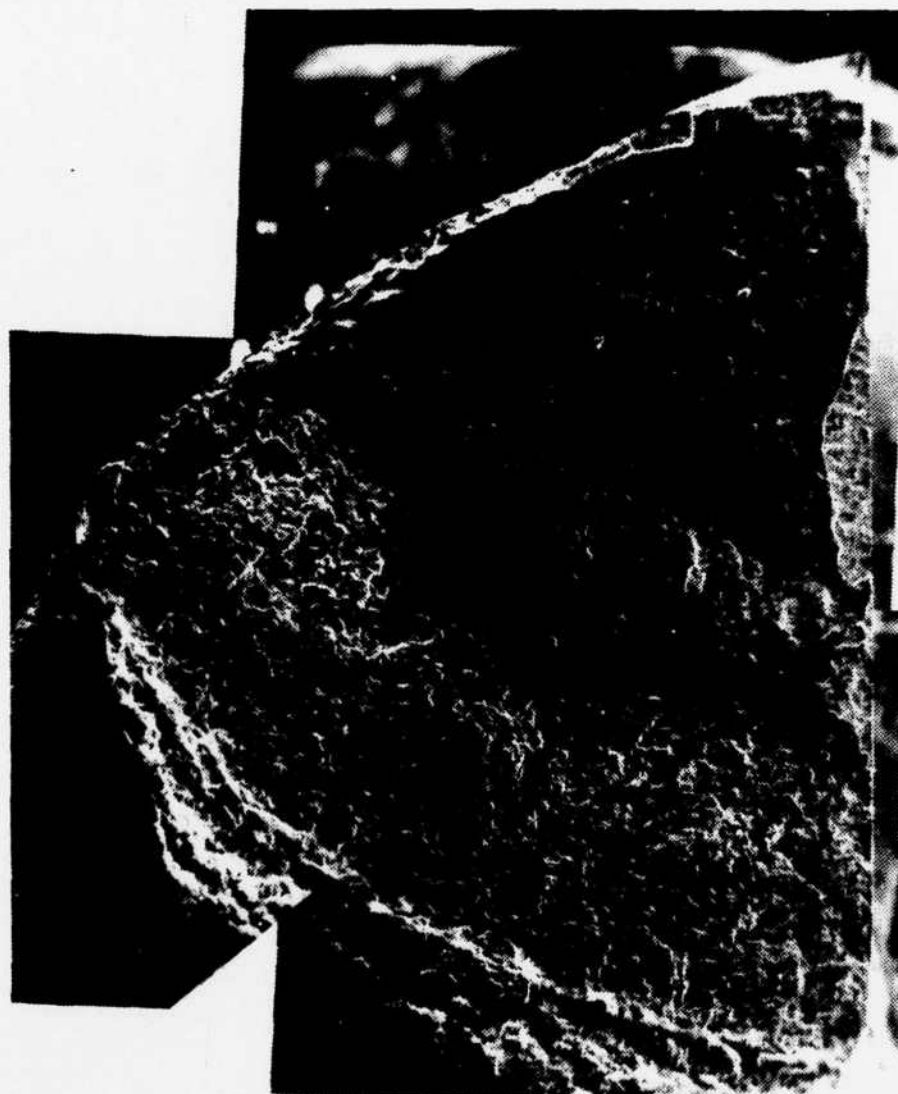
Figure 33. 1/2 Fracture Surface of Annealed Material Subjected to 1/2 Hour Dwell Cycling in Air. Specimen No. 5 (30x)

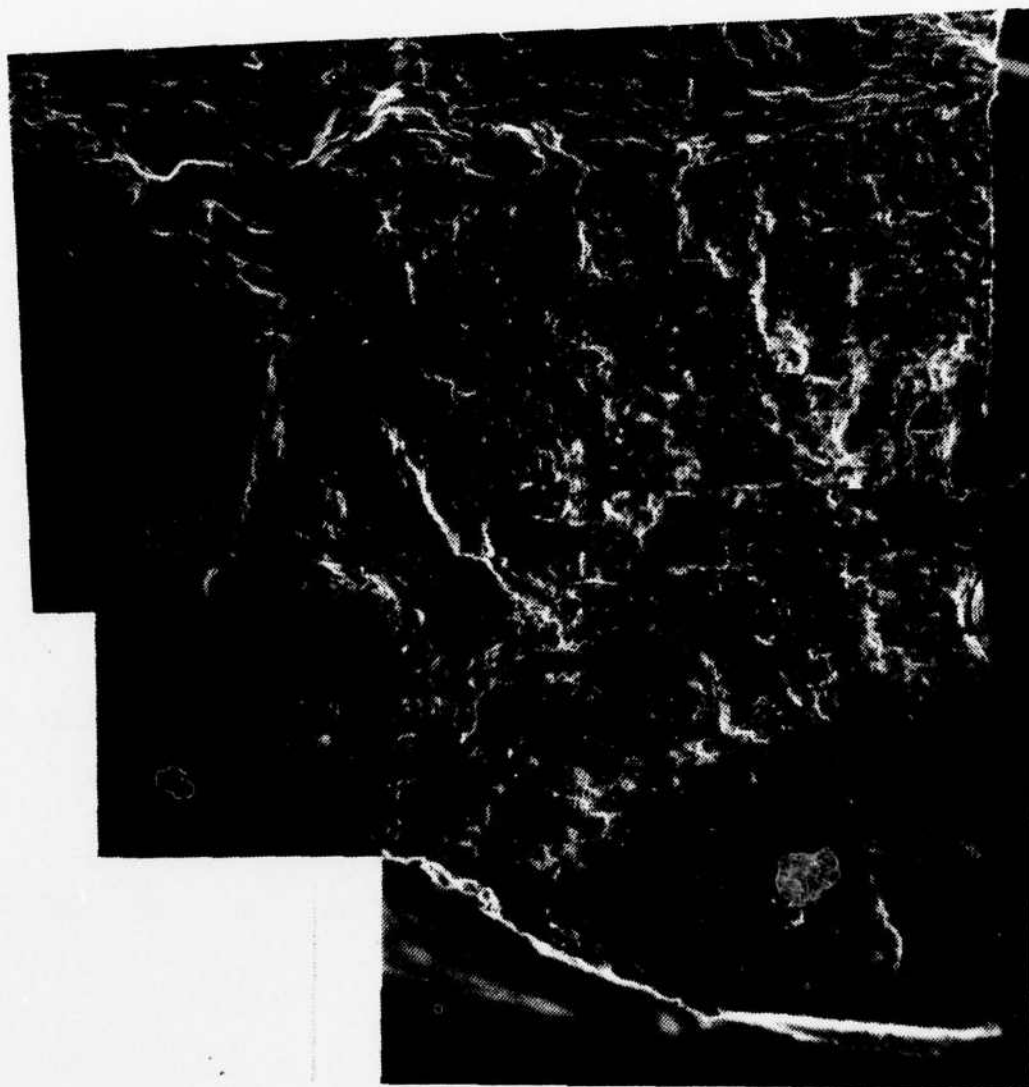
Figure 34. 1/2 Fracture Surface of Normalized and Tempered Material Subjected to 1/2 Hour Dwell Cycling in Air. Specimen No. 11 (26x)

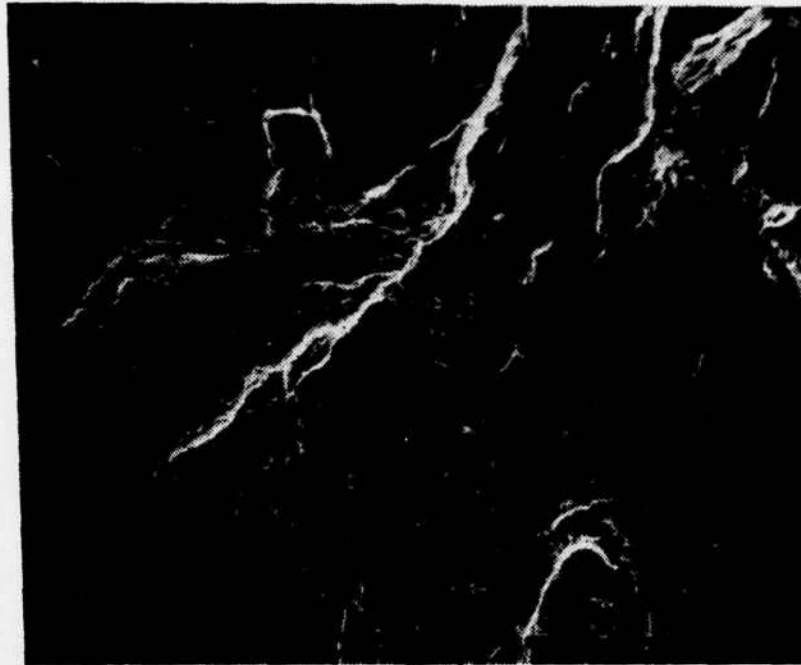
a) Compression - T+C Transition Region (265x)

b) Tension - Compression Transition Region (265x)  
Note "sticky" character of compression surface  
possibly denoting reweldment of the fracture  
surface

Figure 44. Surface Transition Regions for Normalized and Tempered Material in Vacuum. Specimen No. 13.

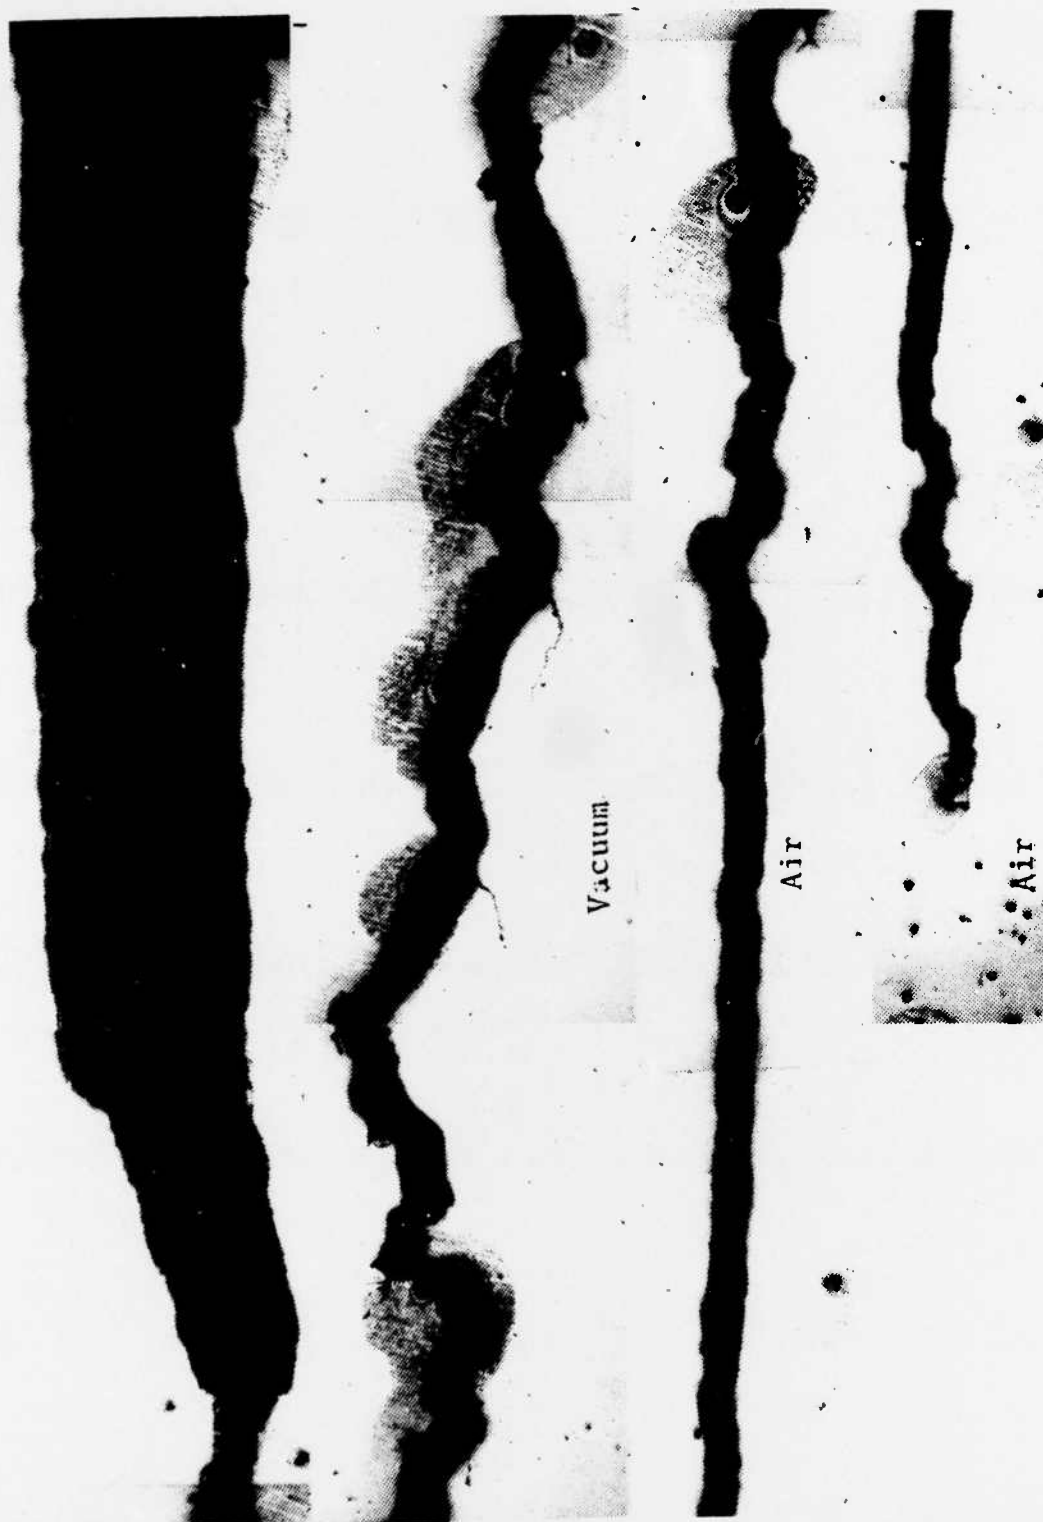
Figure 51. LEFM Crack Profile of Reannealed UKAEA Material (64x).  
Specimen No. 8.
