| REPORT DOCUMENTATION PAGE | | READ INSTRUCTIONS<br>BEFORE COMPLETING FORM |
|---|---|---|
| 4. TITLE (and Subtitle)<br>WILLOW CREEK DAM SPILLWAY AND STILLING BASIN<br>AT HEPPNER, OREGON<br>Hydraulic Model Investigation | | 5. TYPE OF REPORT & PERIOD COVERED |

WILLOW CREEK DAM  
SPILLWAY AND STILLING BASIN  
AT  
HEPPNER, OREGON

Hydraulic Model Investigations

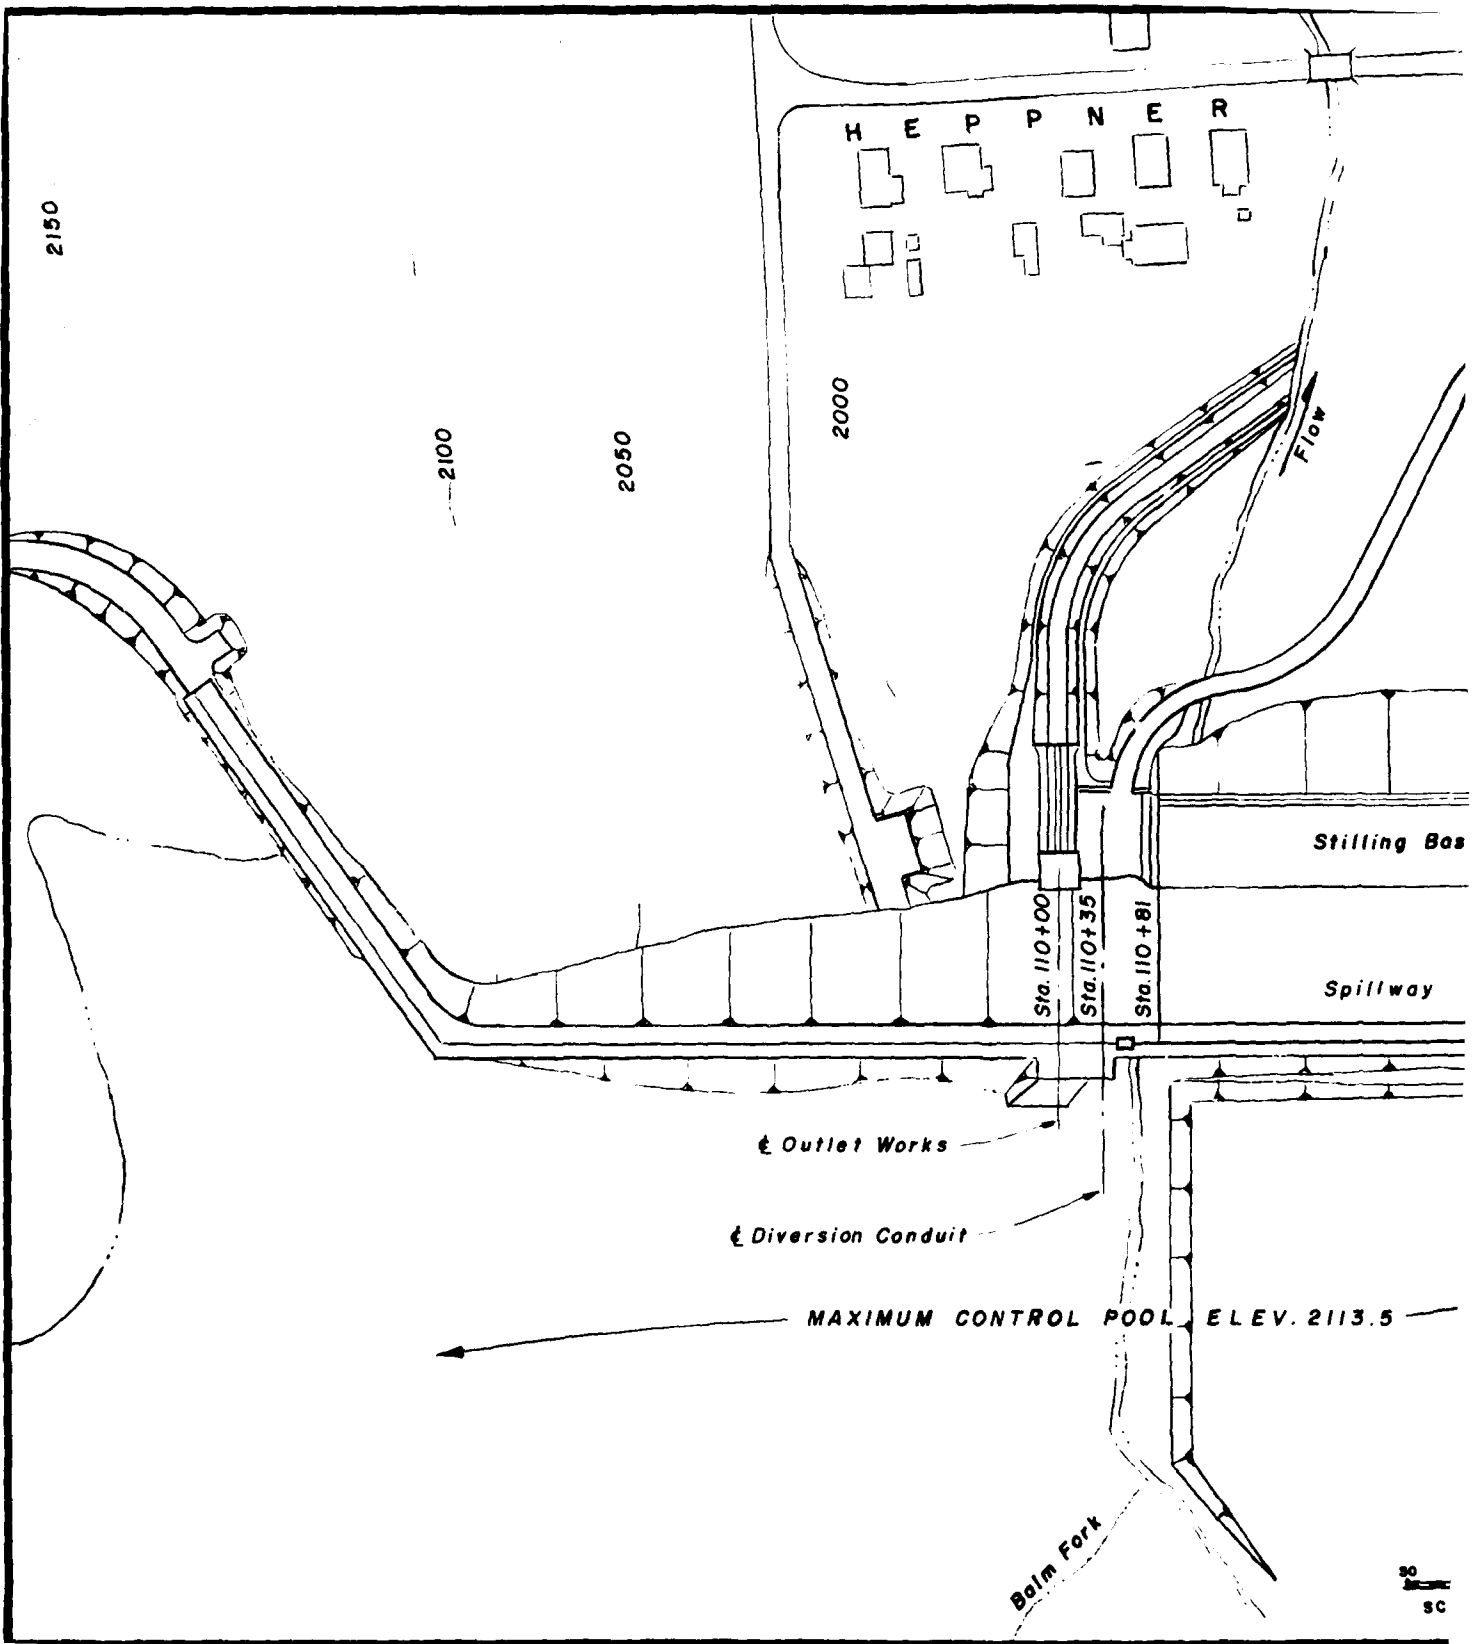
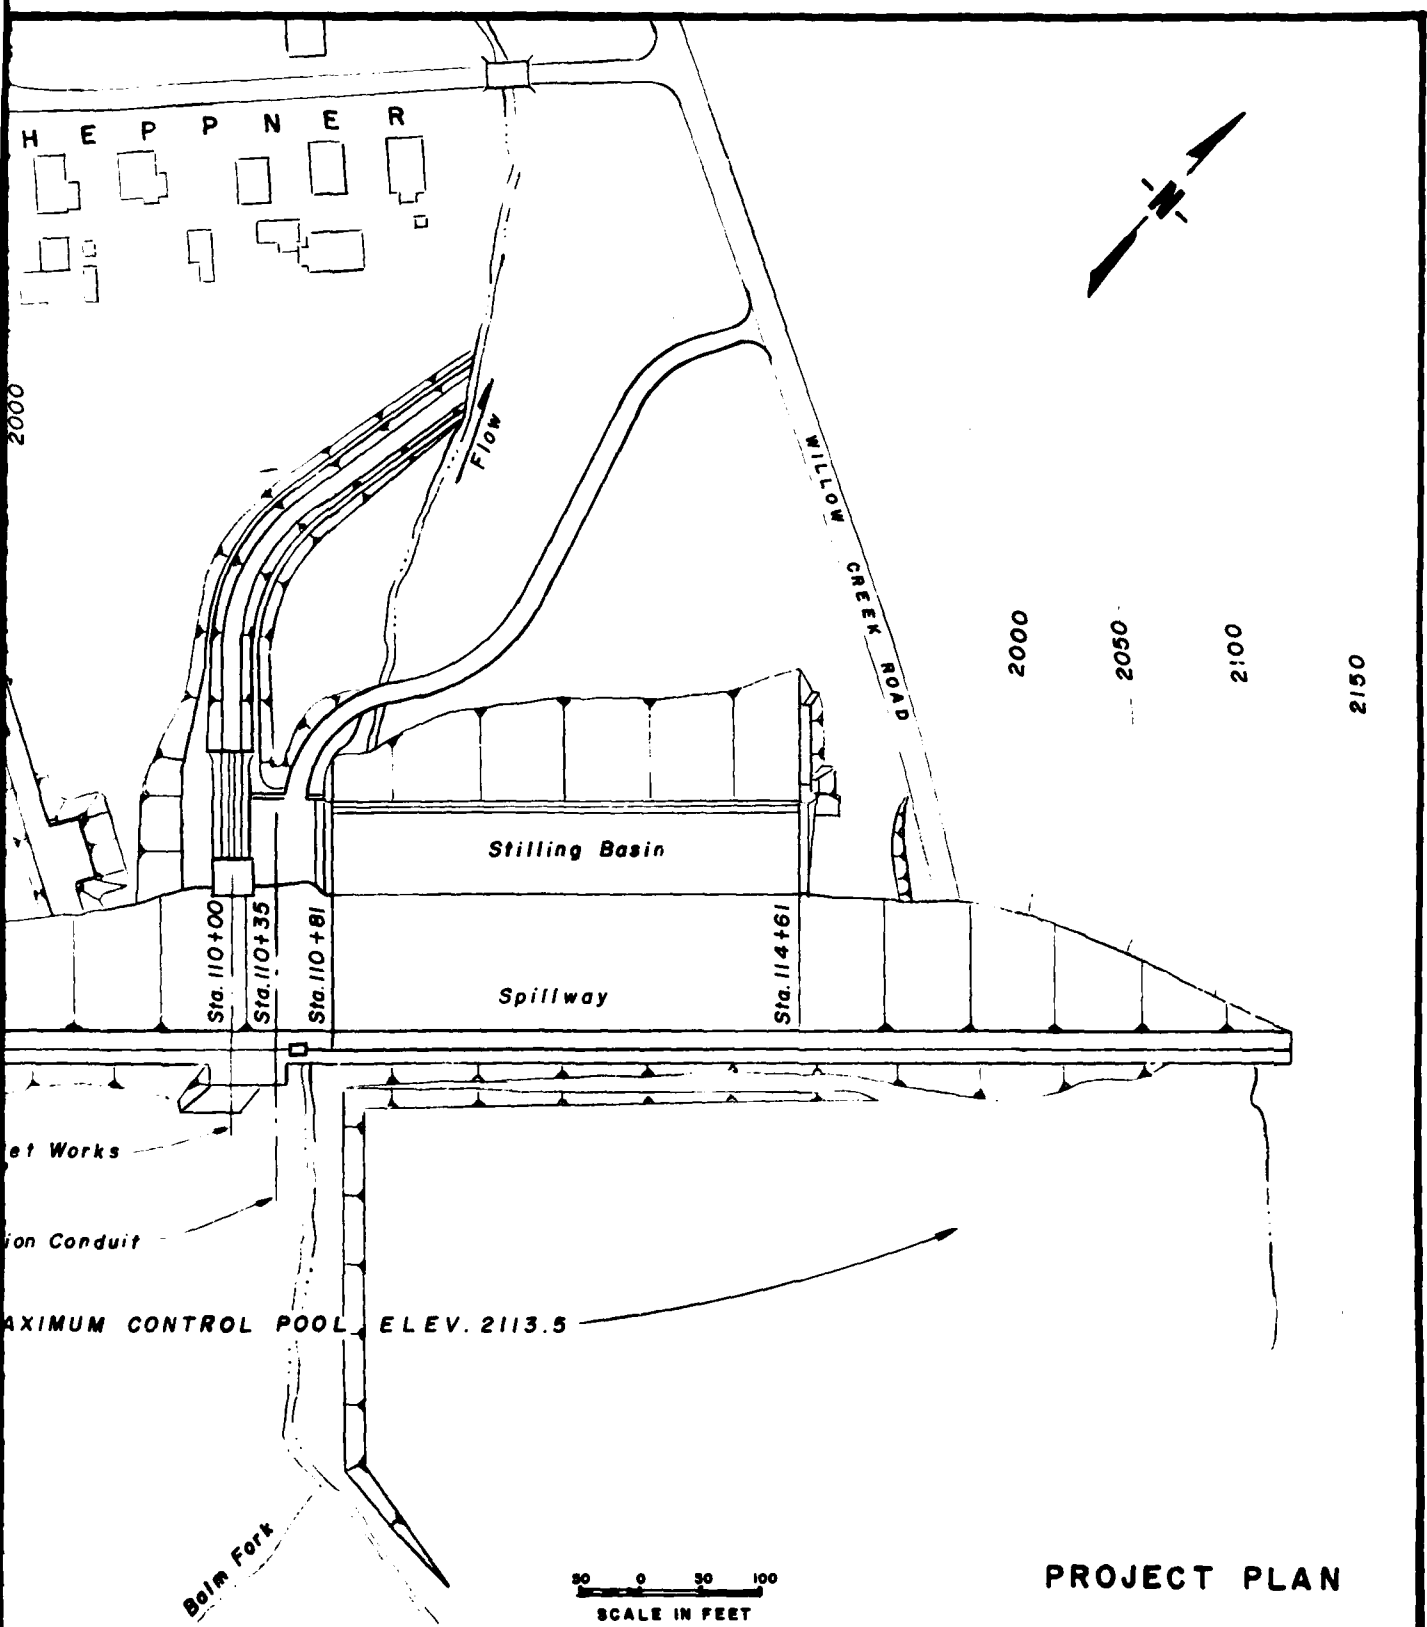
PLATE I

PROJECT PLAN

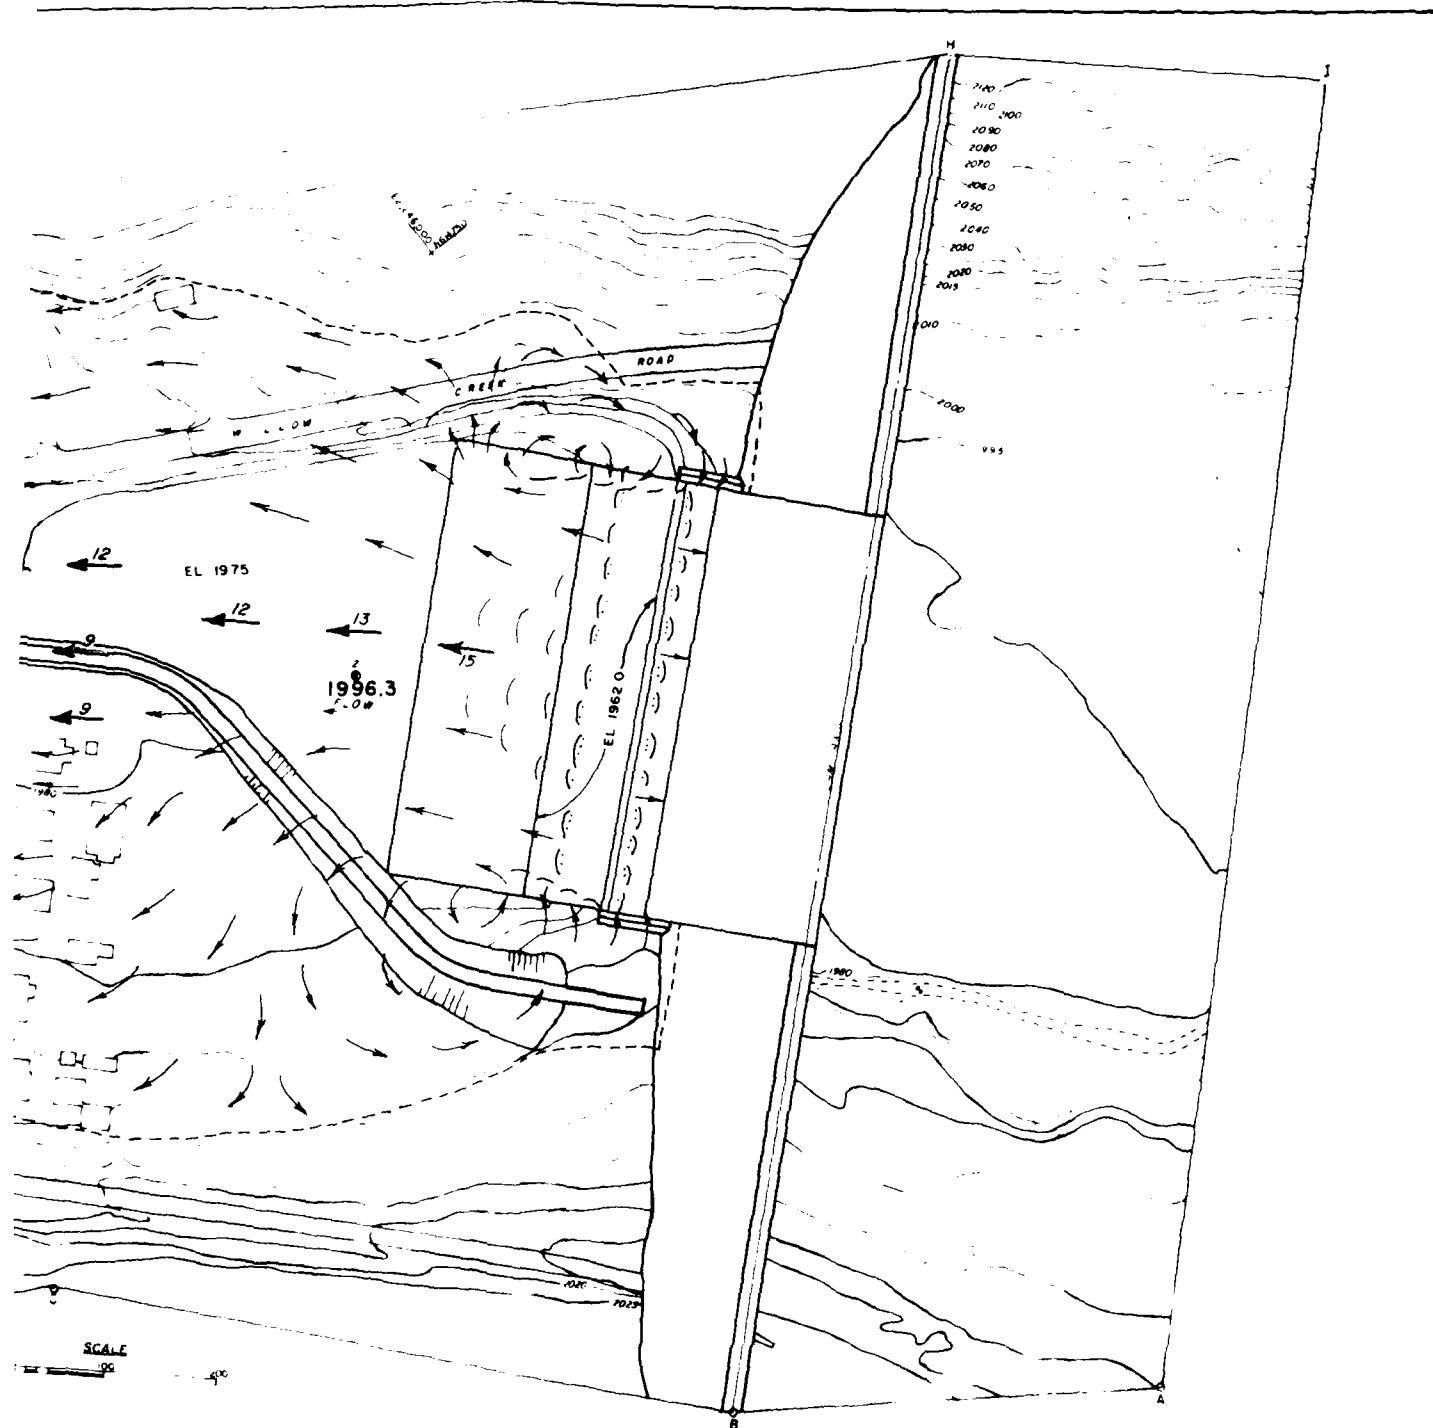
PLATE 5

FLOW CONDITIONS  
REGULATED SPILLWAY DESIGN FLOOD  
DISCHARGE 91 700 CFS

STILLING BASIN FOR 91 700 CFS WITH SCOUR  
AND 4-FT-HIGH END SILL INSTALLED

11. The addition of a 4-foot-high sloping end sill at the downstream end of the concrete apron was sufficient to contain the hydraulic jump within the basin apron and runout slope for all discharges up to 91,700 cfs (photographs 8 and 9). At the design discharge and with the end sill added, velocities on the excavated runout slope were 15 fps and velocities over the simulated scoured area downstream from the runout and near Alfalfa Street were 12-13 fps (plate 5).

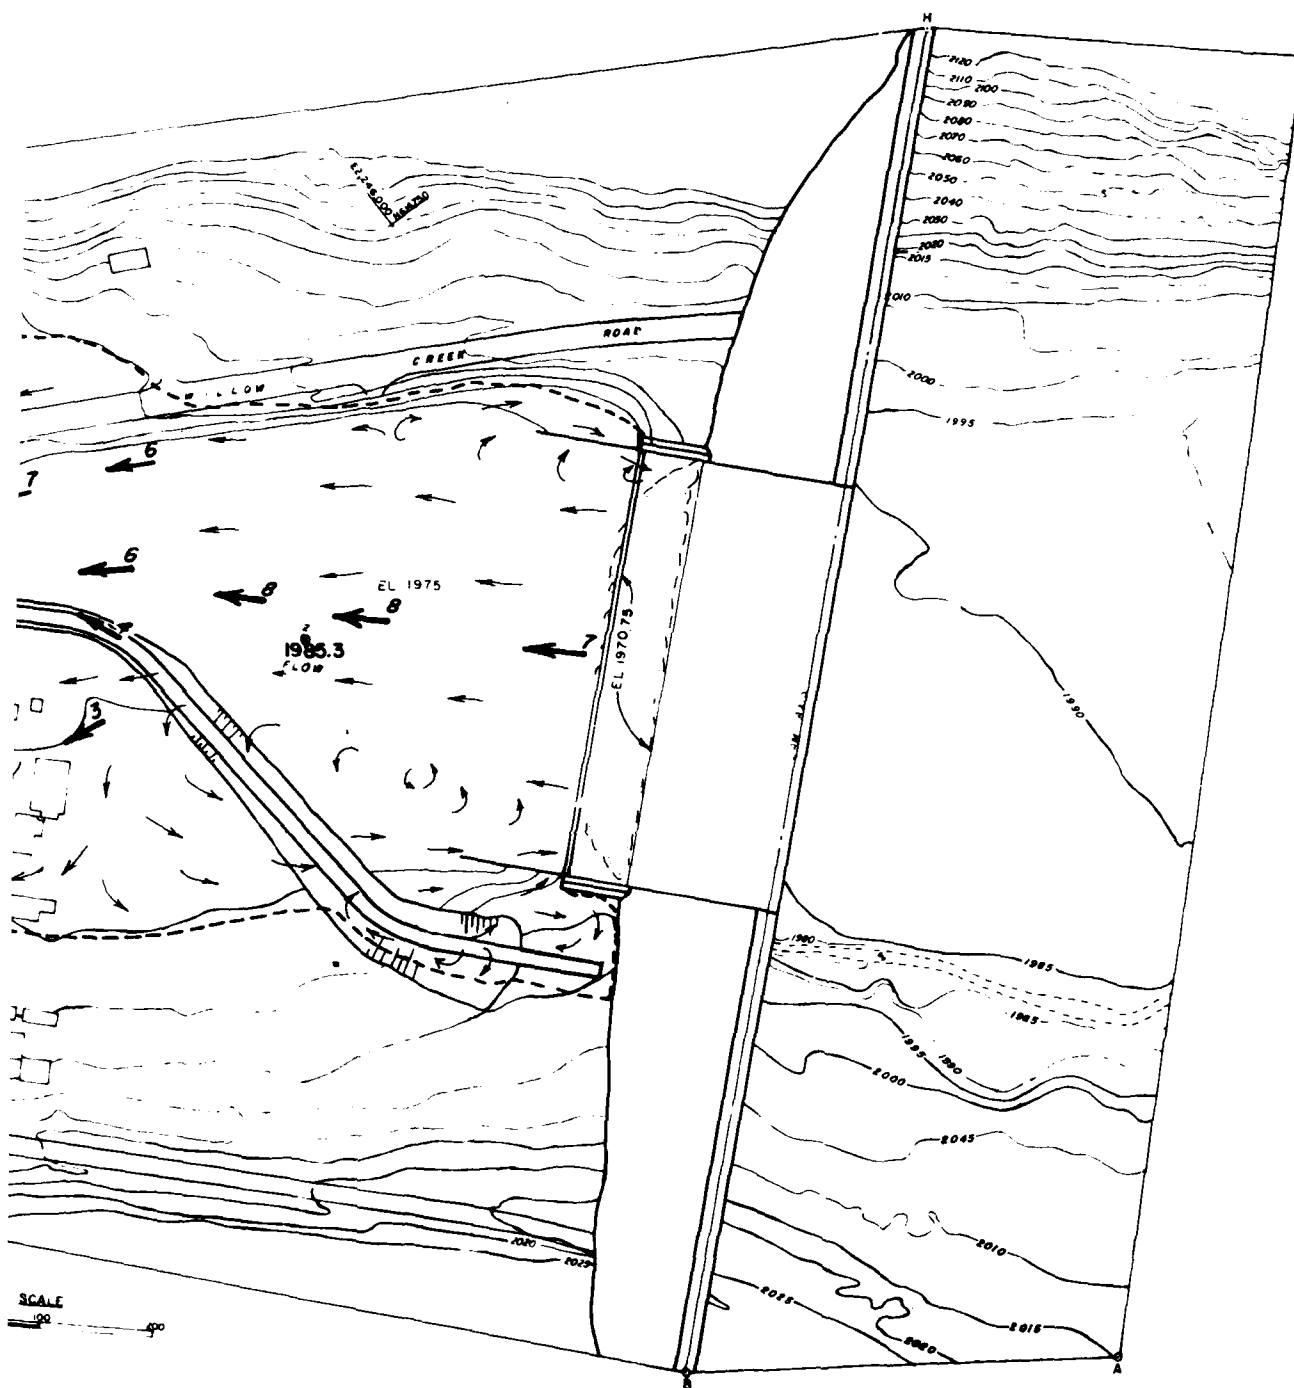
## FLOW CONDITIONS

DISCHARGE 18 000 CFS

STILLING BASIN FOR 18000 CFS WITH SCOUR

area just downstream from the basin, 6 fps at Alfalfa Street bridge, and 12 and 14 fps 100 feet farther downstream (plates 8 and 9). With a discharge of 24,000 cfs, the jump began to sweep from the basin (photograph 19). Velocities in the simulated scoured area were as high as 17 fps. Velocities were 6 fps at the bridge and 14 fps 100 feet downstream (plate 10). With 45,000 cfs, velocities were 37 fps downstream from the sweepout, 12 fps at the bridge, and 18 fps 100 feet downstream (photographs 20 and 21 and plate 11). With the spillway design flood of 91,700 cfs, velocities were 48 fps downstream from the sweepout, 26 fps at the bridge, and 36 fps about 100 feet downstream (photographs 22 and 23 and plate 12). Flooding conditions with the regulated thunderstorm SPF and the SDF are shown in photographs 24 and 25.

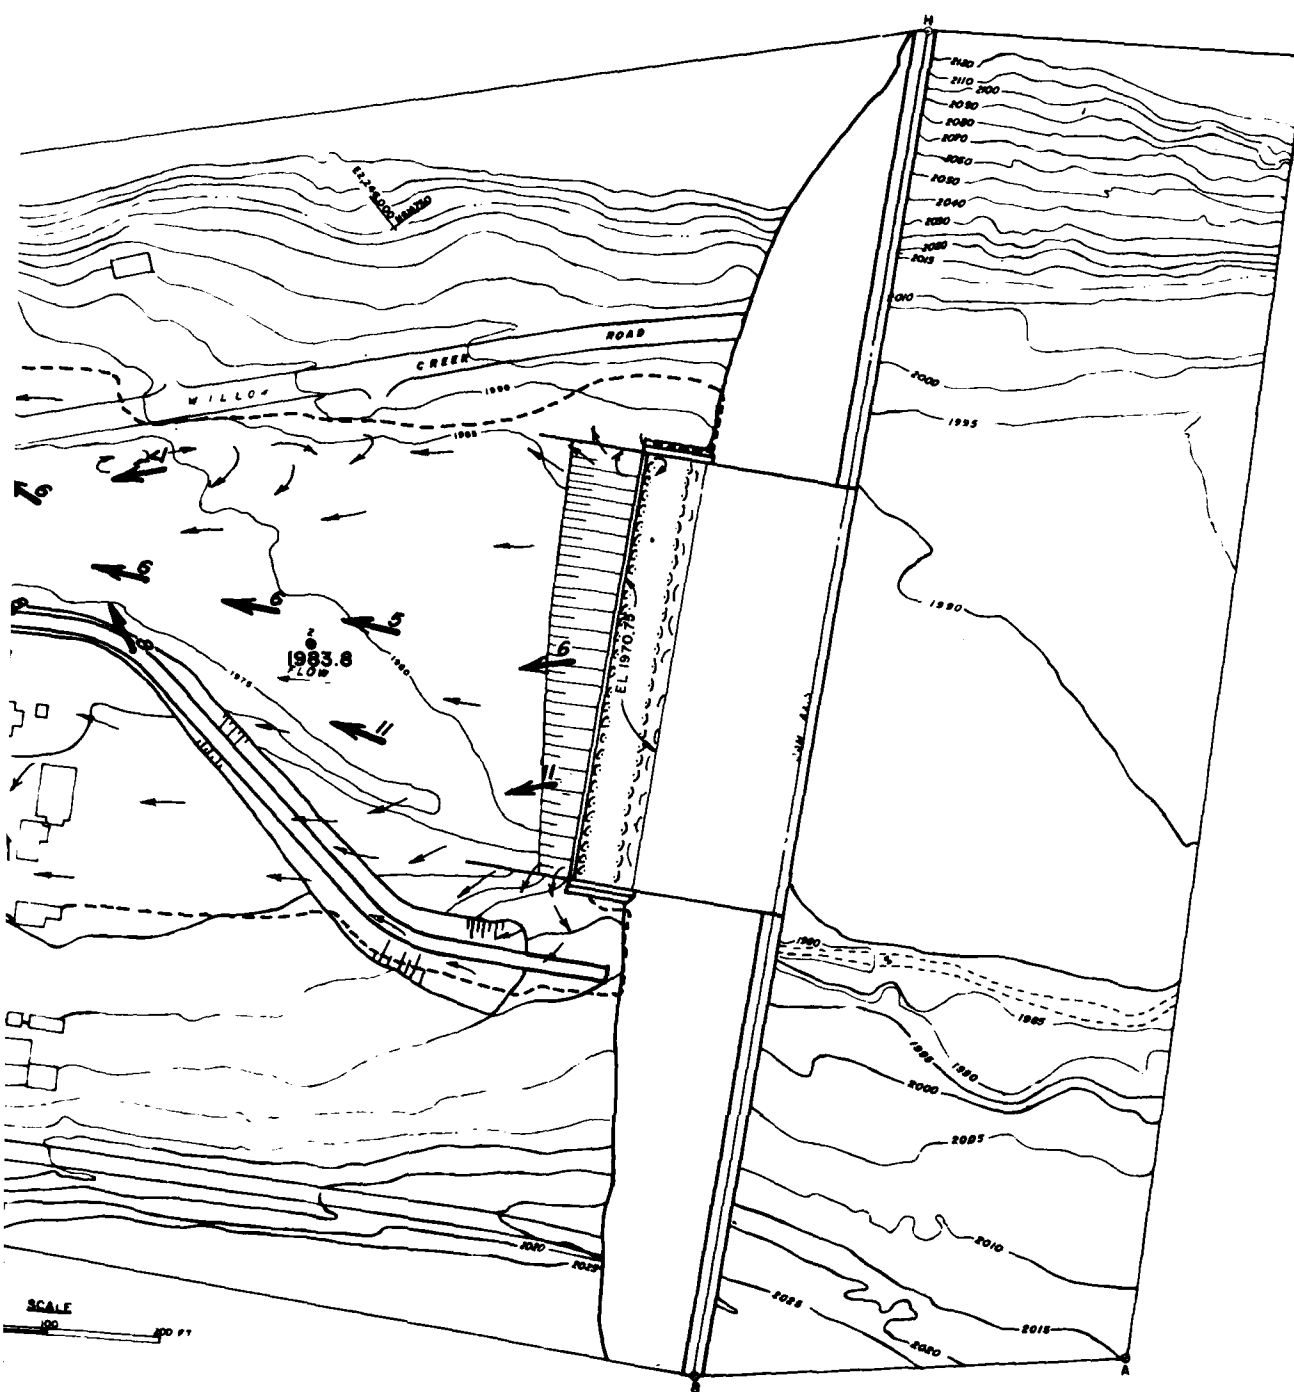
FLOW CONDITIONS  
 REGULATED STANDARD PROJECT FLOOD  
 DISCHARGE 11 700 CFS  
 STILLING BASIN FOR 18 000 CFS  
 WITHOUT SCOUR

15. Performance of the Plan C basin was also evaluated assuming no scouring would occur downstream from the basin (photographs 26 and 27). Flow conditions assuming no scour of the overburden downstream with discharges of 11,700 and 18,000 cfs are shown on plates 13 and 14. Velocities across the overburden were 11 and 12 fps. Velocities were 12 and 13 fps under the Alfalfa Street bridge and 12 and 14 fps just downstream from the bridge. The velocities in the area upstream of the bridge were approximately double those occurring with the area assumed to be scoured to rock. A good hydraulic jump formed in the basin with both flood discharges (photographs 28 and 29). Maximum water surface behind the basin walls was at elevation 1989.0, 1 foot below the walls (plate 14). The jump began to sweep out of the basin with a discharge of 38,800 cfs (photograph 30 and plate 15).

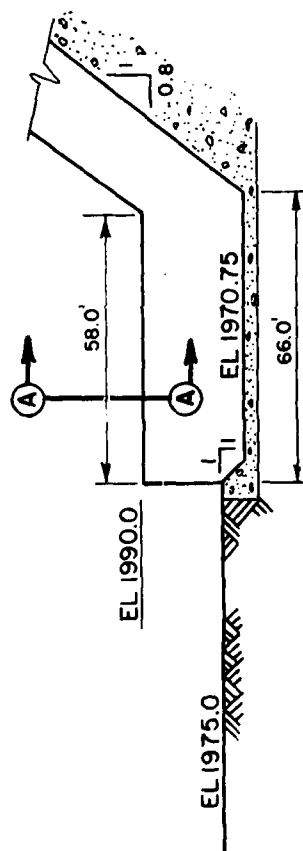
STILLING BASIN PLAN C  
WITHOUT CURVED BUCKET  
FINAL DESIGN

WALL SECTION A-A

16. The Plan C stilling basin without a curved bucket (plate 16) also performed well and was selected as the final design. A good hydraulic jump formed in the basin with the design discharge of 18,000 cfs (photograph 31). Impact pressures on the basin floor 26 inches from the intersection with the spillway chute were 77 feet of water with a discharge of 91,700 cfs, 59 feet with 65,000 cfs, and 43 feet with 45,000 cfs.

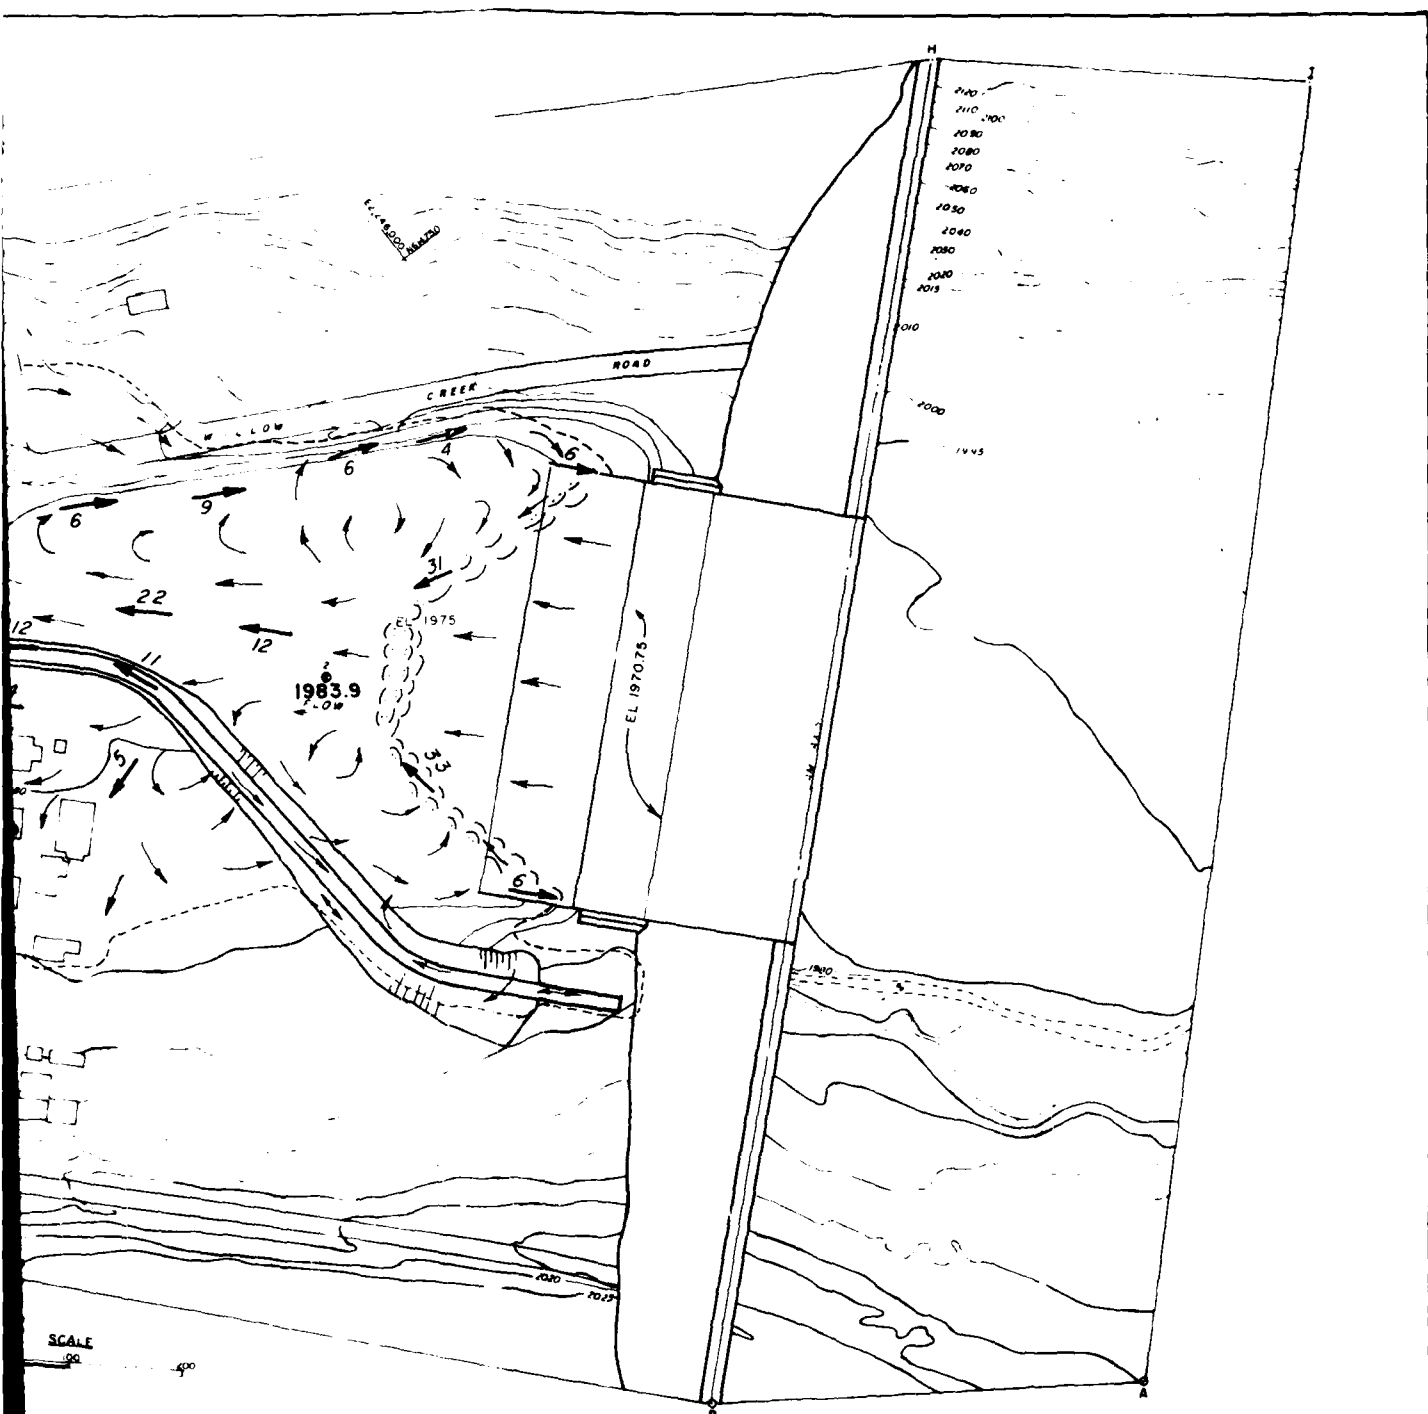
# FLOW CONDITIONS

DISCHARGE 24 000 CFS

STILLING BASIN FOR 18000 CFS WITH SCOUR  
AND NO END SILL

17. Flow conditions assuming the end sill washed out and the area immediately downstream scoured to rock are shown on plates 17 through 19 for the greater-than-design-discharges of 24,000, 45,000, and 91,700 cfs. Flow swept out of the basin and a hydraulic jump formed in the scoured area downstream (photographs 32 and 33). With 91,700 cfs, the jump was at Alfalfa Street (photograph 34). Velocities at the jump were as high as 46 fps.

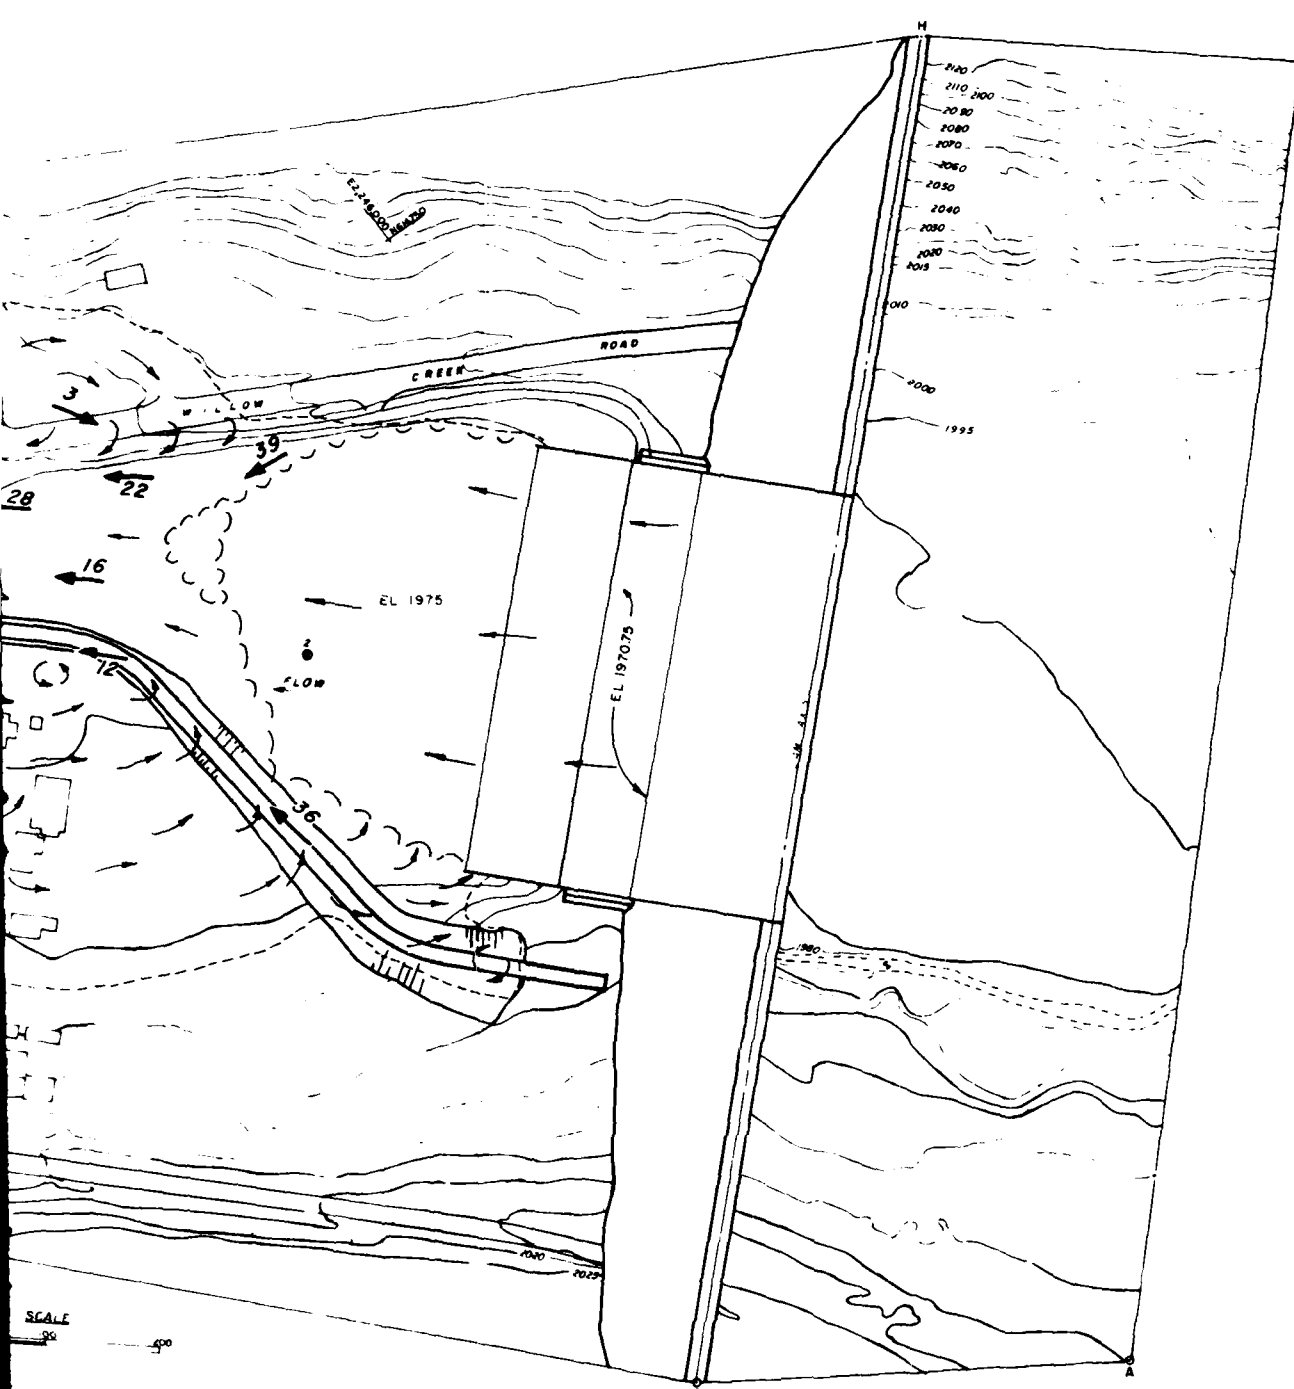
FLOW CONDITIONS

DISCHARGE 45 000 CFS

STILLING BASIN FOR 18000 CFS WITH SCOUR  
AND NO END SILL

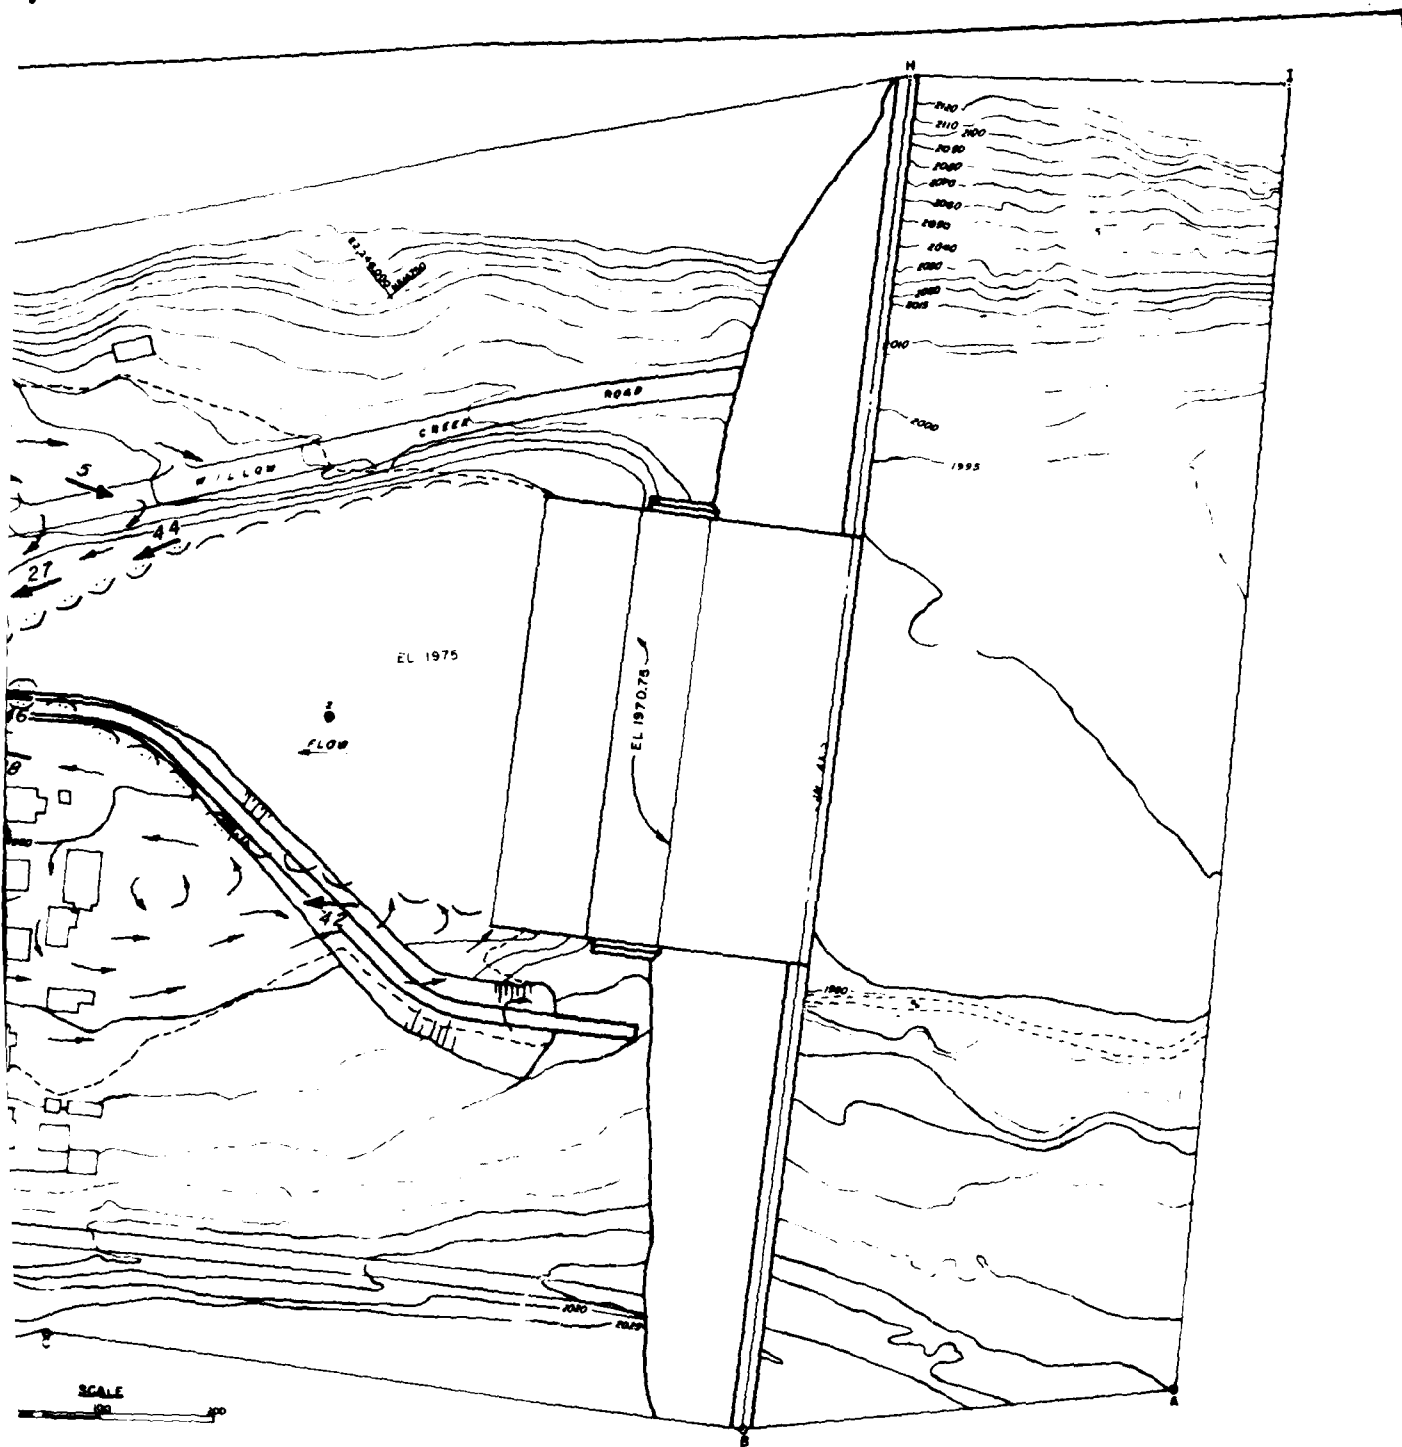
FLOW CONDITIONS  
REGULATED SPILLWAY DESIGN FLOOD  
DISCHARGE 91 700 CFS

STILLING BASIN FOR 18000 CFS WITH SCOUR  
AND NO END SILL
