REPORT NO. NADC-84009-60

PHYSIOLOGICAL ACCEPTABILITY TESTS OF THE MODIFIED SJU-5/A EJECTION SEAT FOR THE F-18 AIRCRAFT

PHASE REPORT
May to June 1983
AIRTASK NO. A511-5113F/001-F/4W1662-000

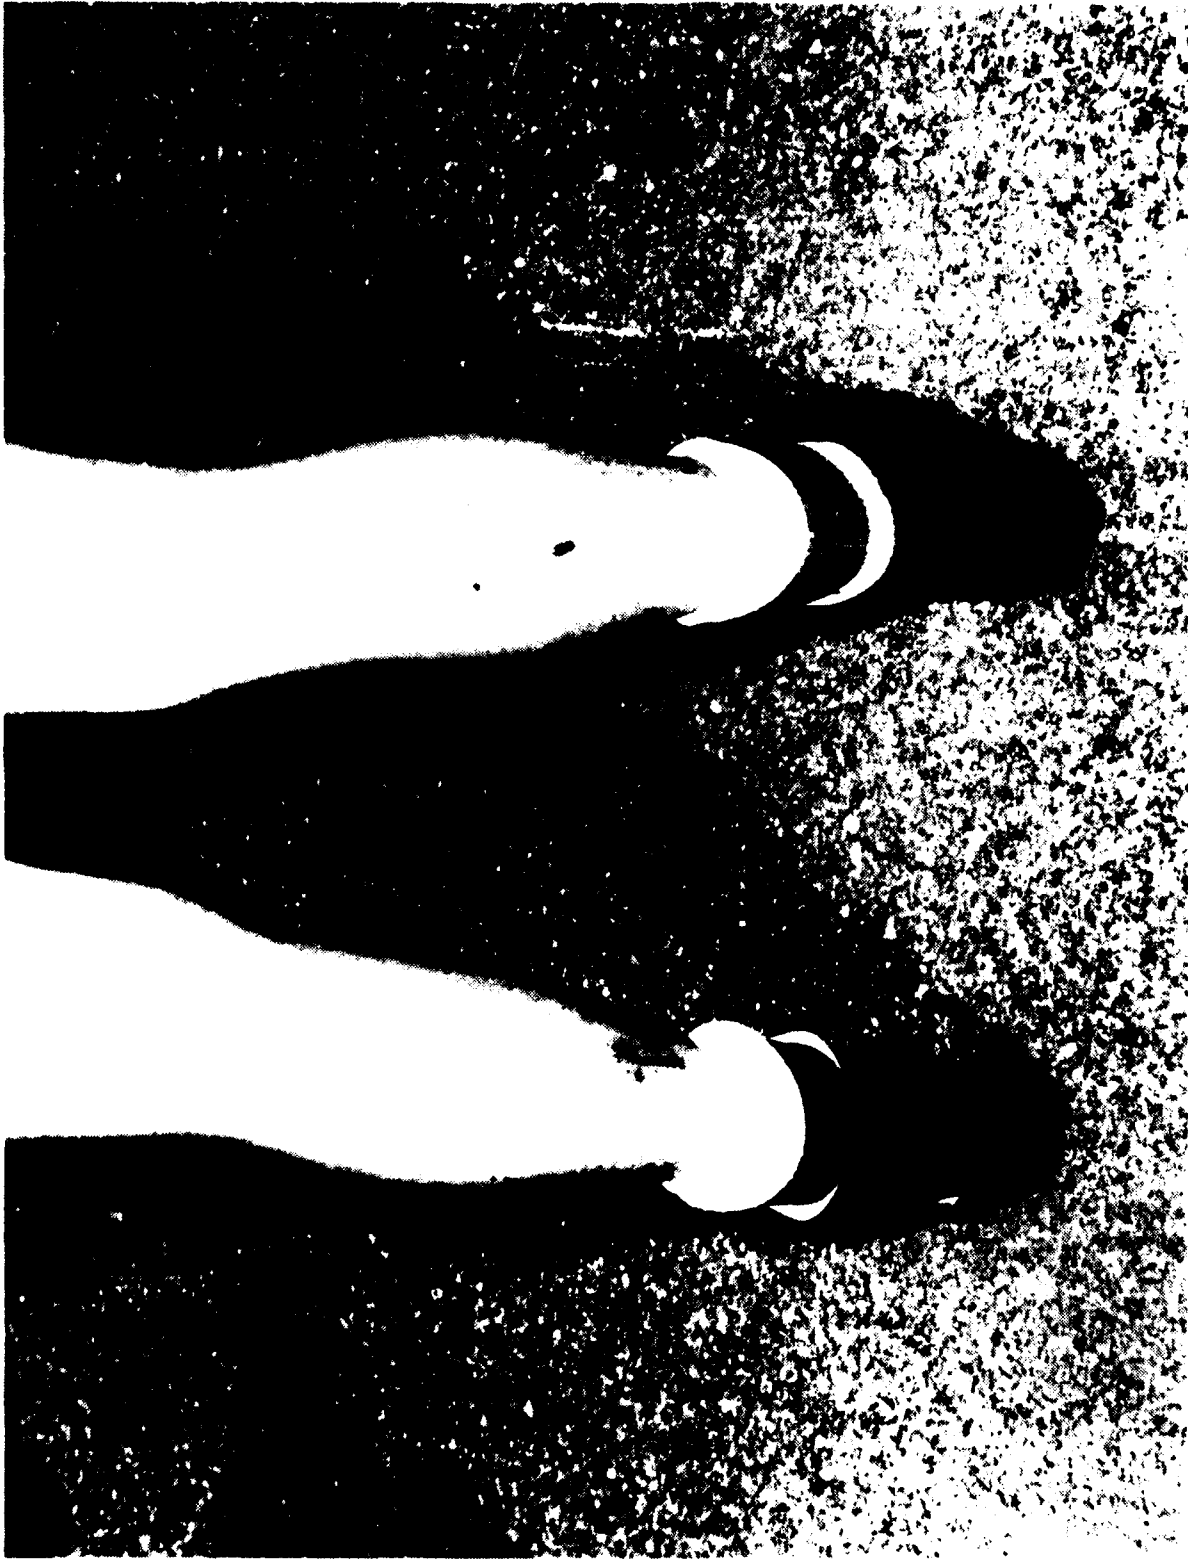
Figure 1. Powder Burns on Subject's Calves

3. Singed hair or powder burns on the back of the subject's legs. (Figure 1)
4. Tenderness near the subject's shoulder blades but no marks.
5. Small blood clot below the right scapula, contusions and abrasions below both scapulas. The pain below the right scapula persisted for over 24 hours. This condition is unacceptable. (Figure 2)

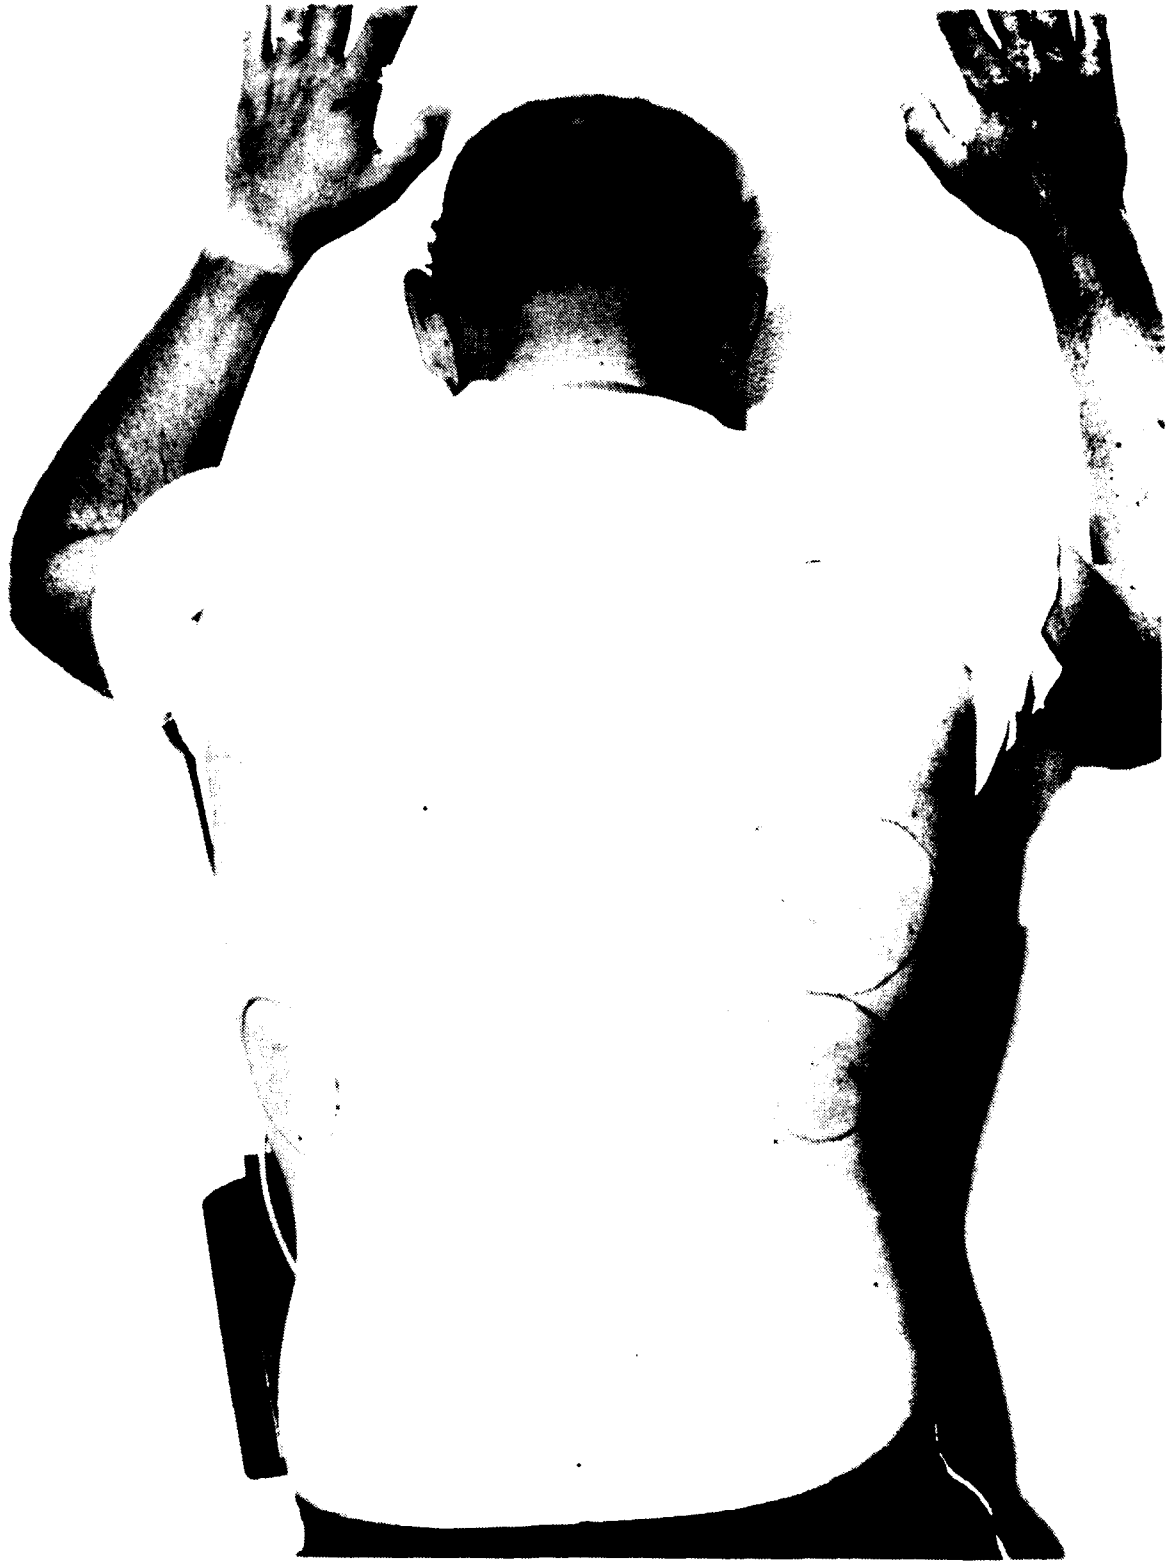
Figure 2. Bruises on Subject's Back

The backwedge as presented at the onset of this test series is unacceptable because it allows scapula impingement. Figure 10 shows the location of the scapula of subject No. 3 with respect to the backwedge. This same subject is shown in figure 11 just prior to ejection initiation and at 6 inches of seat travel. His upper torso can be seen above the backwedge even as his body compresses during the ejection stroke. In order to complete the test program an ensolite pad was placed above the backwedge to prevent scapula impingement. The ensolite was cut to match the contour of the backwedge then placed in a pocket that was sewn to the cushion. Velcro was used to keep the ensolite on top of the backwedge.

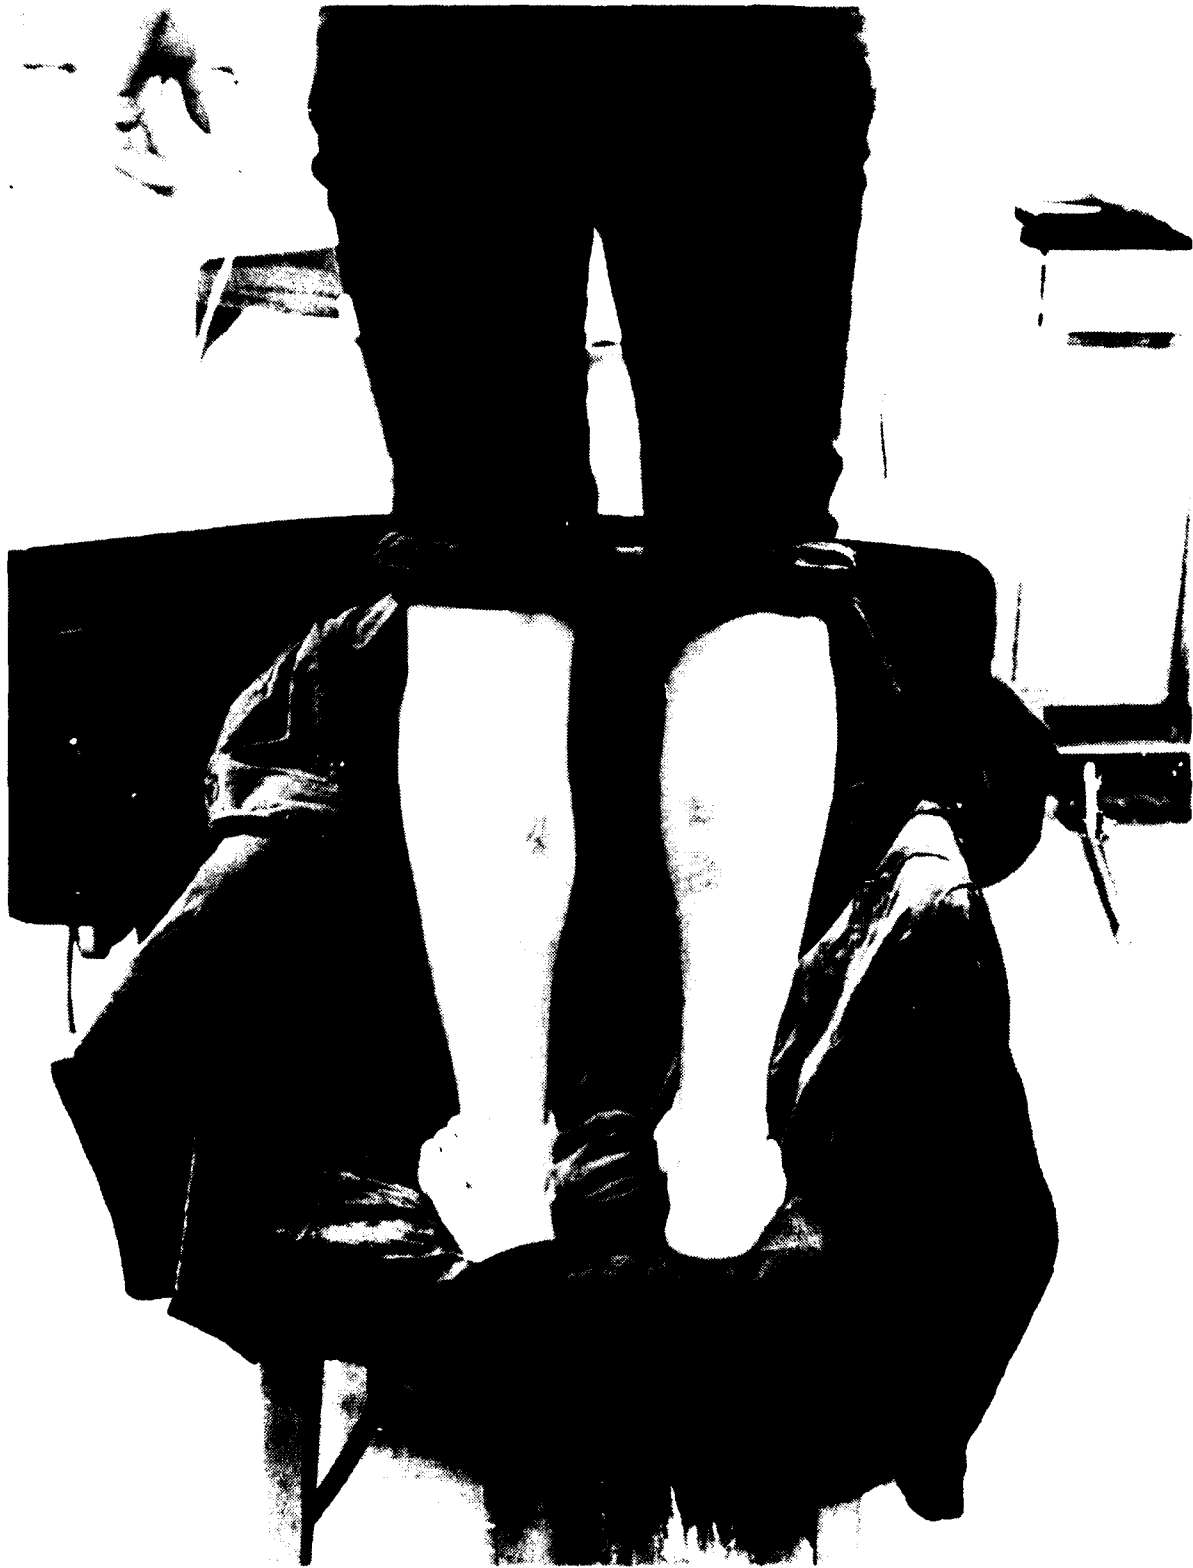
Figure 3. Bruises on Subject's Calves

6. Tenderness or bruising on the subject's calves. (Figure 3)
7. Tenderness near the subject's coccyx.
8. Soreness of the neck and upper back the following day.

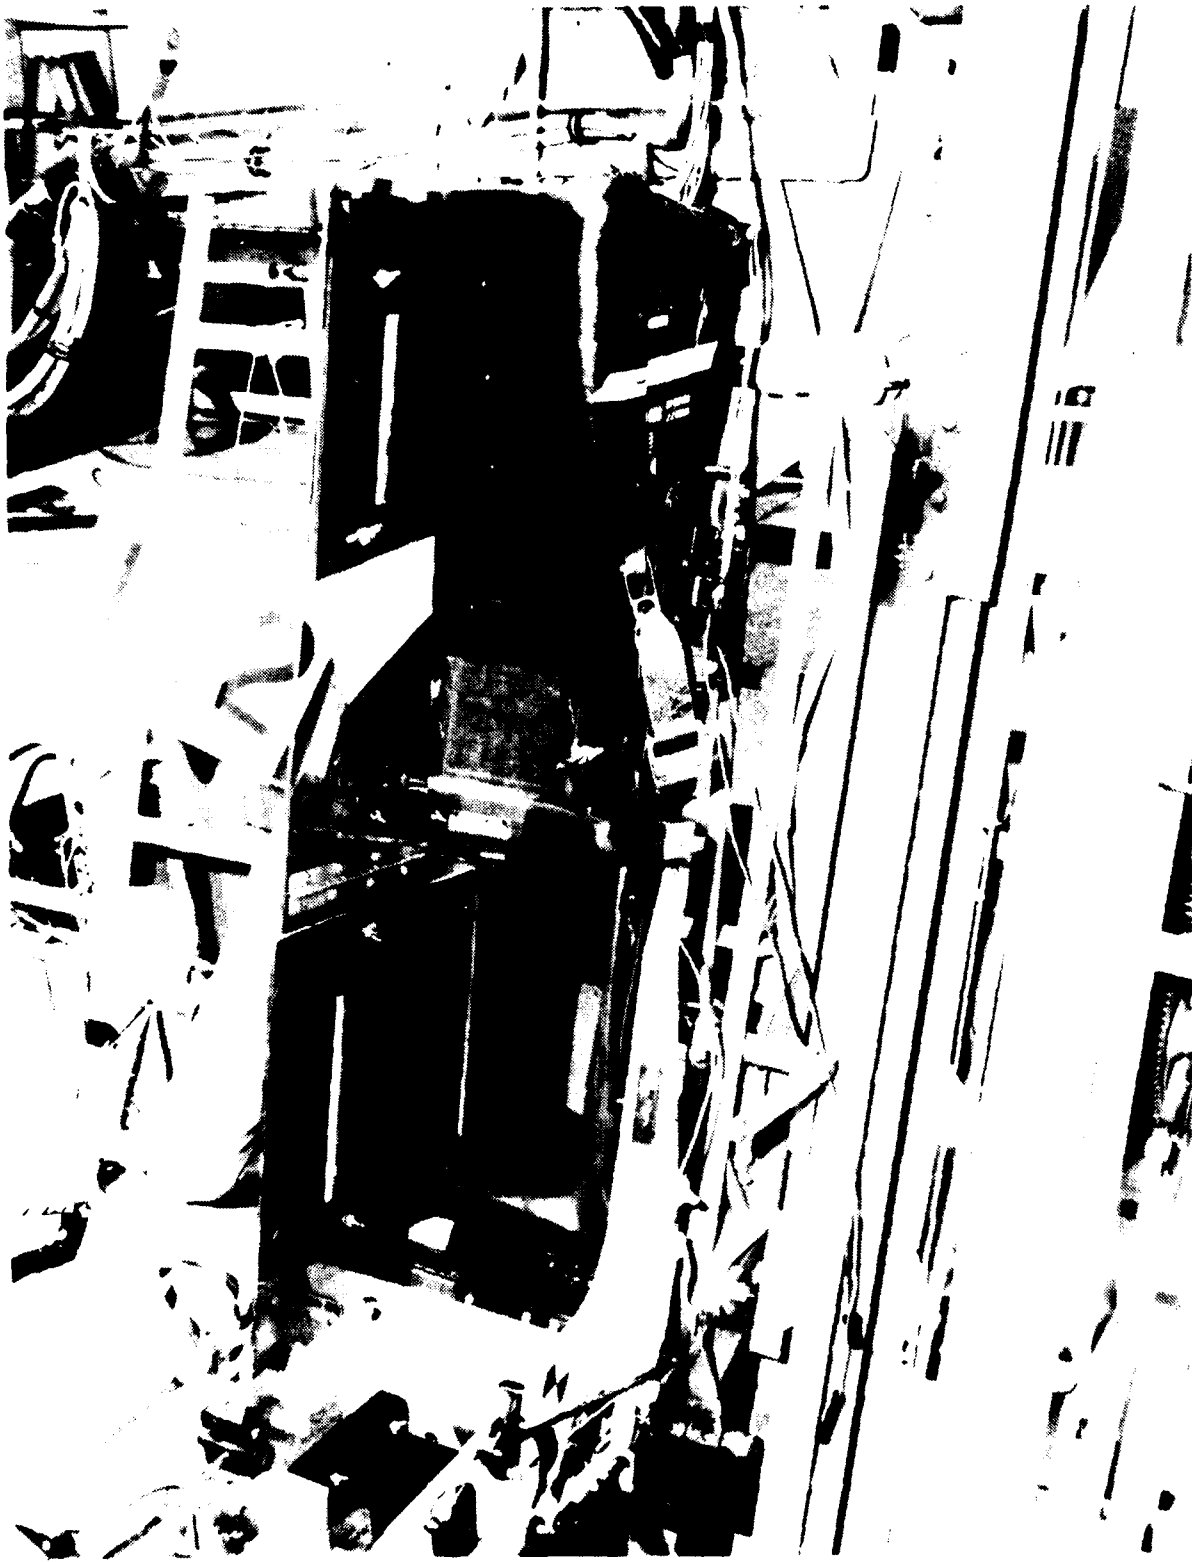
Figure 4. Template Showing Proper Seat Full Down Configuration

The new backwedge and head rest pad geometries were verified before the tests by the use of a template supplied by McDonnell Douglas Corporation. This template can be seen on the seat in figures 4 and 5. The subjects experienced almost no head rotation with the new seat geometry during this test as seen in figures 6 through 9 showing each subject at the end of the catapult stroke.

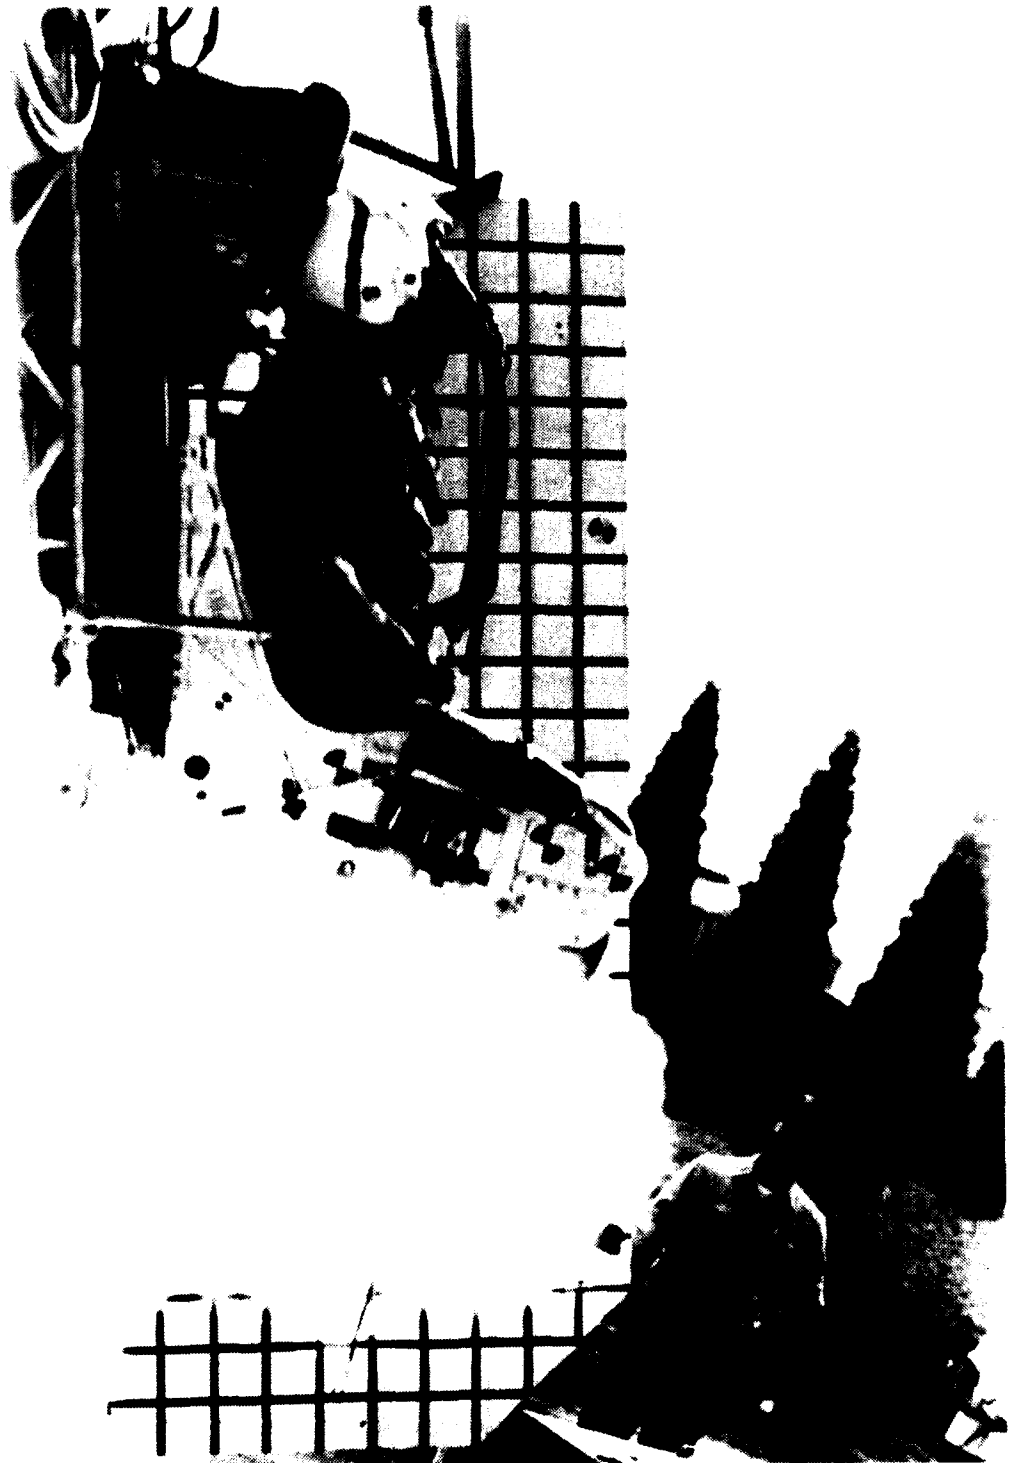
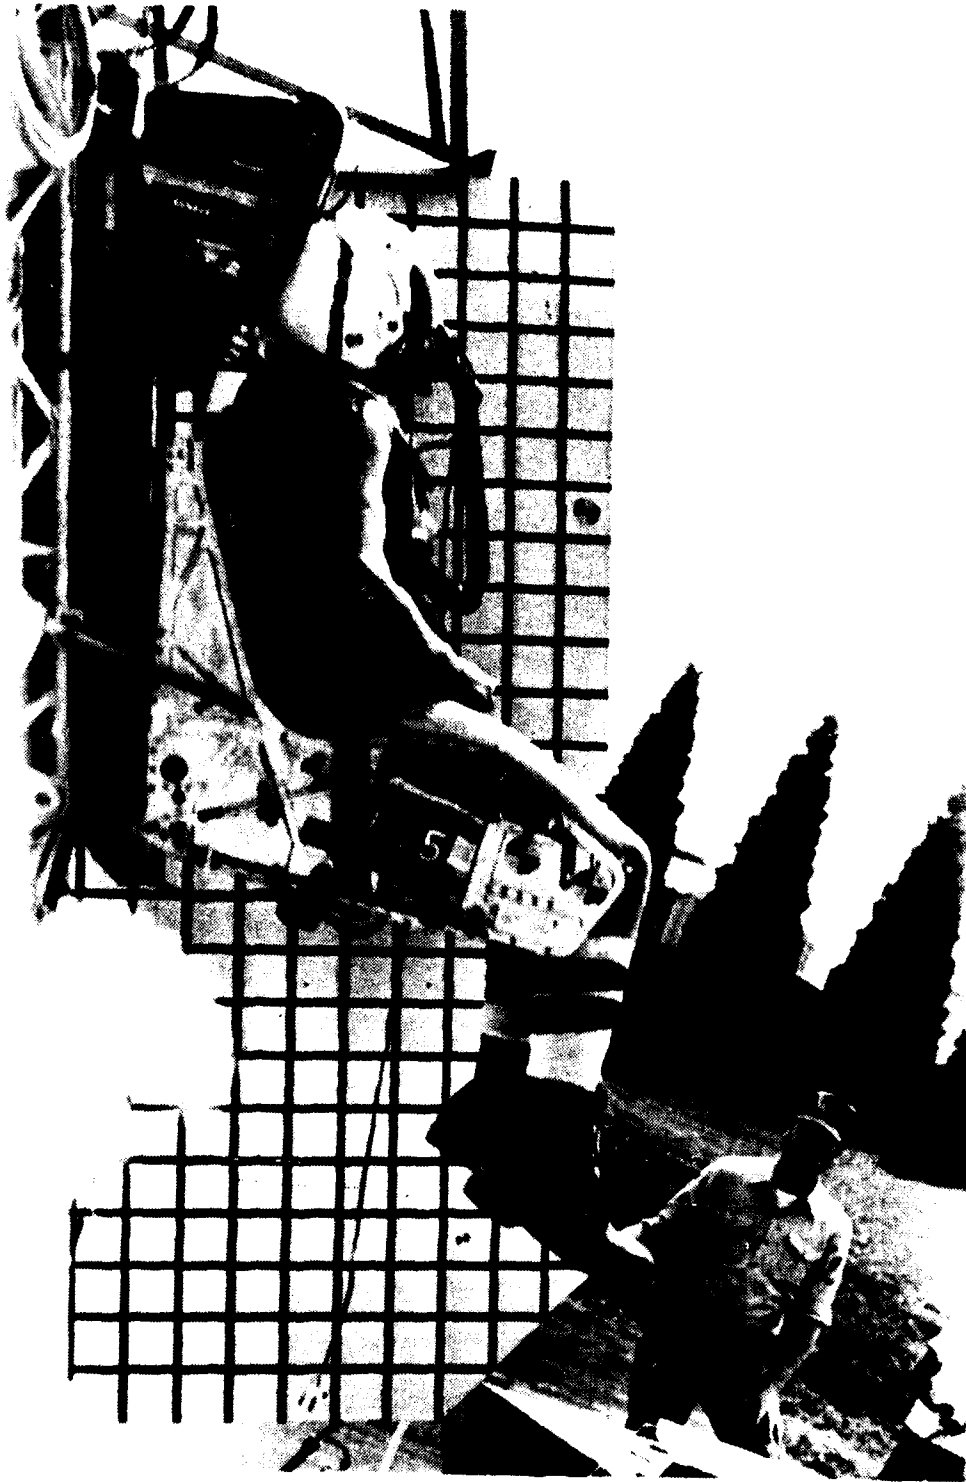
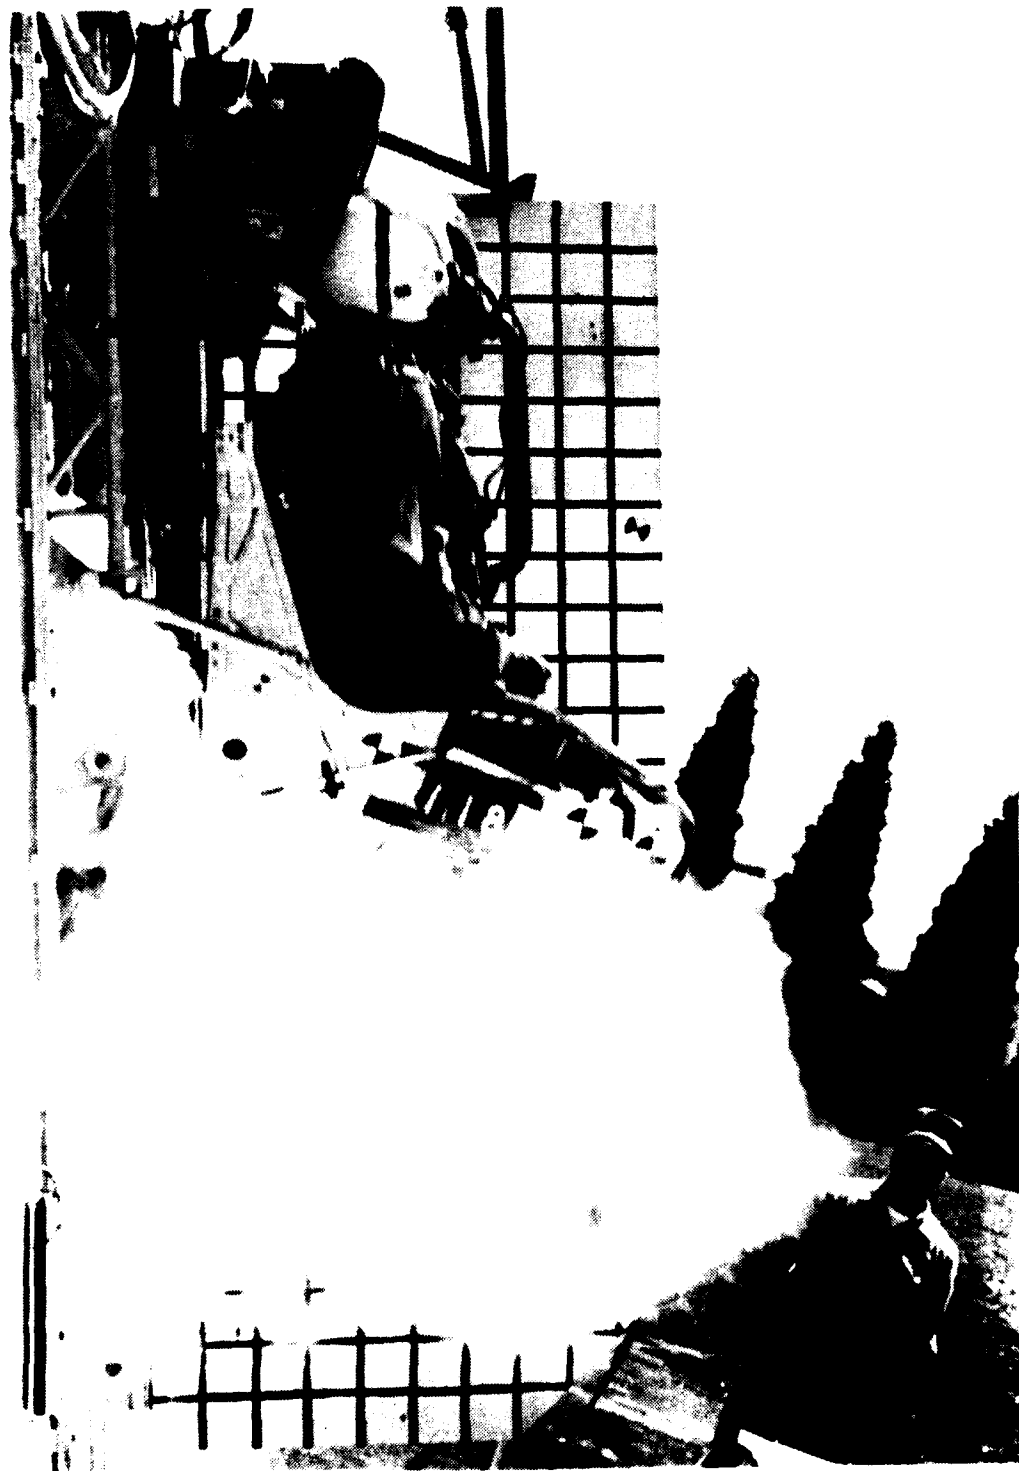
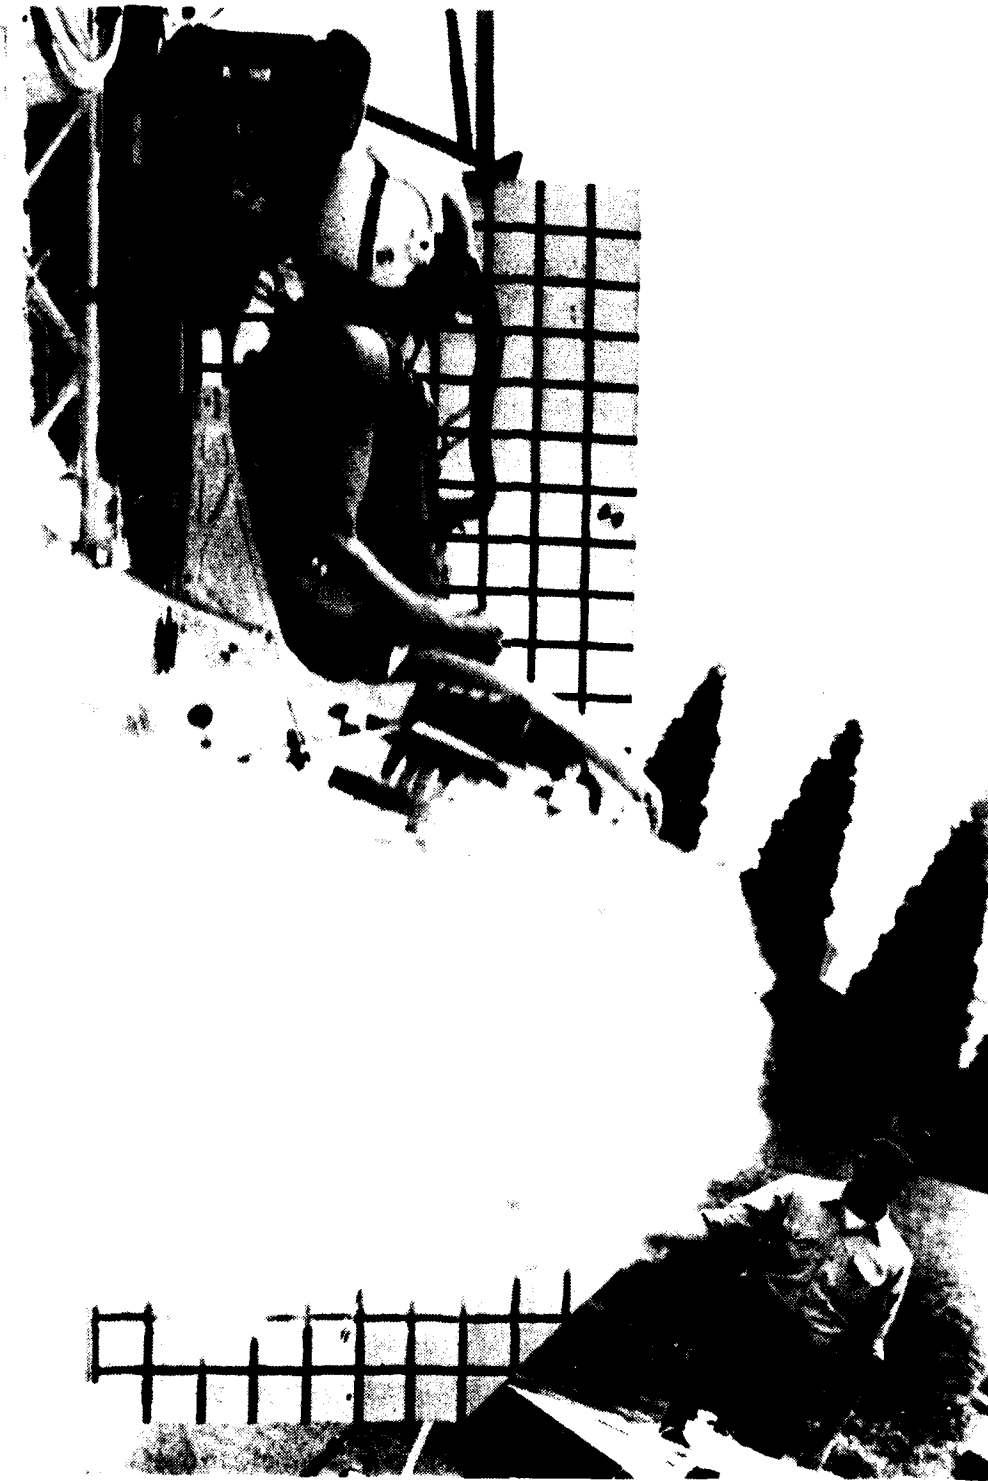
Figure 6. Subject No. 1 at End of Catapult Stroke

Figure 7. Subject No. 2 at End of Catapult Stroke

Figure 8. Subject No. 3 at End of Catapult Stroke

Figure 9. Subject No. 4 at End of Catapult Stroke

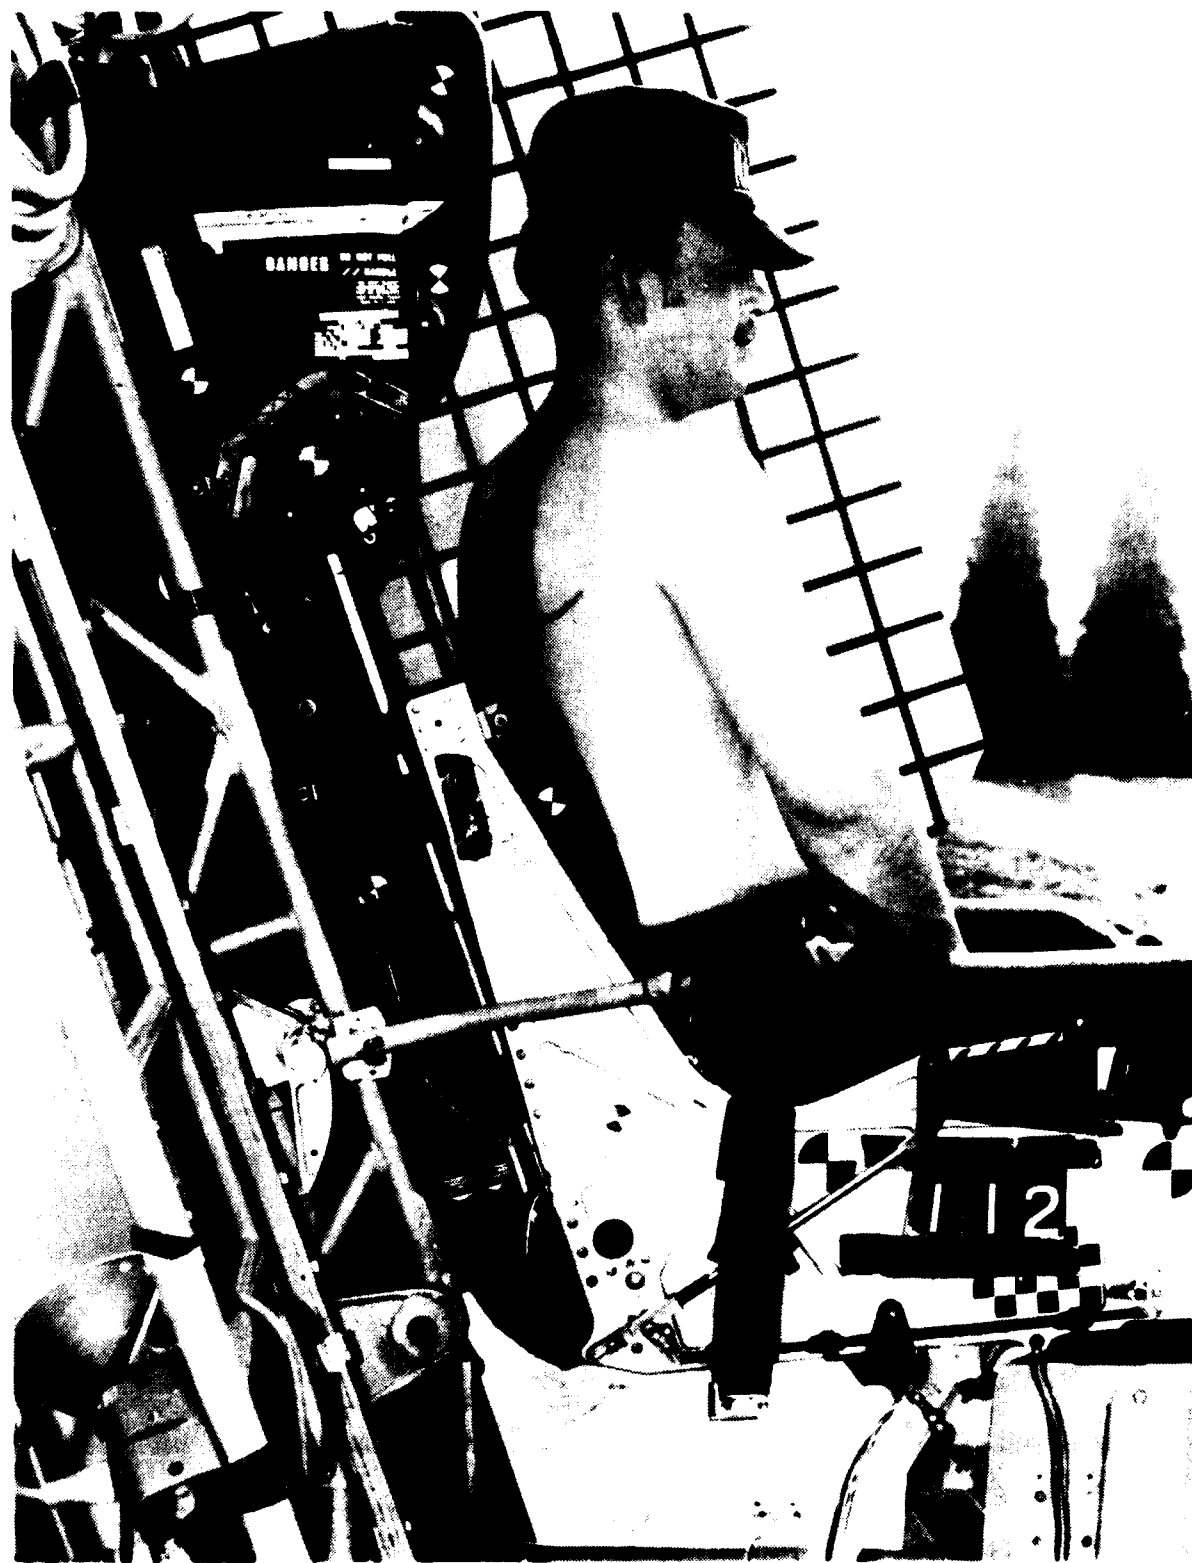
Figure 10. Scapula Location for Subject No. 3

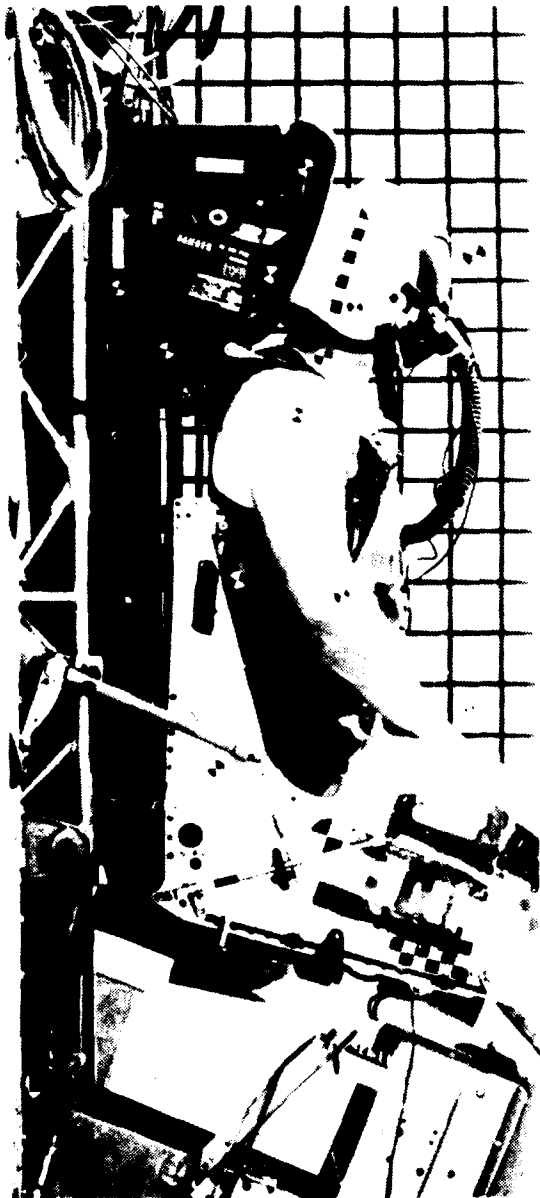
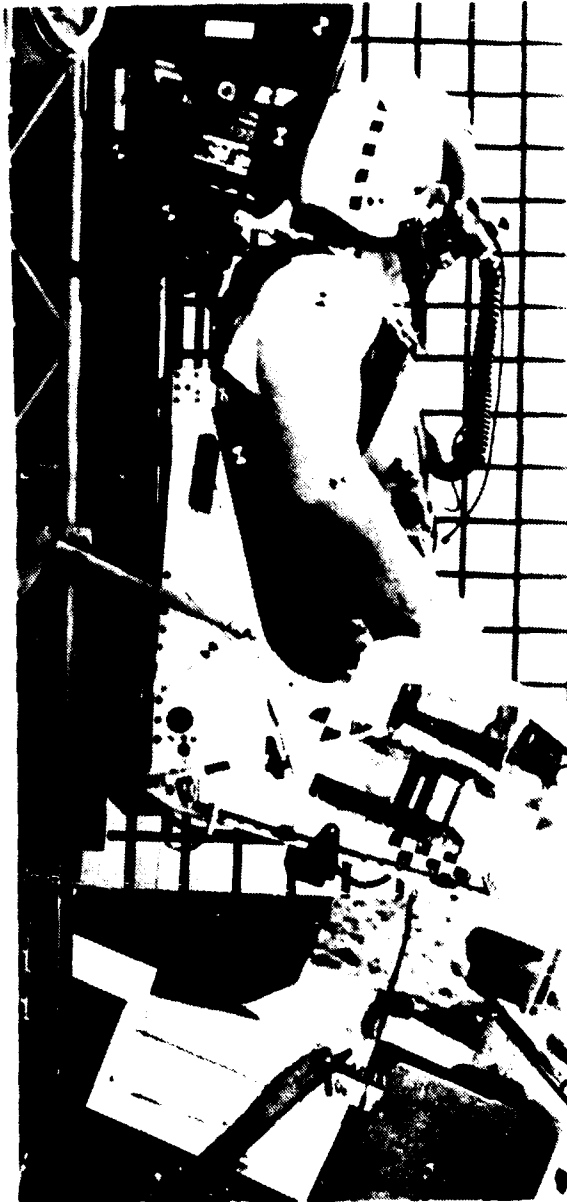
Before Ejection

6 In. of Seat Travel

Figure 11. Subject 3 Before and During Test No. 15
