# **A New Approach to the Evaluation of the Effects of Stress State and Interfacial Properties on the Behavior of Advanced Metal Matrix Composites**

by  
J. E. Hack  
R. A. Page  
G. R. Leverant

TECHNICAL REPORT  
Contract No. DAAG29-81-K-0049

May 31, 1984

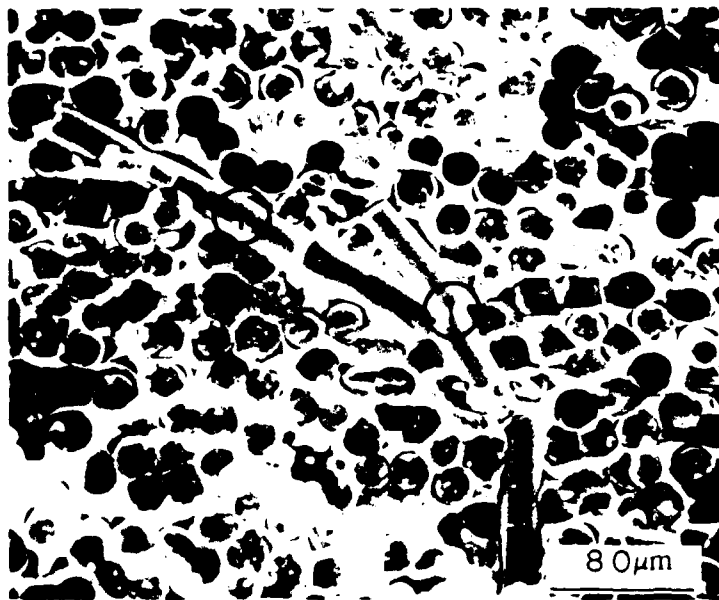
Figure 5. Typical process defects responsible for crack initiation in axial specimens:  $\text{Al}_2\text{O}_3$  fiber reinforced CP Mg (a) transverse fibers (Area 1), and (b) clumps of  $\text{Al}_2\text{O}_3$  grains (Area 2).

axis. The features of the fatigue and overload failures were so similar that it was impossible to determine the extent of fatigue cracking from examinations of the fracture surface. River markings on the fracture surfaces however, indicate that cracking had initiated at process defects. Two distinct types of defects were found to be responsible for fatigue crack initiation: 1) individual fibers which had broken and fallen perpendicular to the stress axis during processing; and 2) large clumps of  $Al_2O_3$  grains which were an order of magnitude larger than the average fiber diameter. Failure of both of these defects was determined (Part II) to be due to delamination of the  $Al_2O_3$ /Mg interface. Examples of the two types of defect are shown in Figure 5.

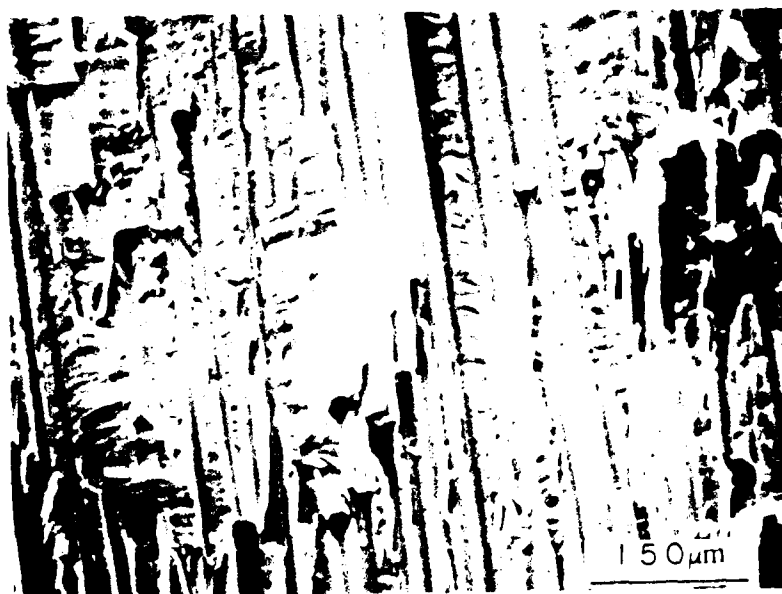
Figure 6. Scanning electron micrographs of typical overload (a) and fatigue (b) failures in off-axis specimens of  $\text{Al}_2\text{O}_3$  fiber reinforced CP Mg. Note that the failure in overload occurs almost exclusively along fiber/matrix interfaces while subcritical fatigue crack growth occurs parallel to the interfaces but primarily through the matrix.

In contrast to the axial specimens, off-axis specimens failed generally parallel to the fiber axis. Furthermore, a striking difference was observed between the fracture morphology of the fatigue and overload regions of the off-axis specimens. This difference is illustrated by the fractographs of Figure 6. The overload regions exhibited features identical to those of the off-axis tensile failures, as would be expected. Delamination of the fiber/matrix interface was the primary mode of failure in all but the 35 v/o material oriented at  $22.5^\circ$ . Thus, the fracture was oriented along the fiber axis in all but the 35 v/o material oriented at  $22.5^\circ$ . The overload failure mode was mixed in these samples, consisting of roughly equal amounts of interfacial delamination and flat fracture across fibers, and occurred approximately perpendicular to the tensile axis.

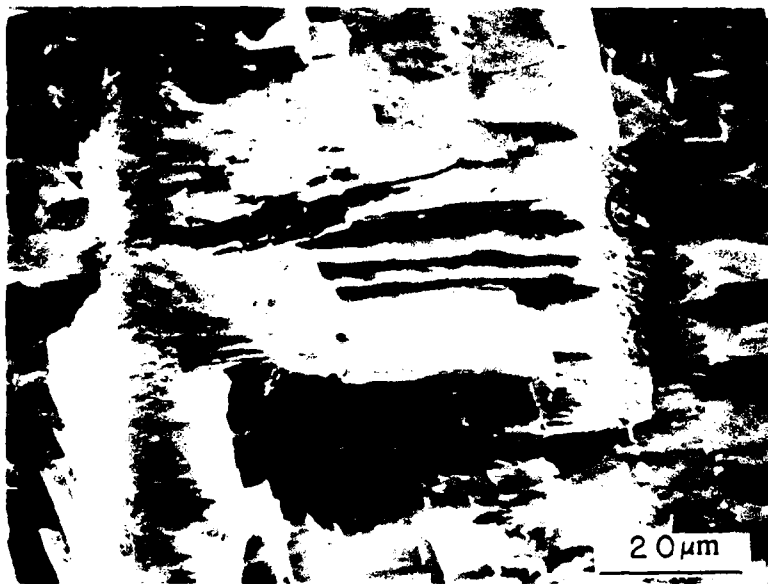
Figure 7. High magnification view of typical cleavage-like fracture morphology in fatigue thumbnail regions of off-axis specimens of  $\text{Al}_2\text{O}_3$  fiber reinforced CP Mg. Fiber trough is visible in region 1.

cleavage (9), as in Figure 7, was the predominant mode. In many instances the crystallographic features were maintained over distances corresponding to from tens to hundreds of fiber diameters. Figure 8 is typical of one such area. Examination of the fatigue regions did not indicate that process defects acted as initiation sites as they had in the axial tests. Metallographic sections taken through a number of the fatigue regions revealed numerous secondary cracks, many of which were entirely situated in matrix material. An example of the secondary cracking observed is presented in Figure 9.

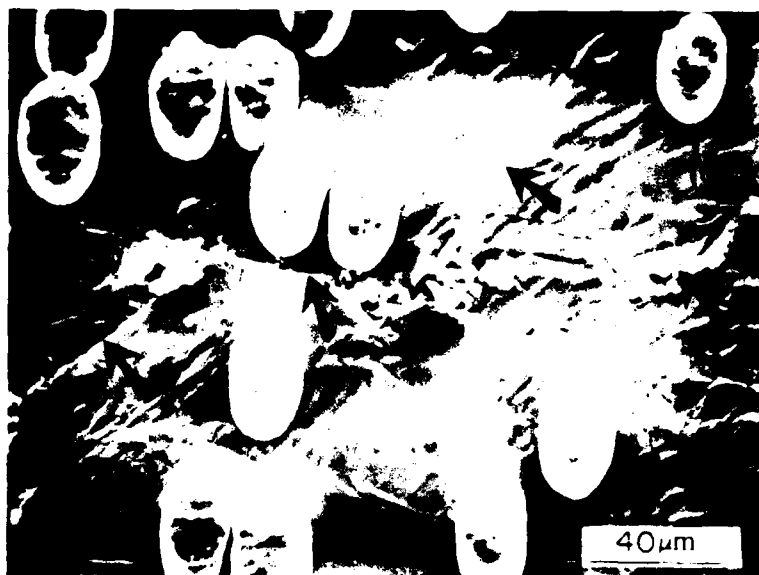
Figure 9. Scanning electron micrograph of a typical secondary crack located in the matrix of an off-axis fatigue specimen of Al<sub>2</sub>O<sub>3</sub> fiber reinforced CP Mg. Note that the cracking avoids fiber/matrix interfaces during subcritical crack growth (crack path denoted by arrows).

\* The observation that fatigue cracking occurred primarily through the matrix is supported by the fractography, Figures 9 and 11, the larger than average fiber spacing observed on the fracture surfaces, Table II, and the observations of the secondary cracks situated entirely in the matrix, Figure 12. Furthermore, sections through the thumbnails indicated that the fatigue cracks tended to step around fibers.

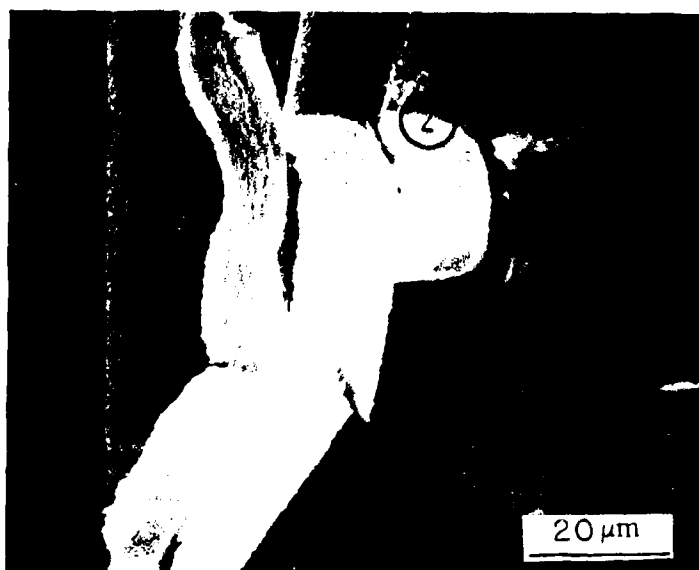
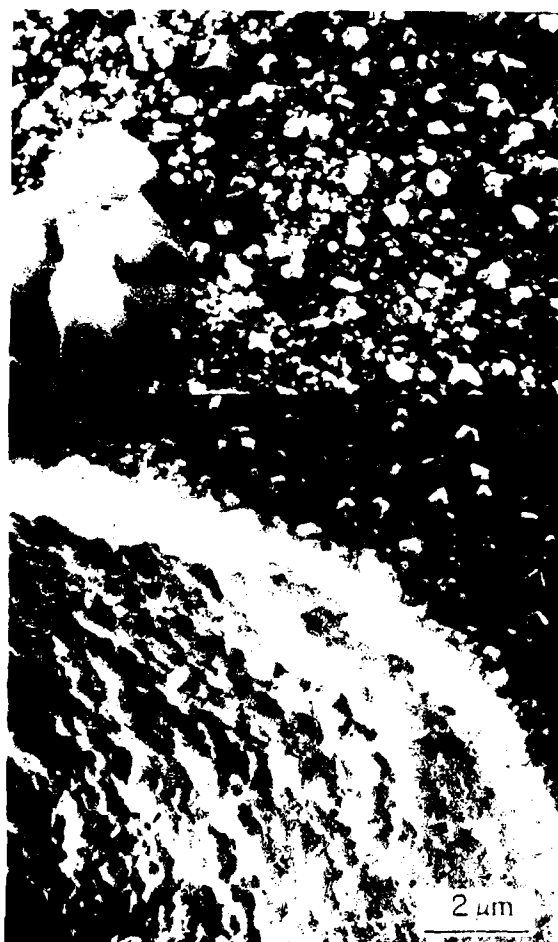
Figure 6. Scanning electron micrograph of a ZE41A specimen fractured in the scanning Auger microprobe. A high magnification view of the fiber surface in Area 2 is shown in (b).

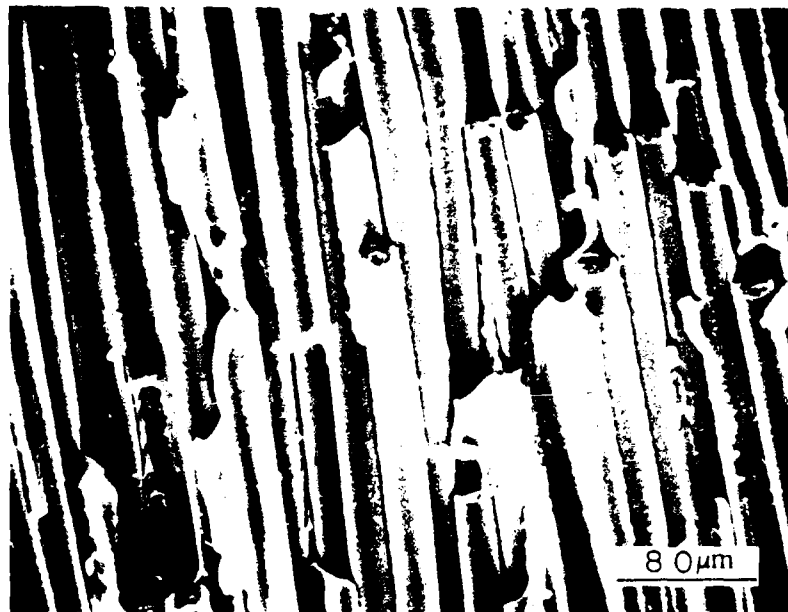
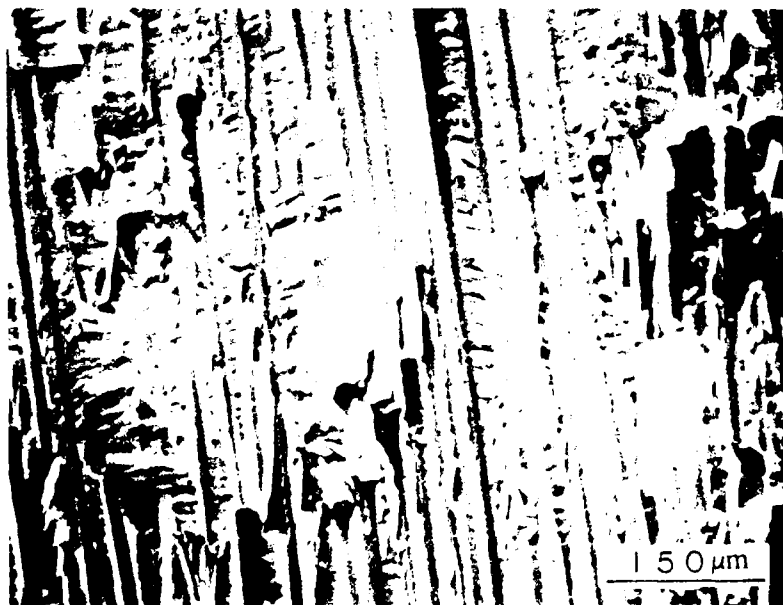
Figure 1. Typical fracture morphology of off-axis specimens in overload failure (a) and fatigue failure (b).

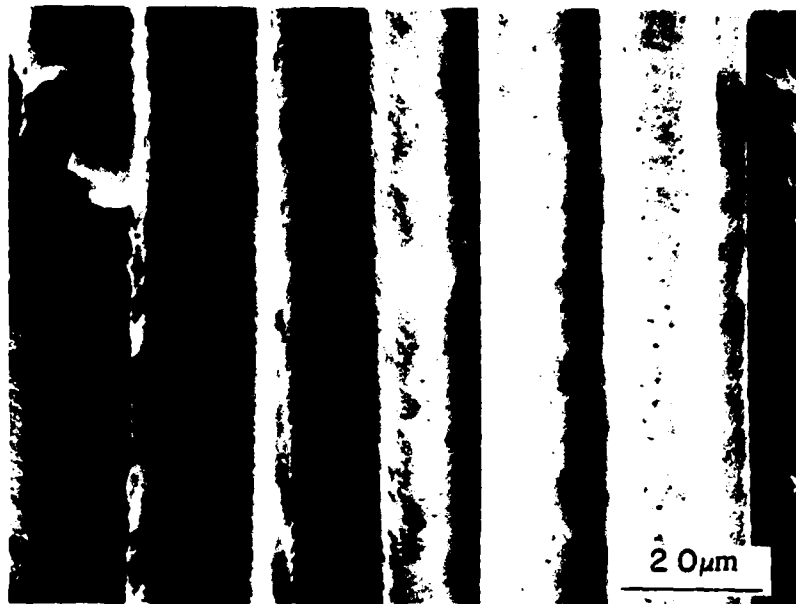
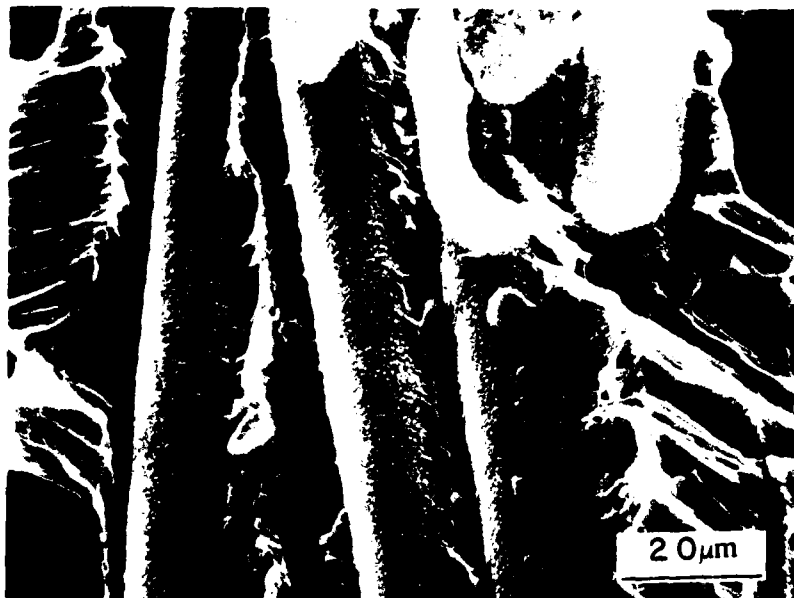
(a) Overall fracture surface of as-received material.

(b) Fiber surface in as-received material.

Figure 1. Fractography of selected  $\text{Al}_2\text{O}_3$  fiber reinforced C.P. Mg composite fracture in situ in the SAM.

(c) Overall fracture surface of material held at 725°C for 15 minutes.

(d) Fiber surface in material held at 725°C for 15 minutes.
