TECHNICAL REPORT GL-84-6

# ENGINEERING CRITERIA FOR USE OF GEOTEXTILE FABRICS IN PAVEMENT AND RAILROAD CONSTRUCTION

Geotechnical Laboratory

June 1984

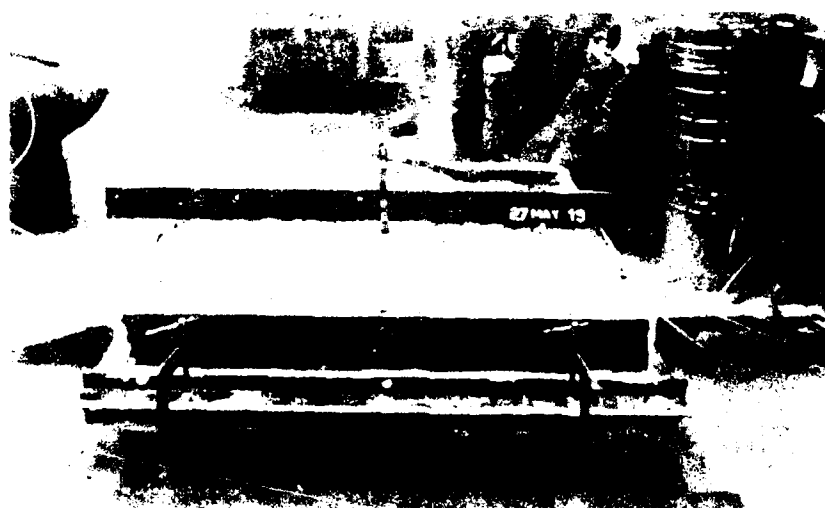
Photo 8. Surface of base course after dry test, test 3

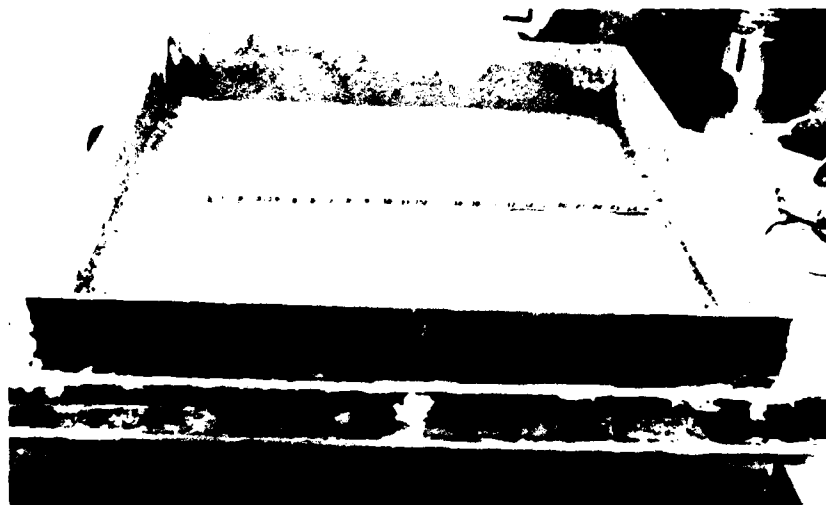
Photo 11. Top of geotextile after base  
course was removed, test 3

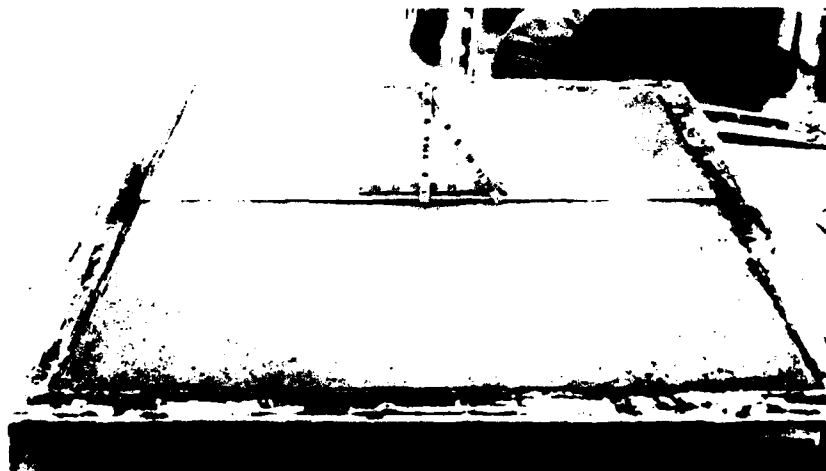
Photo 13. Surface of subgrade after  
wet tests, test 3
