**Initial Feasibility Ground Test  
of a Proposed Photogrammetric System for  
Measuring the Shapes of Ice Accretions  
on Helicopter Rotor Blades During  
Forward Flight**

**Richard L. Palko and Patrick L. Cassady  
Calspan Field Services, Inc.**

**Robert C. McKnight and Robert J. Freedman  
NASA-Lewis Research Center  
Cleveland, Ohio**

**Final Report for Period 1 October to 31 December 1983**

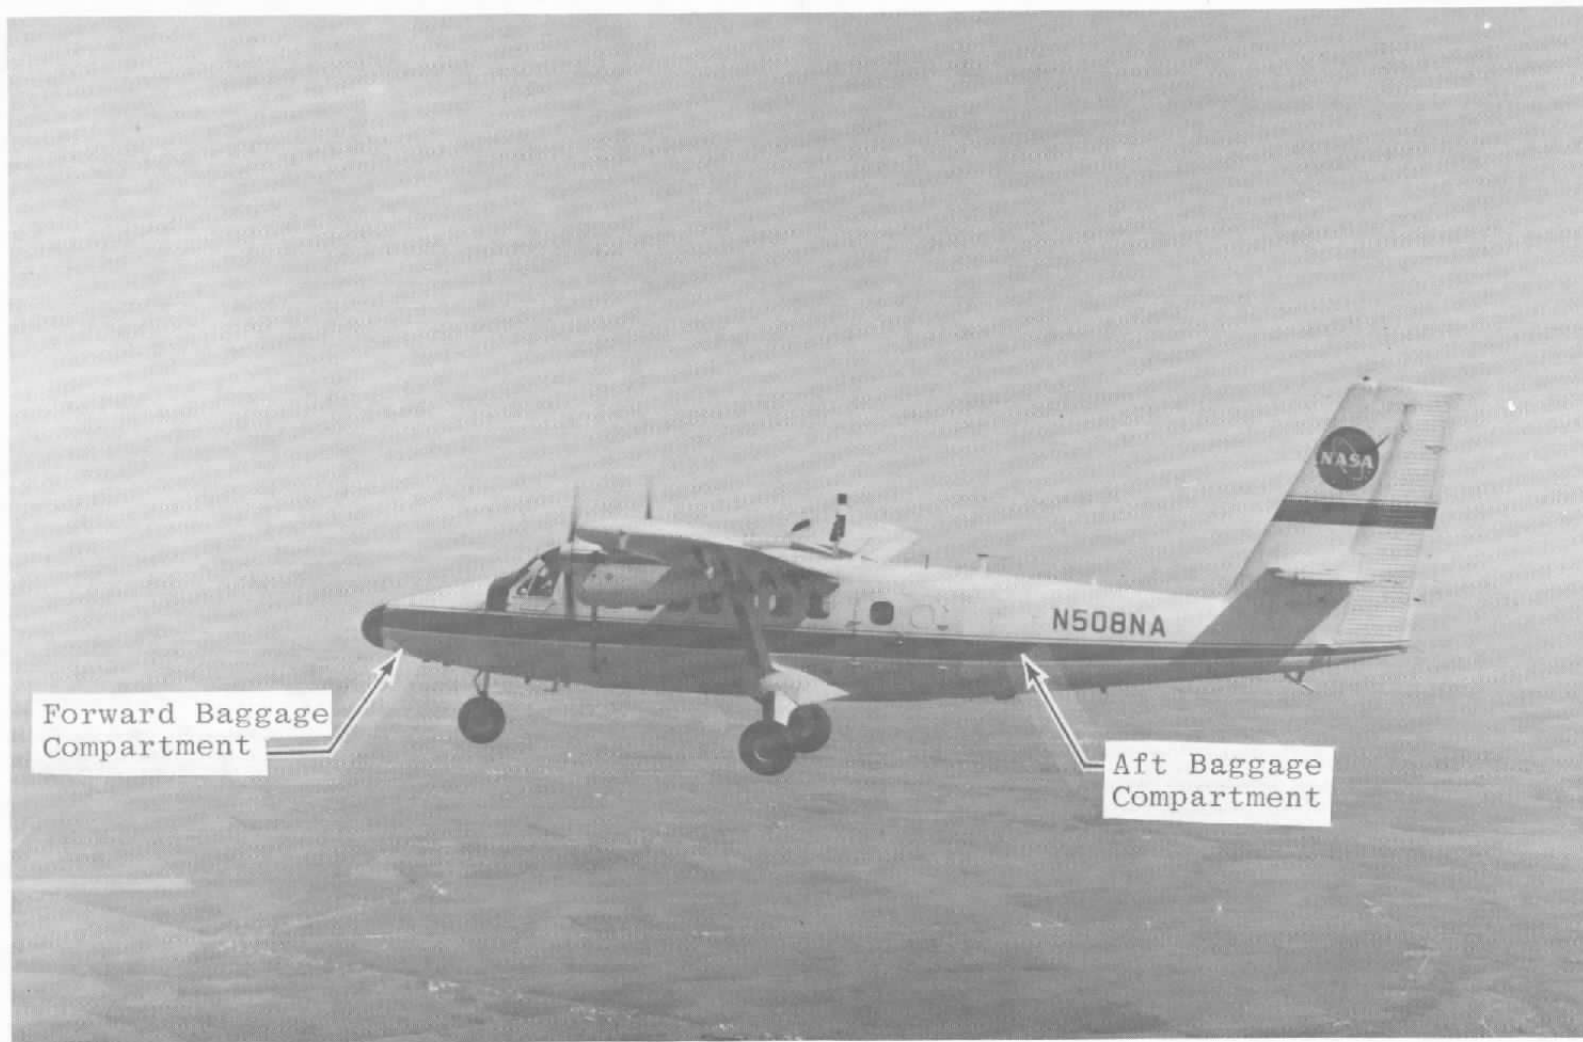
**Figure 5. NASA-LeRC DHC-6 Twin Otter.**

Forward Baggage  
Compartment

Aft Baggage  
Compartment

One way to provide control points on an airfoil is the method used on the NASA-LeRC DHC-6 Twin Otter. This method utilizes control points located on the wing fence and along the airfoil near the fence. The control points along the airfoil are placed far enough aft of the leading edge to avoid becoming iced over. This method will be used for the feasibility study. The method assumes that for short spans (in the neighborhood of 3 or 4 ft) the rotor deflection will be small. In the final flight configuration, multiple fences may be required to cover the rotor span, while for the feasibility study and flight demonstration, only one will be used. An example of the proposed control point layout is shown in Fig. 1. For structural purposes it may be necessary to carry the fence all the way to the trailing edge of the blade; however, for control point purposes this would not be required. Some variation in control point position tolerances may be required for the points farthest from the fence. The variation of the ice thickness on the main rotor during one of the hover-flights is shown in
