HAZARDOUS CHEMICAL DISCHARGE PREVENTION AND REDUCTION

Richard T. Walker

MAY 1984

FINAL REPORT

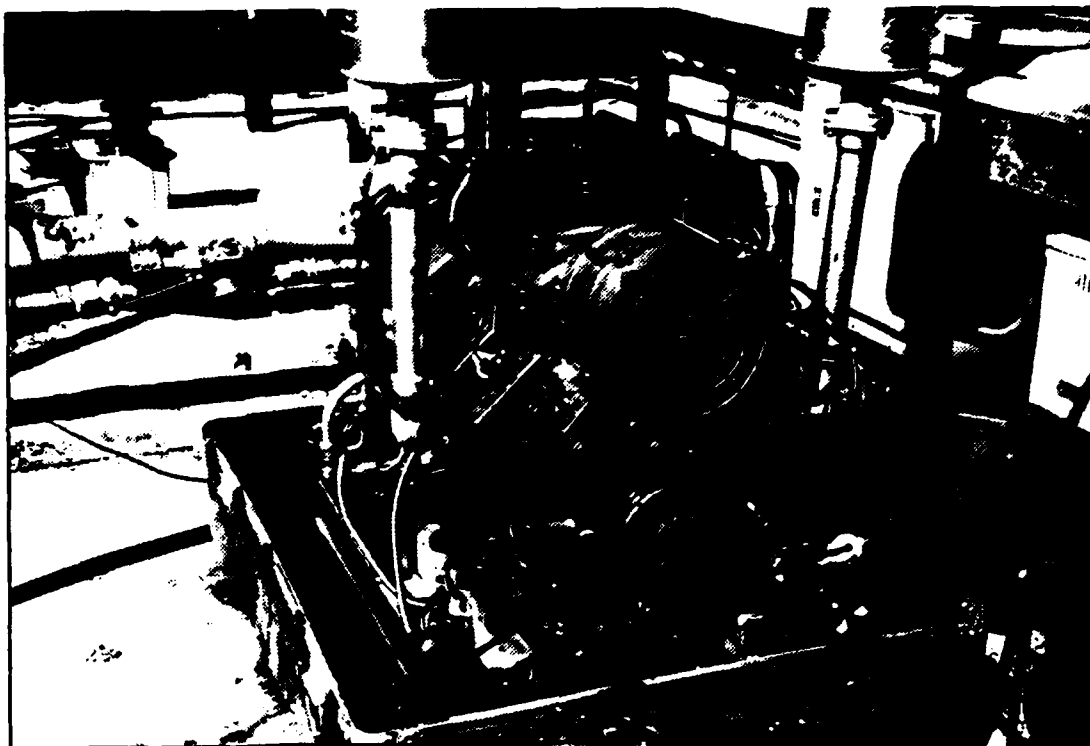
Figure 9. 80 HP VOPS Prime Mover

The tests showed the TK-5 performance was superior to the TK-4, and it worked well with the ADAPTS prime mover. Both the TK-5 and the VOPS pump performed well with the VOPS prime mover. It was found that the VOPS prime mover could operate two TK-5 pumps simultaneously.

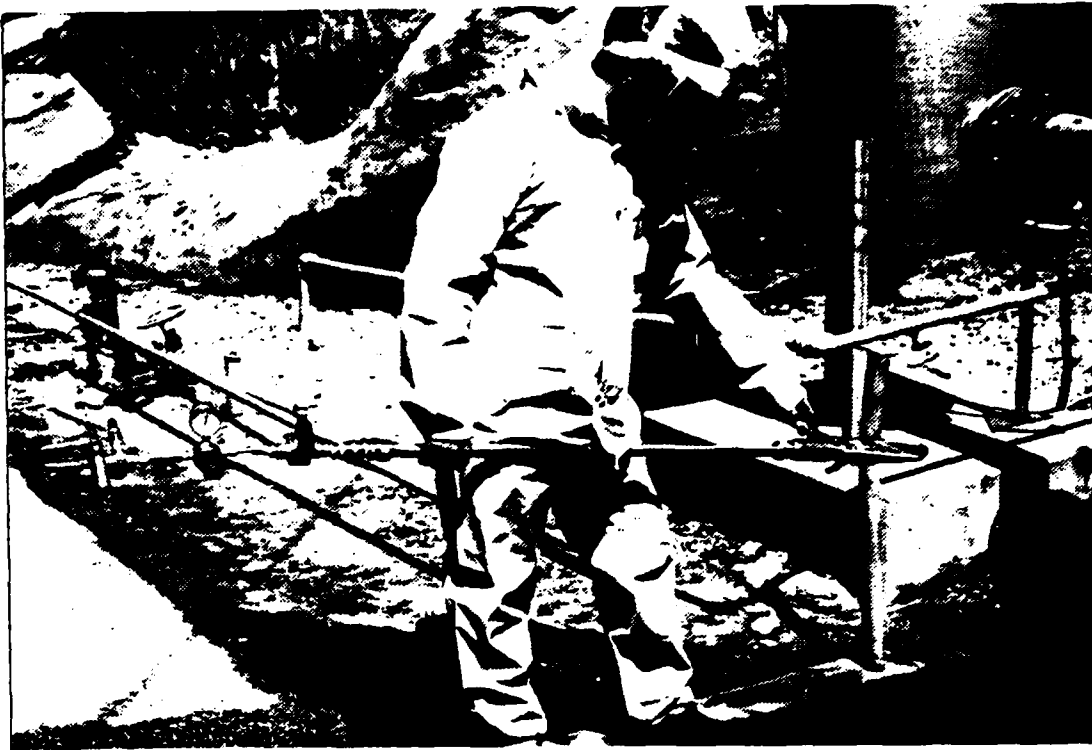
Figure 14. Prototype Leak Plugger

which were simpler, cheaper, and operable in low ambient temperatures and pressures equivalent to 50 feet of sea water. A prototype system was developed using a single component polystyrene foam formulation which met the basic design requirements. Further work was then conducted to refine the leak plugger design, and develop a bulk loading system. The final configuration of the "foam lance" is shown in Figure 15. The stainless steel lance contains the polystyrene foam mixture in solution and under pressure between two burst disc assemblies. An externally mounted trigger fires a CO<sub>2</sub> cartridge to expel the foam from the lance. Figure 16 shows the applicator tip, which consists of a hardware assembly covered by a vinyl fabric bag, and mates to the lance by a Kamlock connector. To operate, the lance is inserted into the damaged area and the trigger is pulled. The expanding CO<sub>2</sub> gas forces the foam solution out of the lance into the applicator tip. The solution off-gases immediately and the foam lattice forms in a matter of seconds. A rigid foam plug forms in the applicator tip in less than 10 seconds. See Figure 17. The Kamlock connector can be released and the foam lance may be reused. Buoyancy packages mounted on the lance make it easy to handle and slightly positive when spent.

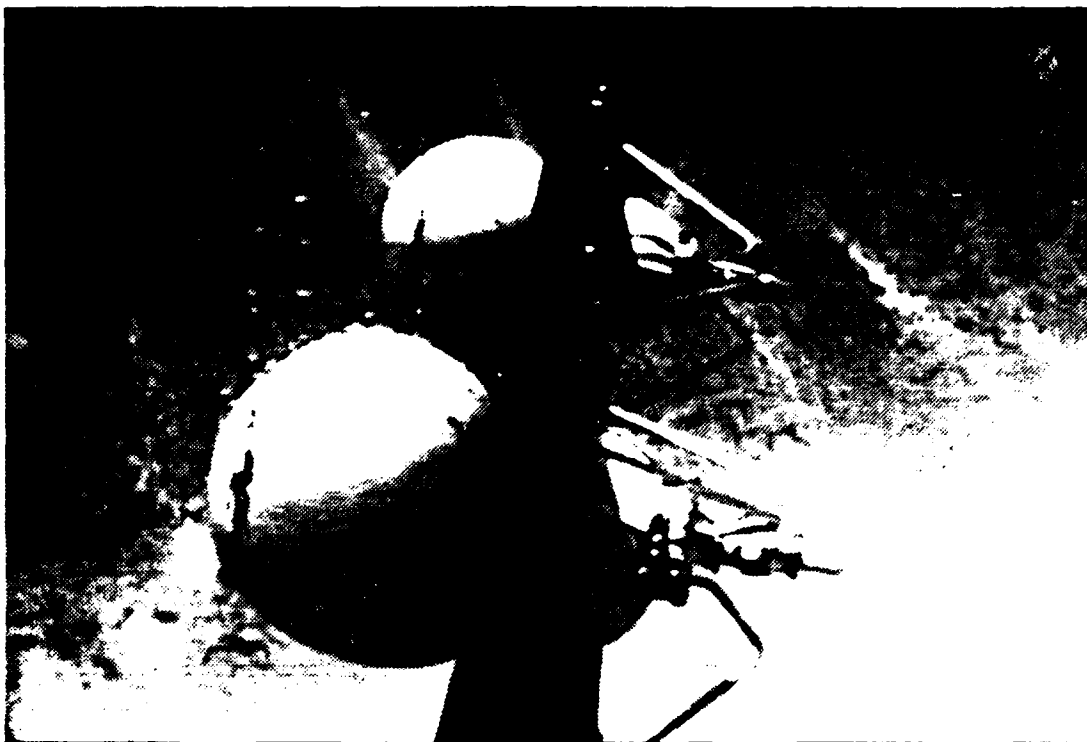
Figure 17. The Rapid Forming Foam Plug

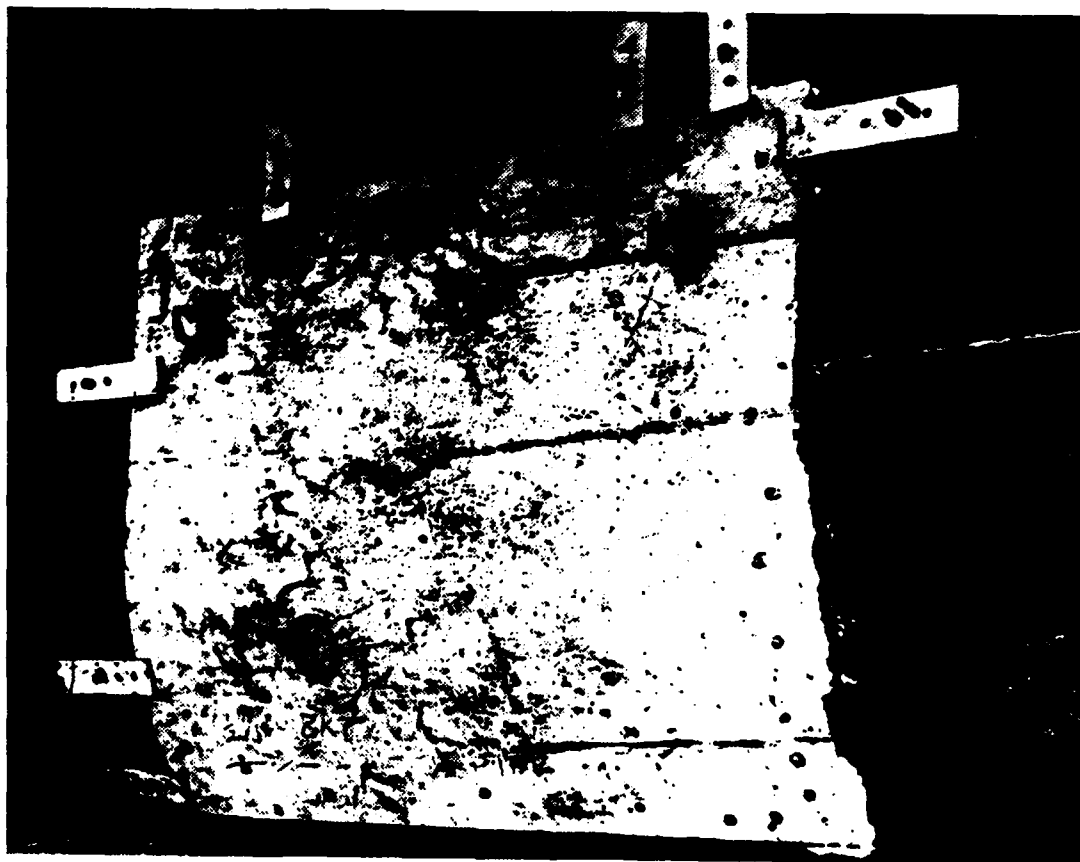
Figure 19. Typical Patching Technique
