TECHNICAL REPORT SL-84-13

# BLAST DOOR AND ENTRYWAY DESIGN AND EVALUATION

David W. Hyde, Sam A. Kiger

July 1984

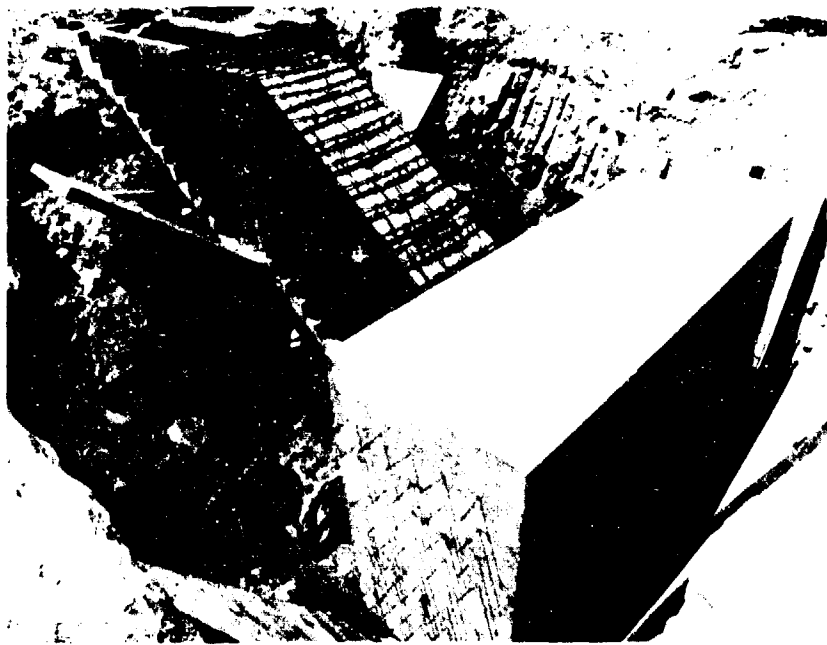
Figure 2.8. Reinforcement of stairwell walls;  
underground chamber complete.

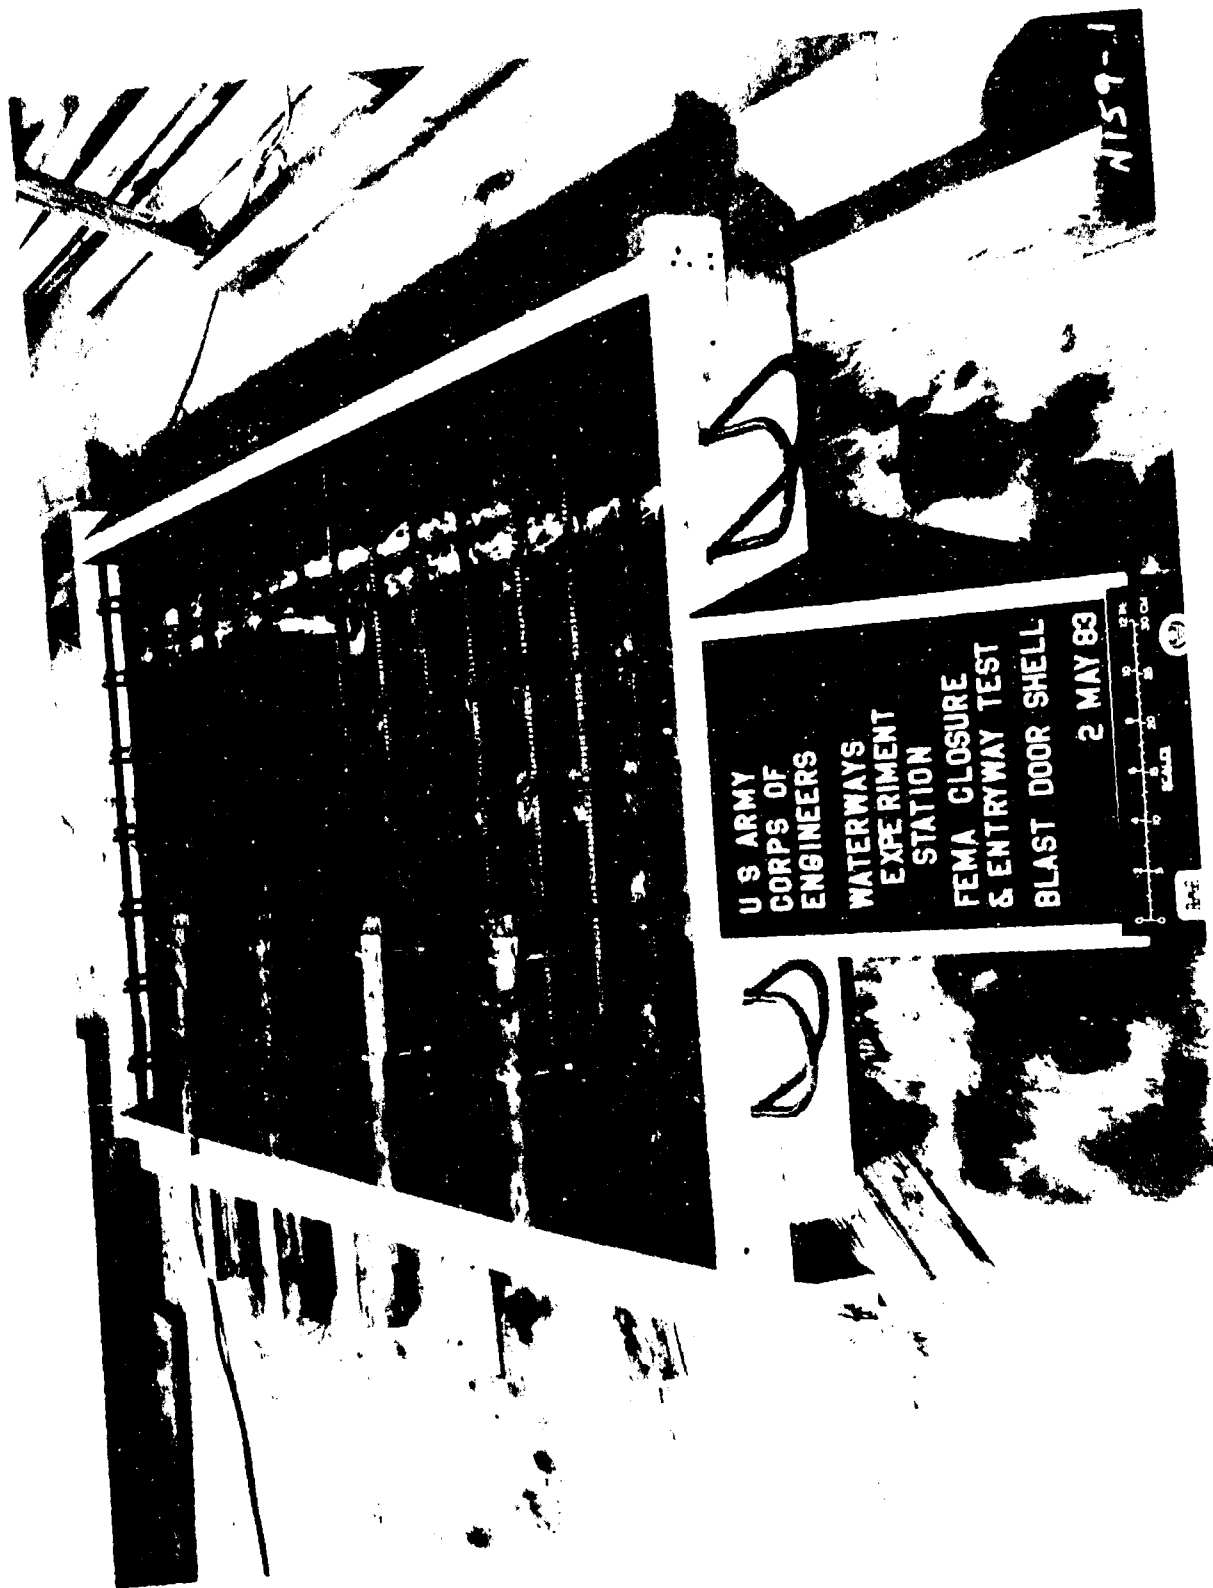
Figure 2.13. Blast door shell prior to concrete placement.

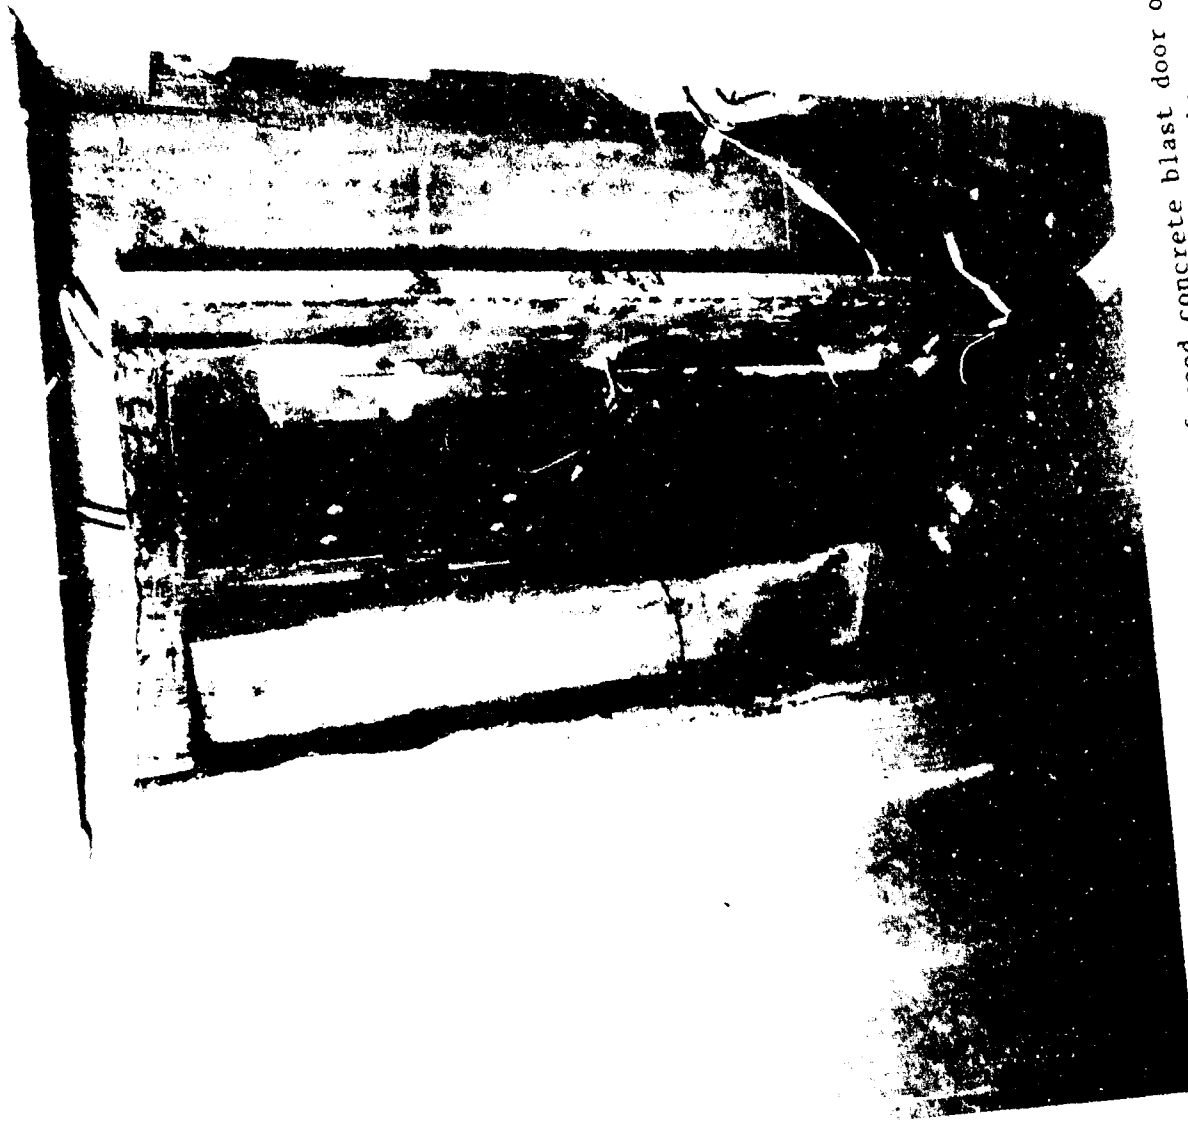
Figure 4.4. Closures, reinforced concrete blast door on  
left, open, commercial door on right.

Upon examination, the blast door showed no signs of damage. The exterior concrete face of the door was intact and had no cracks. The seal surrounding the door's edges was slightly deformed but was not torn. The pressure record from gage P7, immediately behind the door, indicates that there were no pressure leaks at the door's edges. The door's hinges were undamaged and the door

The commercial door was completely destroyed during the test. The door and each of the steel plates supporting it were bent around the wide-flange beams, so that large gaps were left between door and frame at either end of the door. As shown in Figure 4.5, the door was obviously inoperable. One of the steel support plates is shown in Figure 4.6. The pressure records for gages P5 and P6 should have been nearly identical, had the commercial door survived. However, comparison of the pressure records for these gages seems to indicate that the commercial door failed very early (about 10 ms after initial loading).
