NSWC TR 83-508

## **SAFETY EVALUATION OF AN ELECTRONIC TOTALIZER CONTAINING A $\text{Li}/(\text{CF})_x$ CELL**

1 NOVEMBER 1983

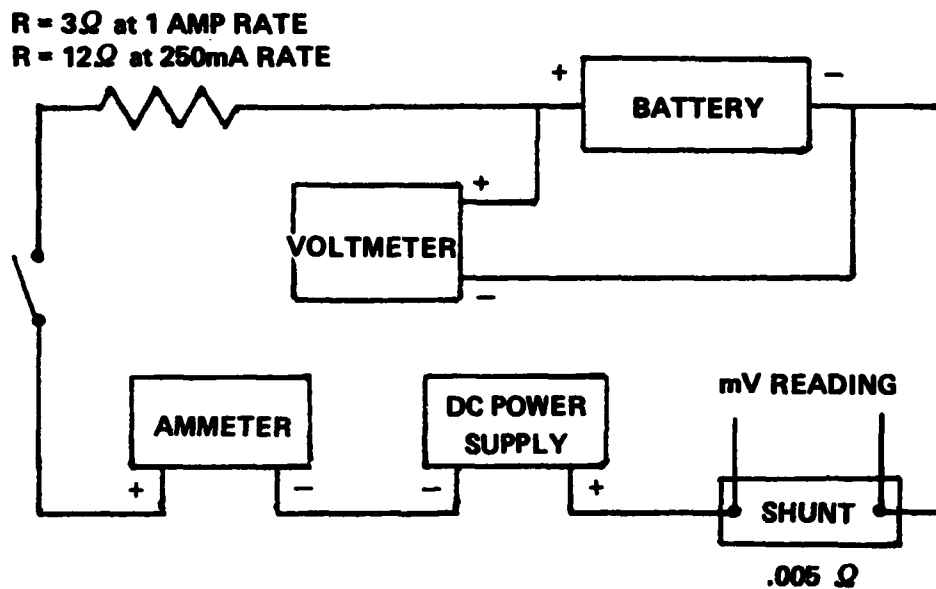
FIGURE 5. SCHEMATIC OF FORCED DISCHARGE CIRCUIT

2) Forced discharges of the cell were conducted with a constant current D.C. power supply and were run at both the 250mA and 1 AMP current level (two tests at each rate). At each current rate, one test was run in the Totalizer and one on the cell alone. Current, voltage, and temperature were monitored during all runs. Figure 5 illustrates the circuit used for the tests.

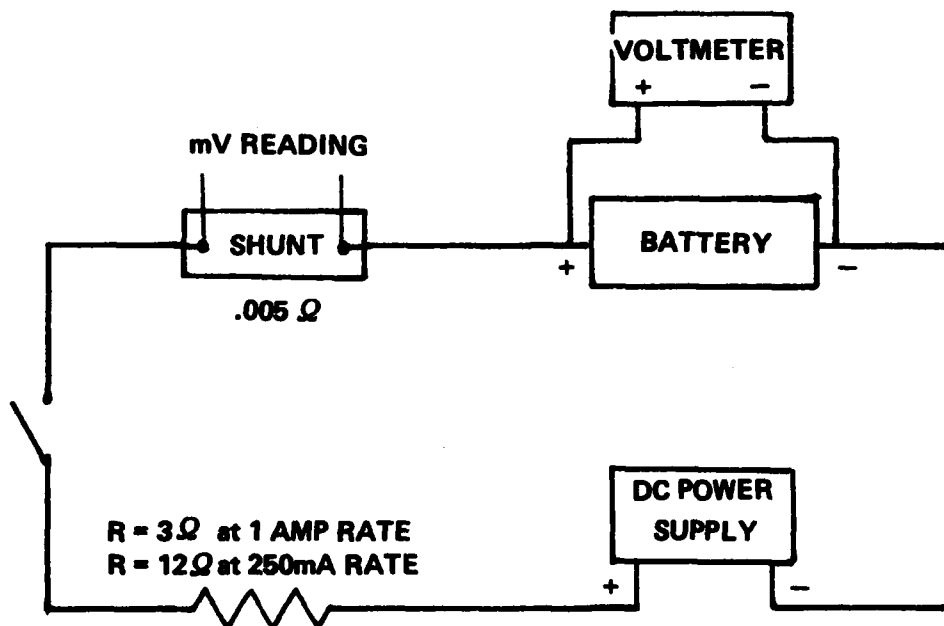
FIGURE 6. SCHEMATIC OF CHARGING TEST CIRCUIT

None of the charging tests were conducted with the cell in the Totalizer as charging could not take place in the Totalizer. Fresh cells were charged to at least 100% of the cell capacity. Partially discharged cells were charged to full capacity, and then continued to at least an additional 100% of cell capacity. Figure 6 depicts the circuit used for the charging tests.

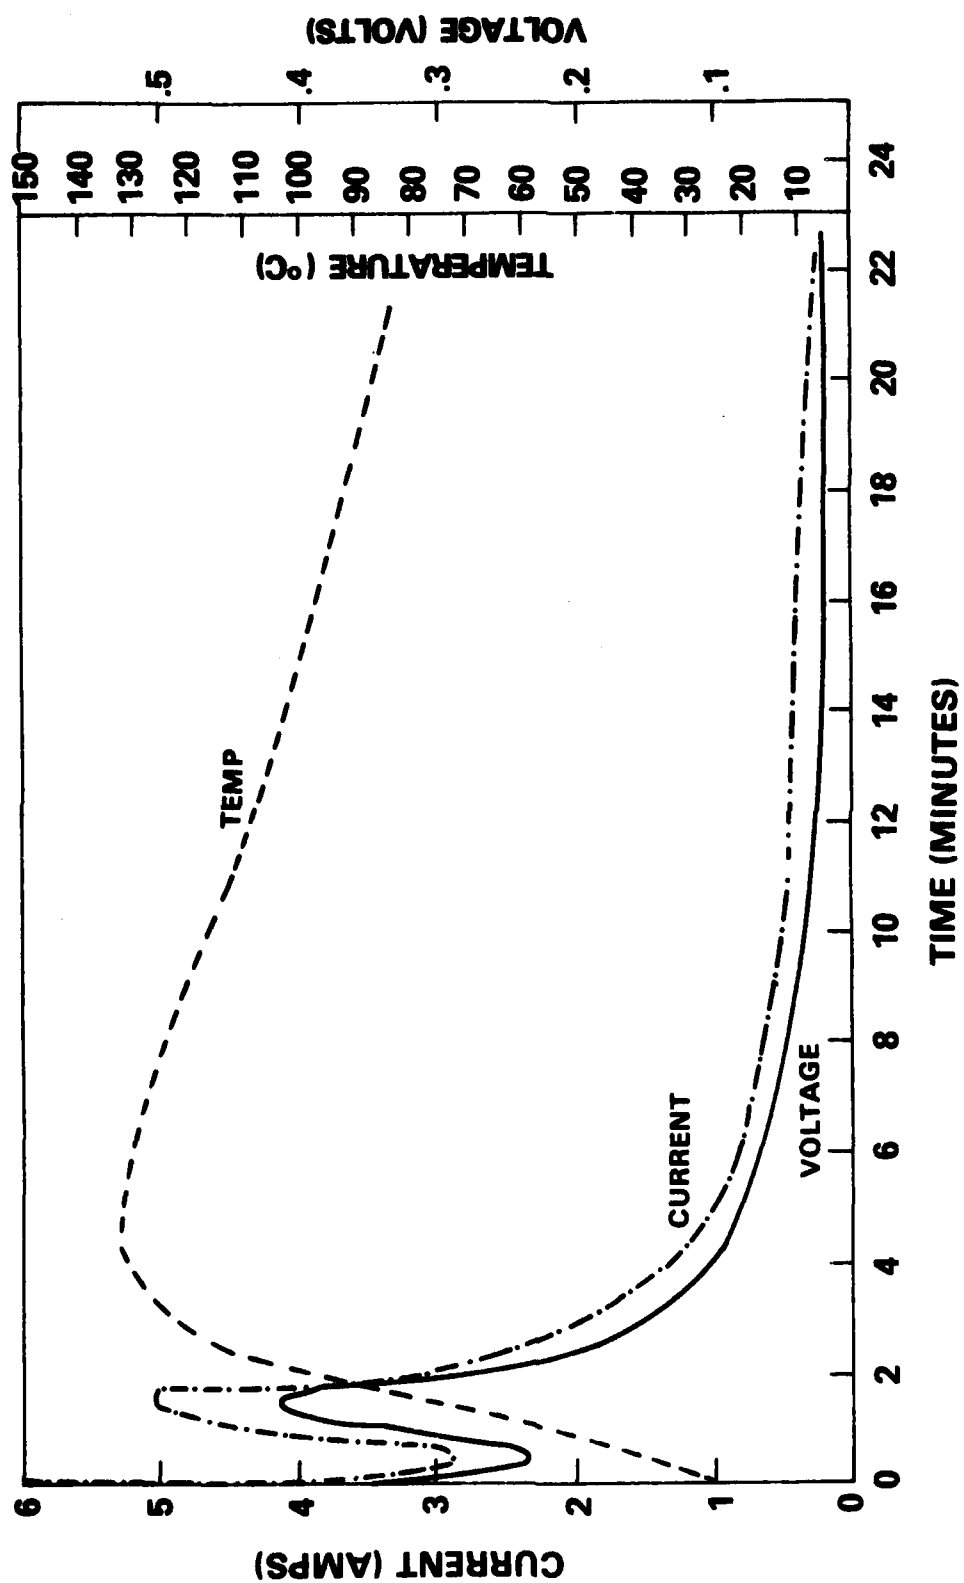
FIGURE 7. SHORT CIRCUIT OF FRESH BR-2/3A CELL IN ELECTRONIC TOTALIZER

Both short circuit tests yielded similar results, and the results of a typical short circuit test is presented in Figure 7. A summary of significant data from both short circuit tests is listed in Table 1. The maximum temperature obtained in both cases was slightly over 130°C, and ventings did not occur. The cell shut itself down in both cases at about two minutes. Cell shutdown occurs when the internal temperature reaches near 130°C and the polypropylene mesh separator apparently fuses. Several weeks after the tests the cells were re-examined and minor leakage was noticed. This was probably due to warpage caused by softening of the plastic top and gasket (one piece) during the high temperatures of the tests. In addition, some minor cracking of the plastic PVC can jacket was noted.

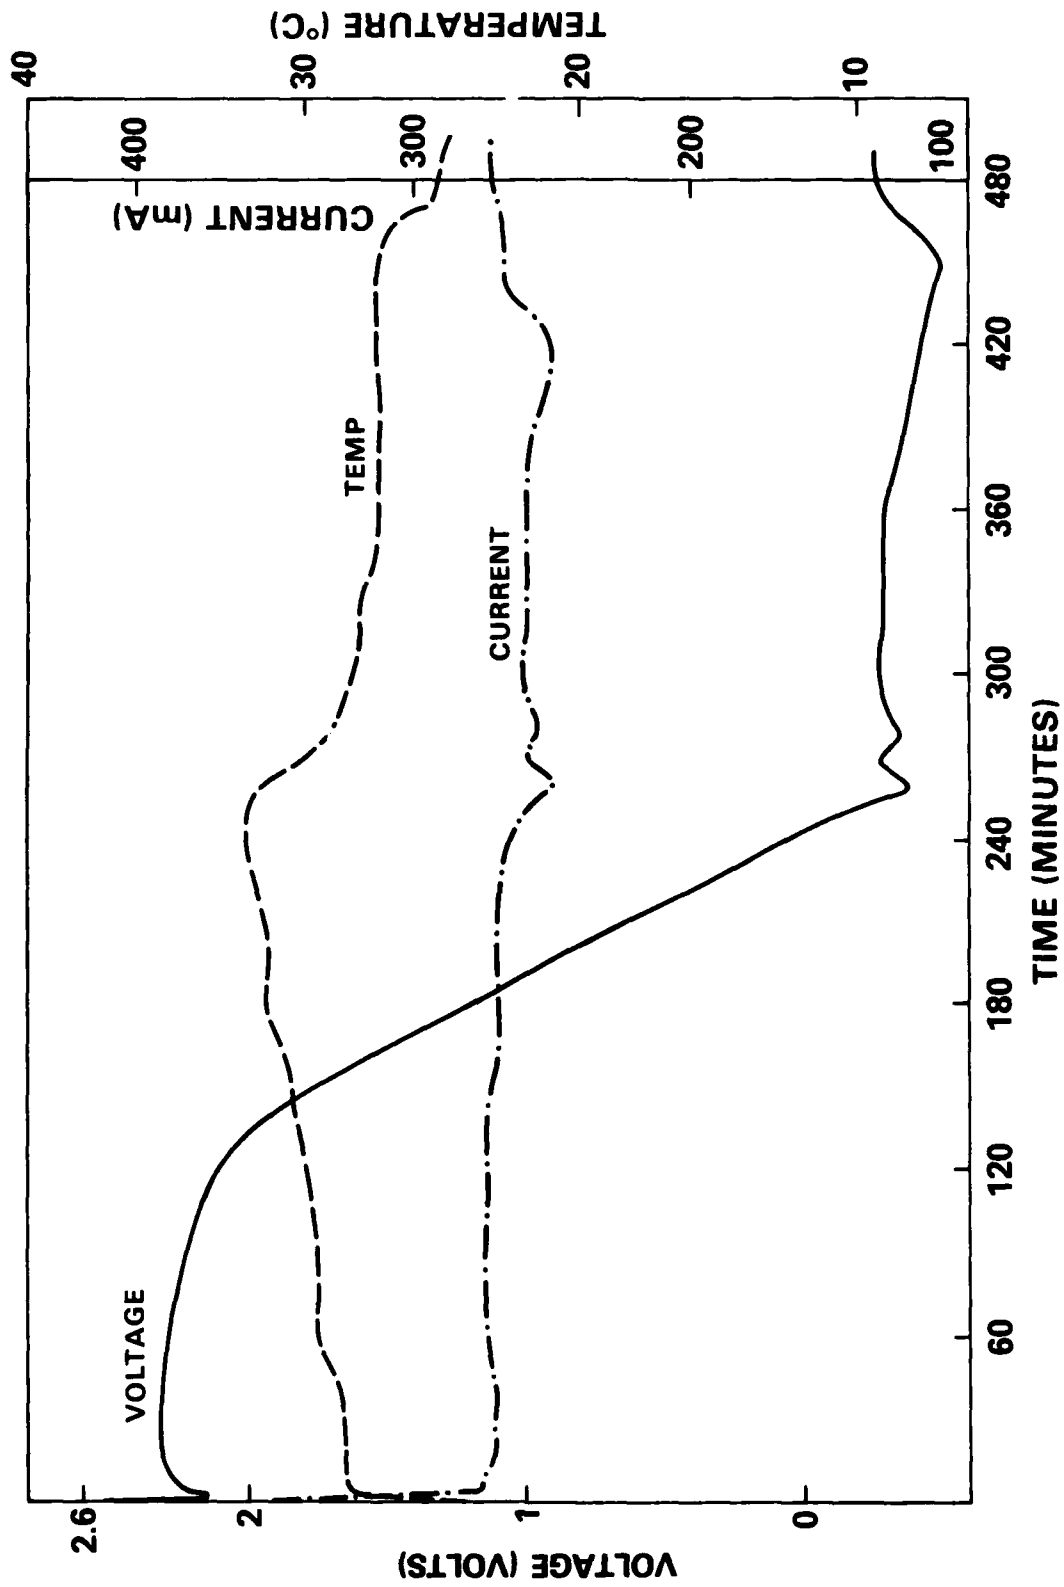
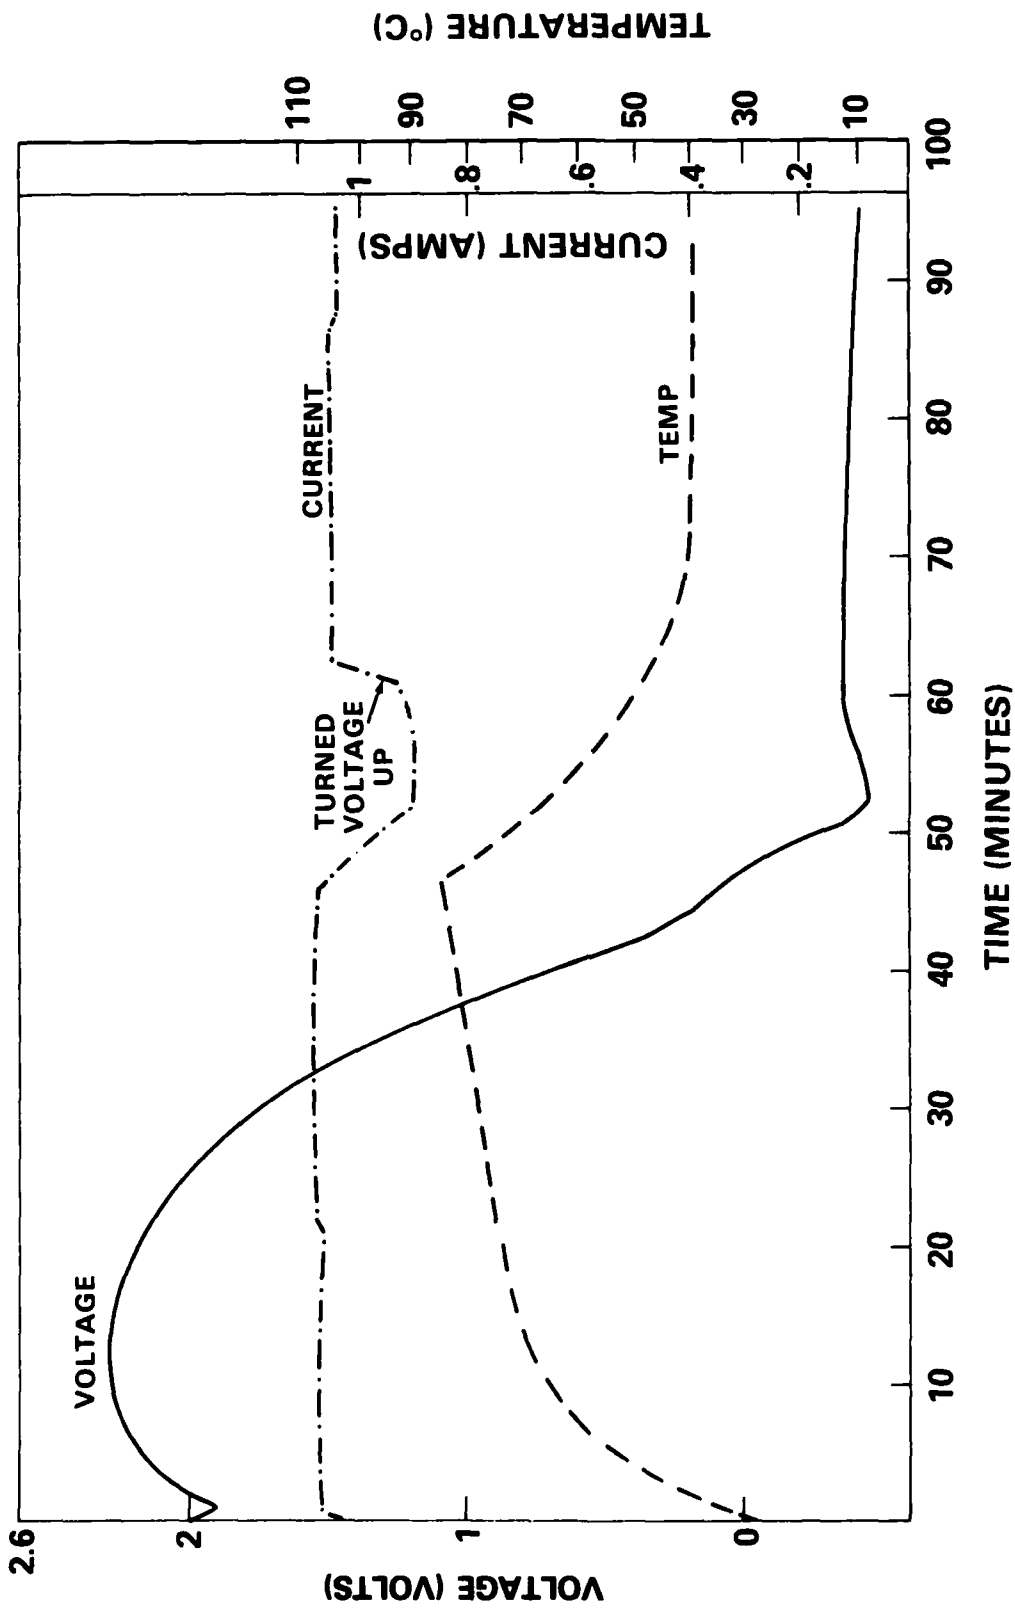
Figures 8 and 9 present the voltage, current and temperature data from the forced discharge tests. Table 2 summarizes the data obtained from all four forced discharge tests. Cells were held in voltage reversal for 100% of cell capacity. Maximum temperature for the 250mA tests was 43°C, and for the 1 AMP tests it was 84°C. No damage to the cell was noticed in any case, and subsequent checks weeks after the tests revealed no cell leakage. As shown in Figure 9, the power supply voltage was turned up at 62 minutes. This was done because the voltage on the constant current power supply had originally been limited to slightly above the cell voltage. When it was apparent that the power supply voltage was limiting the current level during cell voltage reversal, the power supply voltage was increased.

FIGURE 8. FORCED DISCHARGE INTO VOLTAGE REVERSAL ON BR-2/3A CELL (250 mA)

FIGURE 9. FORCED DISCHARGE INTO VOLTAGE REVERSAL ON BR-2/3A CELL (1 AMP)

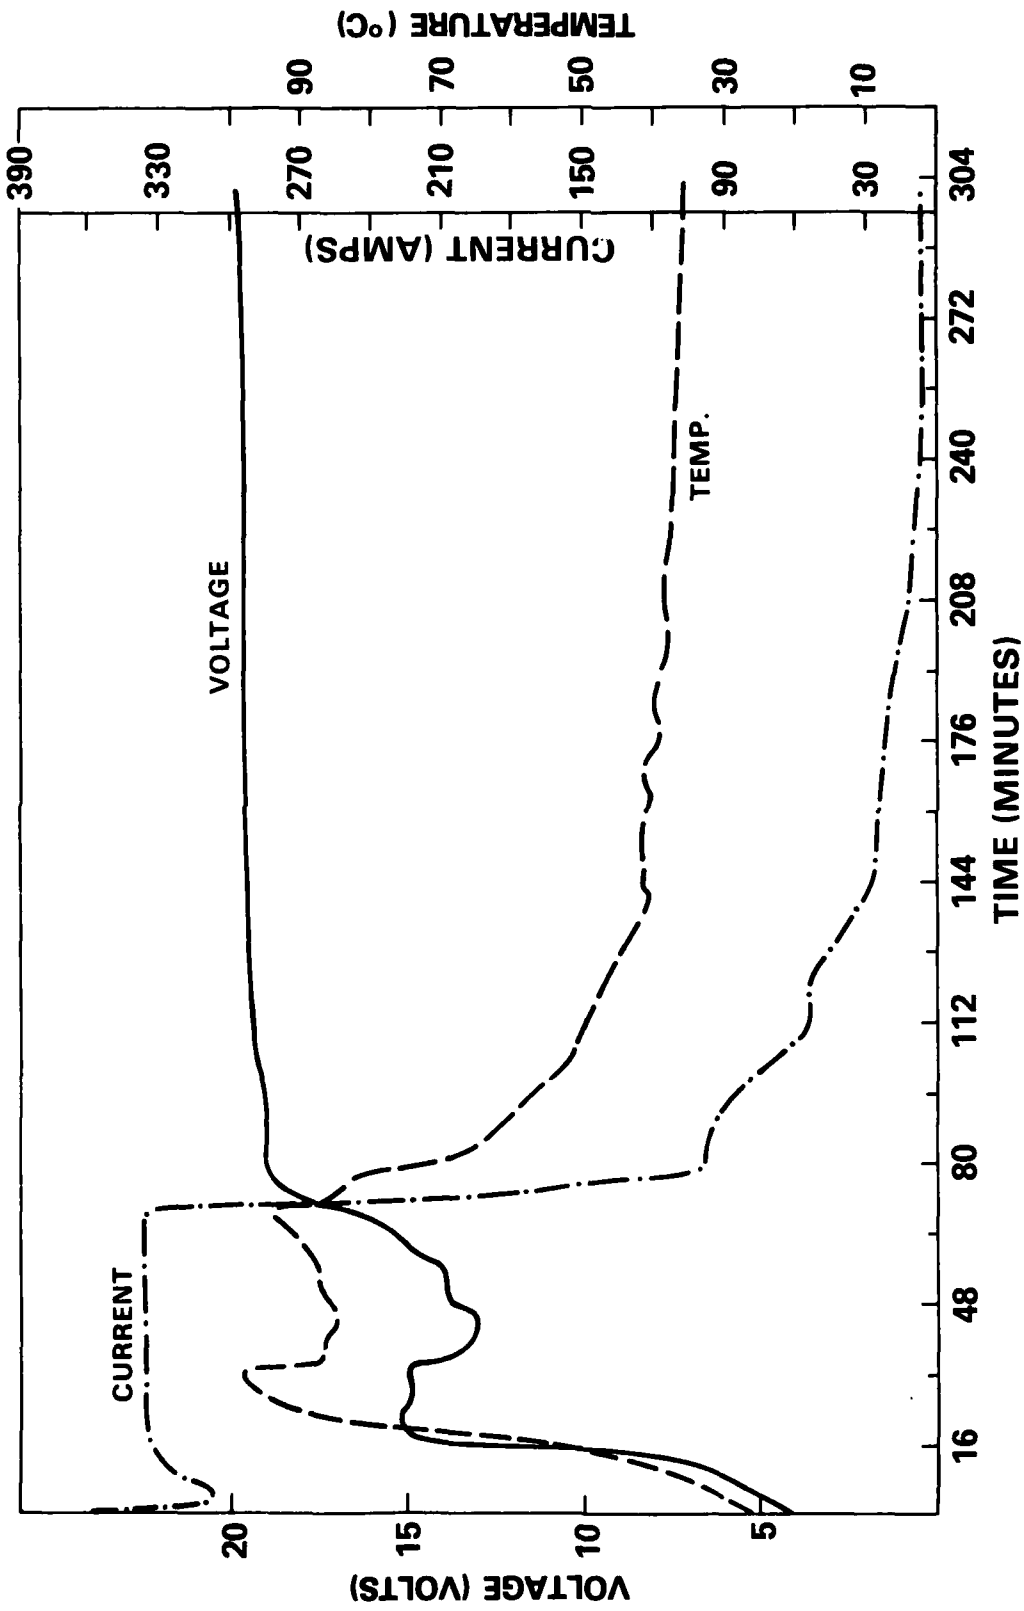
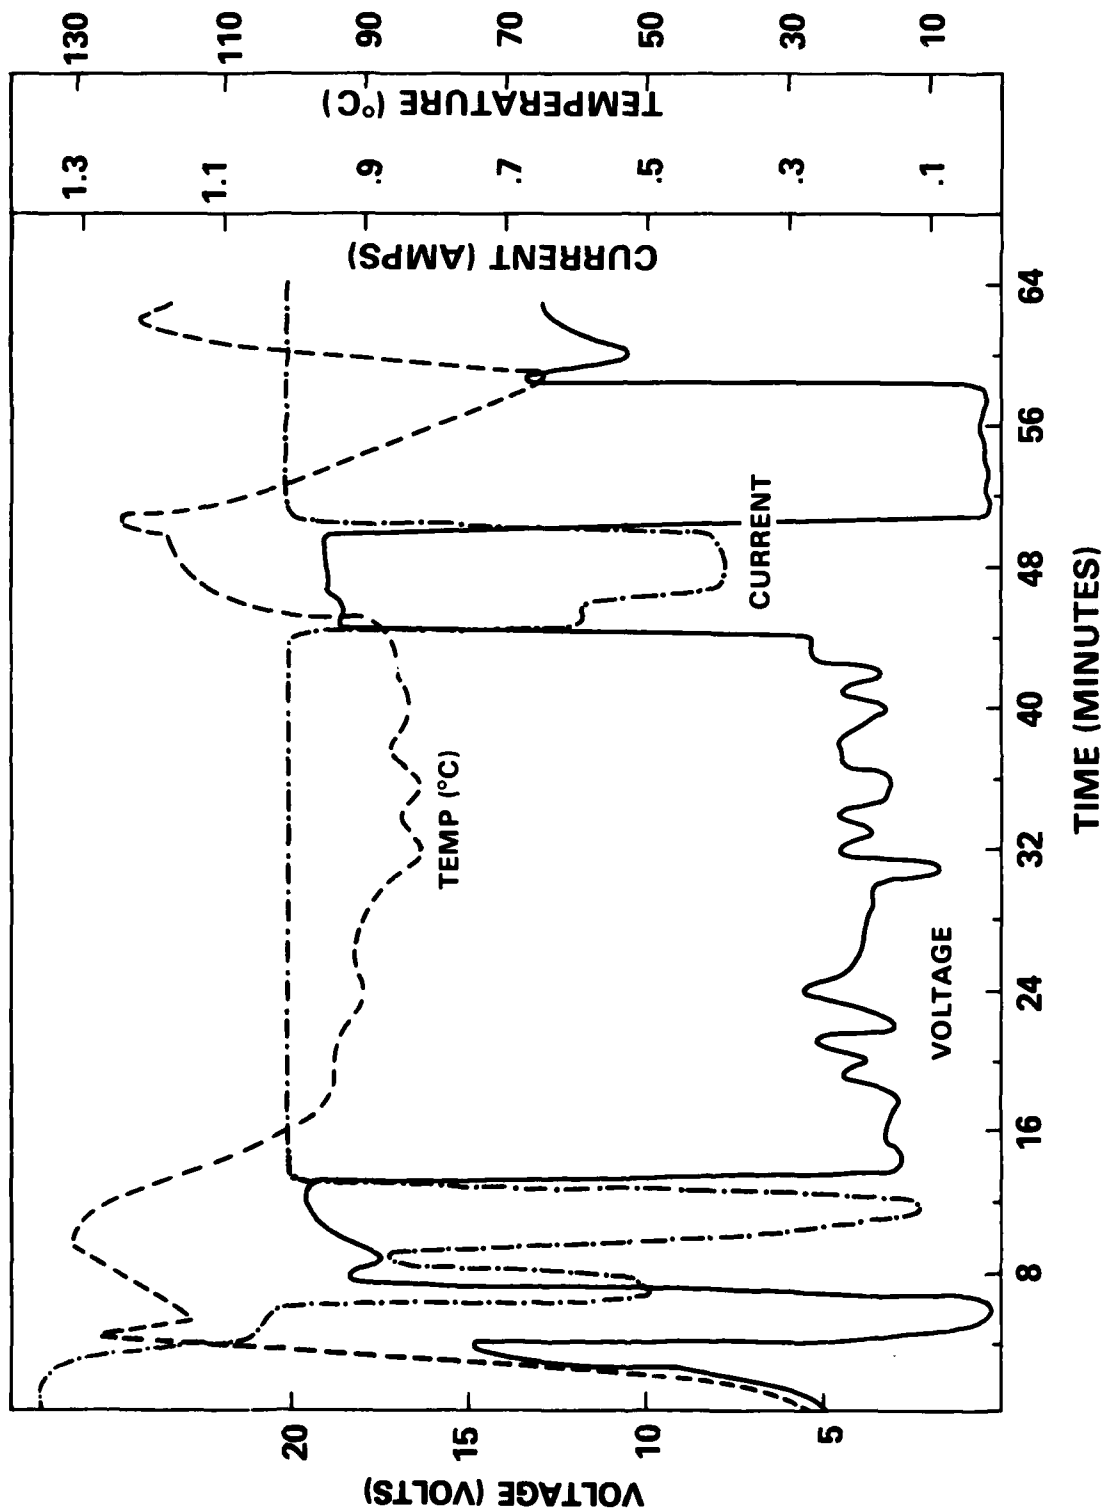
Figures 10 and 11 present the results of the 250mA and 1 AMP charging tests. During both tests "pops" from the cell were heard, and significant smoking occurred. Ventings did occur; and in one test, the top insulation paper was partially pushed out the top during the venting. A photograph of two ventings is presented in Figure 12. Ventings consisted of the pushing of the plastic cap from its seating to allow the release of internal pressure, but in general did not involve fire or flame. However, in one instance at approximately 50 min. into a 1 AMP charging test, a minor and brief fire erupted from the end cap where the cell had vented earlier in the test. This incident occurred on a cell that had been discharged to one half capacity at 1 AMP before commencing charging. No other such incident was noted during any of the charging tests. As can be seen by comparing the data curves, the 1 AMP rate produced much more erratic behavior than did the 250mA rate. In both cases, when the amperage fell from the specified charging rate, the voltage rose to 20 volts. This is due to a power supply limiting voltage of 20. In all cases the PVC outer can jacket was cracked and discolored, but in no test was the steel can affected.

FIGURE 10. 250 mA CHARGING TEST ON FRESH BR-2/3A CELL

FIGURE 11. 1 AMP CHARGING TEST ON FRESH BR-2/3A CELL

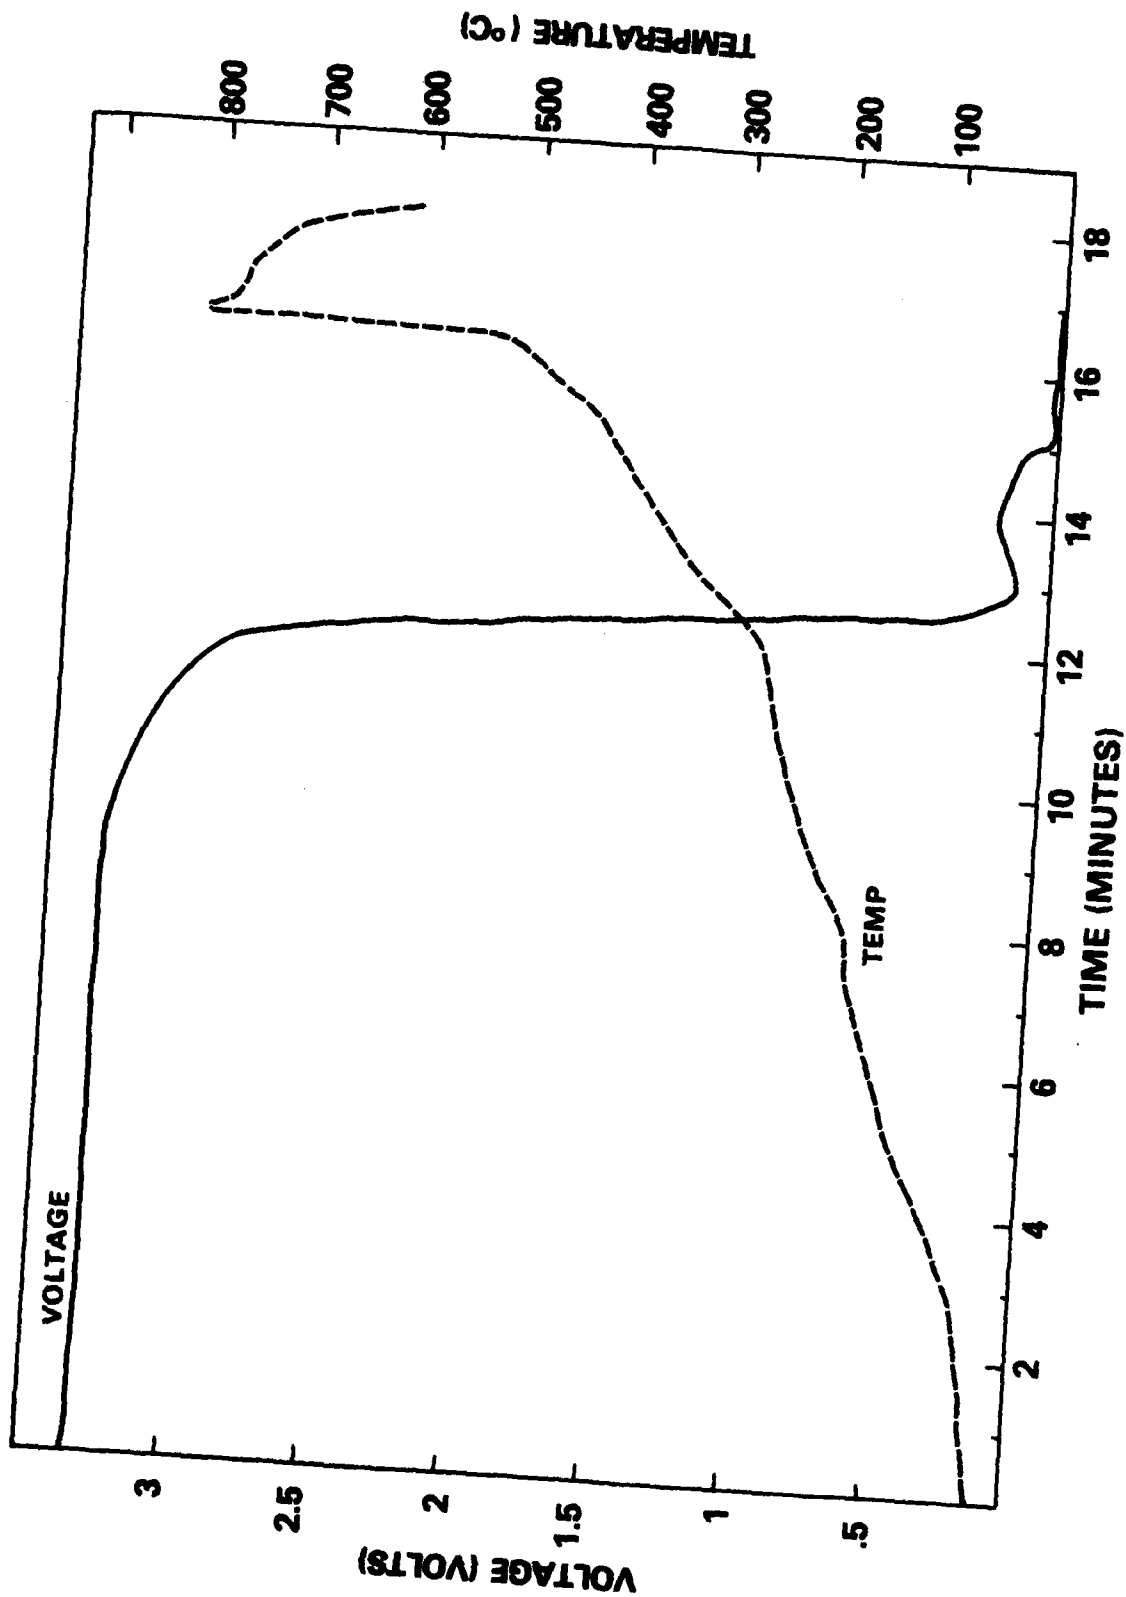
FIGURE 13. HEATING TEST ON BR-2/3A CELL

Those tests that were conducted to only 300°C vented between 200-275°C with loss of voltage, and some minor smoking occurred. Figure 13 presents the typical data obtained for a fresh cell heated to 500°C. On all runs involving fresh cells significant fire and flame erupted between 450-500°C. Initial voltage drop off and venting occurred between 200-275°C. In Figure 13 the temperature rises sharply near 500°C where ignition commenced and a maximum temperature of slightly over 800°C was reached. Those tests on fresh cells conducted in the Totalizer resulted in significant flames escaping from all seams of the Totalizer followed by the Totalizer catching on fire and being totally destroyed. Figure 14 shows the result of the fire on the Totalizer.

As indicated by the manufacturer, the cathode (poly-carbonmonofluoride) is thermally stable up to 400°C. The fact that the majority of incidents (fire or significant smoking) commenced when the battery skin-heat tape interface temperature was approximately 450°C indicates the probable cause of the ignition to be cathode thermal breakdown.

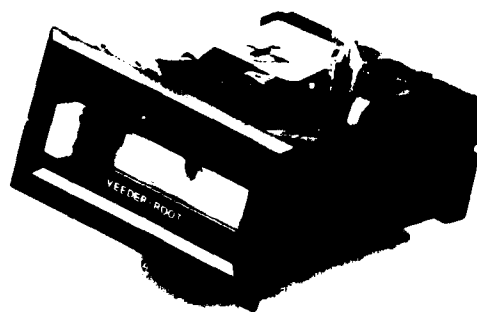
FIGURE 15. HEAT TEST OF TOTALIZER WITH NO CELL

Those tests performed on dead cells produced large amounts of smoke at about 450°C, but did not erupt into flames. A test was run on a Totalizer with no cell, but containing a "dummy" cell consisting of a piece of copper tubing wrapped in heat tape and heated to 500°C. This test was designed to determine if the extreme nature of the fire was due only to the battery flames or other internal components and/or plastic erupting into flames. As shown in Figure 15, the tests resulted in some melting and warpage of the Totalizer, but no significant fire or flame was noted. Upon later inspection it appears that some minor charring did occur to the outside case, but at no time was the Totalizer visibly in flames.
