**Special Flood Hazard
Evaluation Report**

Sandusky River

**City of Tiffin
Seneca County
Ohio**

**US Army Corps
of Engineers
Buffalo District**

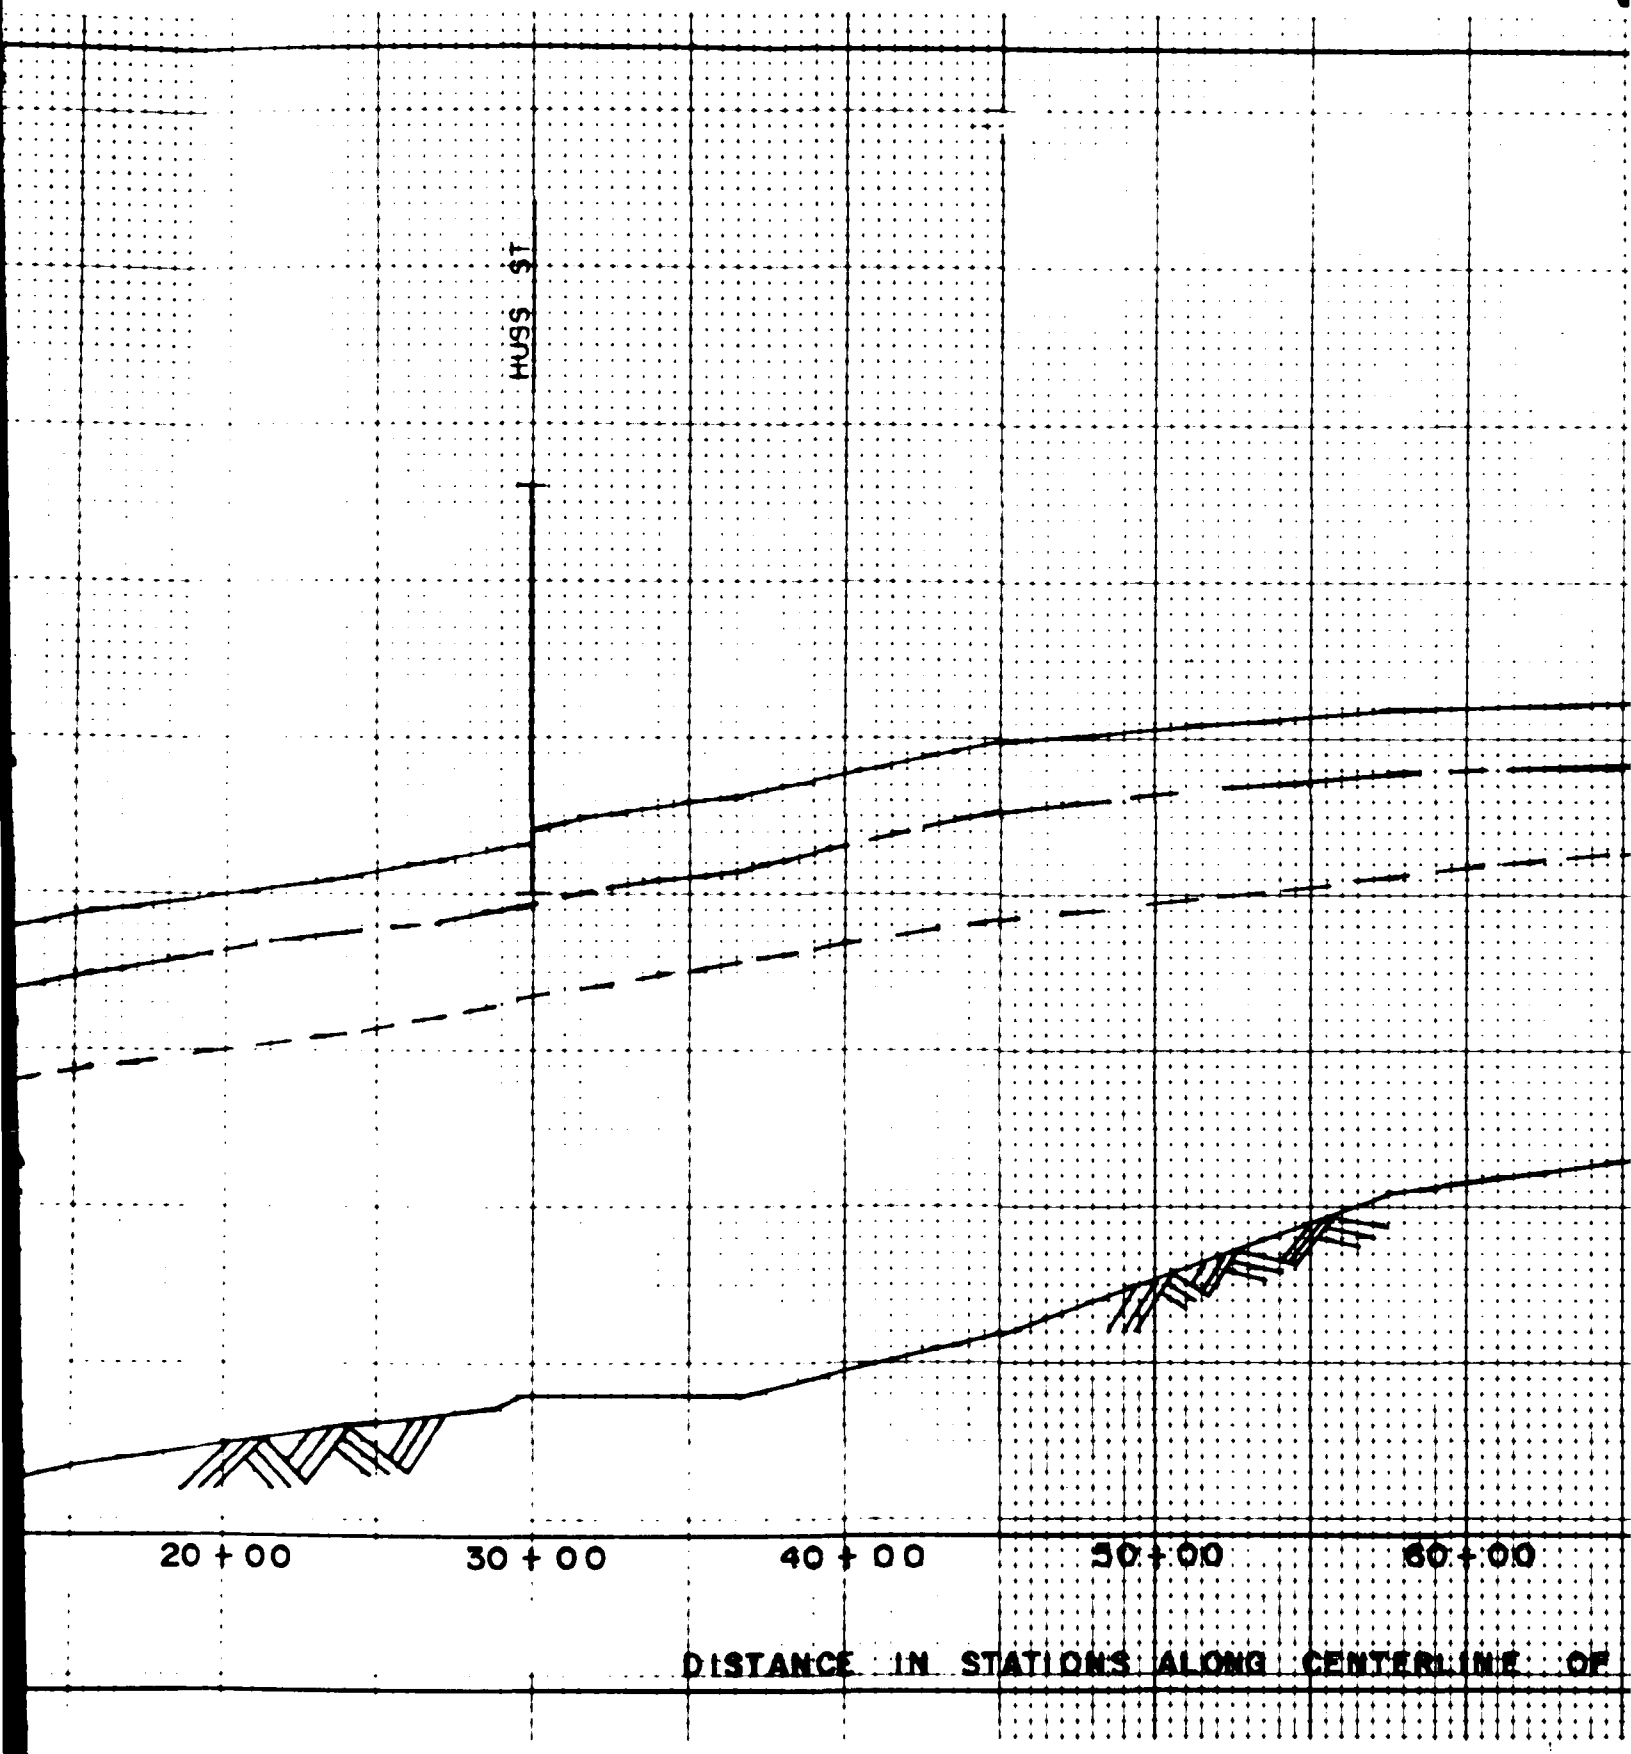
PLATE NO. 1

DEPARTMENT OF THE ARMY
BUFFALO DISTRICT, CORPS OF ENGINEERS
BUFFALO, NEW YORK
FLOOD HAZARD EVALUATION
SANDUSKY RIVER
TIFFIN, OHIO
FLOOD PROFILES
SEPTEMBER 1964

Locations of selected cross sections used in the hydraulic analyses are shown on the Flood Profiles (Plates 1-2). Selected cross-section locations are also shown on the Flooded Area Maps (Plates 3-10).

The flood profiles were generated using the HEC-2 backwater program (Reference 1). Flood profiles were drawn showing computed water surface elevations to an accuracy of 0.5 foot for floods of the selected recurrence intervals. The 10, 100, and 500-year floods are shown on the profiles.

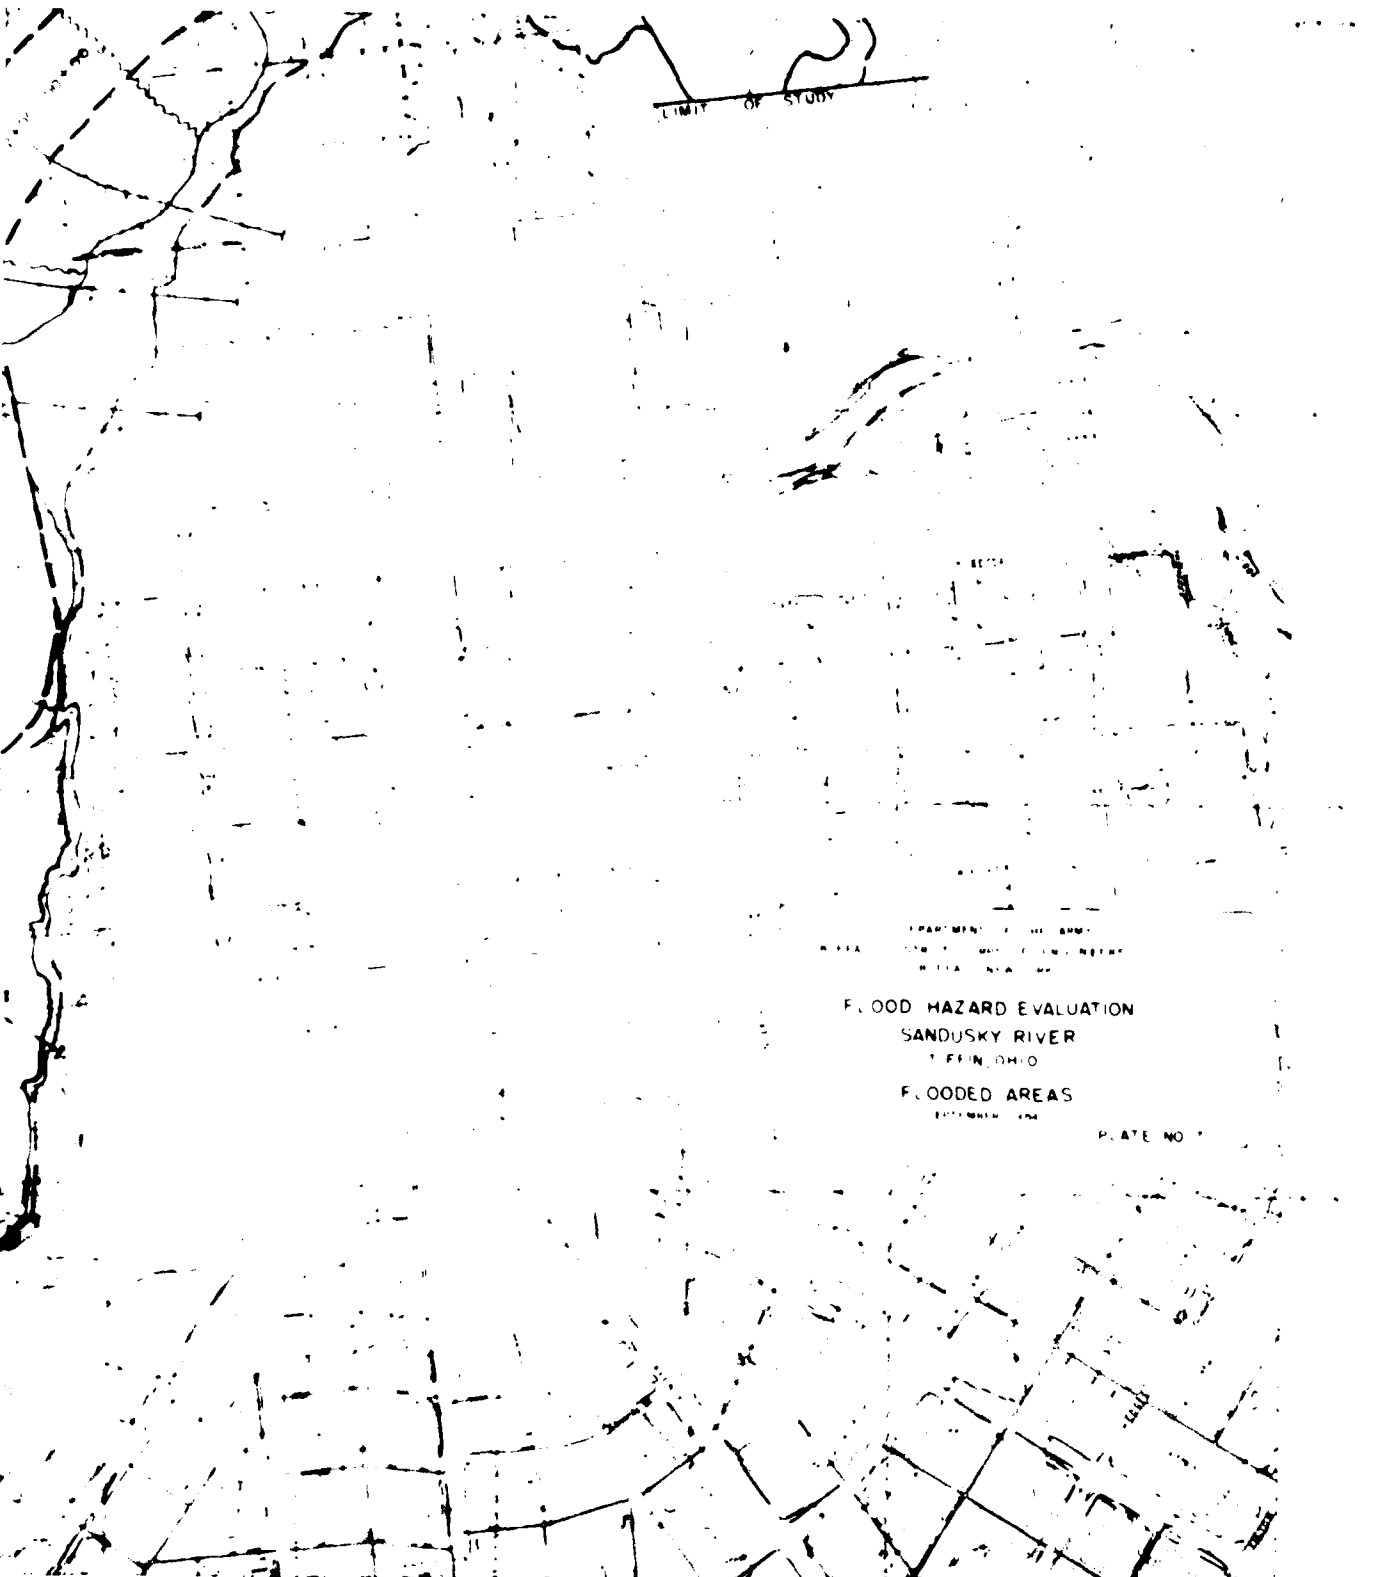
PLATE NO. 8

FLOOD HAZARD EVALUATION
SANDUSKY RIVER
TIFFIN, OHIO
FLOODED AREAS
EIGHTEENTH 1964

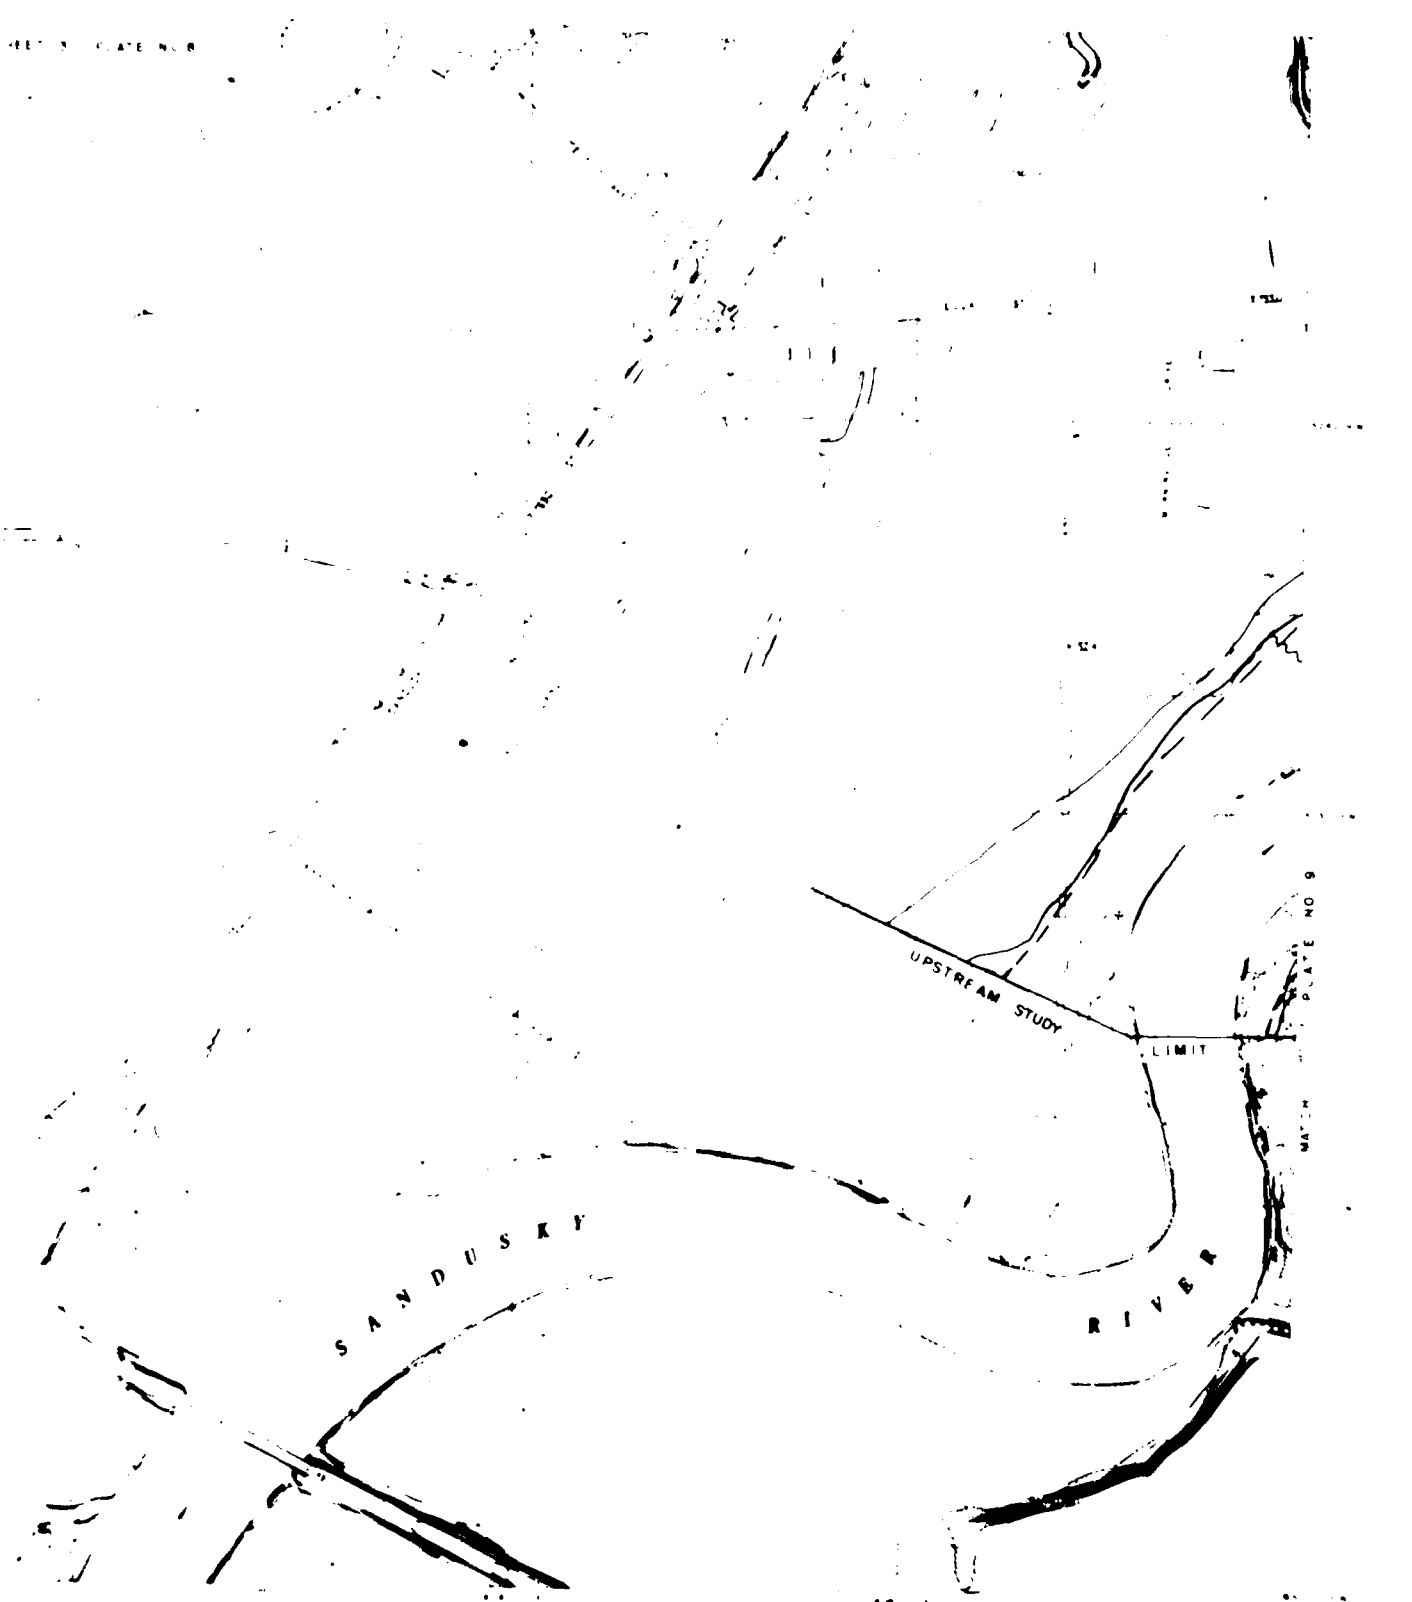
PLATE NO. 8

FOR THE CITY OF TIFFIN, OHIO
CONSULTING ENGINEERS
DATE OF PHOTOGRAPHY APRIL 8, 1984
KERRA & ASSOCIATES, INC.
