**ENVIRONMENTAL AND WATER QUALITY  
OPERATIONAL STUDIES**

TECHNICAL REPORT E-84-11

**ENVIRONMENTAL FEATURES FOR  
STREAMBANK PROTECTION PROJECTS**

Jim E. Henderson, F. Douglas Shields, Jr.  
Environmental Laboratory

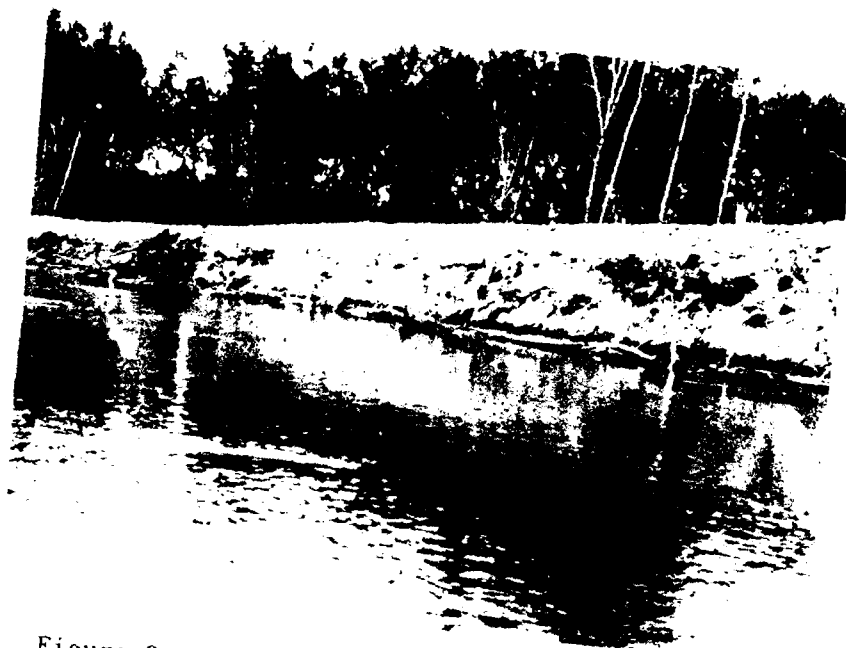
Figure 9. Notch placement of windrow revetment (from OCE 1981, Appendix E)

74. Construction may be either from land or water. Stone fill is placed in one of two ways, in an excavated notch at the top of the bank line (Figure 9) or in a trench excavated near the top of the bank, parallel to the bank line. Placement in a notch requires less bank clearing. The exposed surface of the stone is covered or backfilled with excavated material. Trench placement utilizes an excavation at least 2 ft deep. As further erosion takes place, the stone fill is "launched" down the bank and blankets the bank at a naturally established slope. Stone is then added on an as-needed basis until a stable equilibrium is

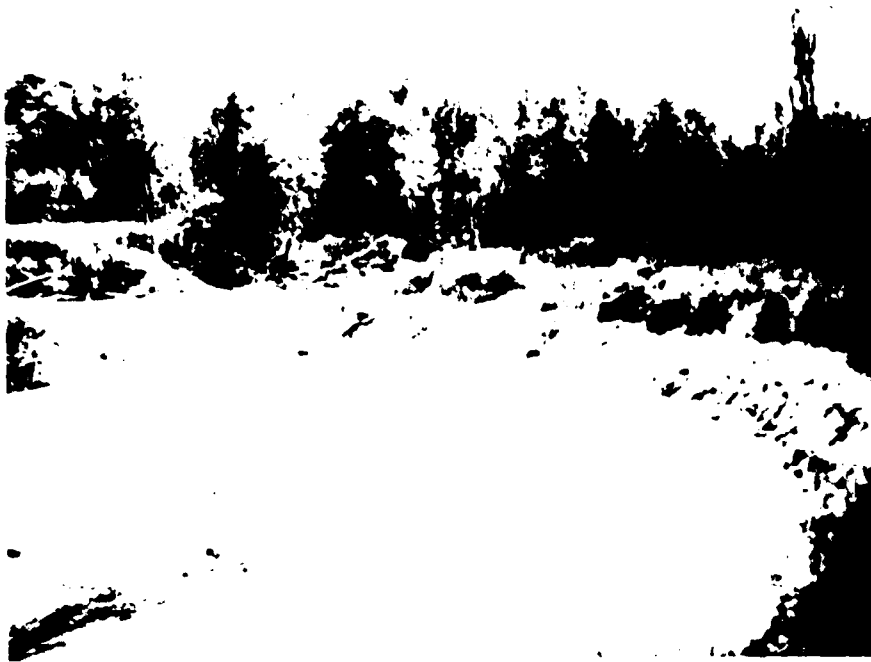
Figure 14. Vegetation established on bank area of toe protection design

93. Environmental considerations. Toe protection is beneficial to terrestrial habitat because the riparian nature of the streambank is restored, either through vegetative treatment of the upper bank or invasion of native species to the stabilized bank (Figure 14). Clearing

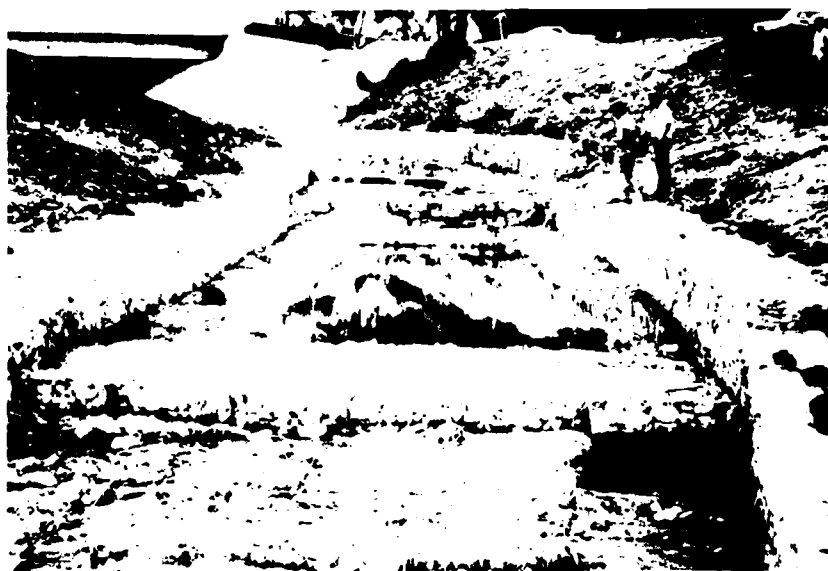
Figure 33. Gabions used for grade control  
(from Linder 1976)

149. Gabion works may be used as toe protection only, or stacked to form grade control structures (Figure 33) (Maccaferri 1981). When gabions are used for toe protection, the upper bank may be graded and planted in grasses, or the upper bank may simply be backfilled behind the gabions. Gabions may be used in enlarged channels to define a low-flow channel as well as to provide toe protection (OCE 1981, Main Report). The USAED, Omaha, used gabions to realign a channel for urban development. This design incorporated gabion drop structures for grade control (OCE 1981, Appendix H).

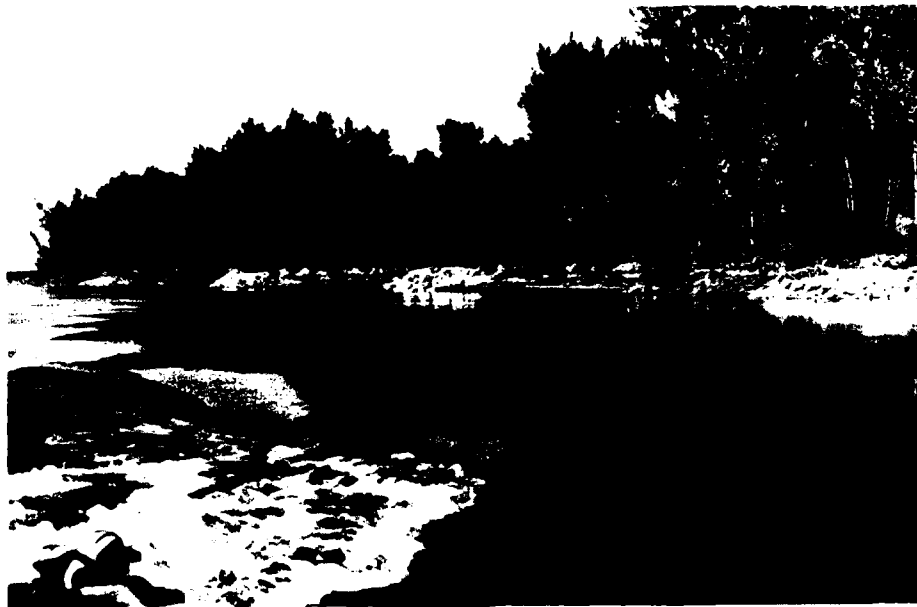
Figure 36. Hard point system (from OCE 1981, Appendix E)

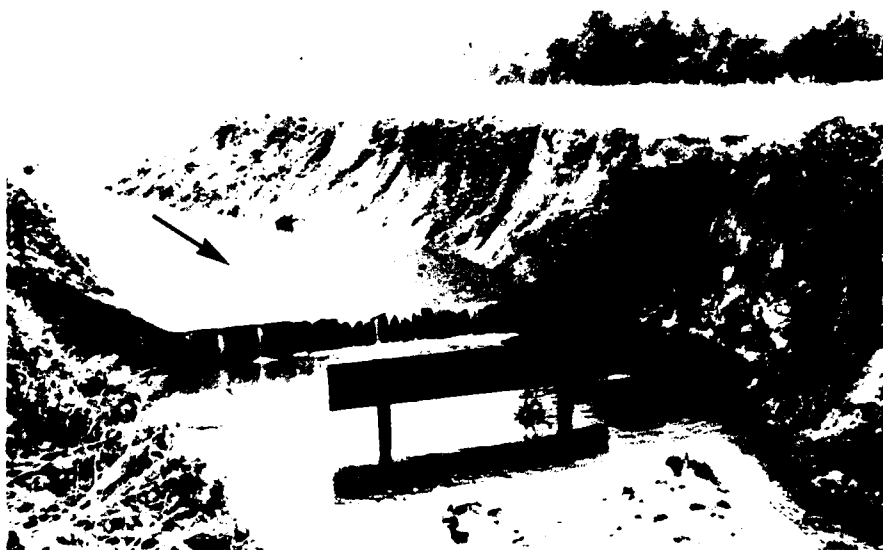
Figure 40. Drop structure consisting of a weir and baffle plate (from OCE 1981, Appendix F)

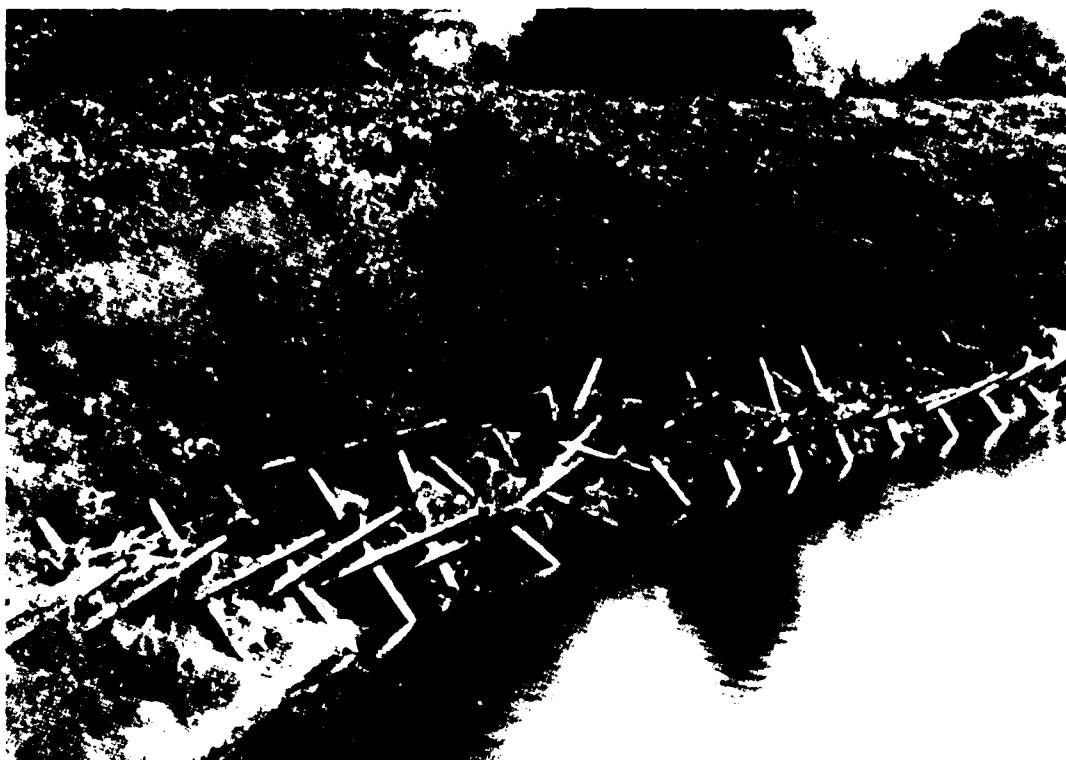
Figure 42. Kellner jacks placed longitudinally along the bank; note vegetation behind the jack line (photo courtesy of SCS)

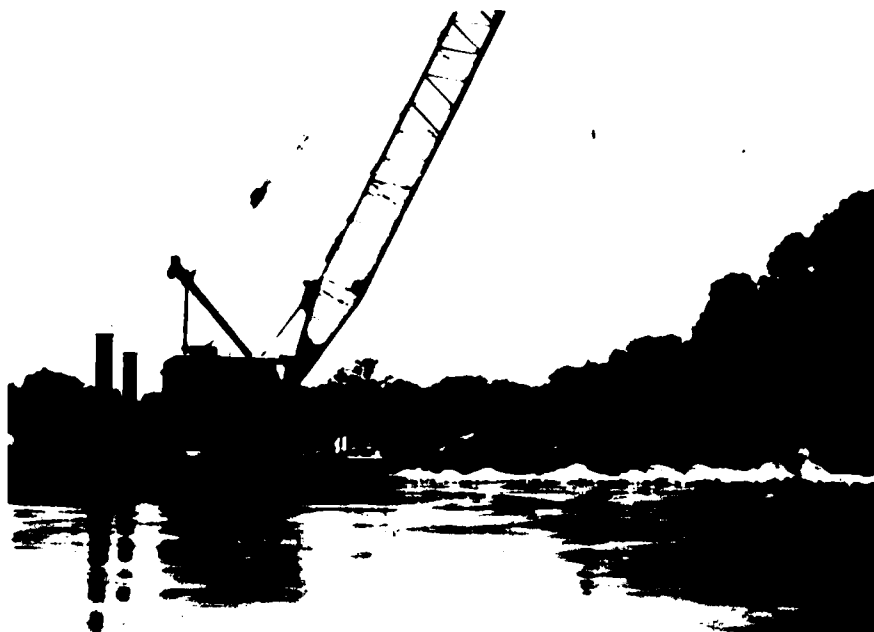
Figure 49. Floating plant construction

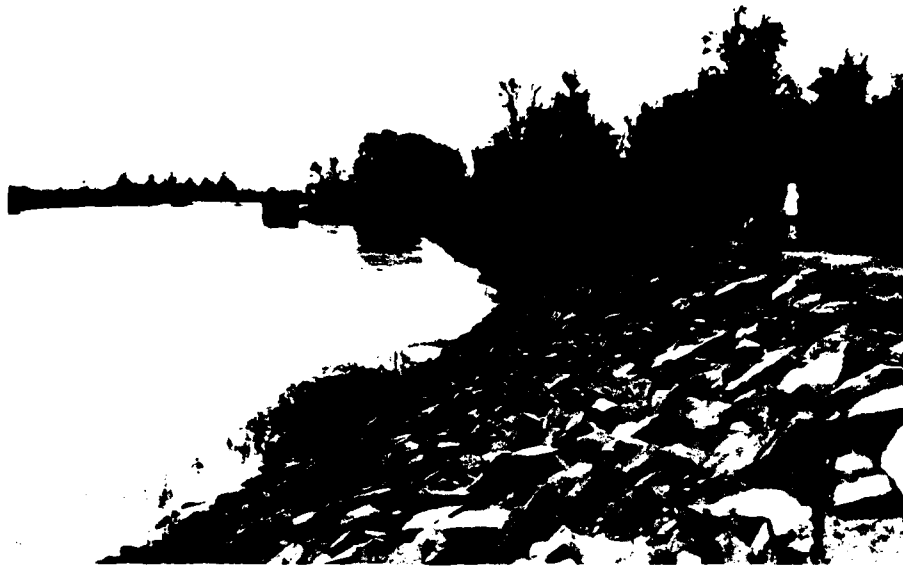
Figure A2. Stone revetment along the Willamette
