MECHANISMS OF CORROSION FATIGUE IN HIGH  
STRENGTH I/M AND P/M ALUMINUM ALLOYS

November, 1984

Final Technical Report

Air Force Office of Scientific Research

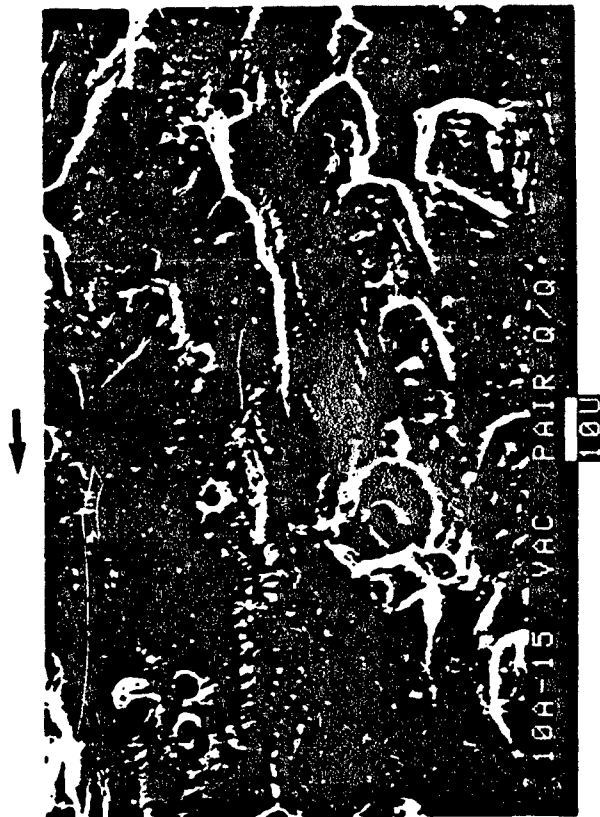
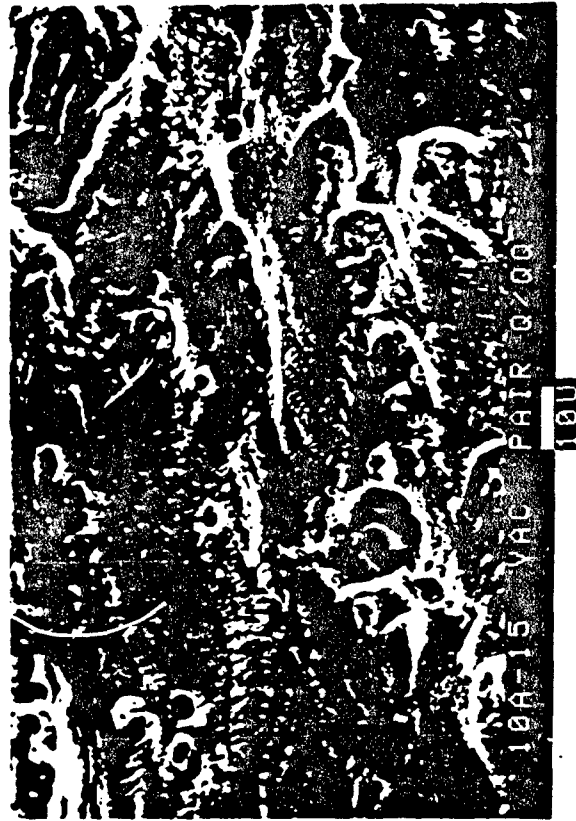
Fig. 43: Stereo pair of the fracture surface morphology for 7075-T651 tested in vacuum.  
The stereo pair of the mating half is shown in Fig. 44.

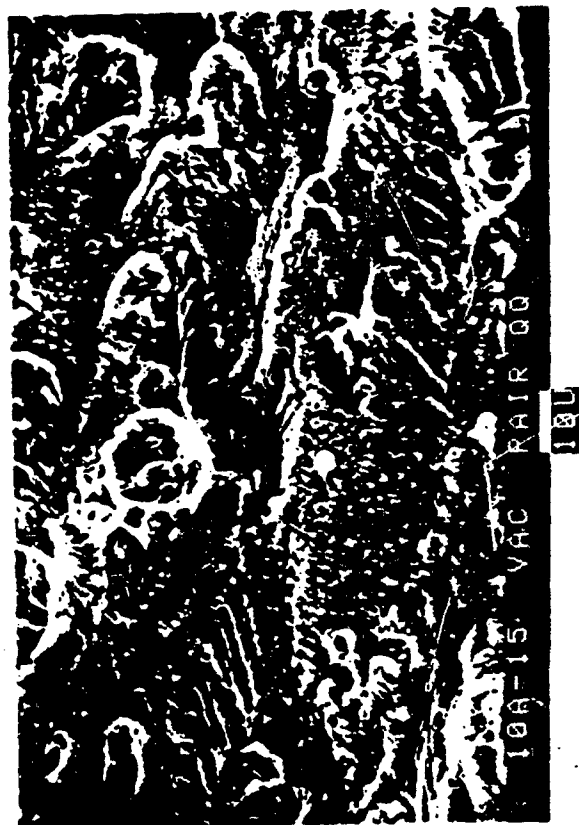
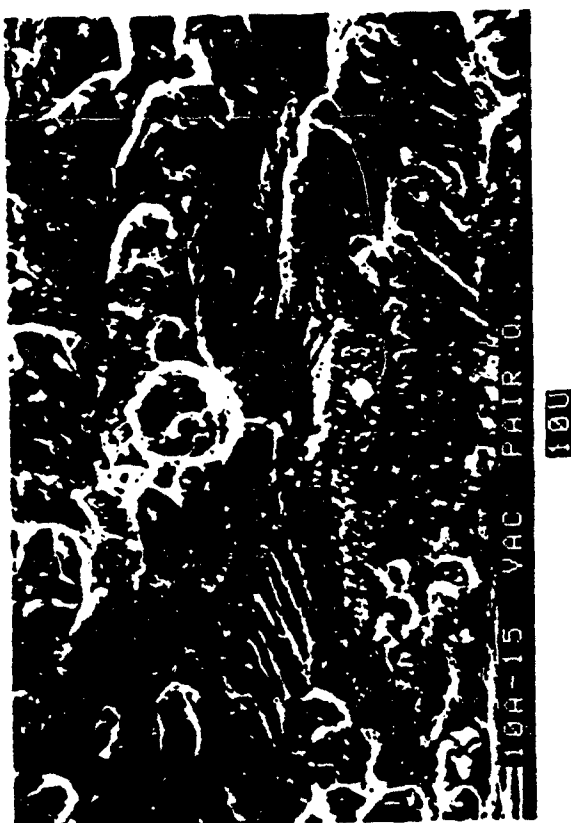
Fig. 44: Stereo pair of the fracture surface morphology for 7075-T651 tested in vacuum. The stereo pair of the mating half is shown in Fig. 43.

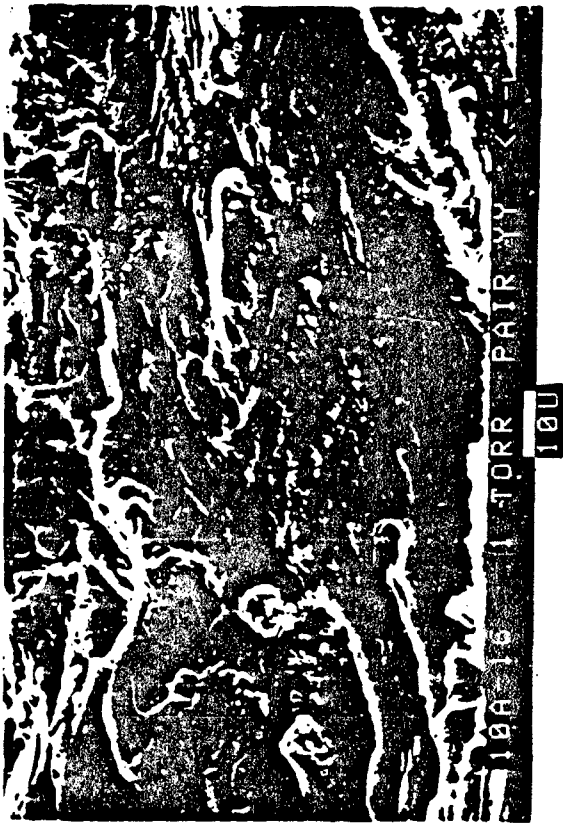
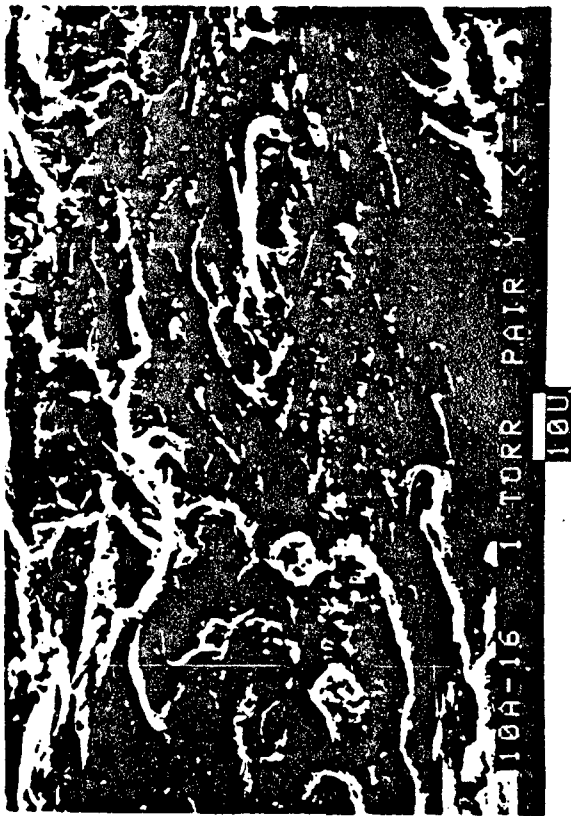
Fig. 51: Stereo pair of the fracture surface morphology for 7075-T651 tested at 133.3 Pa in water vapor. The stereo pair of the mating half is shown in Fig. 52.

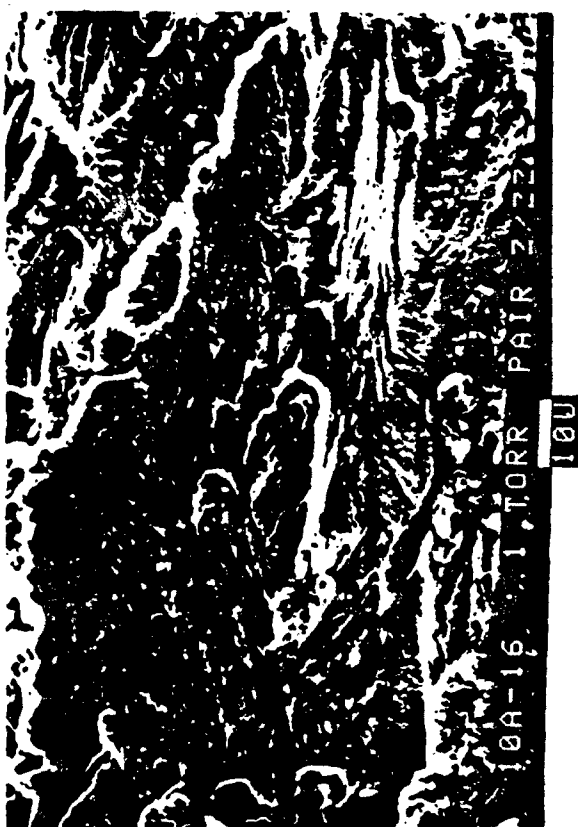
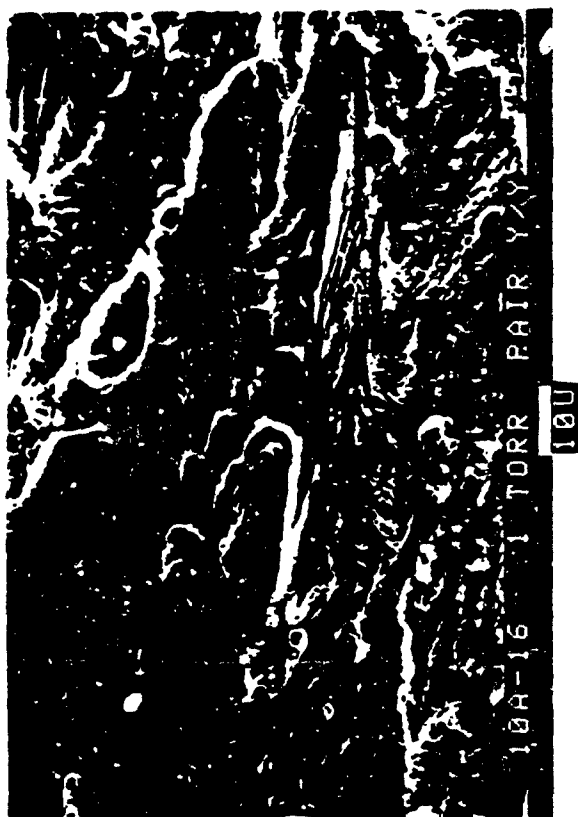
Fig. 52: Stereo pair of the fracture surface morphology for 7075-T651 tested at 133.3 Pa in water vapor. The stereo pair of the mating half is shown in Fig. 51.
