**TECHNICAL REPORT M-85/05**

**Improved and New Roofing for Military Construction**

**SLOPED ROOF CONVERSIONS FOR SMALL,  
FLAT-ROOF BUILDINGS**

by  
**Myer J. Rosenfield  
Carter Doyle**

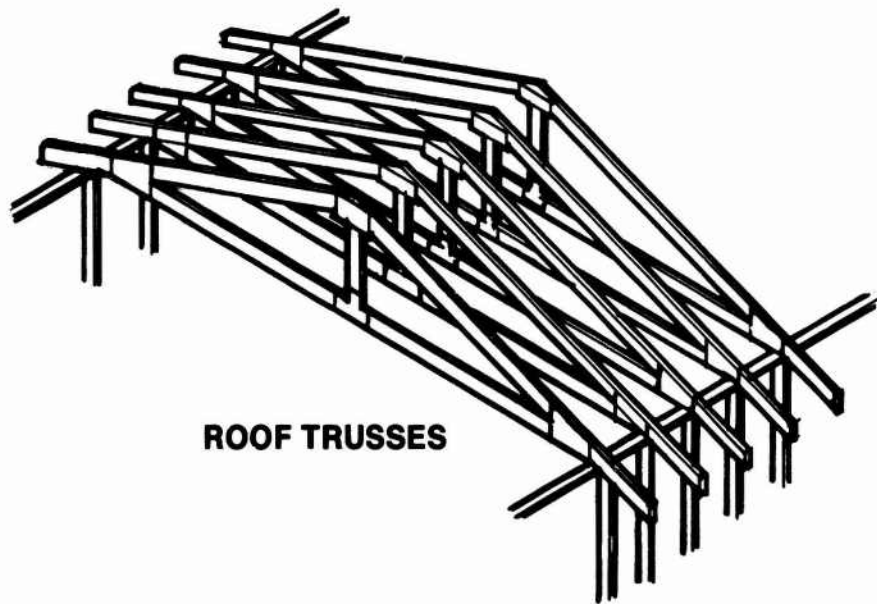
**ROOF TRUSSES**

**Figure 2. Roof framing systems.**

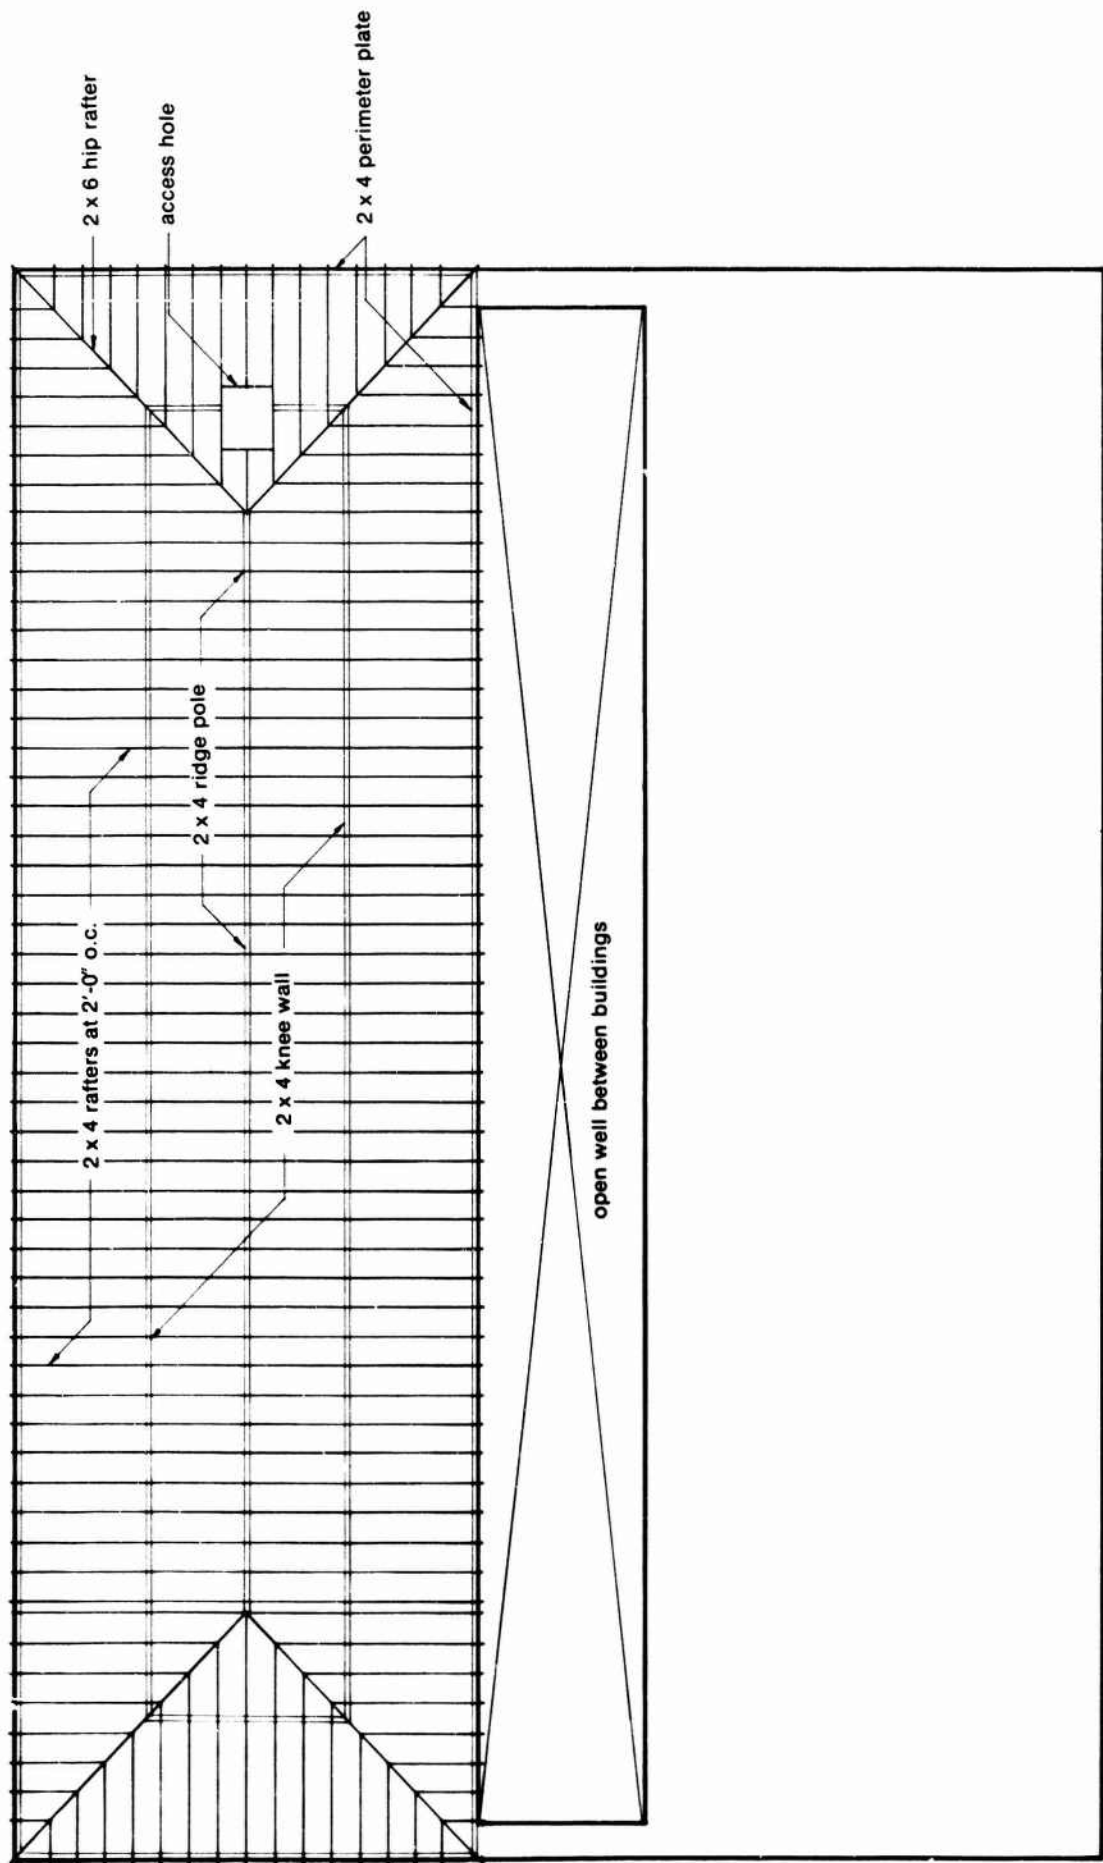
Figure 3. Roof framing plan, Case Study No. 1.

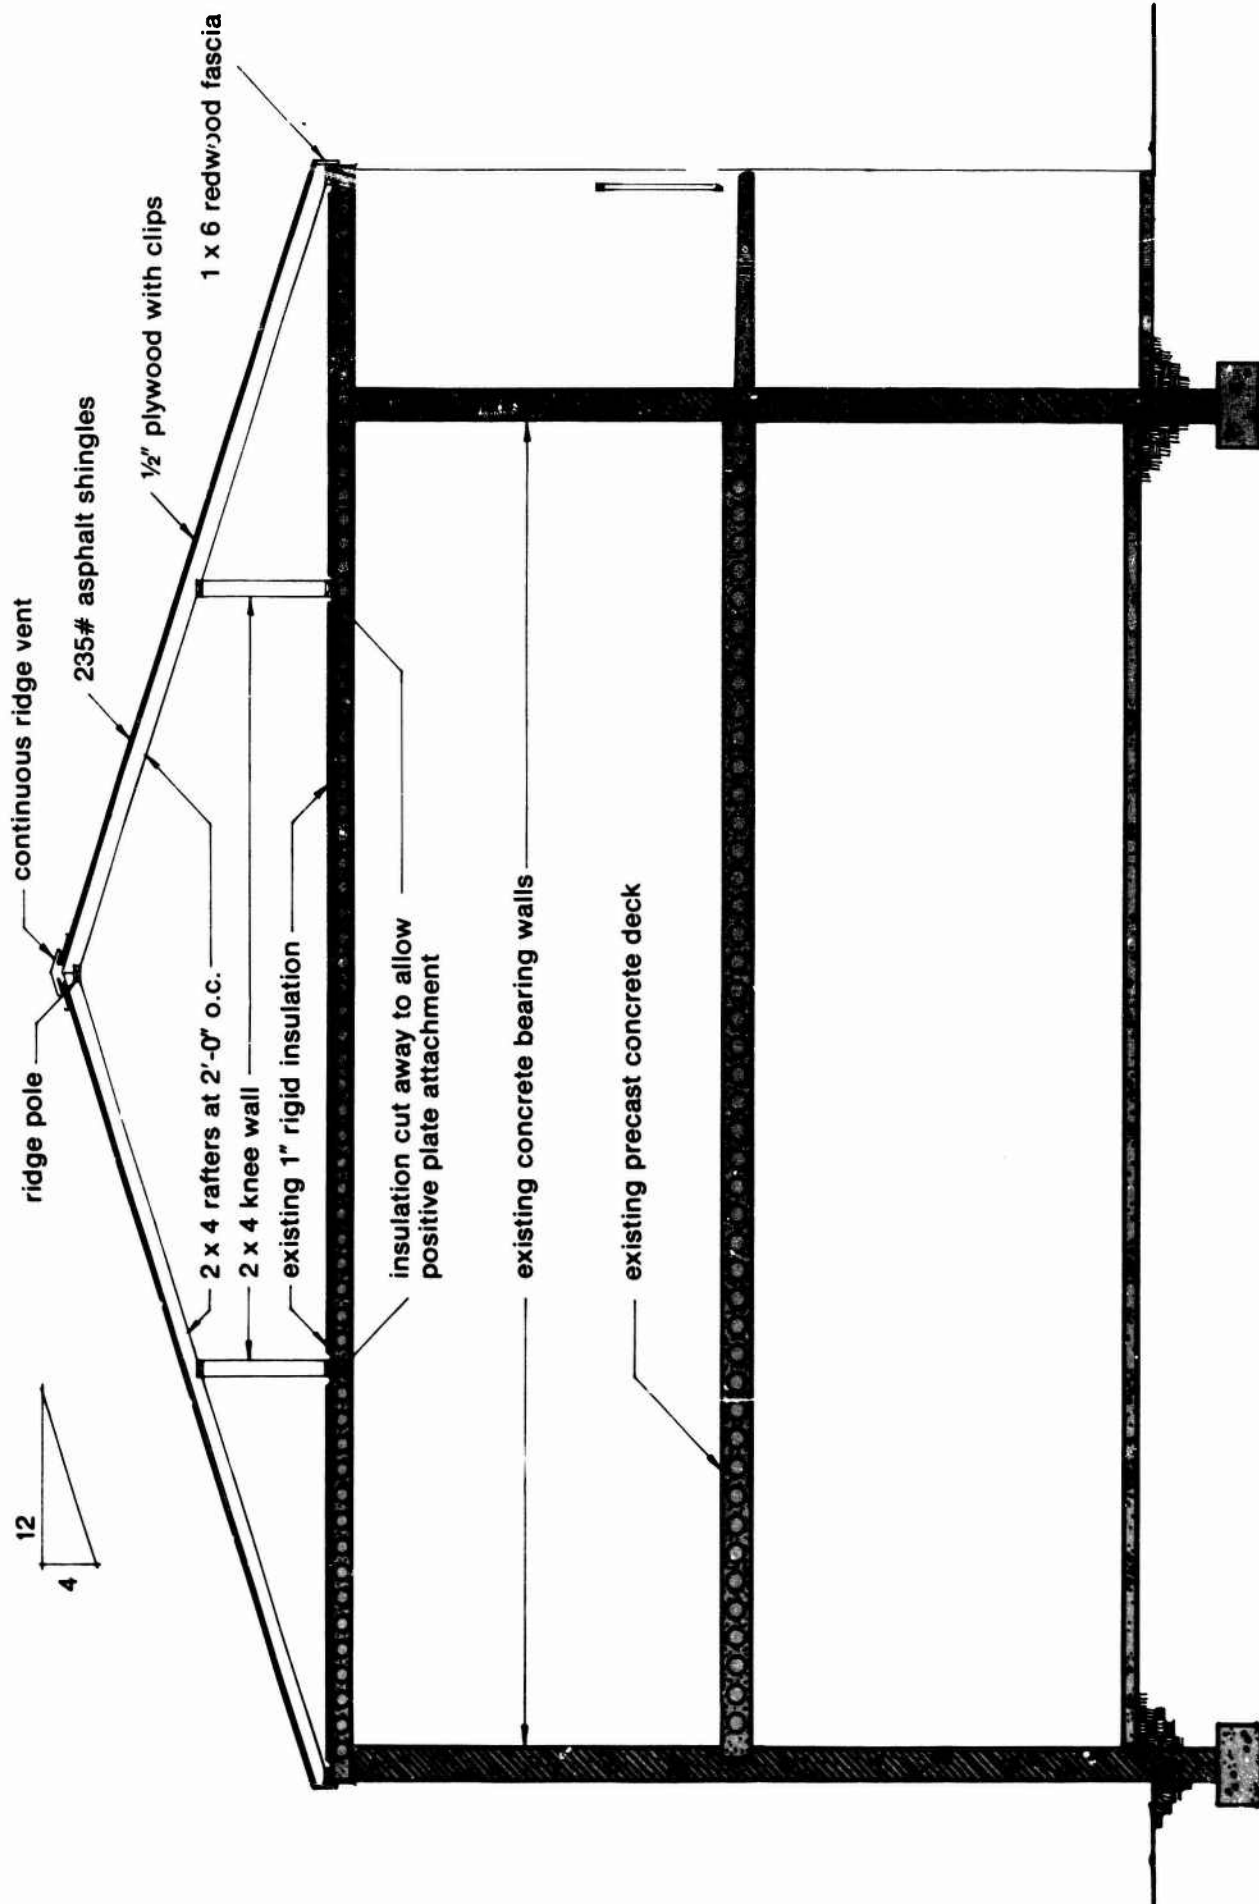
Figure 4. Section through building, Case Study No. 1.

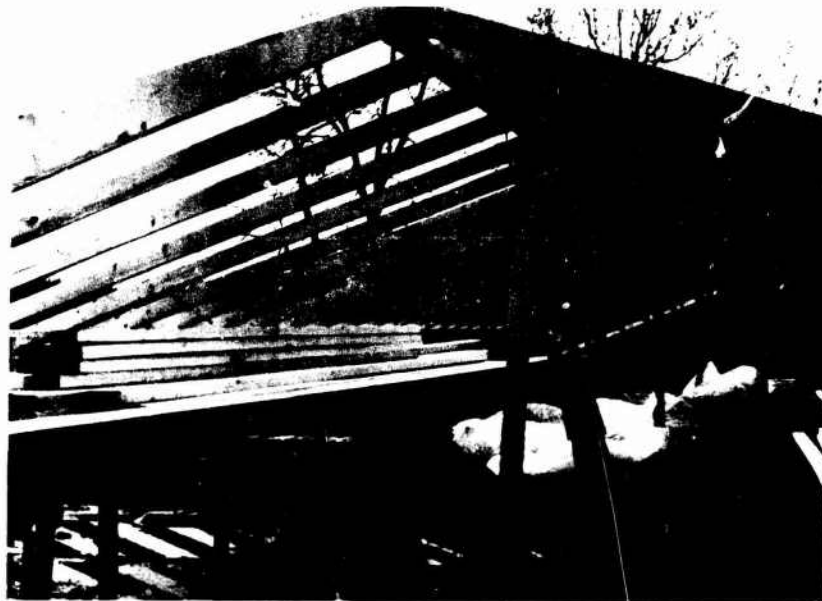
Figure 5. View looking under framing, Case Study No. 1. The job was done during February so the knee walls were temporarily supported until it was completely roofed. Later the roofing and insulation on the existing roof were cut away to allow the 2- x 4-in. (5- x 10-cm) plates to be fastened.

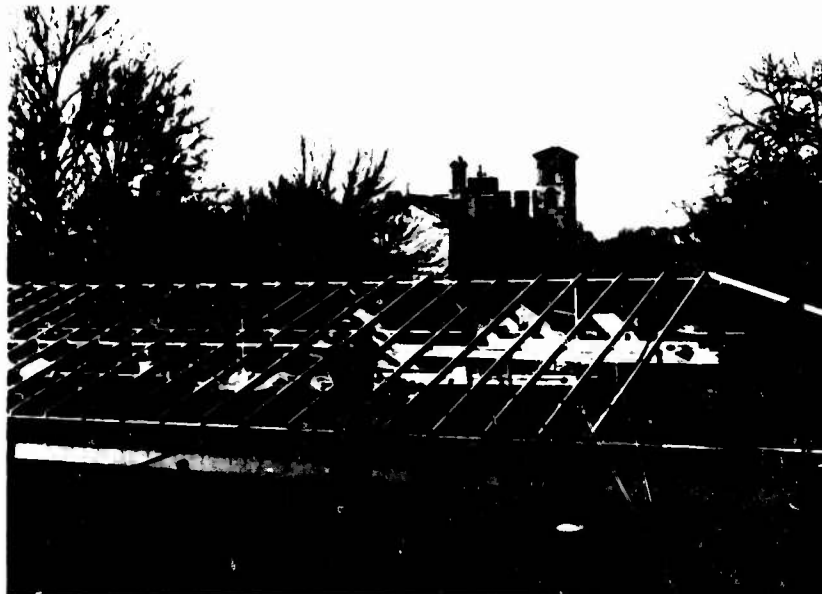
Figure 6. General view of framing, Case Study No. 1.

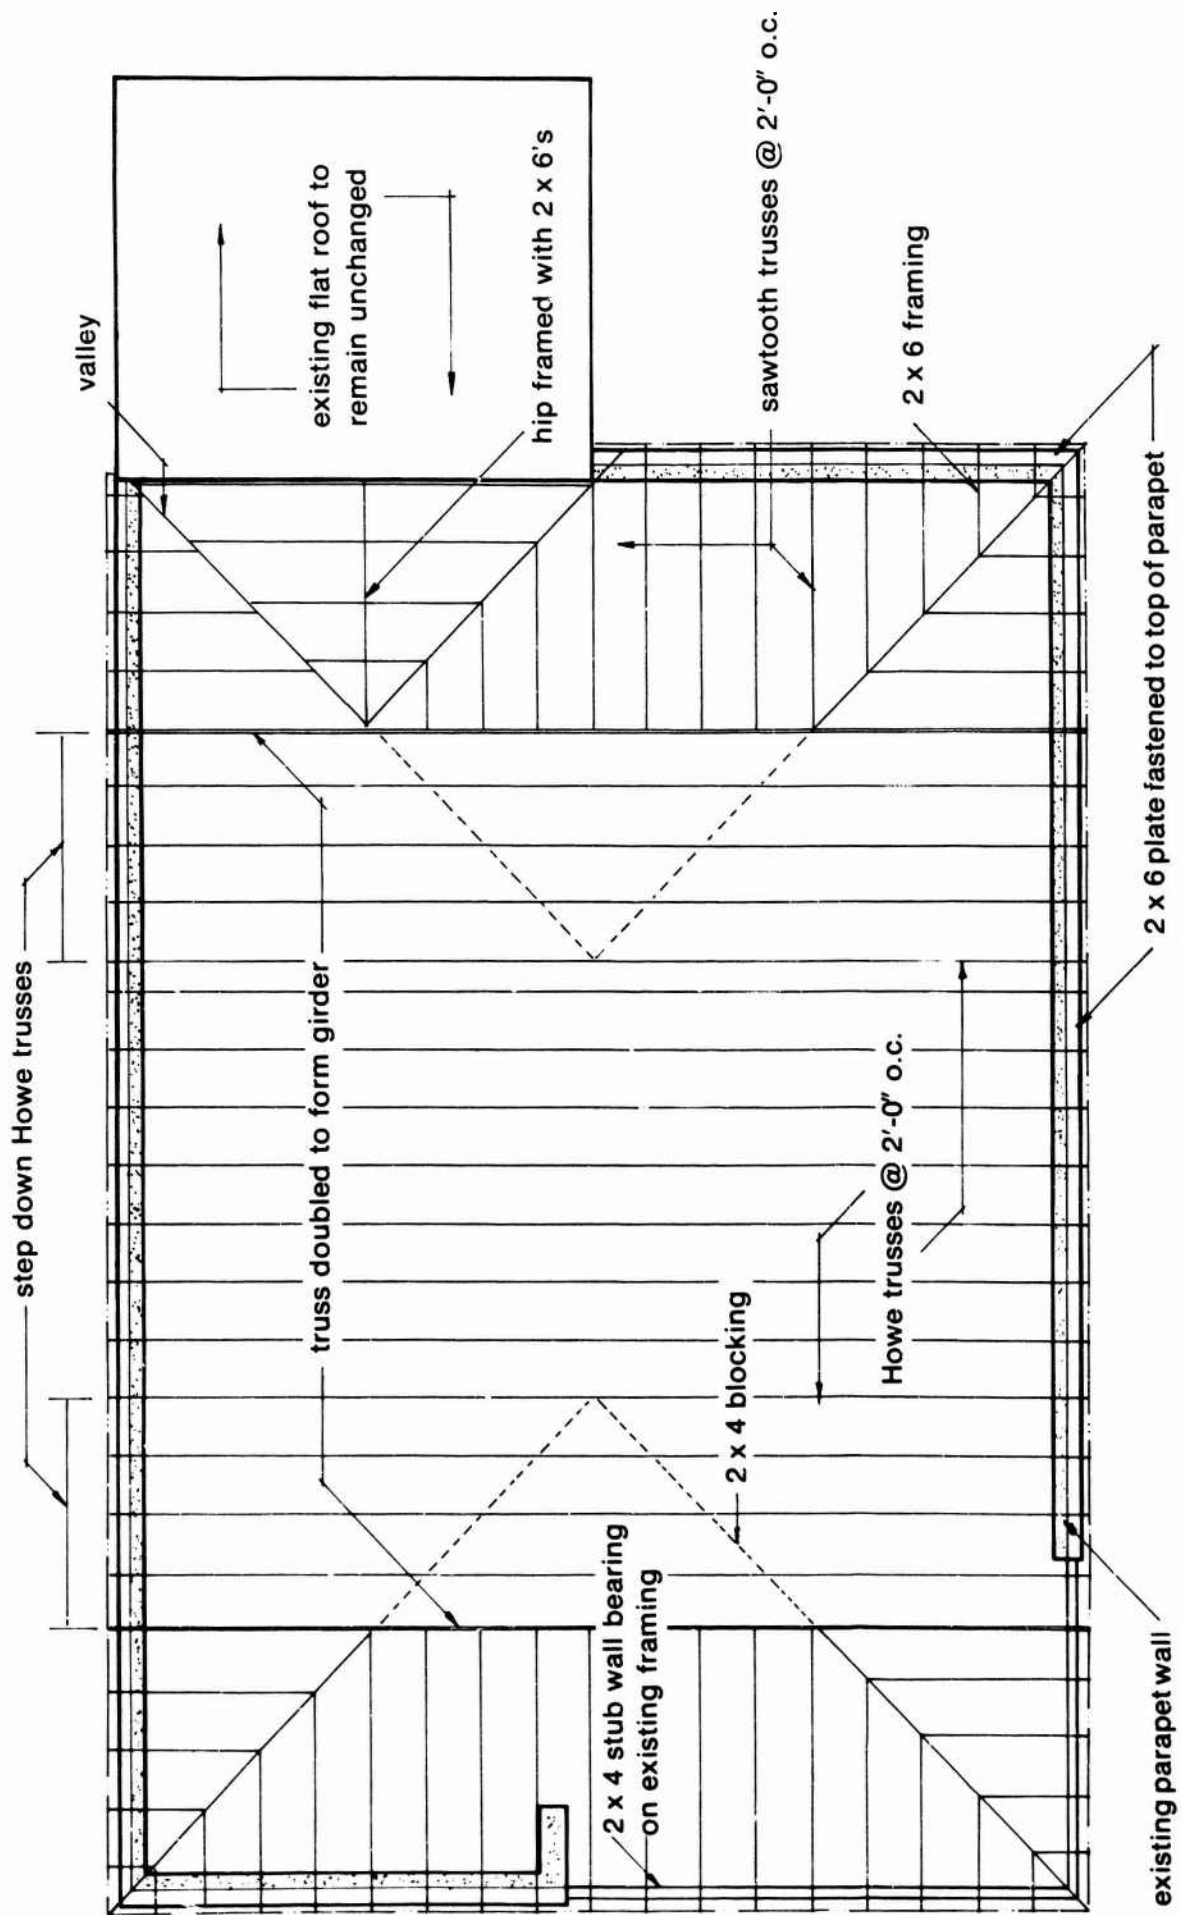
Figure 9. Roof plan, Case Study No. 2.

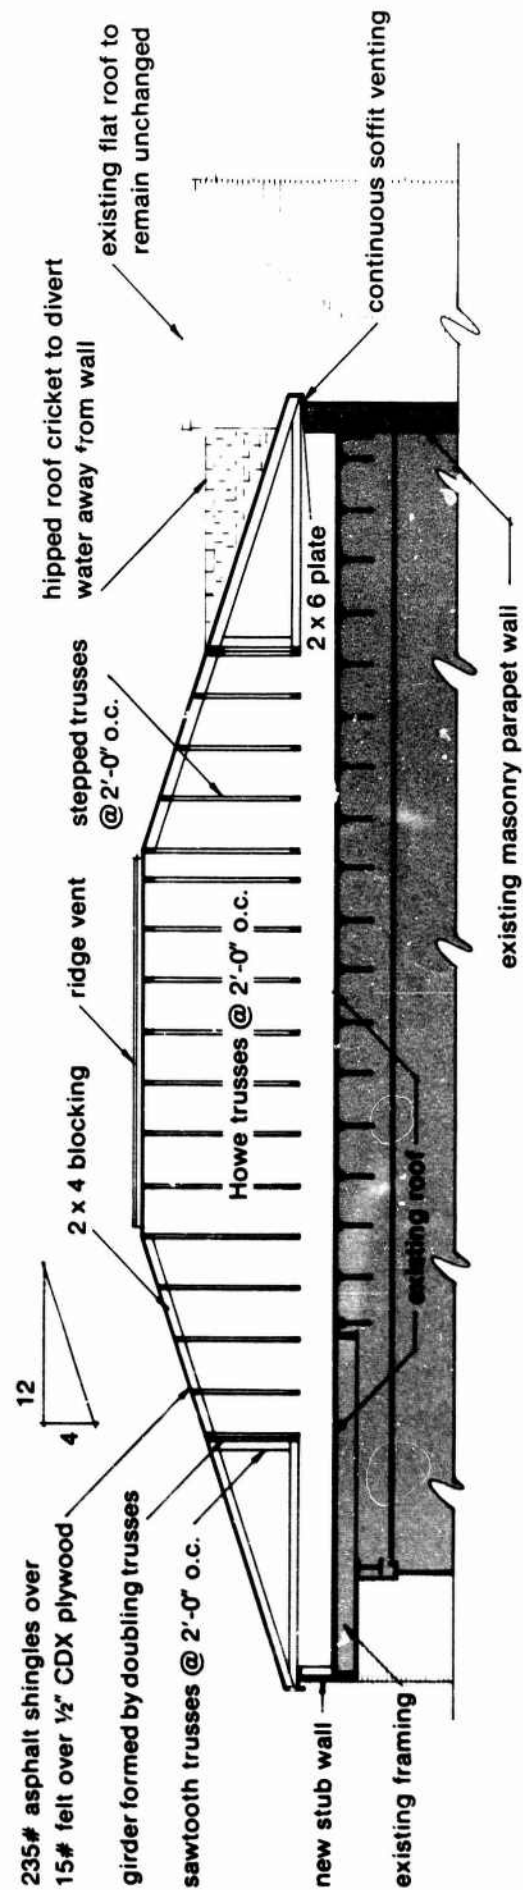
Figure 10. Longitudinal section through the roof, Case Study No. 2.

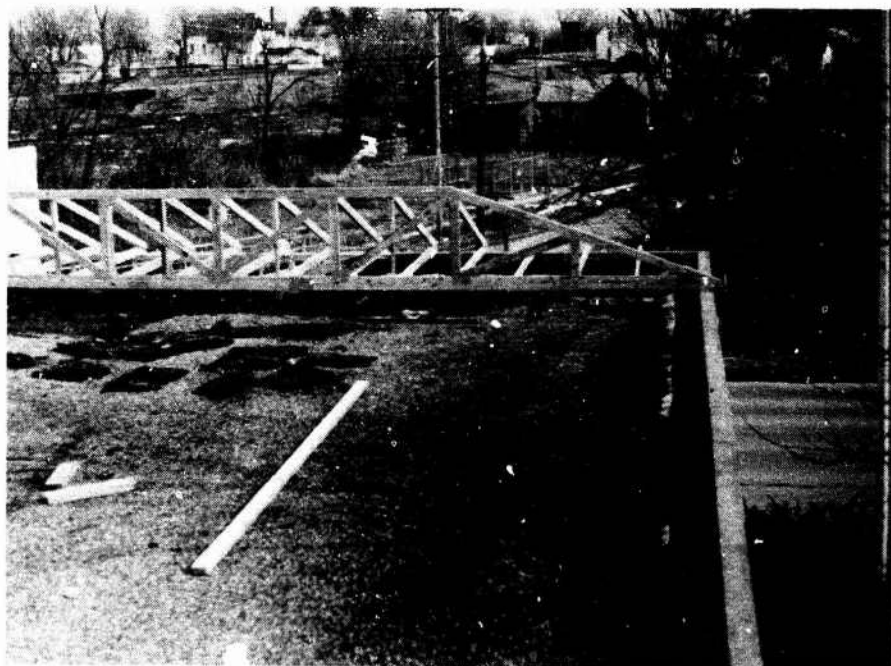
Figure 11. View on top of roof during beginning construction stage, Case Study No. 2. Note the 2- x 4-in. (5- x 10-cm) plate bolted to the top of the parapet wall and the allowable clear area for adding insulation.

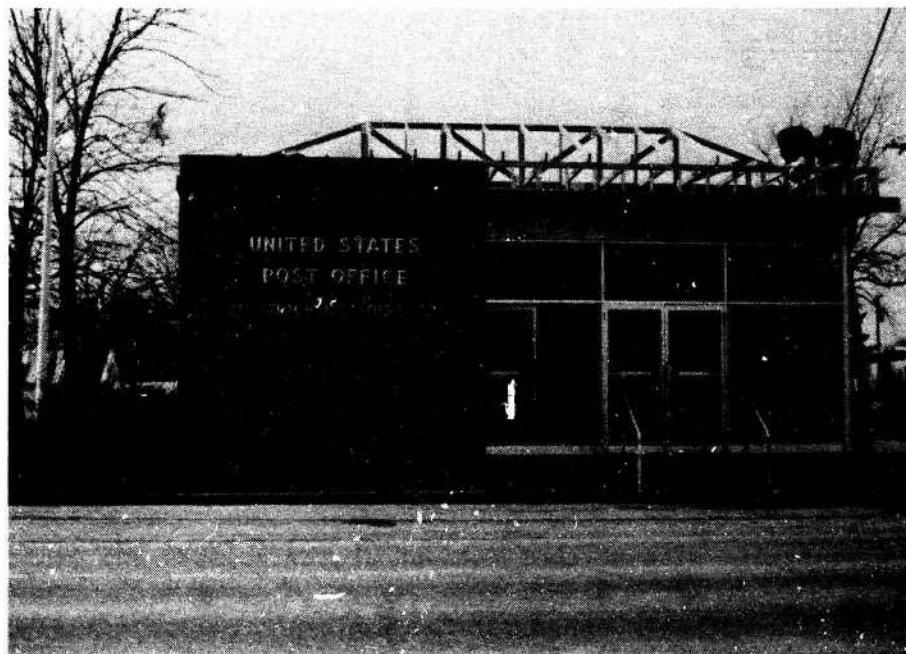
Figure 13. View of the beginning of construction, Case Study No. 2. One full-length stepped truss and the front sawtooth trusses are in place.

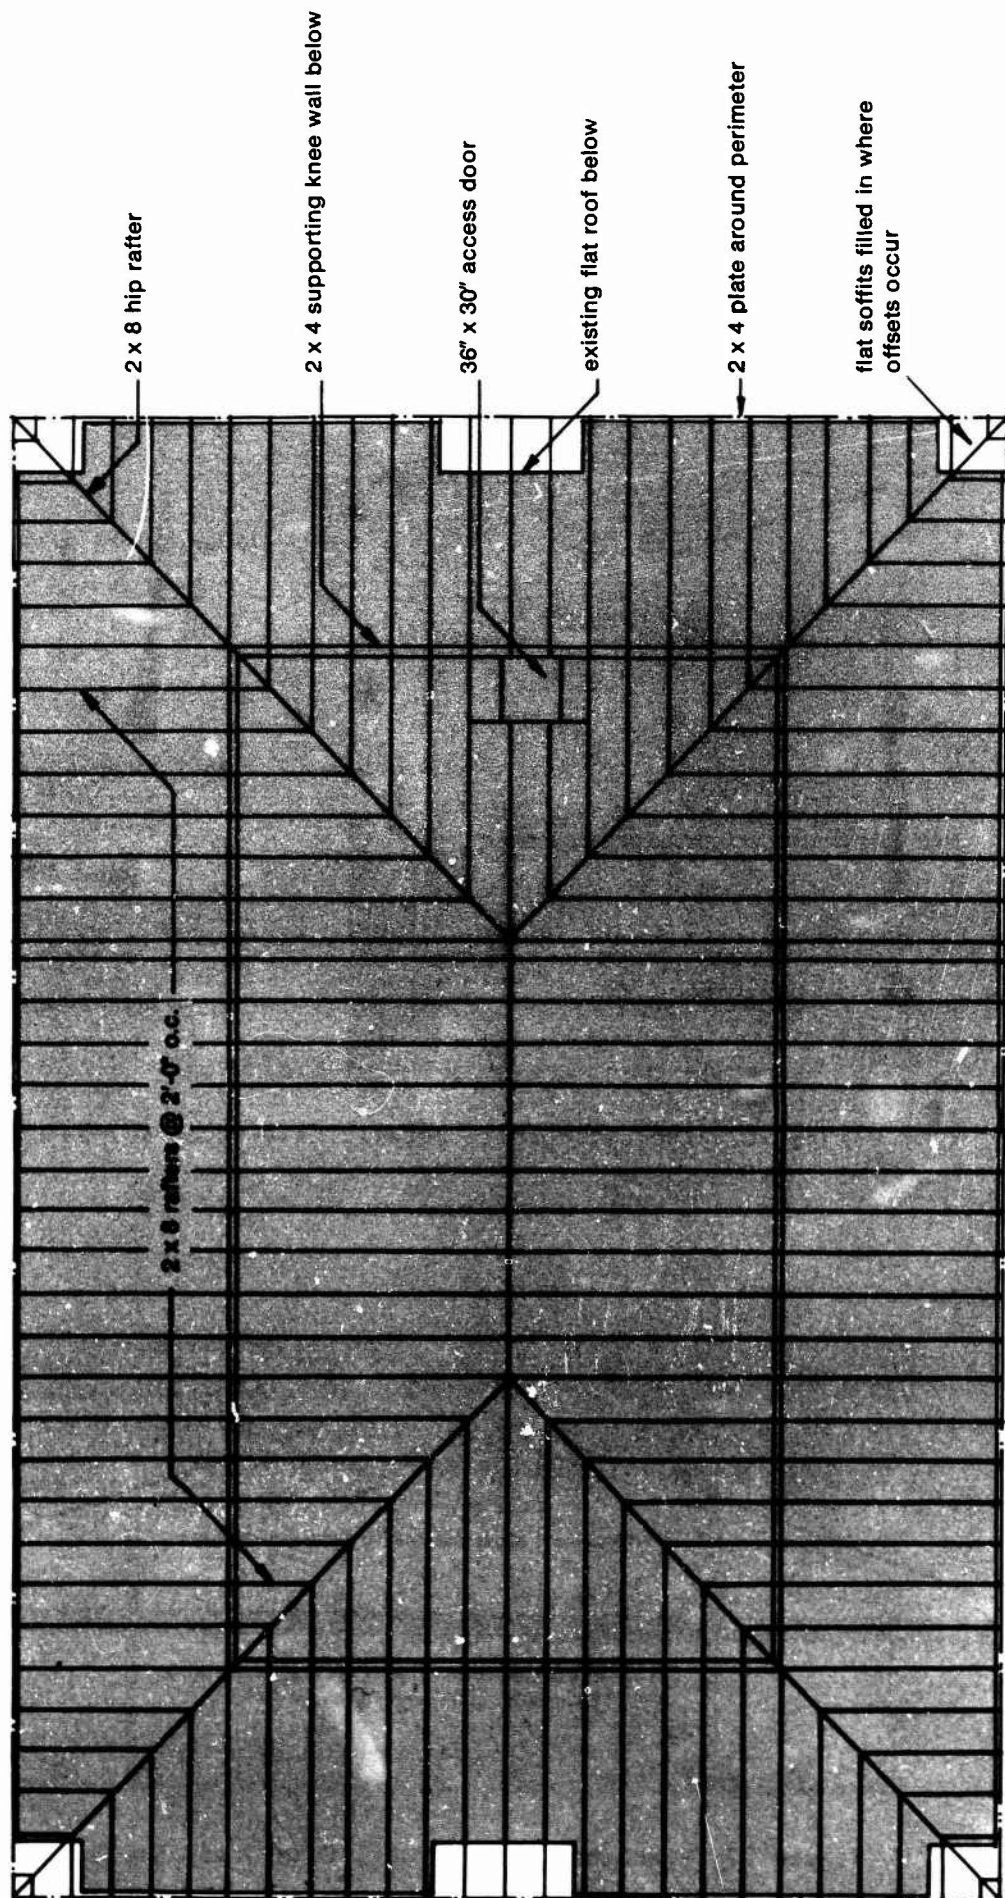
Figure 15. Roof plan, Case Study No. 3.

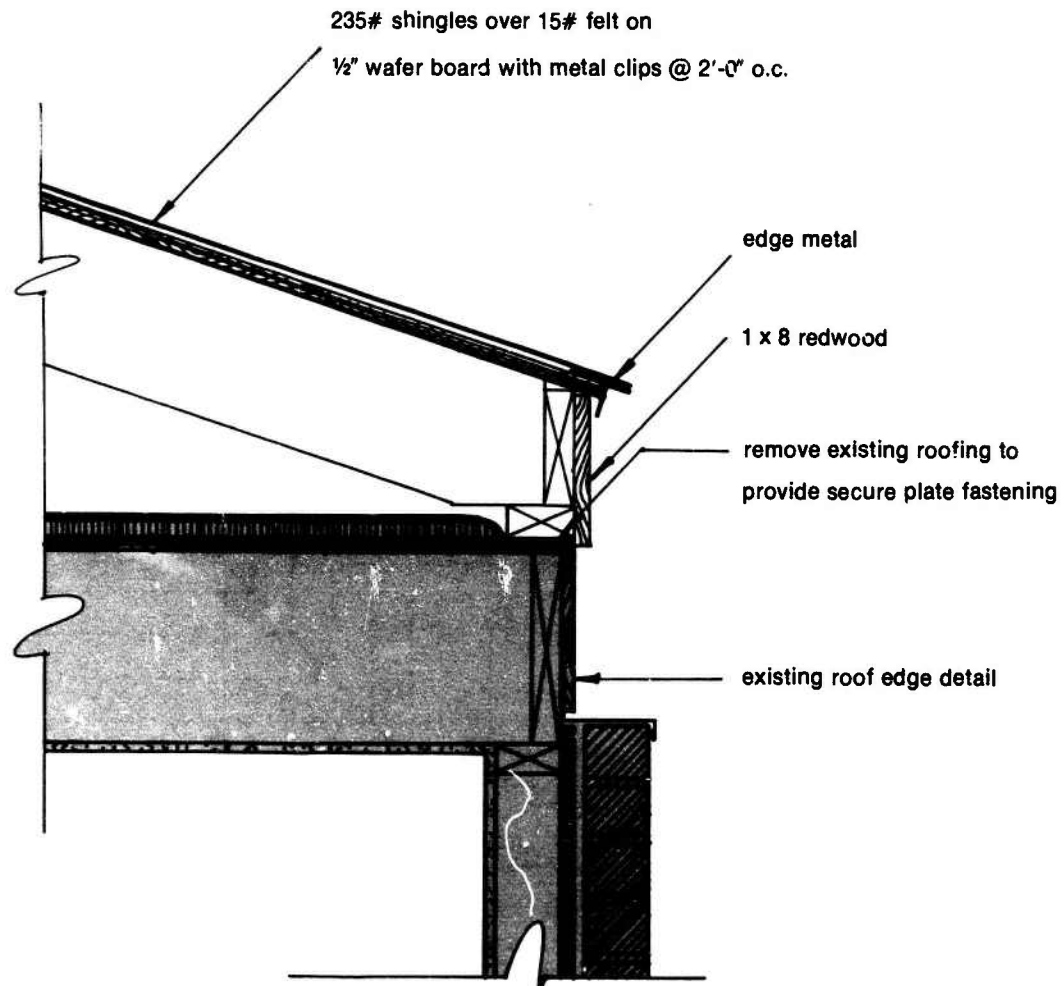
Figure 16. Typical cornice detail, Case Study No. 3.

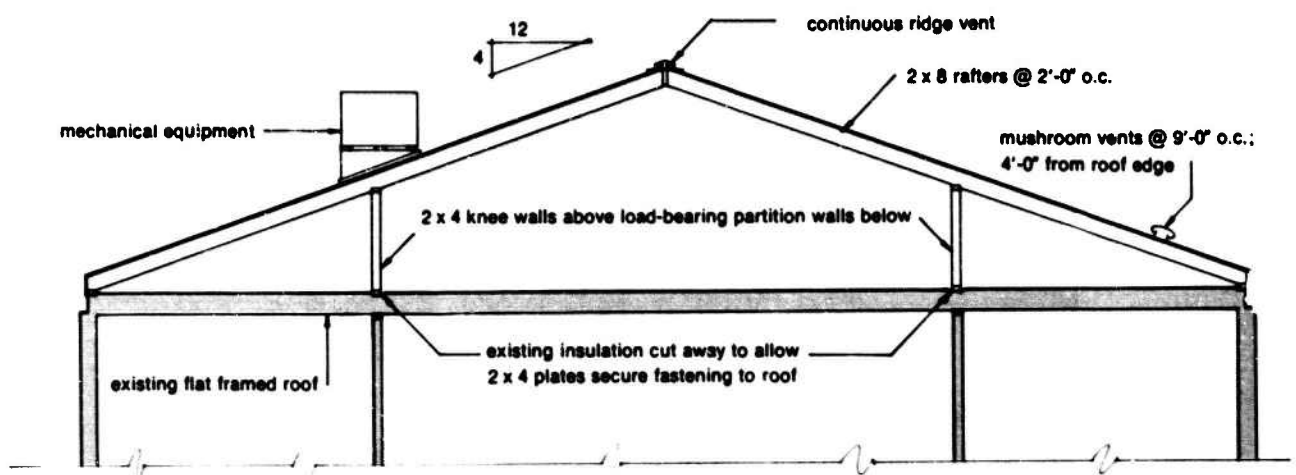
Figure 17. Section through roof, Case Study No. 3.

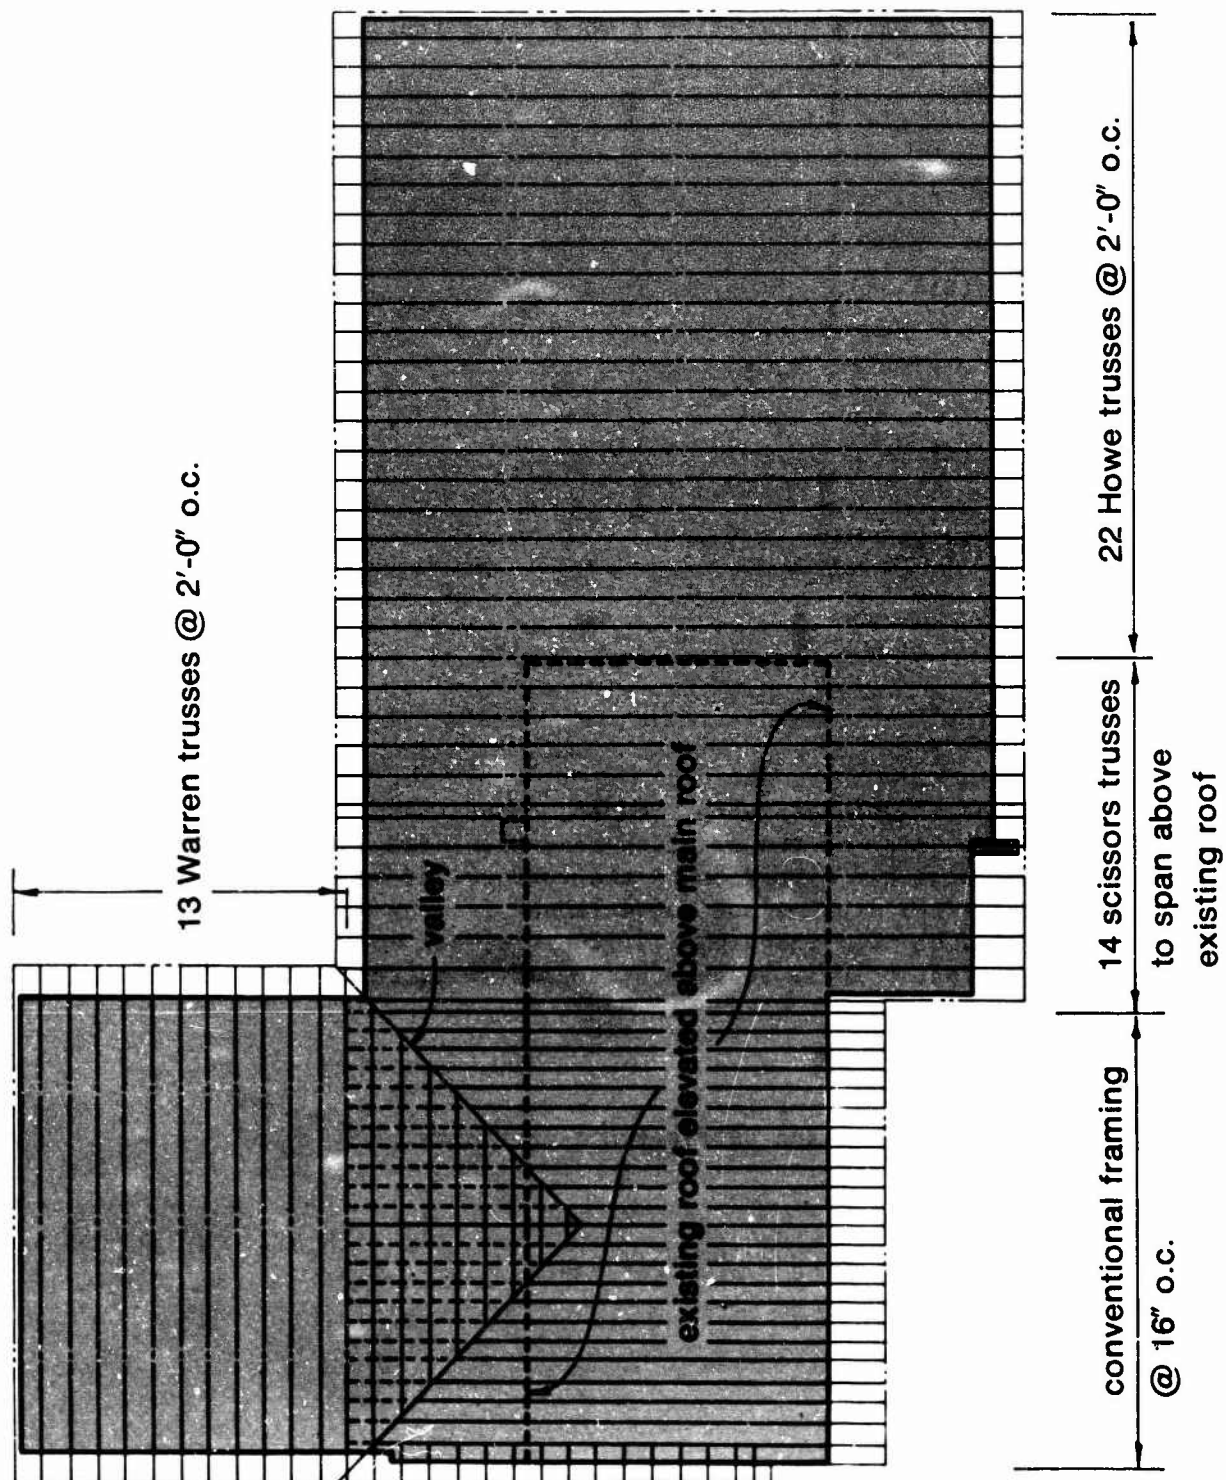
Figure 21. Roof plan, Case Study No. 4.

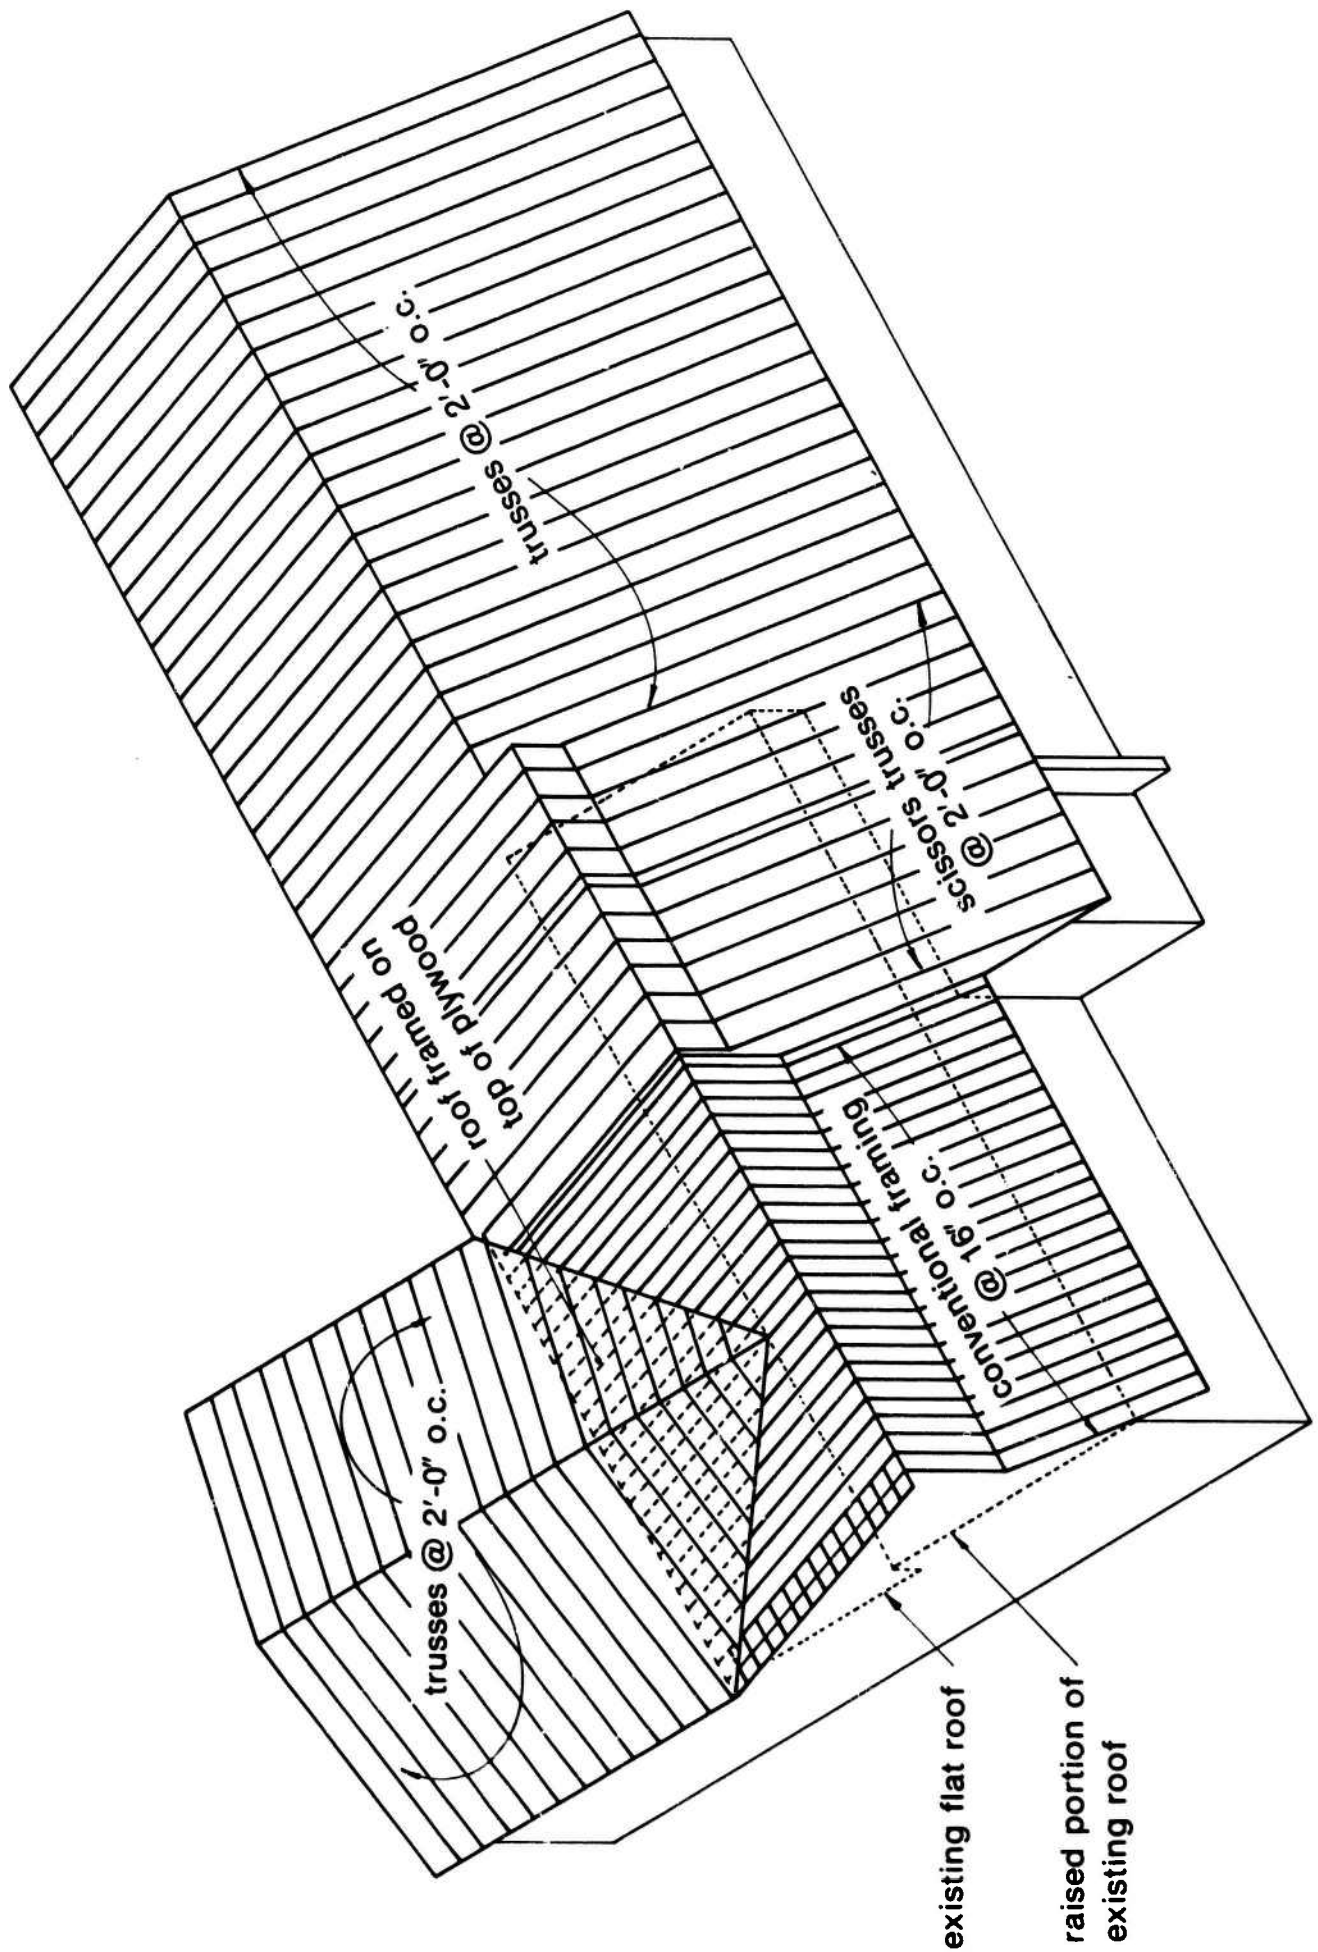
Figure 22. Diagrammatic isometric of roof framing, Case Study No. 4.

235# asphalt shingles over 15# felt  
over 1/2" CDX plywood

trusses @ 2'-0" o.c.

A combination of wood scissors trusses, conventional framing, and Howe trusses was used because of the existing conditions and the design solution. The existing building had a portion of the roof raised to provide clerestory windows. The scissors trusses and conventional framing were used to raise the roof over this rather than removing it. Conventional Howe trusses were used elsewhere. The final 5 in 12 slope was covered with fiberglass-reinforced asphalt shingles.

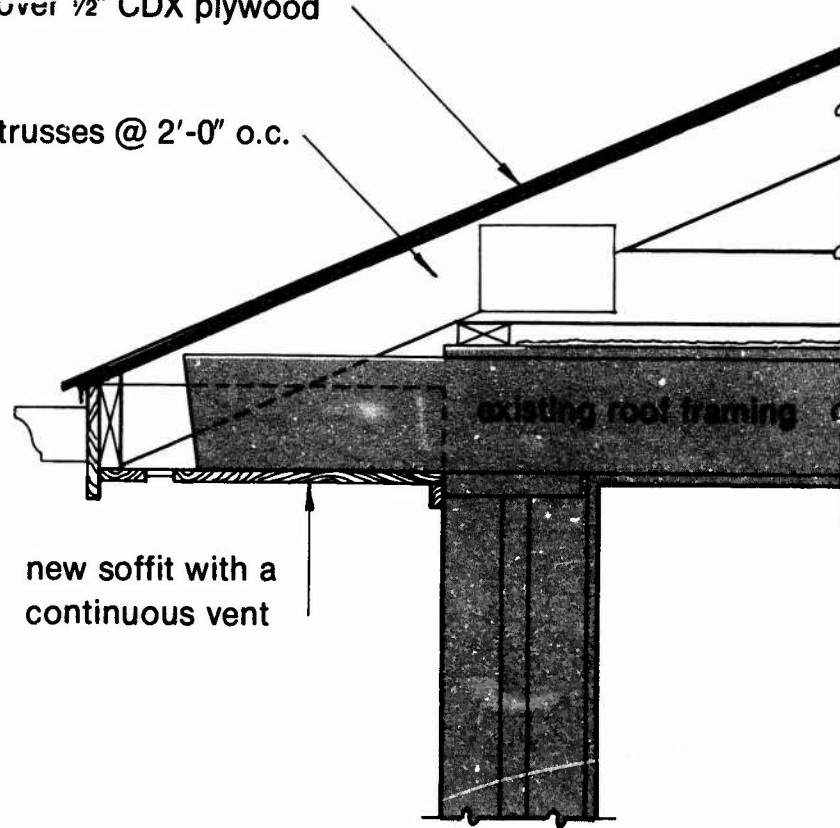
Figure 23. Roof edge detail, Case Study No. 4.

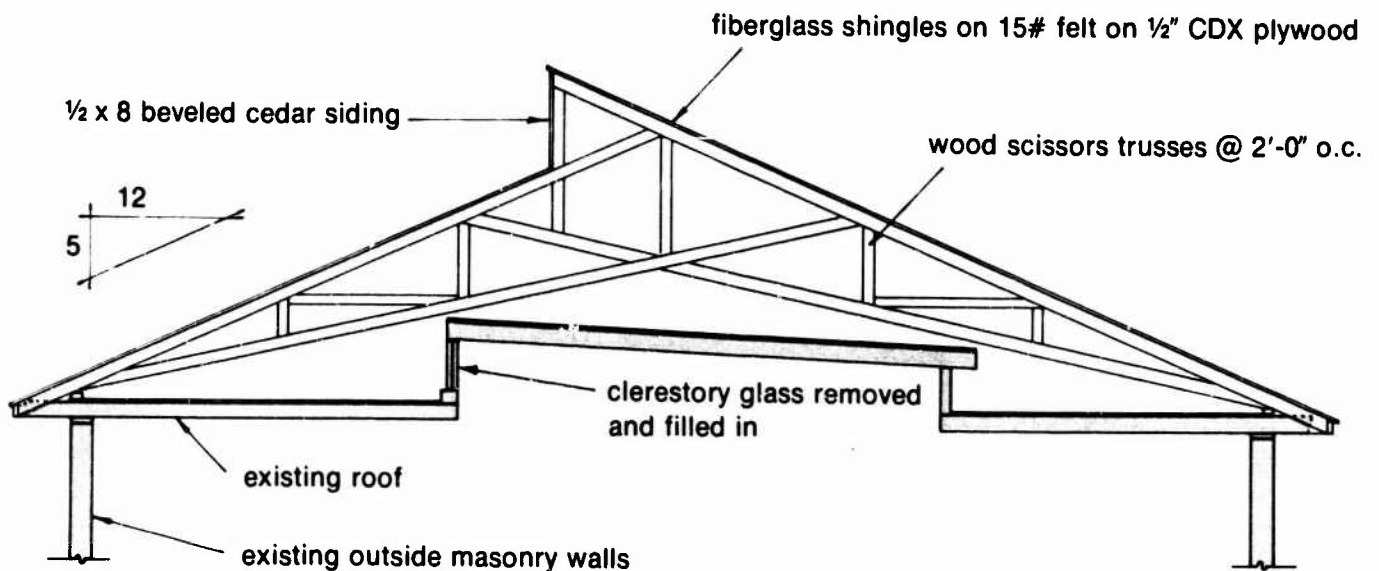
Figure 24. Section through roof, Case Study No. 4.

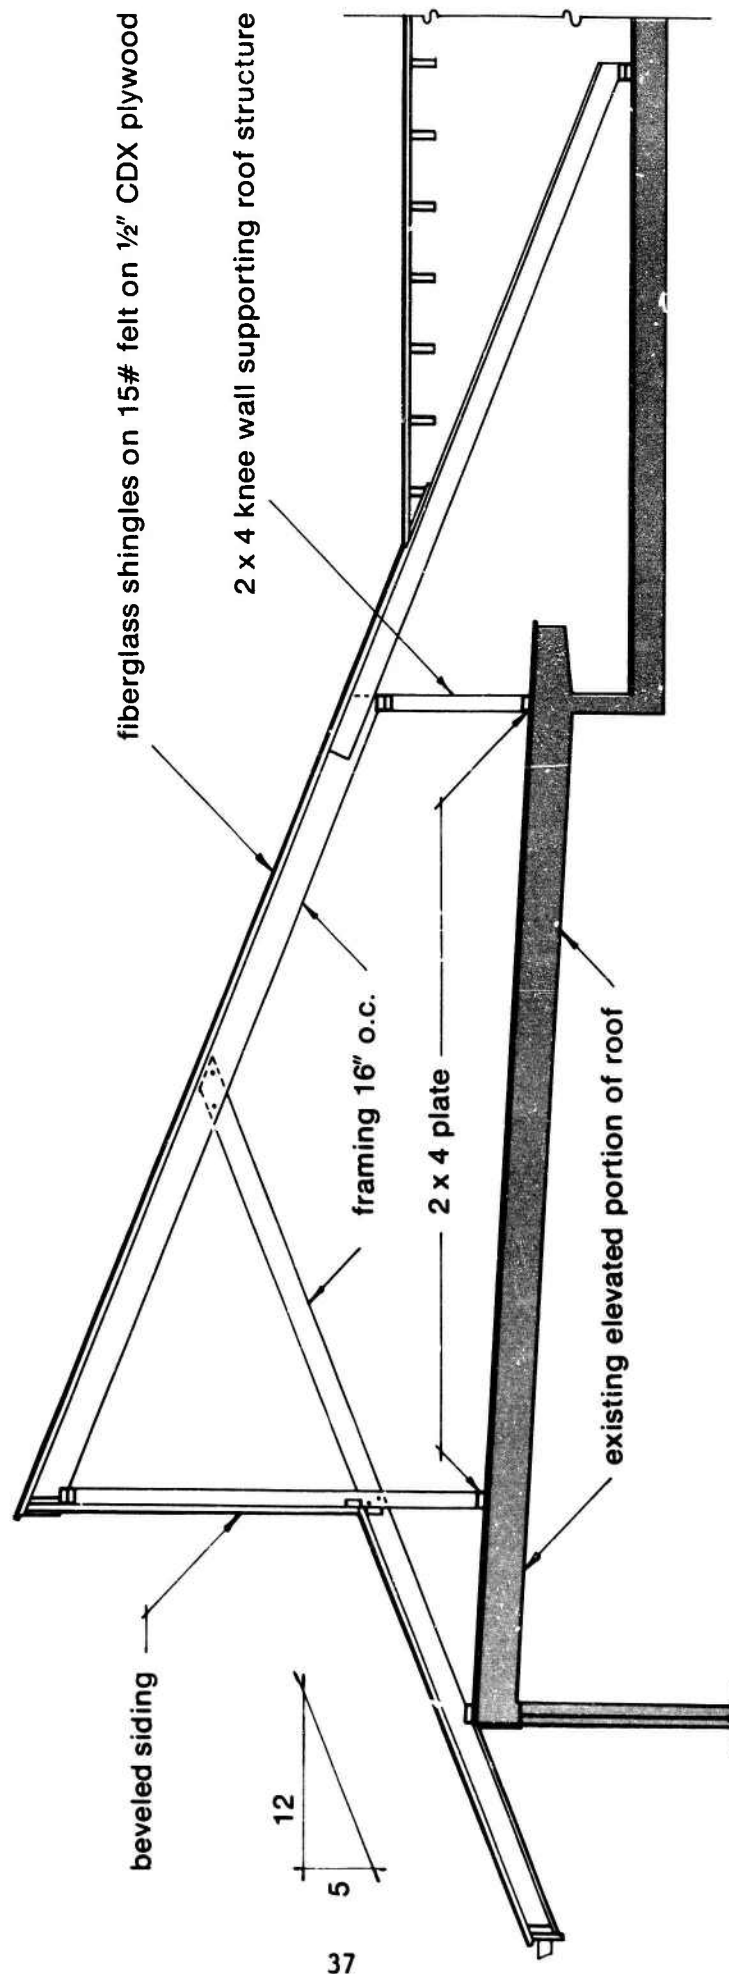
Figure 25. Detailed section through roof, Case Study No. 4.

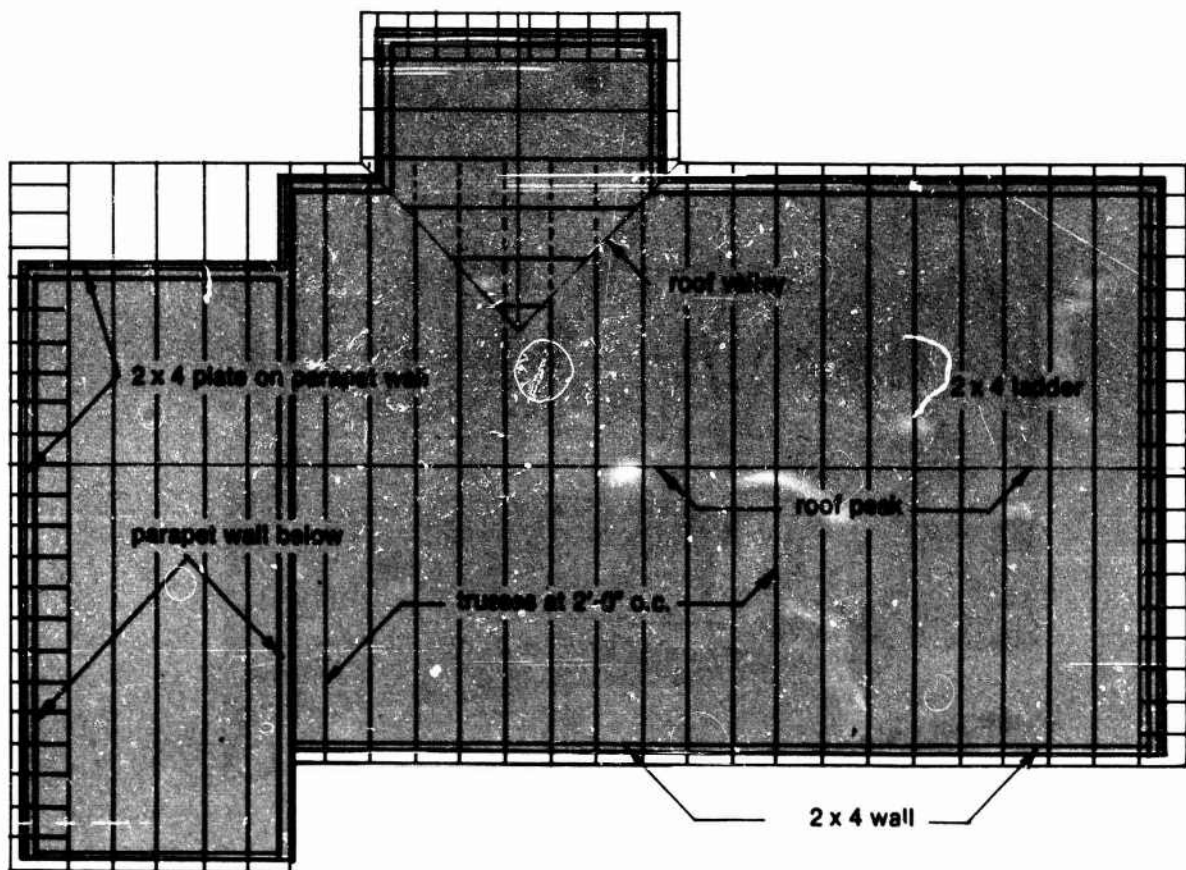
Figure 31. Roof plan, Case Study No. 5.

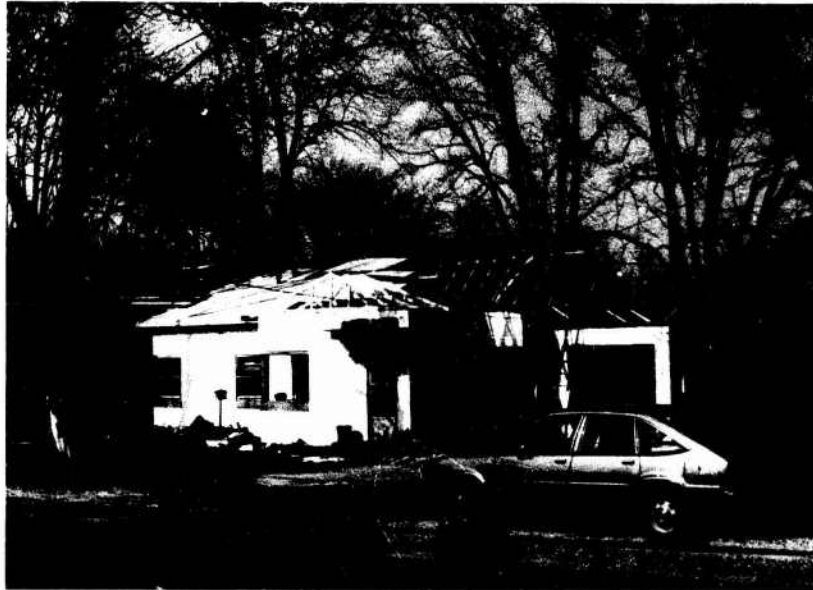
Figure 32. View under construction, Case Study No. 5.
