**TECHNICAL REPORT M-85/05**

**Improved and New Roofing for Military Construction**

**SLOPED ROOF CONVERSIONS FOR SMALL,  
FLAT-ROOF BUILDINGS**

by  
**Myer J. Rosenfield  
Carter Doyle**

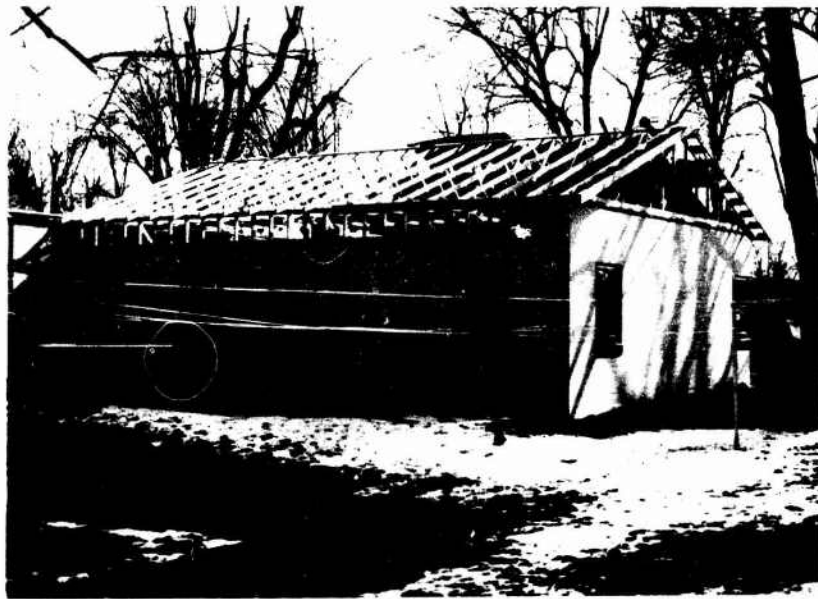
Figure 34. View of trusses in place during construction, Case Study No. 5. Note the frame wall; it is necessary for truss construction that supporting walls are level.

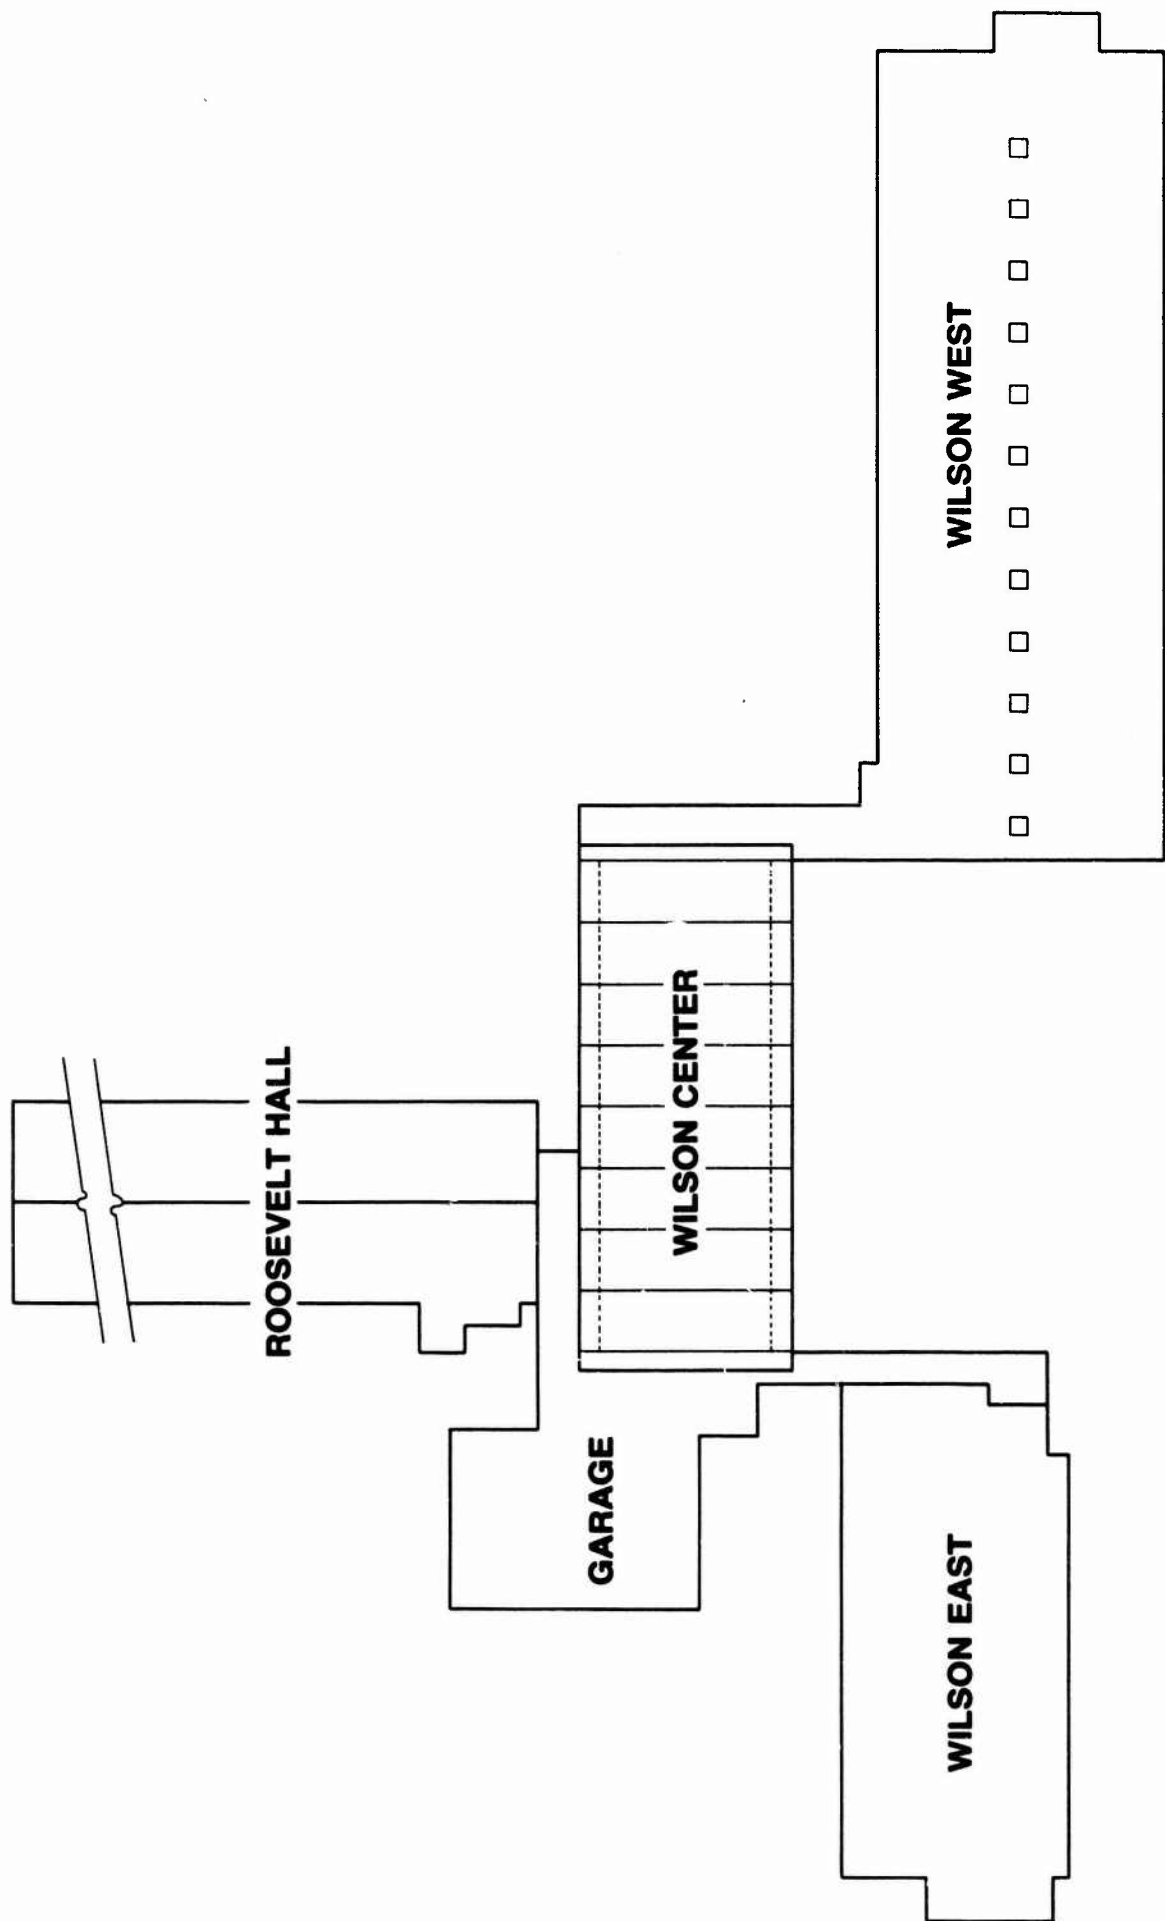
Figure 36. Premodified roof plan of Camden County College complex, Case Study No. 6a and 6b.

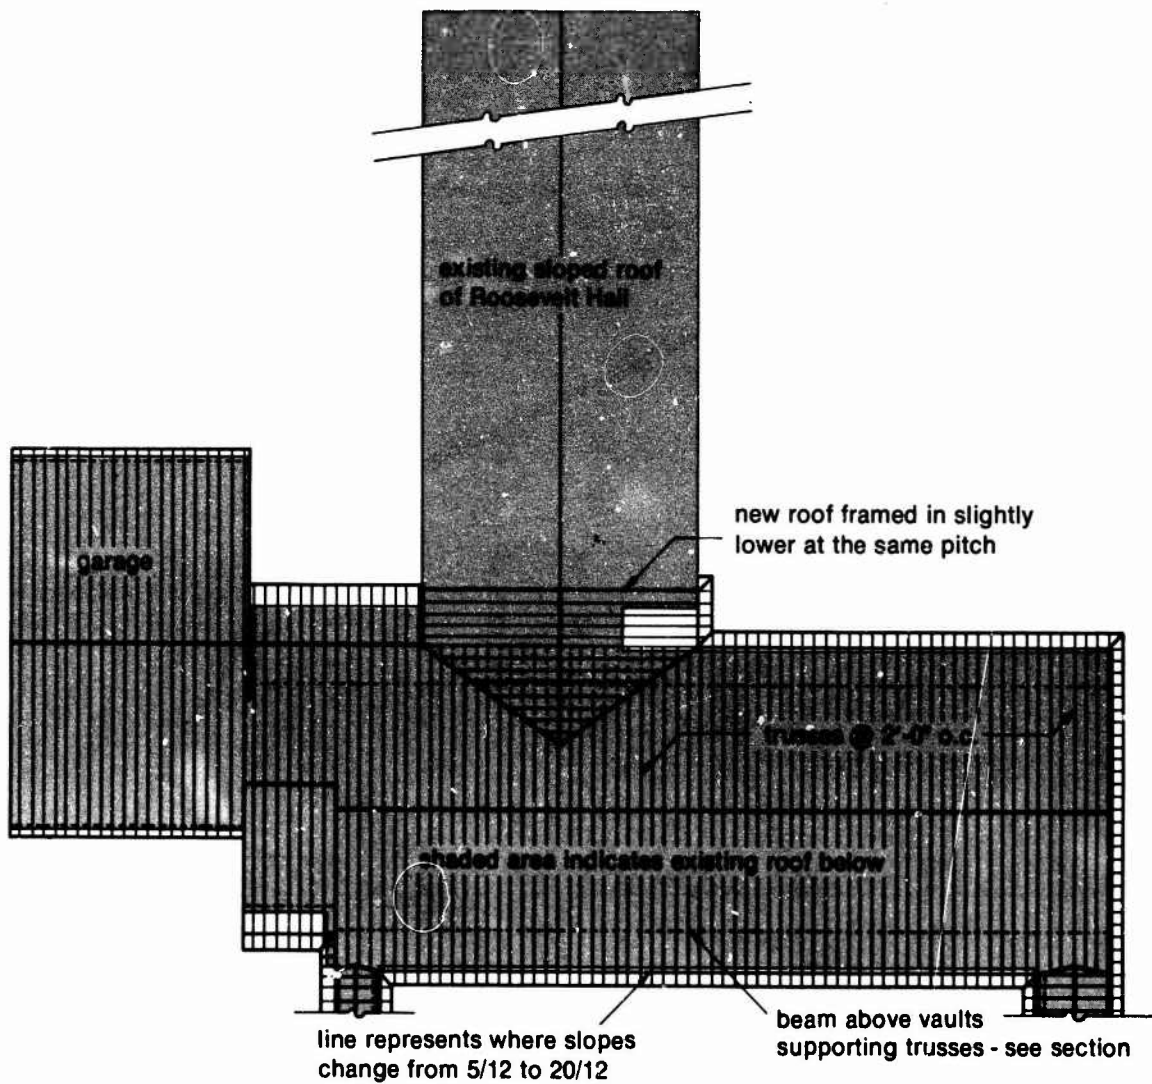
Figure 37. Roof framing plan for Wilson Center, Case Study No. 6a.

This project is part of Camden County College, Blackwood, NJ, and consists of five separate buildings linked together. The buildings are different sizes and shapes, and are constructed from different materials. Several of the buildings had leakage problems. The architects proposed converting to sloped roofs on all of the buildings. Two of the buildings (Wilson West and East) are steel frame with concrete roof decks. Two other buildings (garage and Roosevelt Hall) have masonry bearing walls with wood frame roof structures. Wilson Center has steel columns supporting concrete barrel vaults.

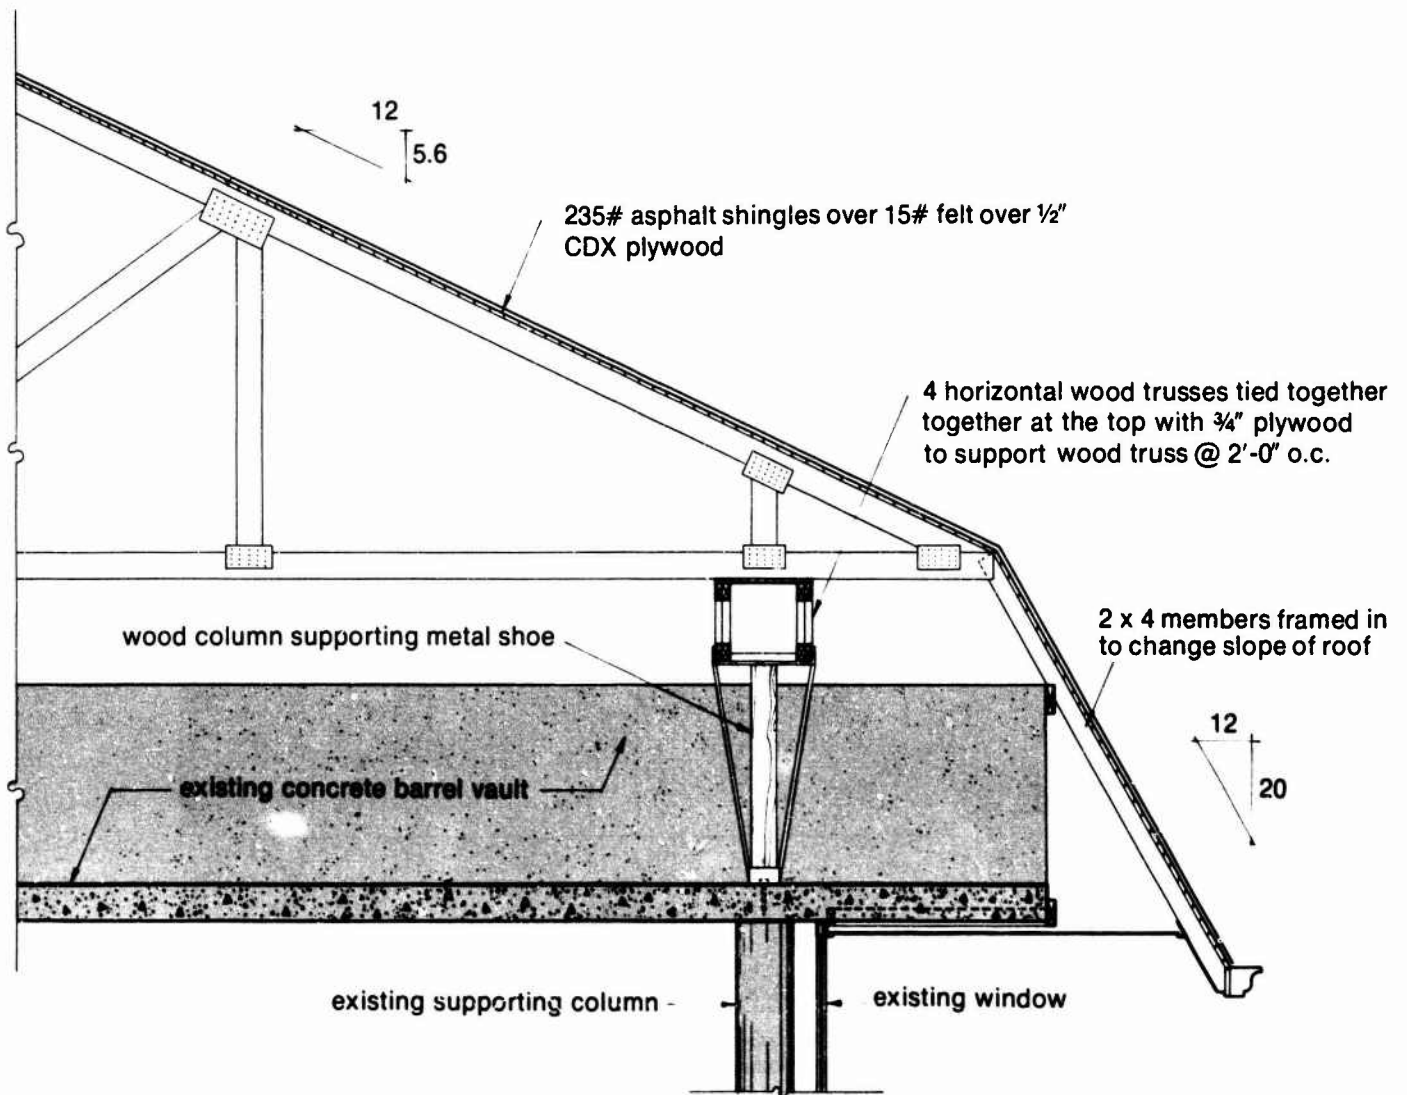
Figure 38. Section through roof edge, Case Study No. 6a.

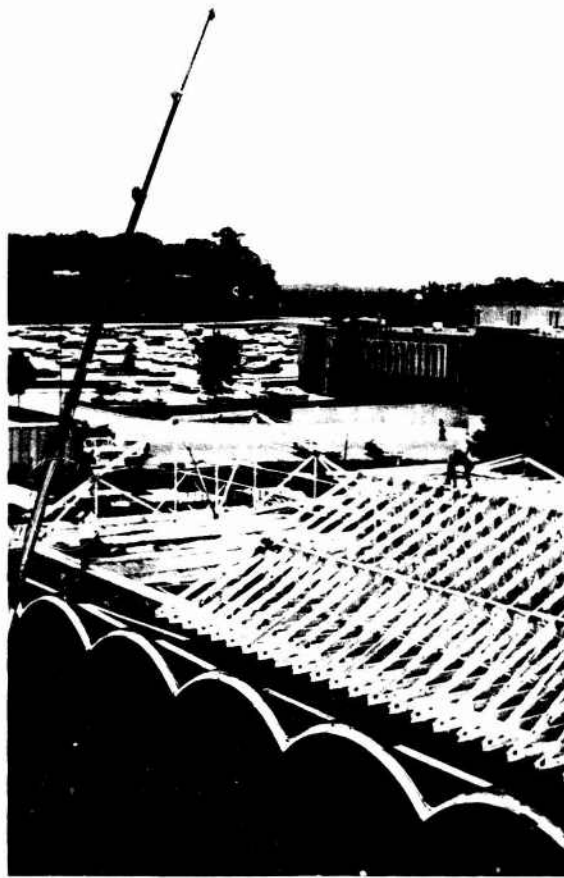
Figure 41. View of trusses being erected, Case Study No. 6a. Note piggy-back trusses were used because a single full height truss would have been too tall to transport.

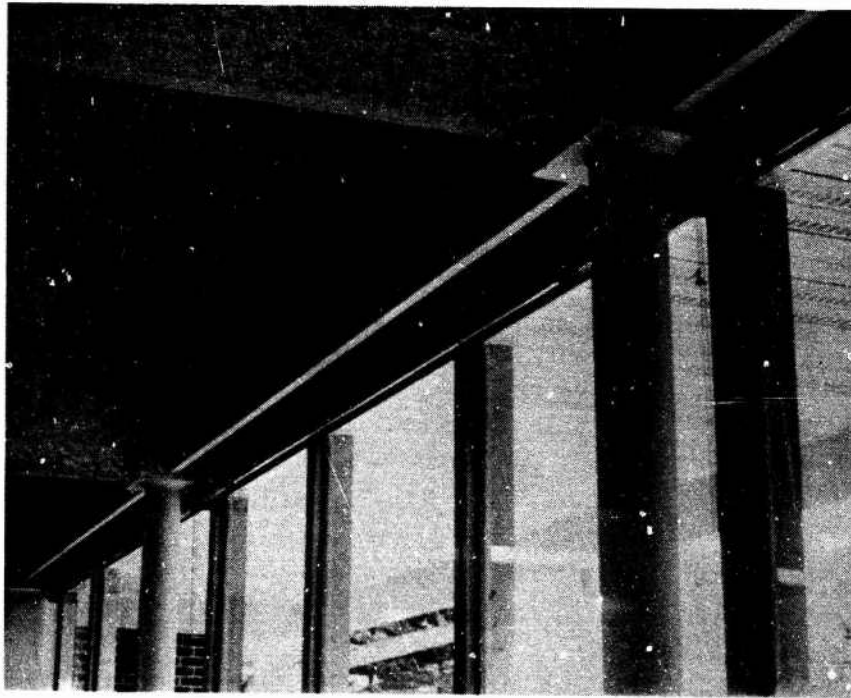
Figure 43. Inside Wilson Center looking out, Case Study No. 6a. Note, the soffit aligns with existing transom. The glass above the transom remains in place; it is painted black.

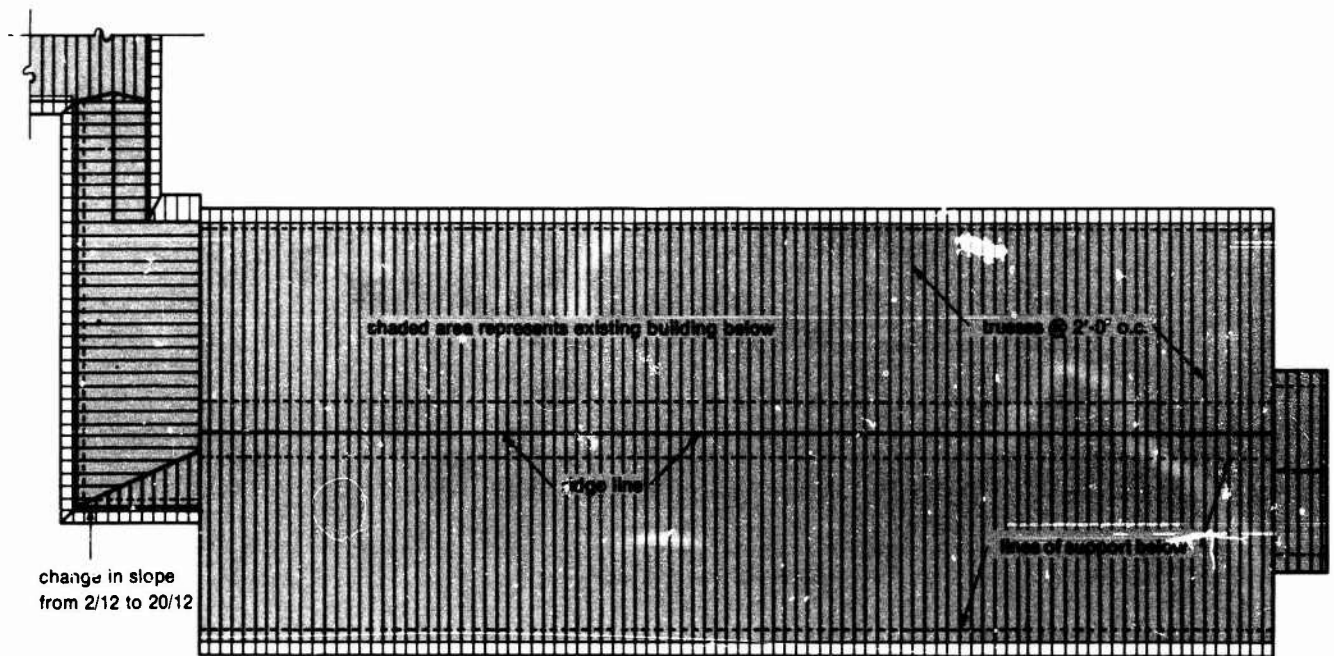
Figure 44. Roof framing plan for Wilson West, Case Study No. 6b.

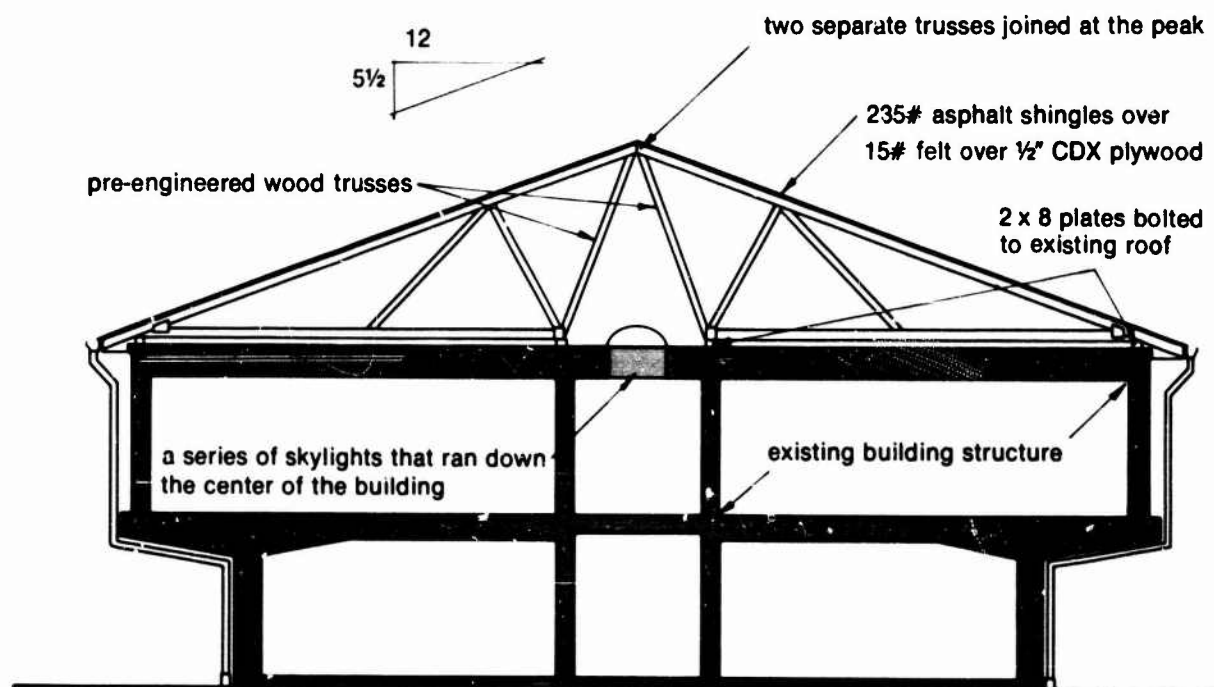
Figure 45. Section through Wilson West, Case Study No. 6b.

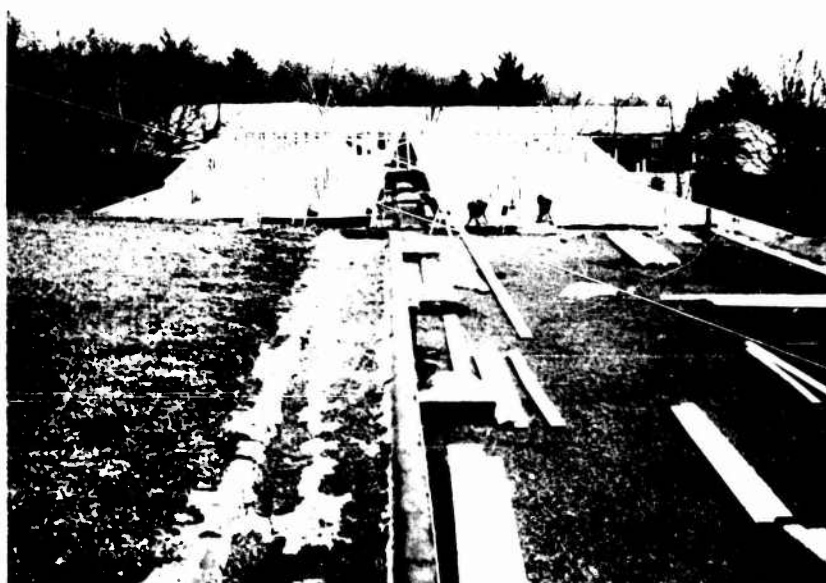
Figure 47. View of roof of Wilson West during construction, Case Study No. 6b. Two trusses joined at the ridge. Continuous bottom chords would conflict with the series of skylights down the center of the building.

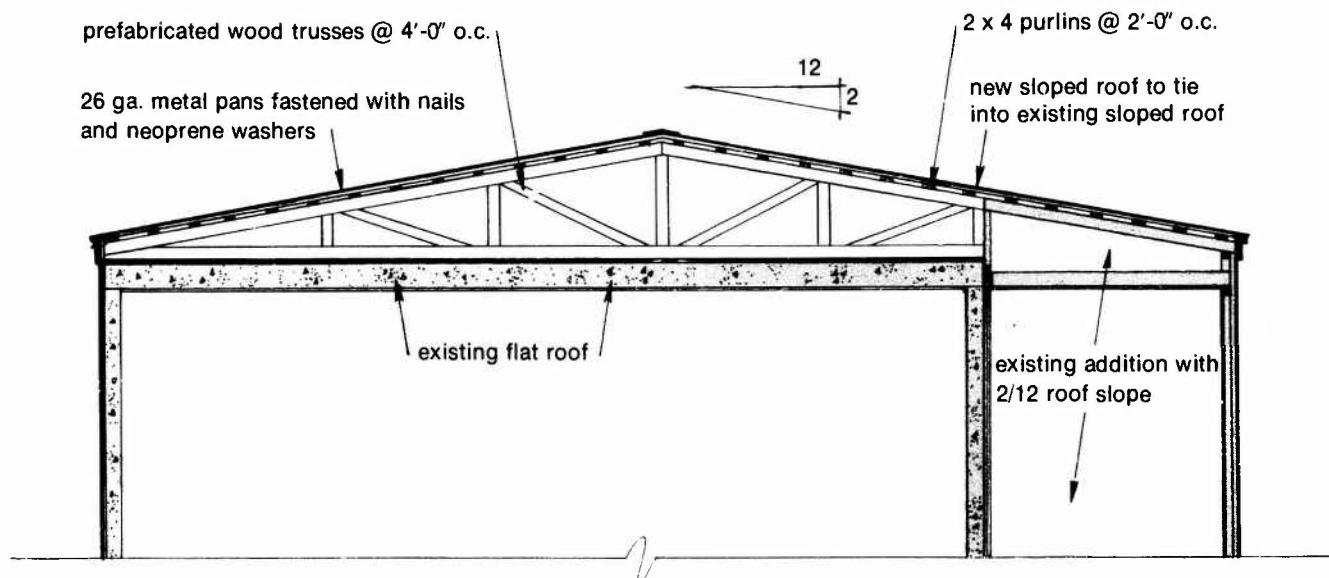
Figure 50. Section through building, Case Study No. 7.

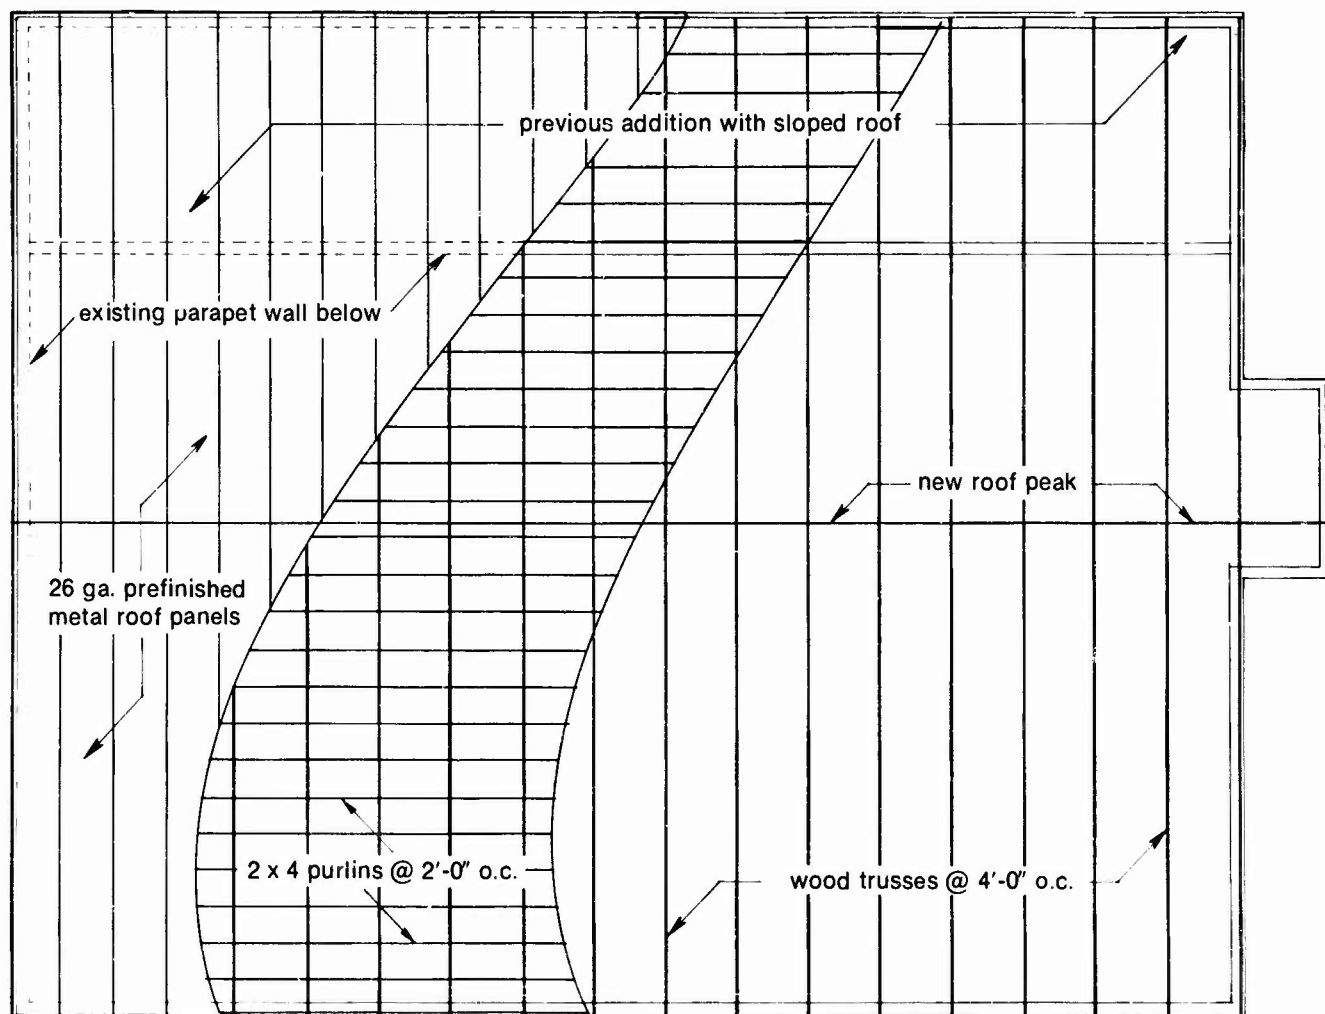
Figure 51. Roof plan, Case Study No. 7.

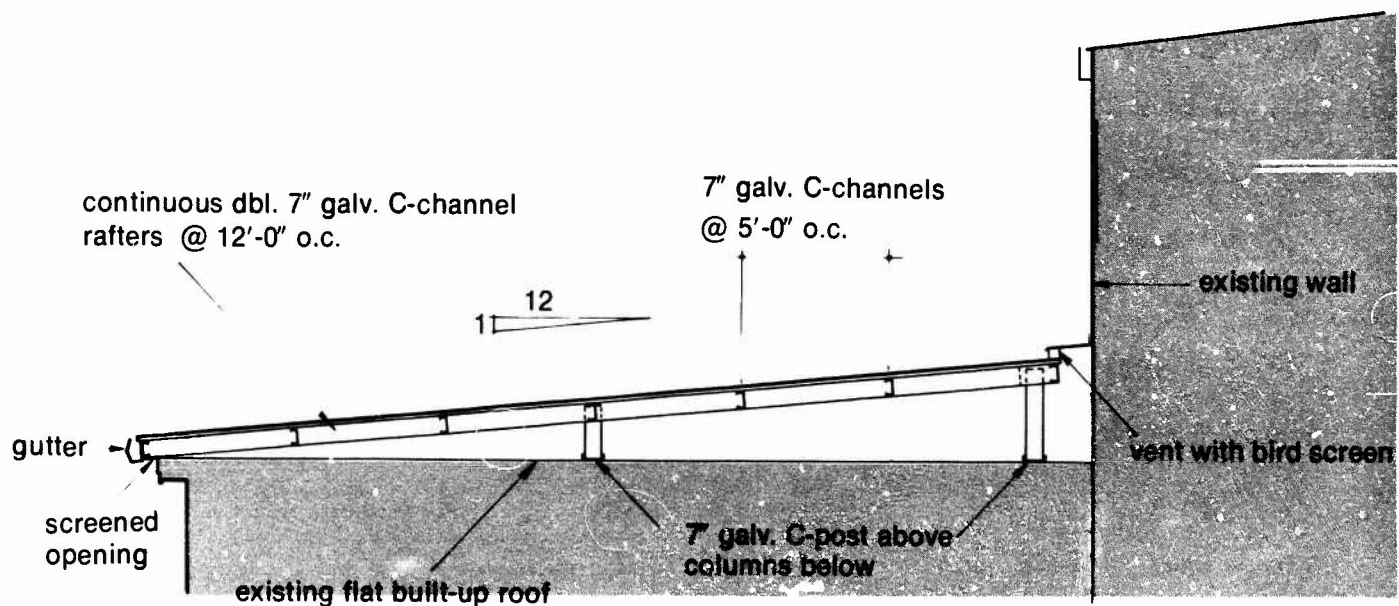
Figure 53. Section through roof, Case Study No. 8.

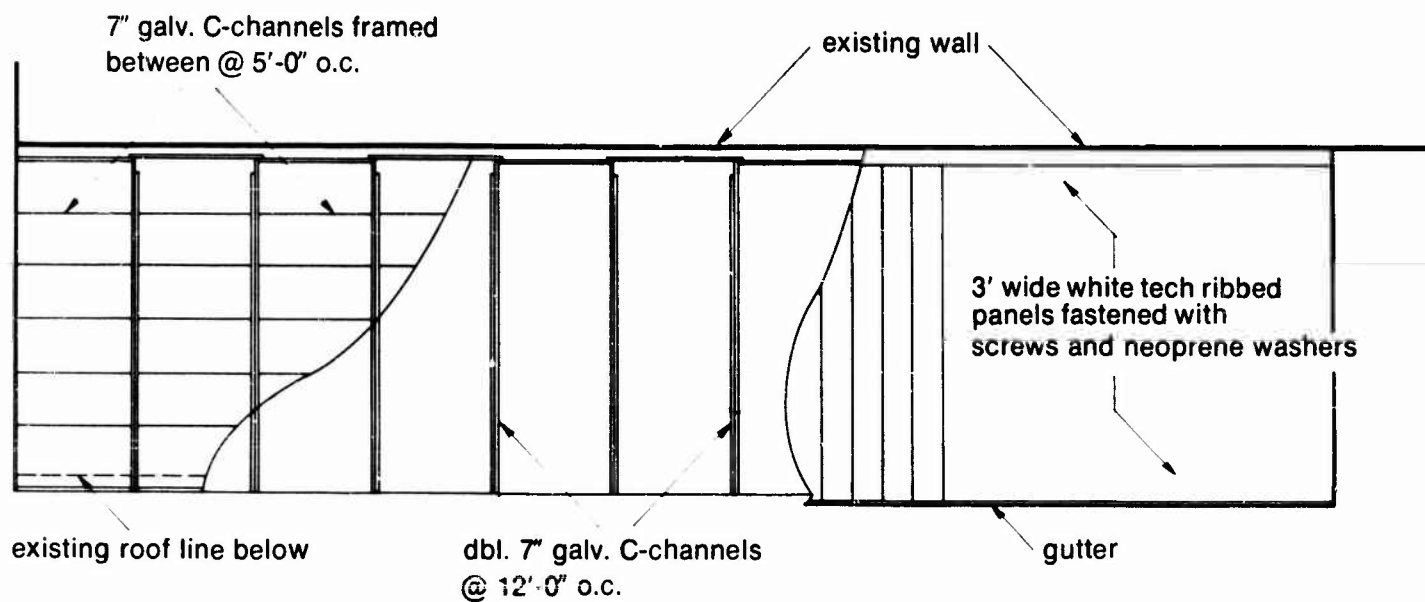
Figure 54. Roof plan, Case Study No. 8.

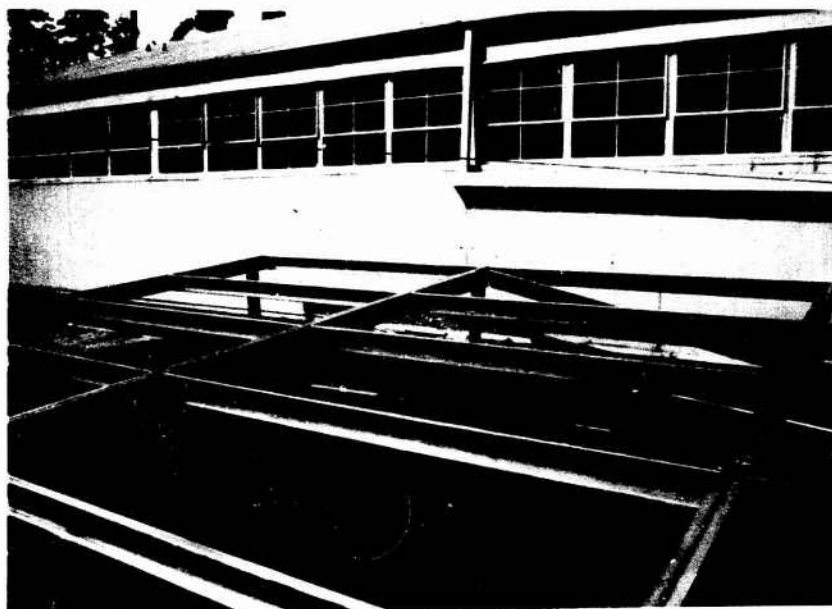
7-in. channels framed  
between rafter @  
5-ft-0-in. o.c.

Double 7-in. channel  
rafters @ 12-ft-0-in. o.c.

Figure 55. View of framing, Case Study No. 8.

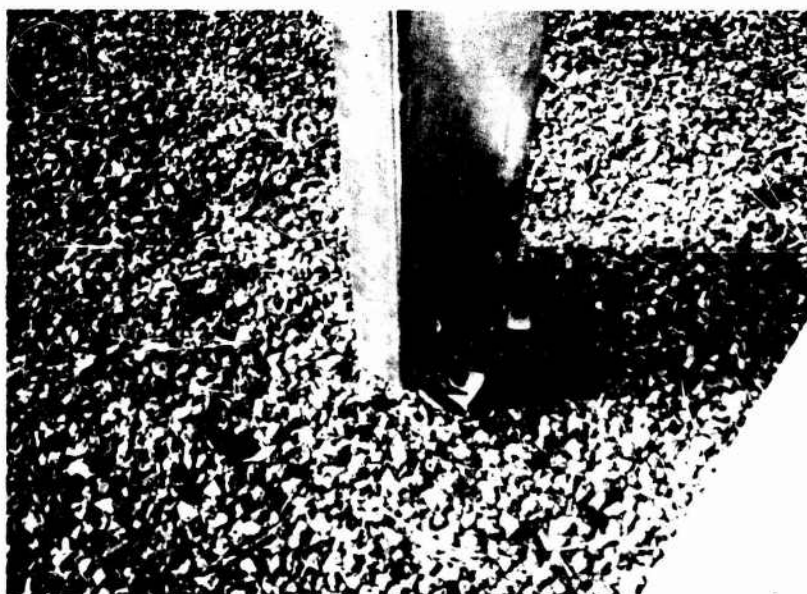
Figure 56. Detail of column connection to the existing roof, Case Study No. 8.

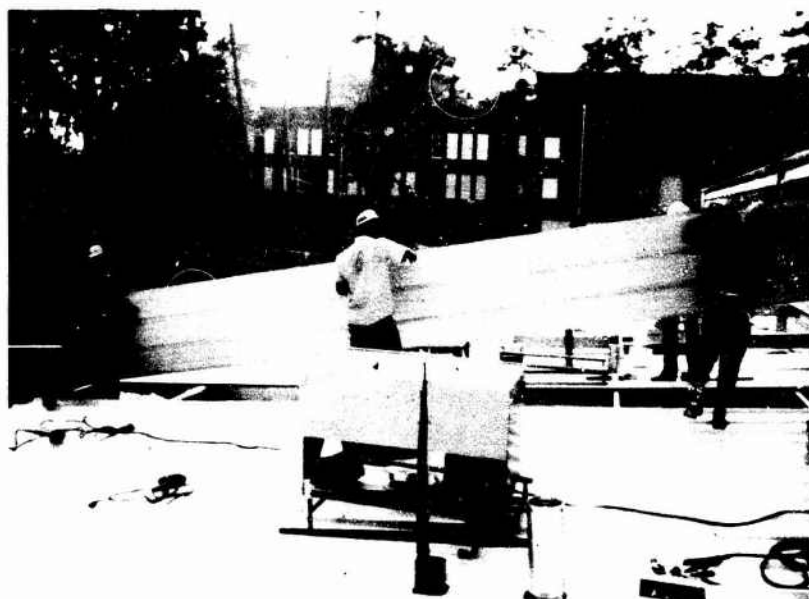
Figure 57. View during application of 3-ft wide by 31-ft long white Tech-Rib metal roofing, Case Study No. 8.

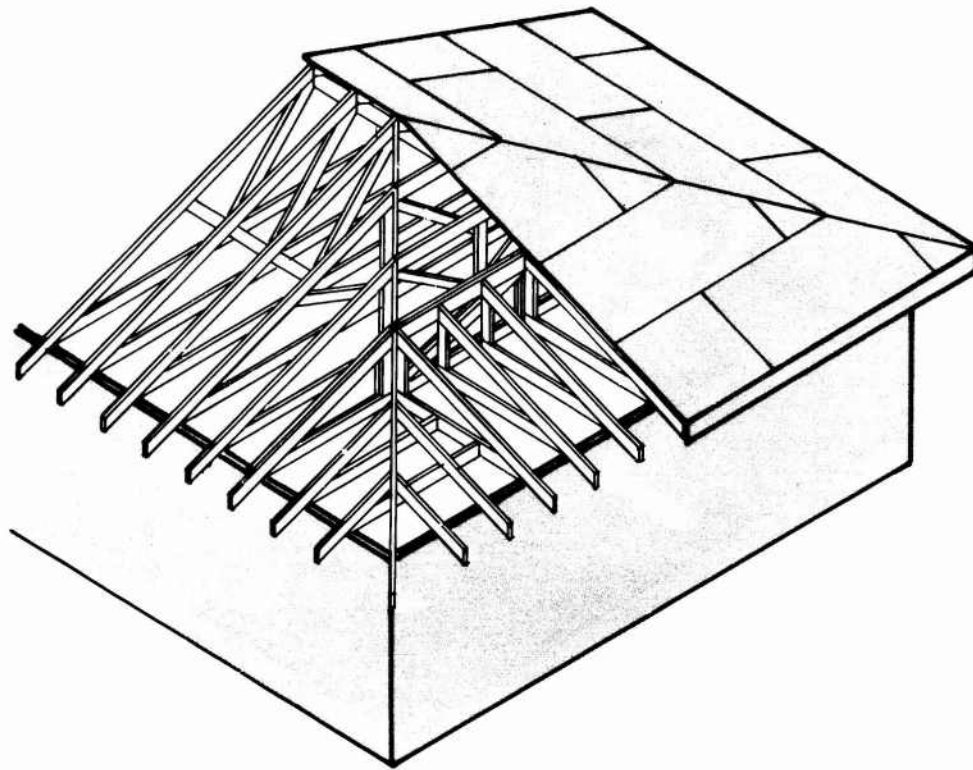
Figure 61. Step-down hip system.

A step-down hip system (Figure 61) seems to be the most frequently used. It employs three types of trusses: a common truss, a step-down truss,

and a mono truss (sometimes called a half or sawtooth truss). The common trusses are used to frame the main body of the roof. The step-down truss is the same span as the common truss but is truncated at the top to gradually decrease in height to form a sloping hip. A series of step-down trusses is used between the common trusses and the step-down girder. The step-down girder (two or more step-down trusses combined) carries the mono trusses which finish out the bottom of the roof (see Case Study No. 2). The cost of the step-down truss system in roof conversions generally averages between \$3.00 to \$4.00/sq ft (\$32.30 to \$43/m<sup>2</sup>) with simple rectangular shapes.

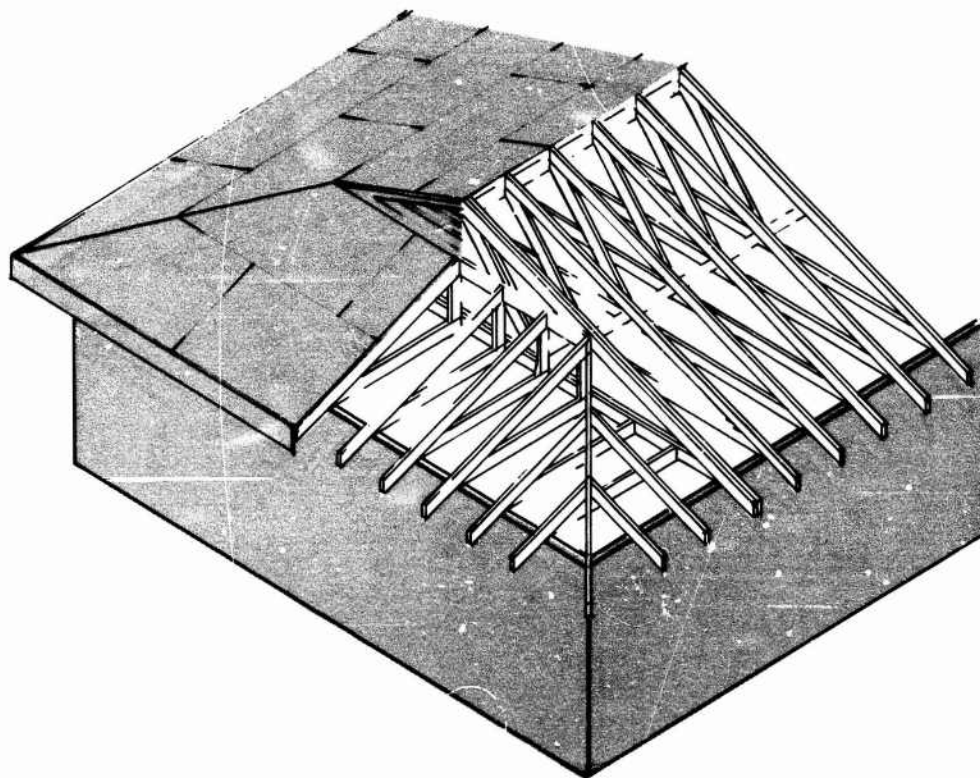
Figure 62. Dutch hip system.

The Dutch hip system (Figure 62) combines a hip end and a gable end. The gable can be for a louver or for appearances. This system uses common and mono trusses. The small hipped area is normally conventionally framed with a hip rafter and jack rafters. The cost of a Dutch hip system generally is slightly more than the step-down system because of the louver and/or gable finishes.

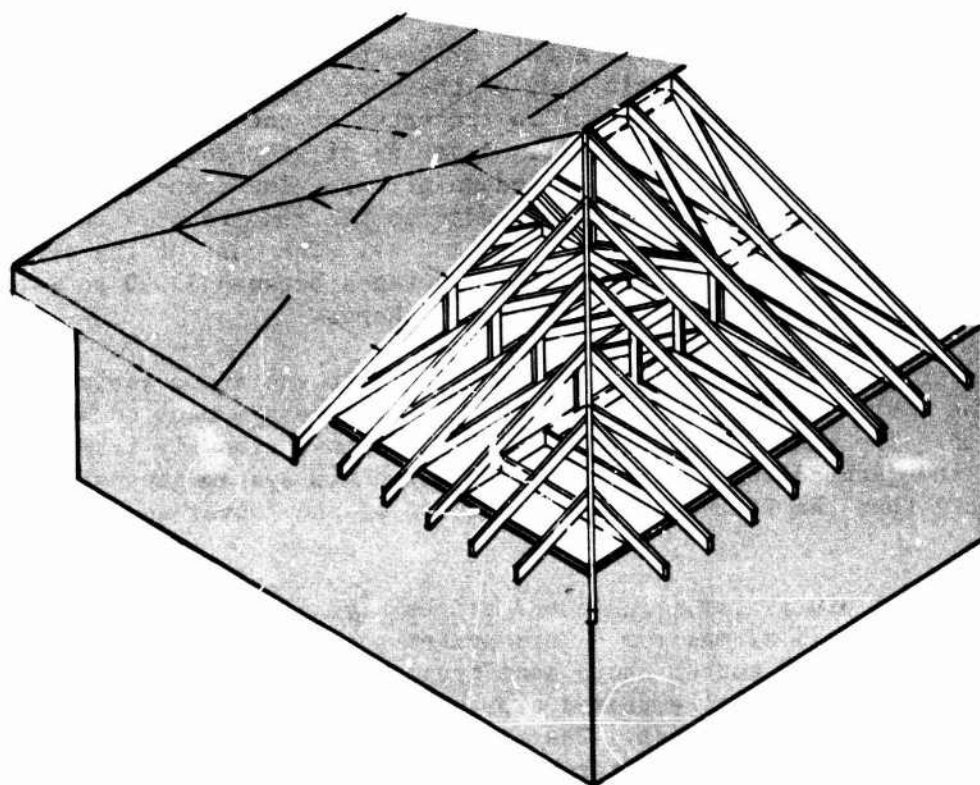
Figure 63. Terminal hip system.

The terminal hip system (Figure 63) can be used for small span application only--32-ft (9.75 m) maximum. This system combines common trusses (for the main body) and long bottom chord mono trusses for the same application as jack rafters in conventionally framed hips. The hip rafter is a conventionally framed rafter and not a truss. The bottom chord of the mono truss is longer on one side of the hip rafter than the other, and the top chords are beveled to tie into the hip rafter. No examples were found using this system for a roof conversion, so costs are unknown.

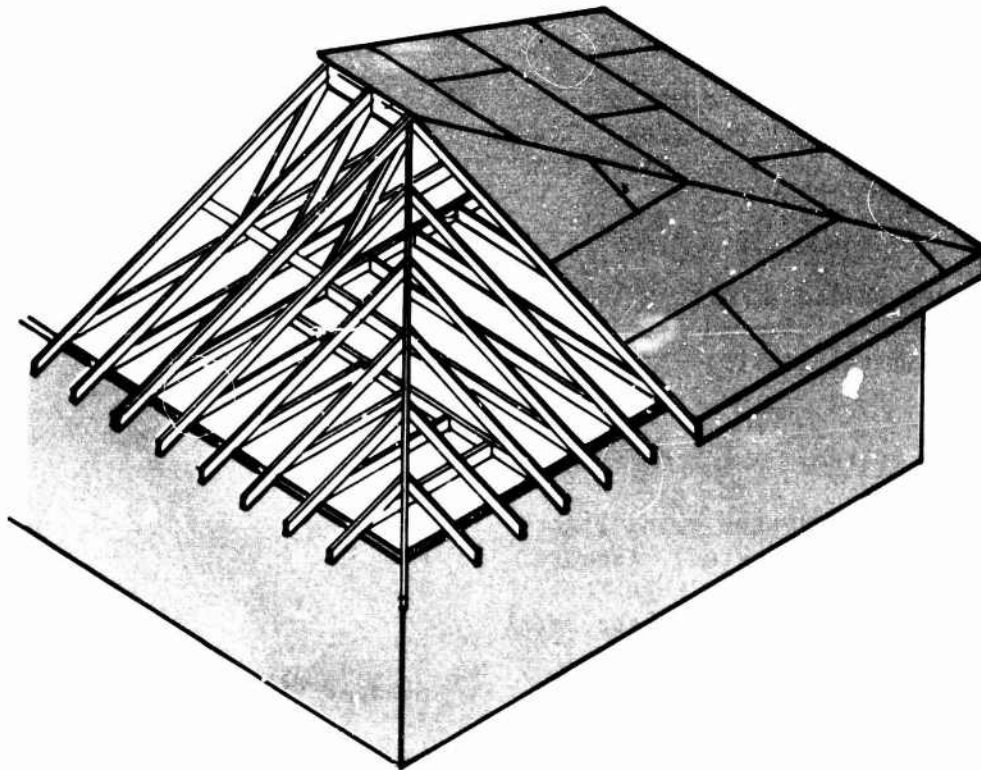
Figure 64. Common trussed/conventional framing hip system.

The combination of common trusses and conventional framing (Figure 64) in some respects offers the best of both systems. Since common trusses are used to frame the main body of the roof, economy is maintained through the repetition. At the point where the hip begins, the trusses stop and the conventional framing begins. The hip rafter and the jack rafters are conventionally framed. This system is particularly economical for long roofs in which many identical trusses can be used. When the number of trusses is reduced, some of the economy is lost. Average cost of this system is \$3.00/sq ft (\$32.30/m<sup>2</sup>).

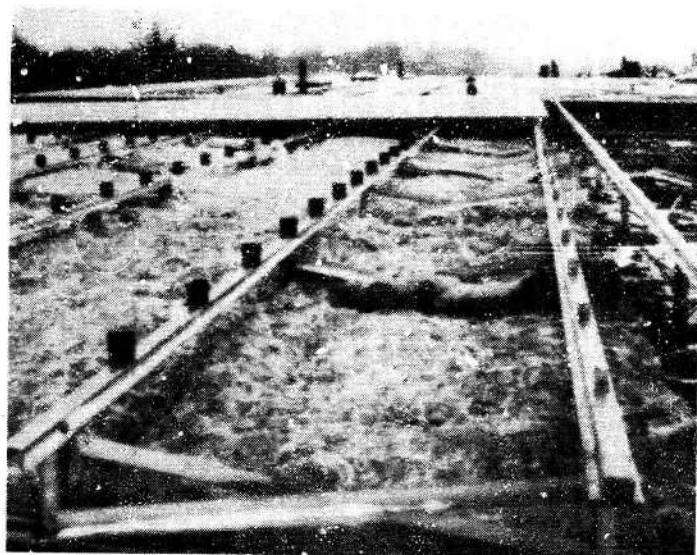
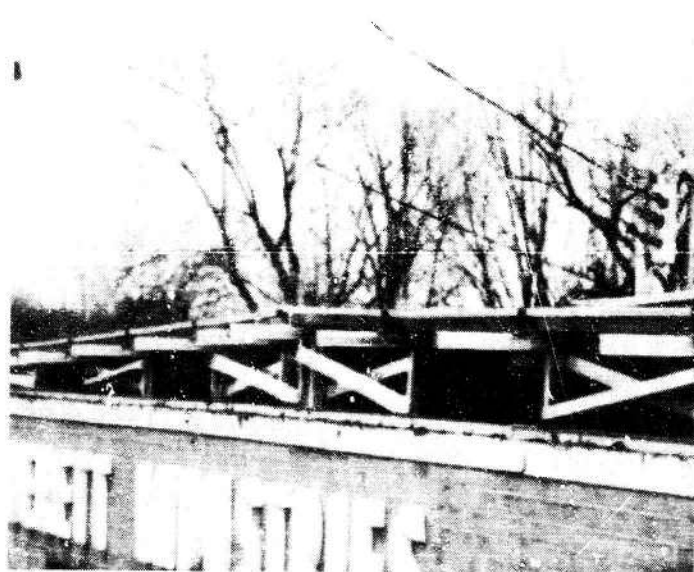
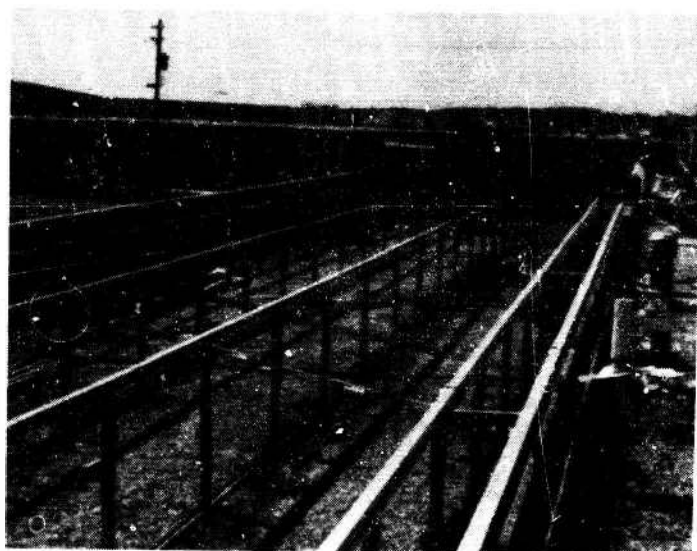
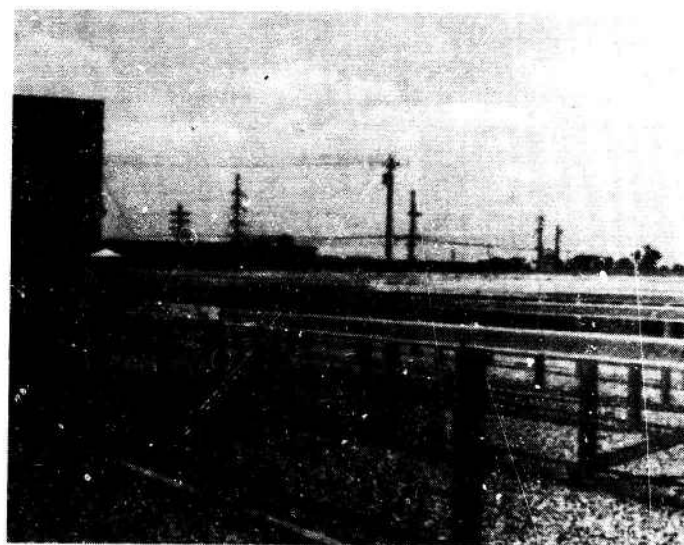
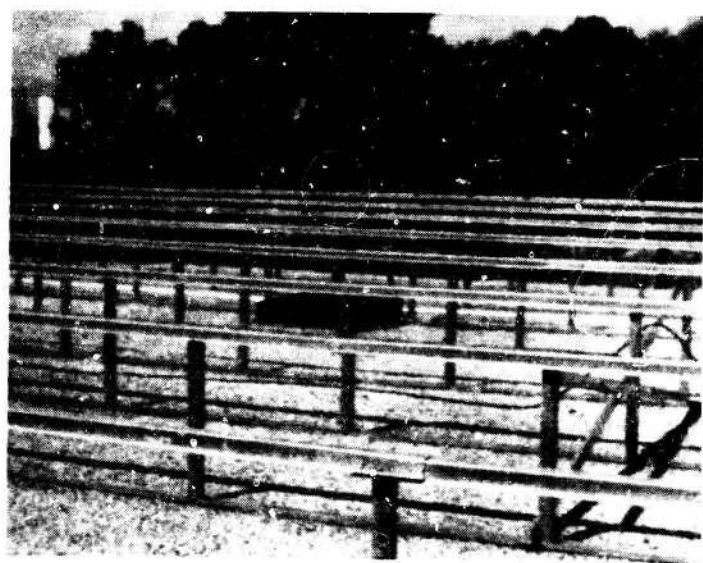
Figure 65. Examples of the Retroframe system.

The Retroframe system is particularly good for industrial and large-scale applications. The use of 1/4 in 12 slopes allows coverage of large areas economically. The system adds less than 3 lb/sq ft (15 kg/m<sup>2</sup>) of dead load, which is about a third of the weight of a comparable wood system. The owner/inventor states the total installed costs range between \$2.75 to \$3.50/sq ft (\$29.60 to \$37.68/m<sup>2</sup>). The range of installed price varies, depending on the area labor costs.

The job-built framing system is fastened together with no. 12 self-drilling screws. The knee walls are constructed from hat sections for the top and bottom plates, and tubes as the vertical support members. A heavy layer of roofing cement is applied under the bottom hat section to provide a gasketing effect when the bottom plate is fastened to the existing roof. This technique helps eliminate leaking during construction. The whole system is prepunched for faster erection time. Standing seam clips are pre-attached on 2-ft (61-cm) centers. A 4-in. (10-cm) diameter air opening is provided in the rake trim, covered with bird screening, to provide ventilation. Examples of construction using the Retroframe system are seen in Figure 65.

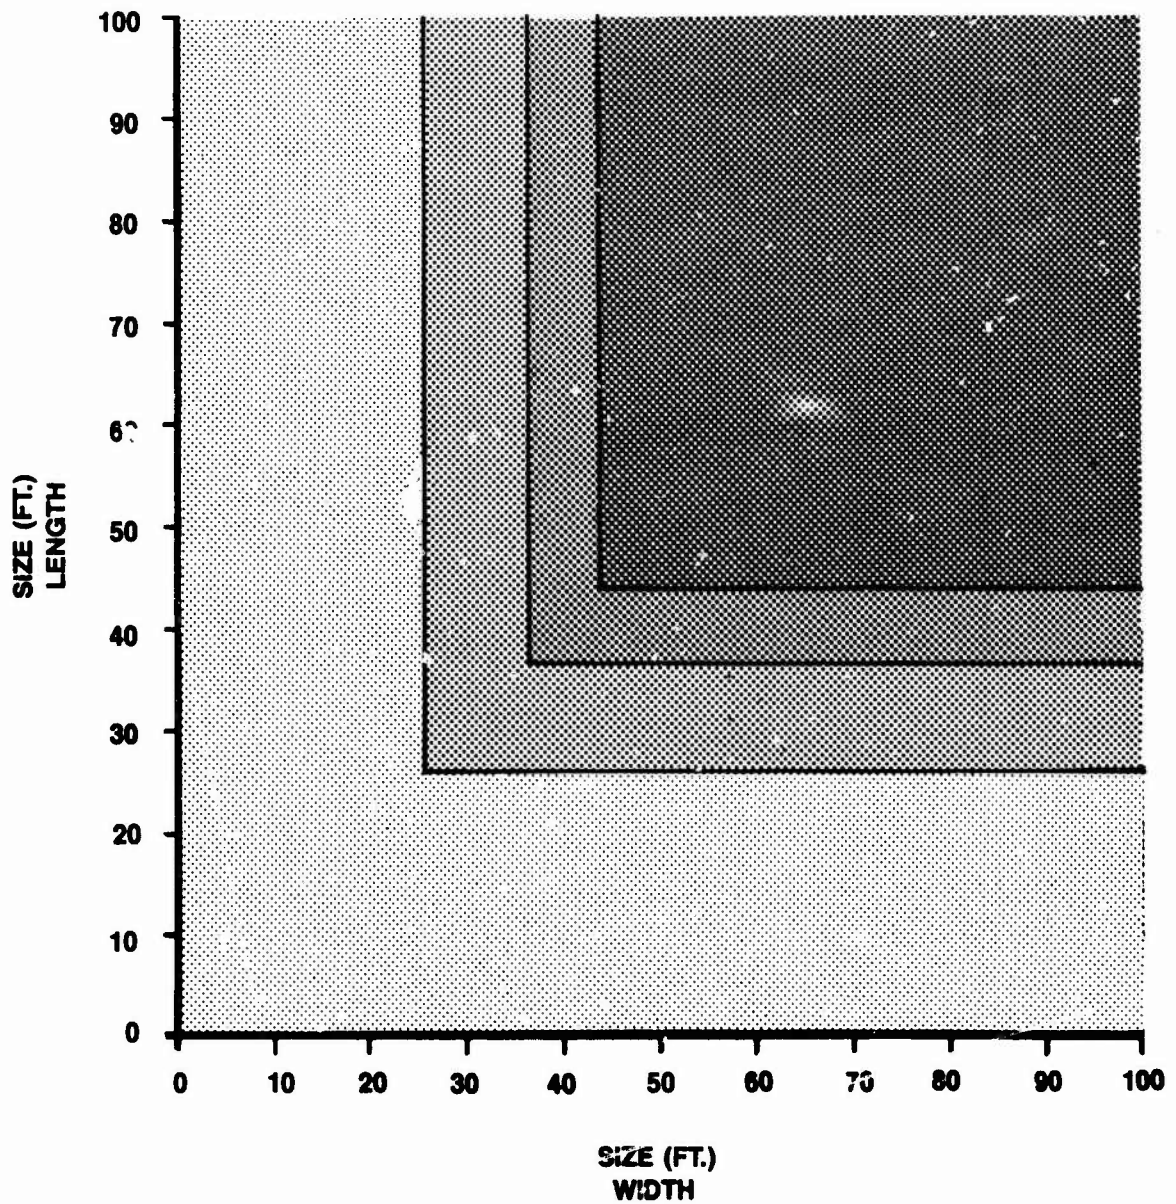
Figure 67. Cost per square foot vs. the size of a building for southern loading conditions (15 lb L.L., 15 lb D.L.).

The cost per square foot is based on the minimum width of the building. A building that is relatively narrow (even though it may be very long) will maintain the economy depicted on the graphs for the short span. The three graphs (Figures 67, 68, and 69) illustrate this point by showing the total cost per square foot for roof conversions using wood trusses for three loading conditions. These conditions represent the three basic loading conditions in the United States: southern, intermediate, and northern. The dead load is 15 lb/sq ft for all categories because there is not any ceiling load--only the trusses, plywood, and shingles. The live loads represent the various snow loads in the United States: 15 lb/sq ft, 30 lb/sq ft, and 50 lb/sq ft.
