**TECHNICAL REPORT M-85/05**

**Improved and New Roofing for Military Construction**

**SLOPED ROOF CONVERSIONS FOR SMALL,  
FLAT-ROOF BUILDINGS**

by  
**Myer J. Rosenfield  
Carter Doyle**

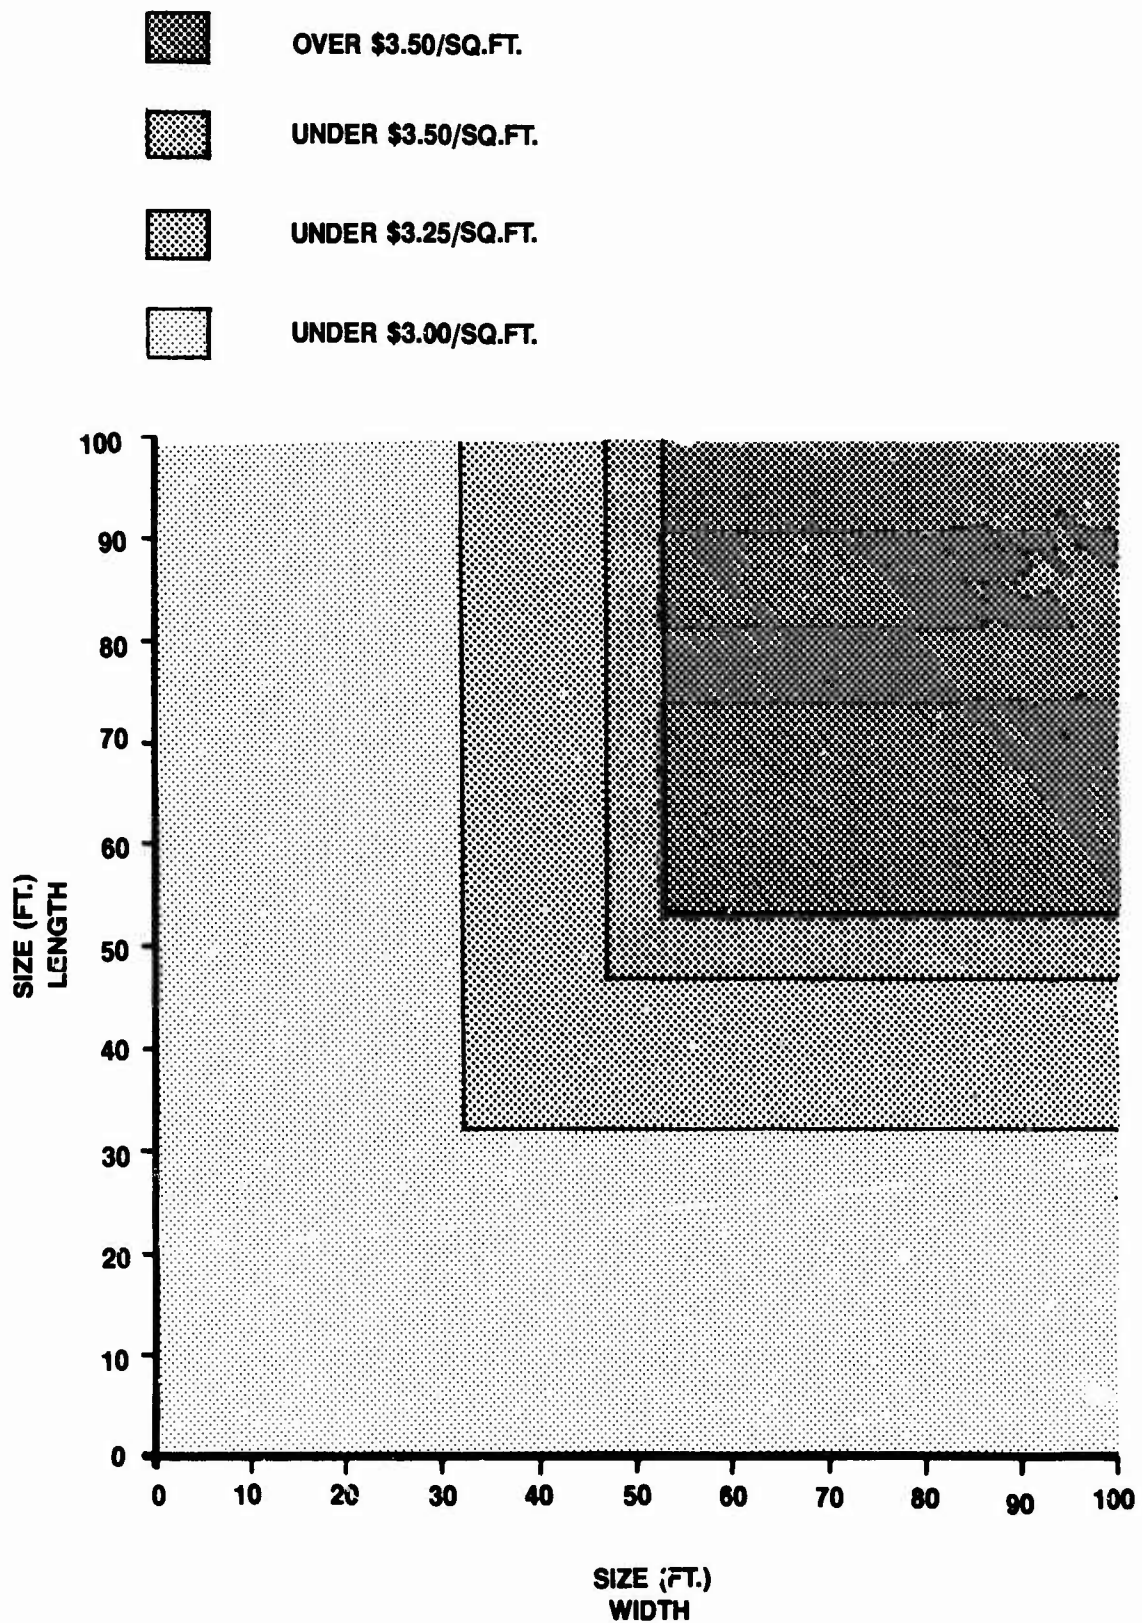
Figure 68. Cost per square foot vs. the size of a building for intermediate loading conditions (30 lb L.L., 15 lb D.L.).

The cost per square foot is based on the minimum width of the building. A building that is relatively narrow (even though it may be very long) will maintain the economy depicted on the graphs for the short span. The three graphs (Figures 67, 68, and 69) illustrate this point by showing the total cost per square foot for roof conversions using wood trusses for three loading conditions. These conditions represent the three basic loading conditions in the United States: southern, intermediate, and northern. The dead load is 15 lb/sq ft for all categories because there is not any ceiling load--only the trusses, plywood, and shingles. The live loads represent the various snow loads in the United States: 15 lb/sq ft, 30 lb/sq ft, and 50 lb/sq ft.

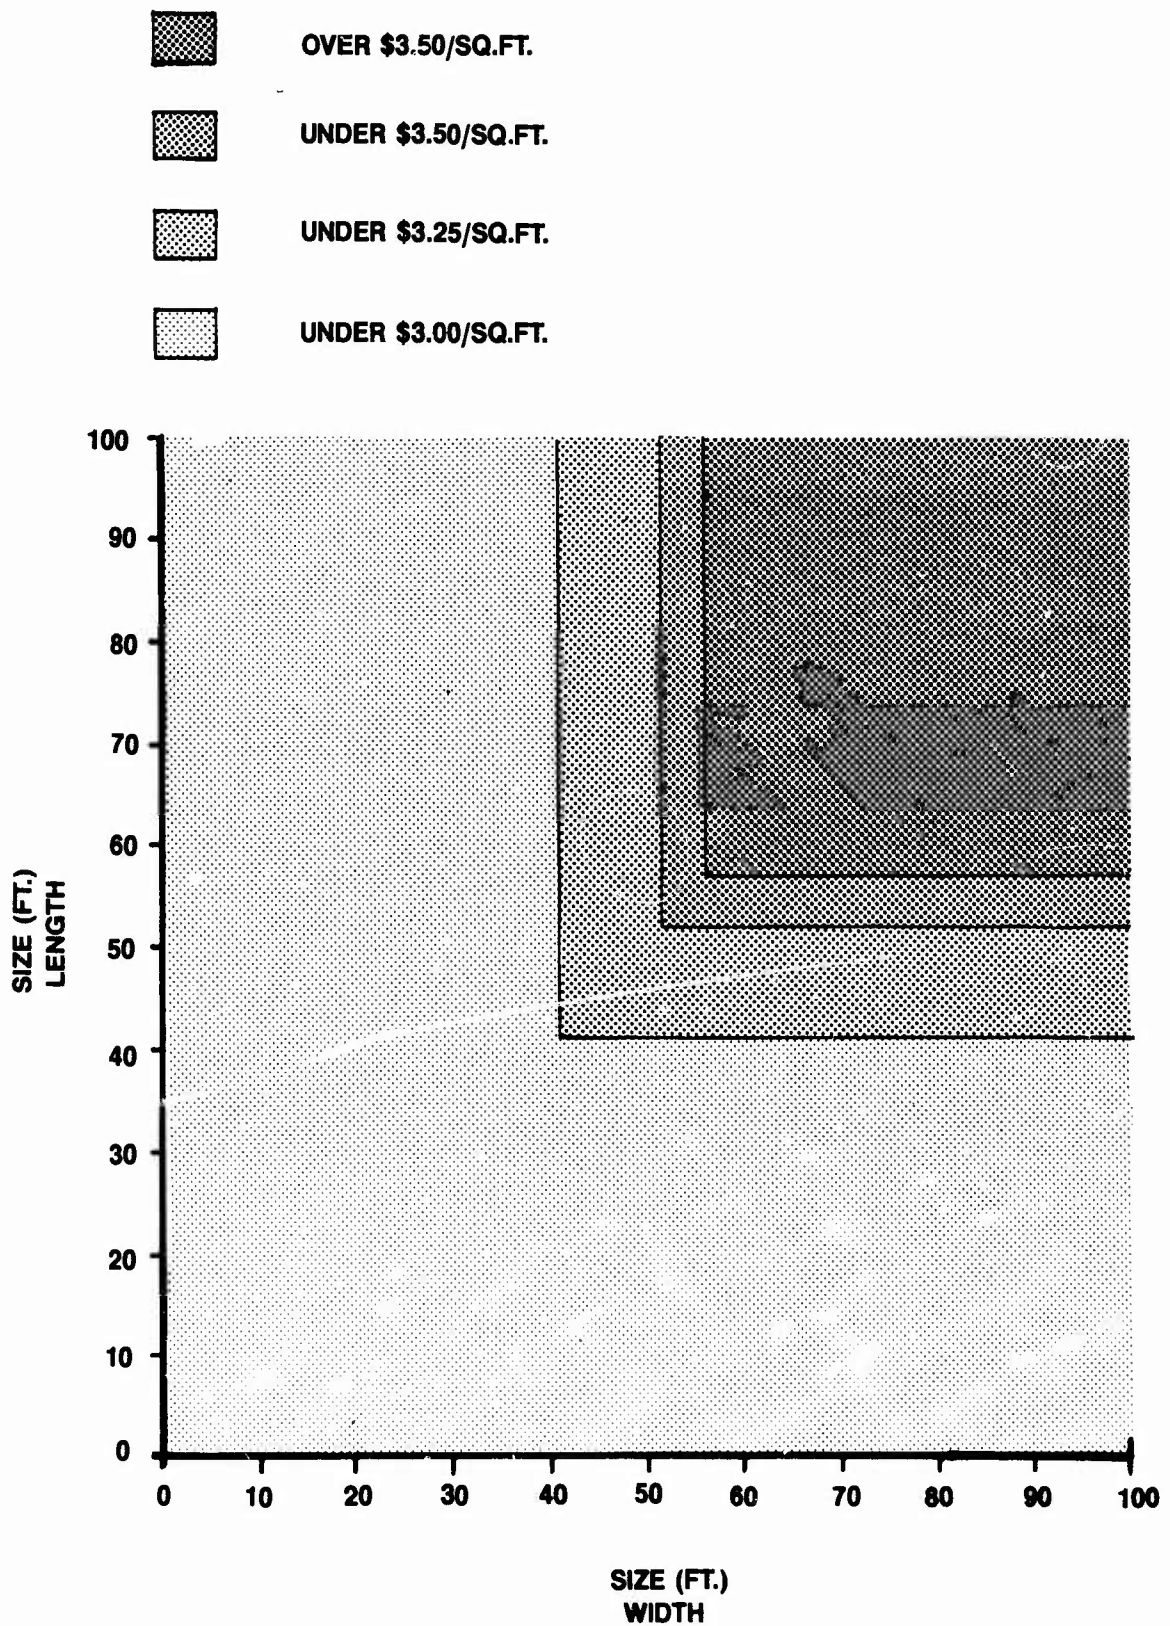
Figure 69. Cost per square foot vs. the size of a building for northern loading conditions (15 lb L.L., 15 lb D.L.).
