USAFSAM-TR-85-19

## DENTAL ELECTRIC HANDENGINES Test and Evaluation

Final Report for Period February 1984 - February 1985

USAF SCHOOL OF AEROSPACE MEDICINE  
Aerospace Medical Division (AFSC)  
Brooks Air Force Base, TX 78235-5301

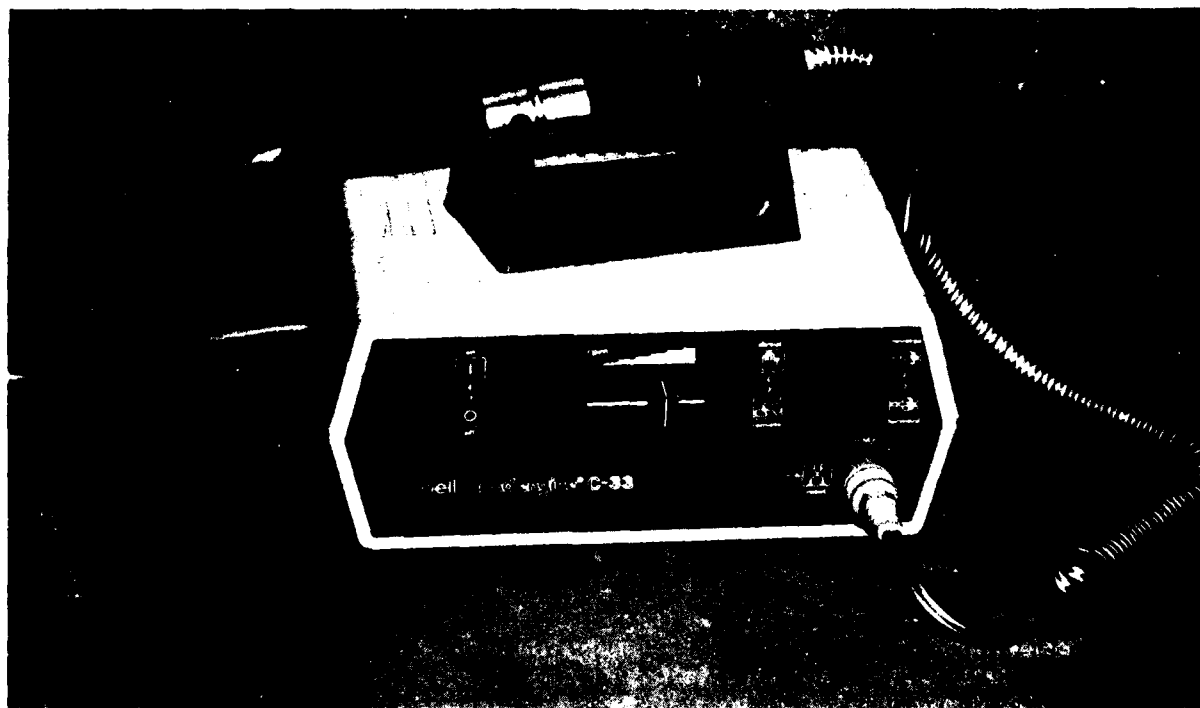
Figure 5. Bell 38L Handengine and C-33 Power Unit.

The Bell Royal 38L Handengine was evaluated with four different power units. The C-33 (Fig. 5) had a countertop control box with optional on/off foot-pedal control and was available in 100-120V or 220-240V configurations. The Mark VIII power unit (Fig. 6) could be used connected to a power source or as a rechargeable power pack. The Mark X power unit (Fig. 7) was a foot-controlled rheostat. The DX power unit (Fig. 8) was a foot-controlled on/off switch with rheostat.
