**AERO PROPULSION REPORT 163**

**APPLICATIONS OF VIBRATION ANALYSIS TO THE**  
**CONDITION MONITORING OF ROLLING**  
**ELEMENT BEARINGS**

**N. S. SWANSSON and S. C. FAVALORO**

JANUARY 1984

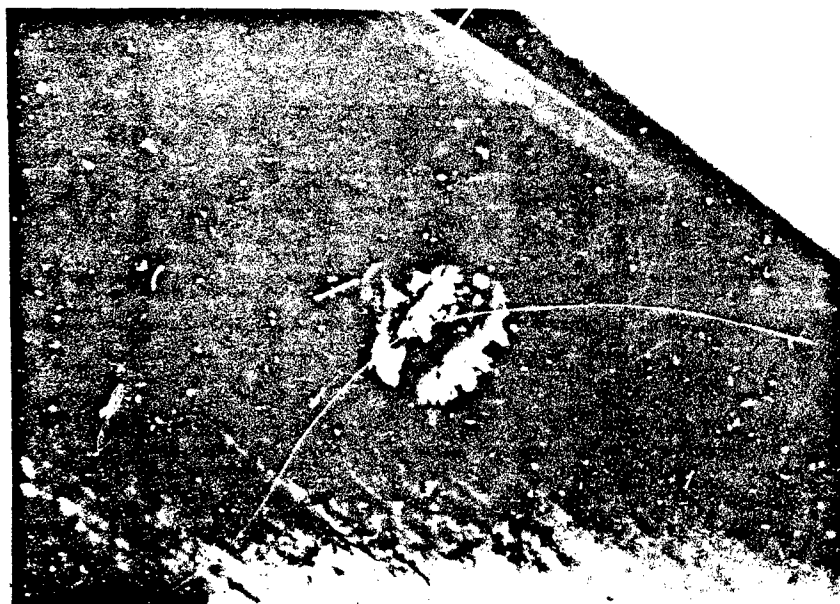
(a) Inner race spall size: .75 mm x .5 mm

(b) Outer race spall size: 2.5 x 2.0 mm

FIG 6.1 DAMAGE TO BEARING AFTER 65 HOURS RUNTIME

One bearing was tested at a speed of 6000 rpm and a load of 4500 N. After 65 hours the bearing had sustained spalling damage of the kind illustrated in Fig. 6.1. Such damage causes substantial impulsive action and these effects are well illustrated in the kurtosis trend plots in Fig. 6.2.
