TECHNICAL REPORT ARLCD-TR-85003

**INVESTIGATION OF DAMAGED LANDS OF M185 CANNON  
MOUNTED ON THE 155-MM M109A1 HOWITZER**

**RICHARD J. KOPMANN**

**JUNE 1985**

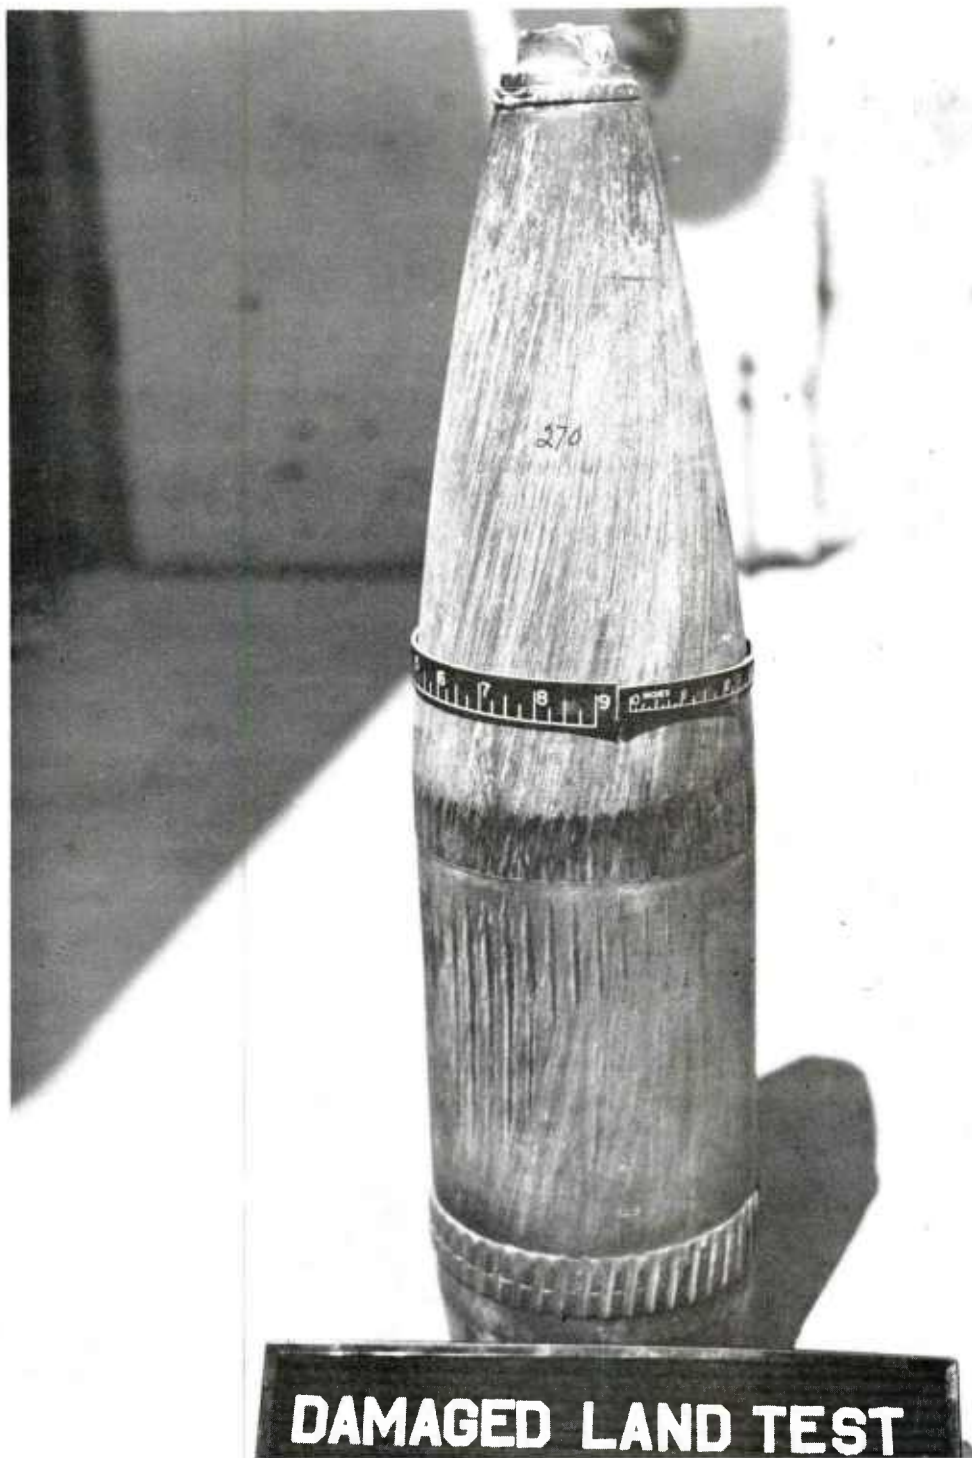
Figure 10. Recovered projectile--fallback test

a. Projectile 9 fired 1 April 1981

b. Projectile 2 fired 31 March 1981

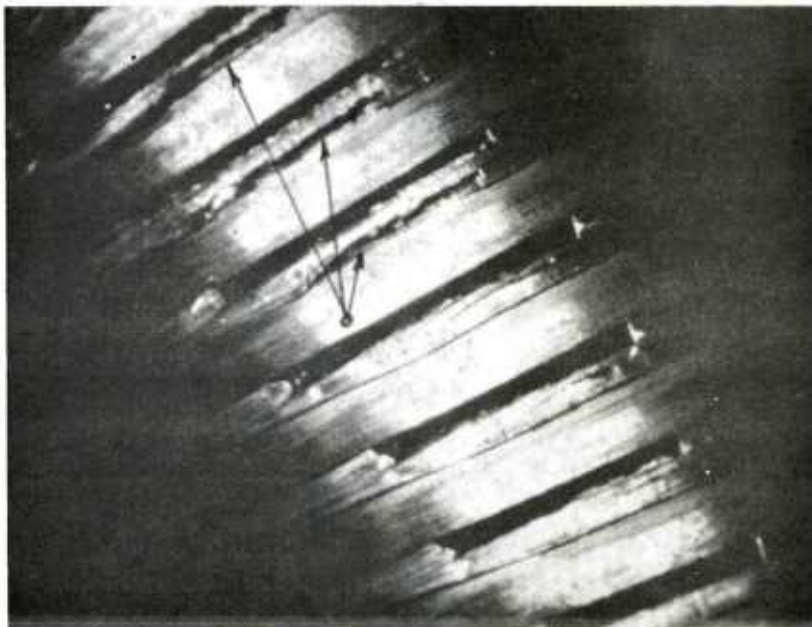
Figure 34. 155-mm M185 howitzer tube S/N 25460

a. Origin of rifling 1 to 3 o'clock after firing 611 rounds

b. Condition of rifling 44.75 to 48 in. 6:30 to 9:30 o'clock after firing 522 rounds
