✓  
AMMRC-TR-85-18

# RELIABILITY AND LIFE PREDICTION METHODOLOGY - M60 TORSION BARS

R. S. BARSOUM, W. M. BETHONY, R. H. BROCKELMAN, H. P. HATCH,  
C. F. HICKEY, Jr., W. T. MATTHEWS, and D. M. NEAL

June 1985

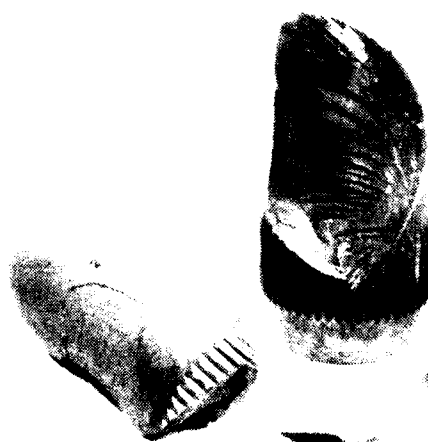
Figures 12a through 12d show typical field failures which were obtained from Anniston Army Depot, APG, Ft. Knox and GD, which exhibited similar failures. They obviously initiated within the splines at the ends of the bar, and in most cases at the wheel arm end. One exception is a case observed at APG where the failure was at the anchor block end. These observations are supported by case studies obtained from the Measurement and Analysis Division at APG<sup>5</sup> and GD.<sup>6</sup>

Light microscopy and scanning electron microscopy (SEM) were used in the examination of the fracture surfaces. The failed bar in Figure 12a was cut open and examined. The arrow shows the origin of the fracture. The arrow on Figure 13a shows the surface of the serration which experienced surface plastic flow at the initiation site. This indicates high stresses at the inner end of the splines. There is a slight indication of fatigue marking in Figures 13b and 13c, but not as large as usual. The SEM examination (Figure 13d), however, did not show the usual striation beach marks associated with fatigue crack growth. This indicated that once fatigue crack initiation occurred, the propagation stage was very short. Further away from the initiation site, the fracture surface showed signs of corrosion and hydrogen embrittlement. It should be noted here that the fracture surface was old and could have been contaminated by the environment after failure.

Figure 12. Typical field failures: (a-c) failure at wheel arm end, and (d) failure at anchor end.
