TECHNICAL REPORT SL-85-5

# EFFECTS OF REINFORCEMENT CONFIGURATION ON RESERVE CAPACITY OF CONCRETE SLABS

S. C. Woodson, S. B. Garner

Structures Laboratory

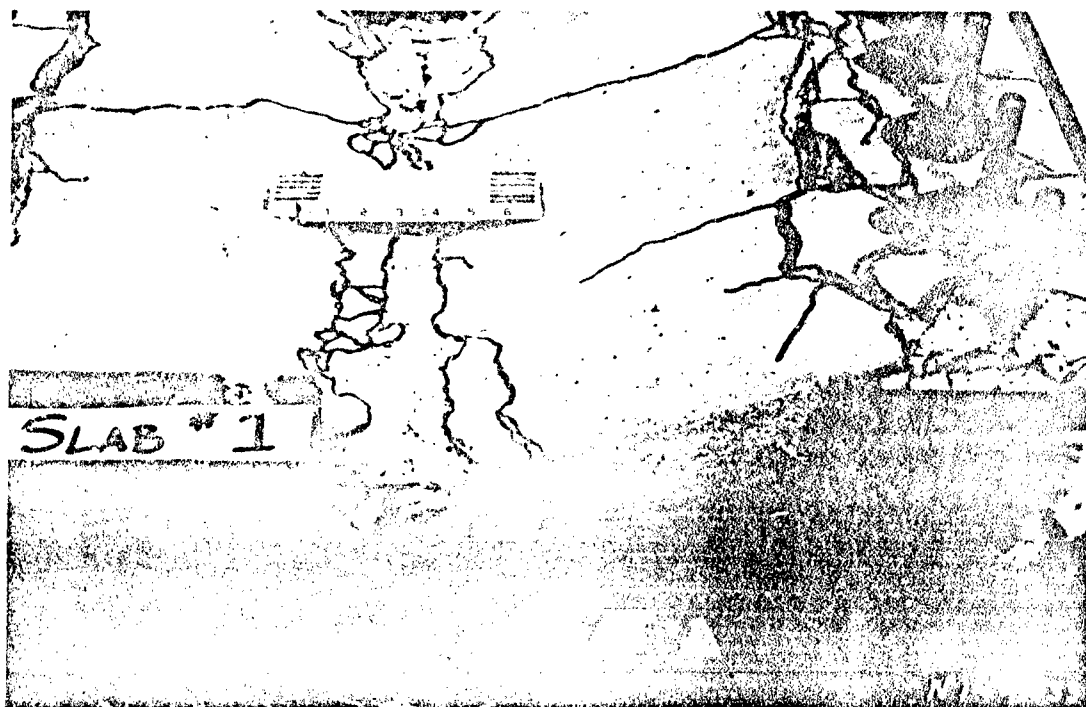
Figure 4.4. Slab 1, posttest.

Figure 4.5. Closeup view of Slab 1, posttest.

4.3.1.1 Slabs 1 and 2. Complete midspan cracking and crushing through the slab thickness occurred over about one-fourth of the width in Slab 1 (Figures 4.4 and 4.5) and throughout the entire width in Slab 2 (Figures 4.6 and 4.7). Very little cracking occurred outside of the hinge areas.

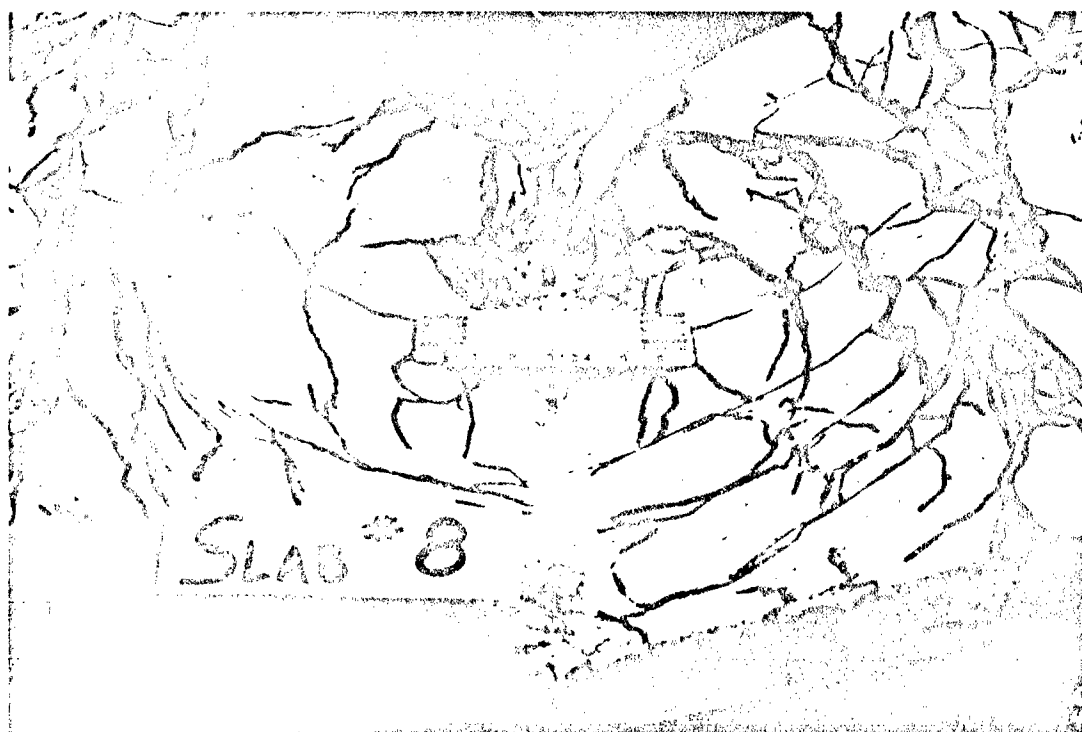
Figure 4.18. Slab 8, posttest.

Figure 4.19. Closeup view of Slab 8, posttest.

Slabs 7 (Figure 4.17) and 8 (Figures 4.18 and 4.19) behaved similarly, with few top bars broken at the supports, 40 to 60 percent of bottom reinforcing broken at midspan, and no compressive steel broken. Failure was clearly by Mode 2.
