DIRECTIONAL STABILITY

MODEL TESTS

OF THE BARGE "SEACON"

REPORT NO. 78-026-001

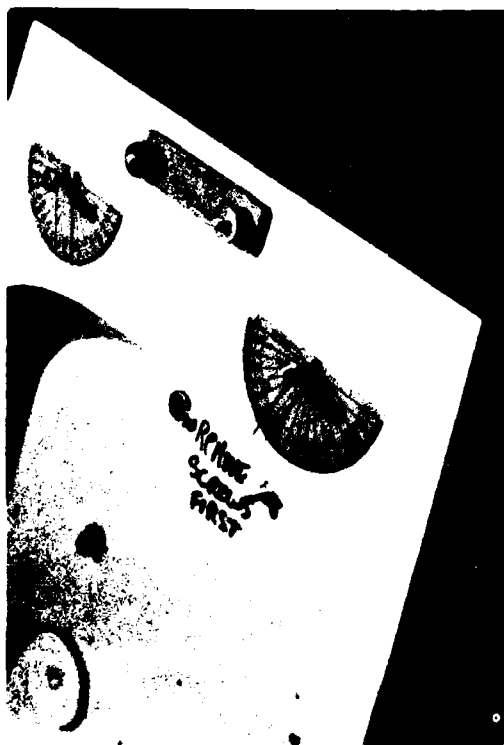
Fig. 1A Stern from above showing  
skeg quadrants

Arrangements were made to conduct the experiments at the Ship Hydrodynamics Laboratory at the University of Michigan. This laboratory which has considerable experience in tests of this type, has as its primary facility a ship model towing tank 313 feet long by 20 feet wide by 12 feet deep. A 1:32 scale model of the SEACON was constructed for the test. Characteristics of the model and the full size barge are given in Table I. The model was designed so that the propulsors could be removed and replaced by fairing pieces. The skegs could also be removed and aft skegs were fitted so that they could be turned at various angles to the centerline. Photographs of various features of the stern of the model are shown in Figure 1.
