CULTURAL RESOURCES SURVEY OF THE SMALL BOAT HARBOR PROJECT  
AT LAKE OF THE WOODS, WARROAD, MINNESOTA

Project Director: Alan P. Brew, Associate Professor of  
Anthropology  
Institution: Bemidji State University  
Report Authors: Alan P. Brew and William J. Yourd  
Contracting Agency: U.S. Army Corps of Engineers, St. Paul  
District  
Contract Number: DACW37-77-M-1859  
Date: November 1, 1977

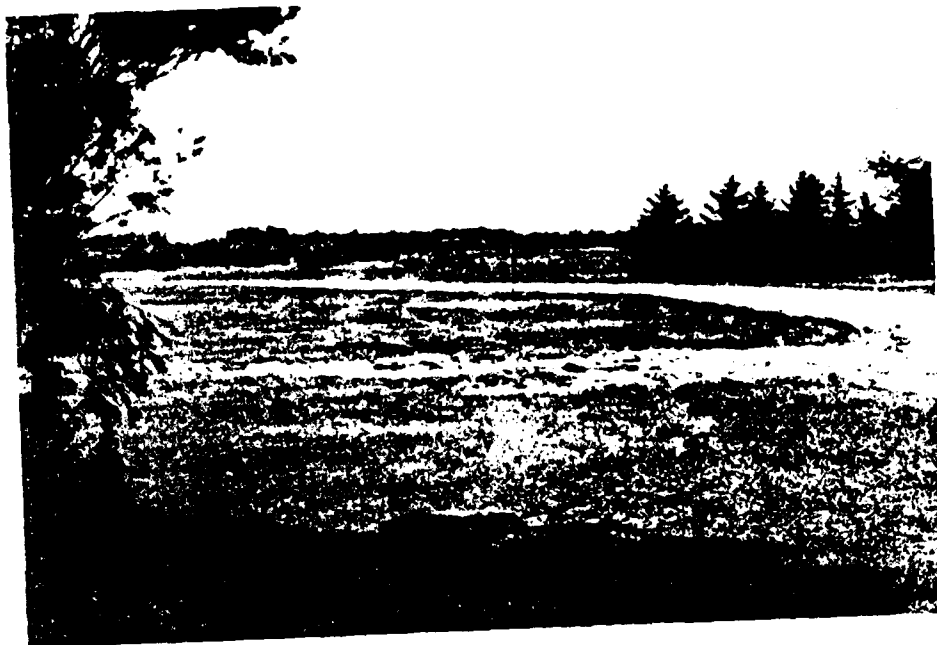
Plate I. Looking northwest along Line 1. Line extends 200 m. from Pit L1-1 (foreground, with sod replaced) toward northeast corner of sewage treatment plant (in distance).

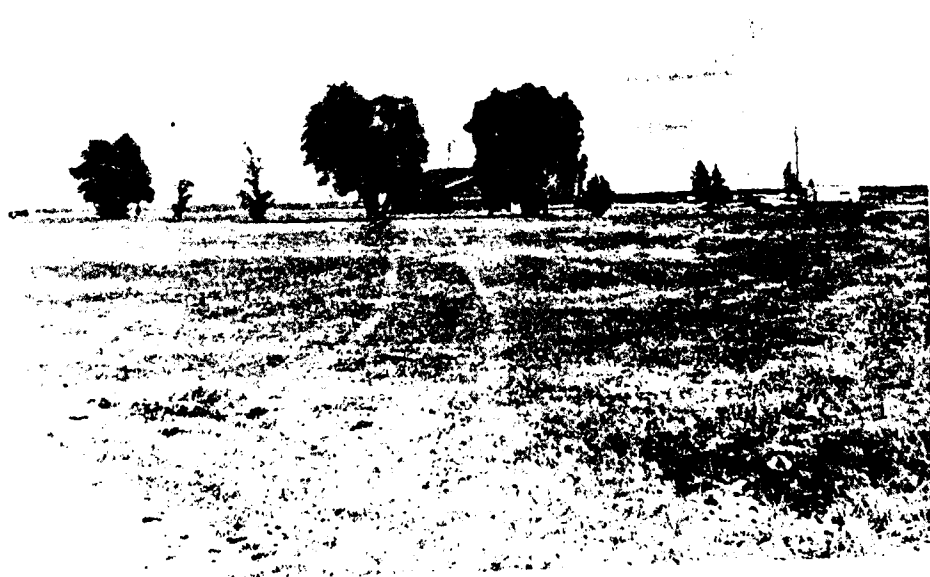
Plate II. Looking southeast along Line 2. Line extends 125 m. from Pit L2-1 (foreground, with sod replaced) toward northwest corner of trading post (in distance).

The areas of highest priority in the field investigation were the proposed channel and the adjacent land which may be affected by substantial landscaping and the construction of a swimming pool. Three lines of shovel tests were excavated in these areas (Fig. 1). A line (Plate I) of nine pits at 25 m. intervals was laid out with a dumpy level along the approximate center of the proposed inland channel. This line sampled about 42% of the total length of the channel. Extension of the line was deemed inappropriate because the area to the east is paved and is used heavily and the area to the west is occupied by an operating sewage treatment plant and its lagoons. The area to the north of the line is lakeshore lowland. Two lines of pits were excavated in the swimming pool area; the first (Plate II) consisted of six pits, the second, of two.

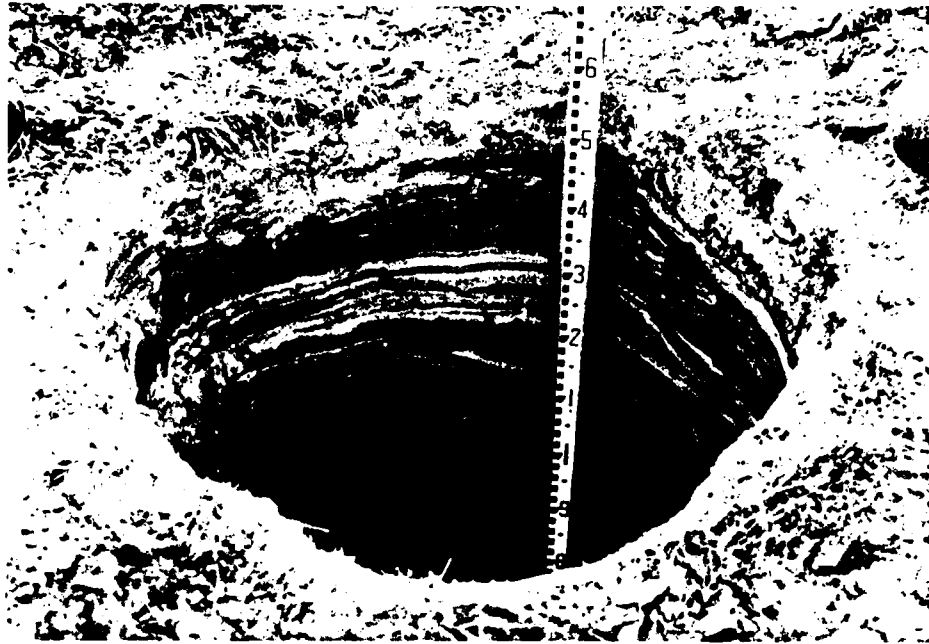
Plate III. Upper .6m of Pit L1-3 showing characteristic profile of laminated artificial fill produced by pump-dredging of Warroad River channel, circa 1930.

(1) an upper layer, varying in thickness from 7 to 56 cm., of sand and gravel, containing occasional pieces of brick and some glass, metal, and leather objects; (2) deposits of laminated muck, peat, and sand, 10 to 70 cm. thick, varying in the amount of sand present; and (3) pure peat deposits, 20 to 80 cm. thick, which contain some historic and prehistoric artifacts. In four pits, a layer of sawdust and wood chips 15 to 20 cm. thick underlies the gravel fill. The sawdust is fresh and dry and has undergone no decomposition. Informants' statements

The problem presented by the latter interpretation was resolved through the aid of Peter Harder of Warroad. Mr. Harder reported that "37 or more years ago" he had worked on the dredging project which had resulted in the filling of Lakeview Park. The project entailed the pumping of "muck" from the river channel into the park area, behind a dike. The material was pumped through one-foot diameter pipes in such a fashion that large quantities of essentially pure organic matter were incorporated in the fill. Mr. Harder stated that bullheads and other fish were sucked through the pipes. Occasional replacements of the pipes, variations in the rate of flow through them, and differences in topography in the lowland area account for the laminated fill which appears in most profiles (Plate III). The basal deposit, which was reached in 11 of the 15 pits, varies in texture from sand to clay and in color from light
