FLOOD EMERGENCY PLAN FOR MOUNT MORRIS DAM GENESEE RIVER 1/2  
WATERSHED NEW YORK VOLUME 2 APPENDIX A(U) CORPS OF  
ENGINEERS BUFFALO NY BUFFALO DISTRICT OCT 85

FLOOD EMERGENCY PLAN FOR  
MOUNT MORRIS DAM

APPENDIX A

HYDROLOGY

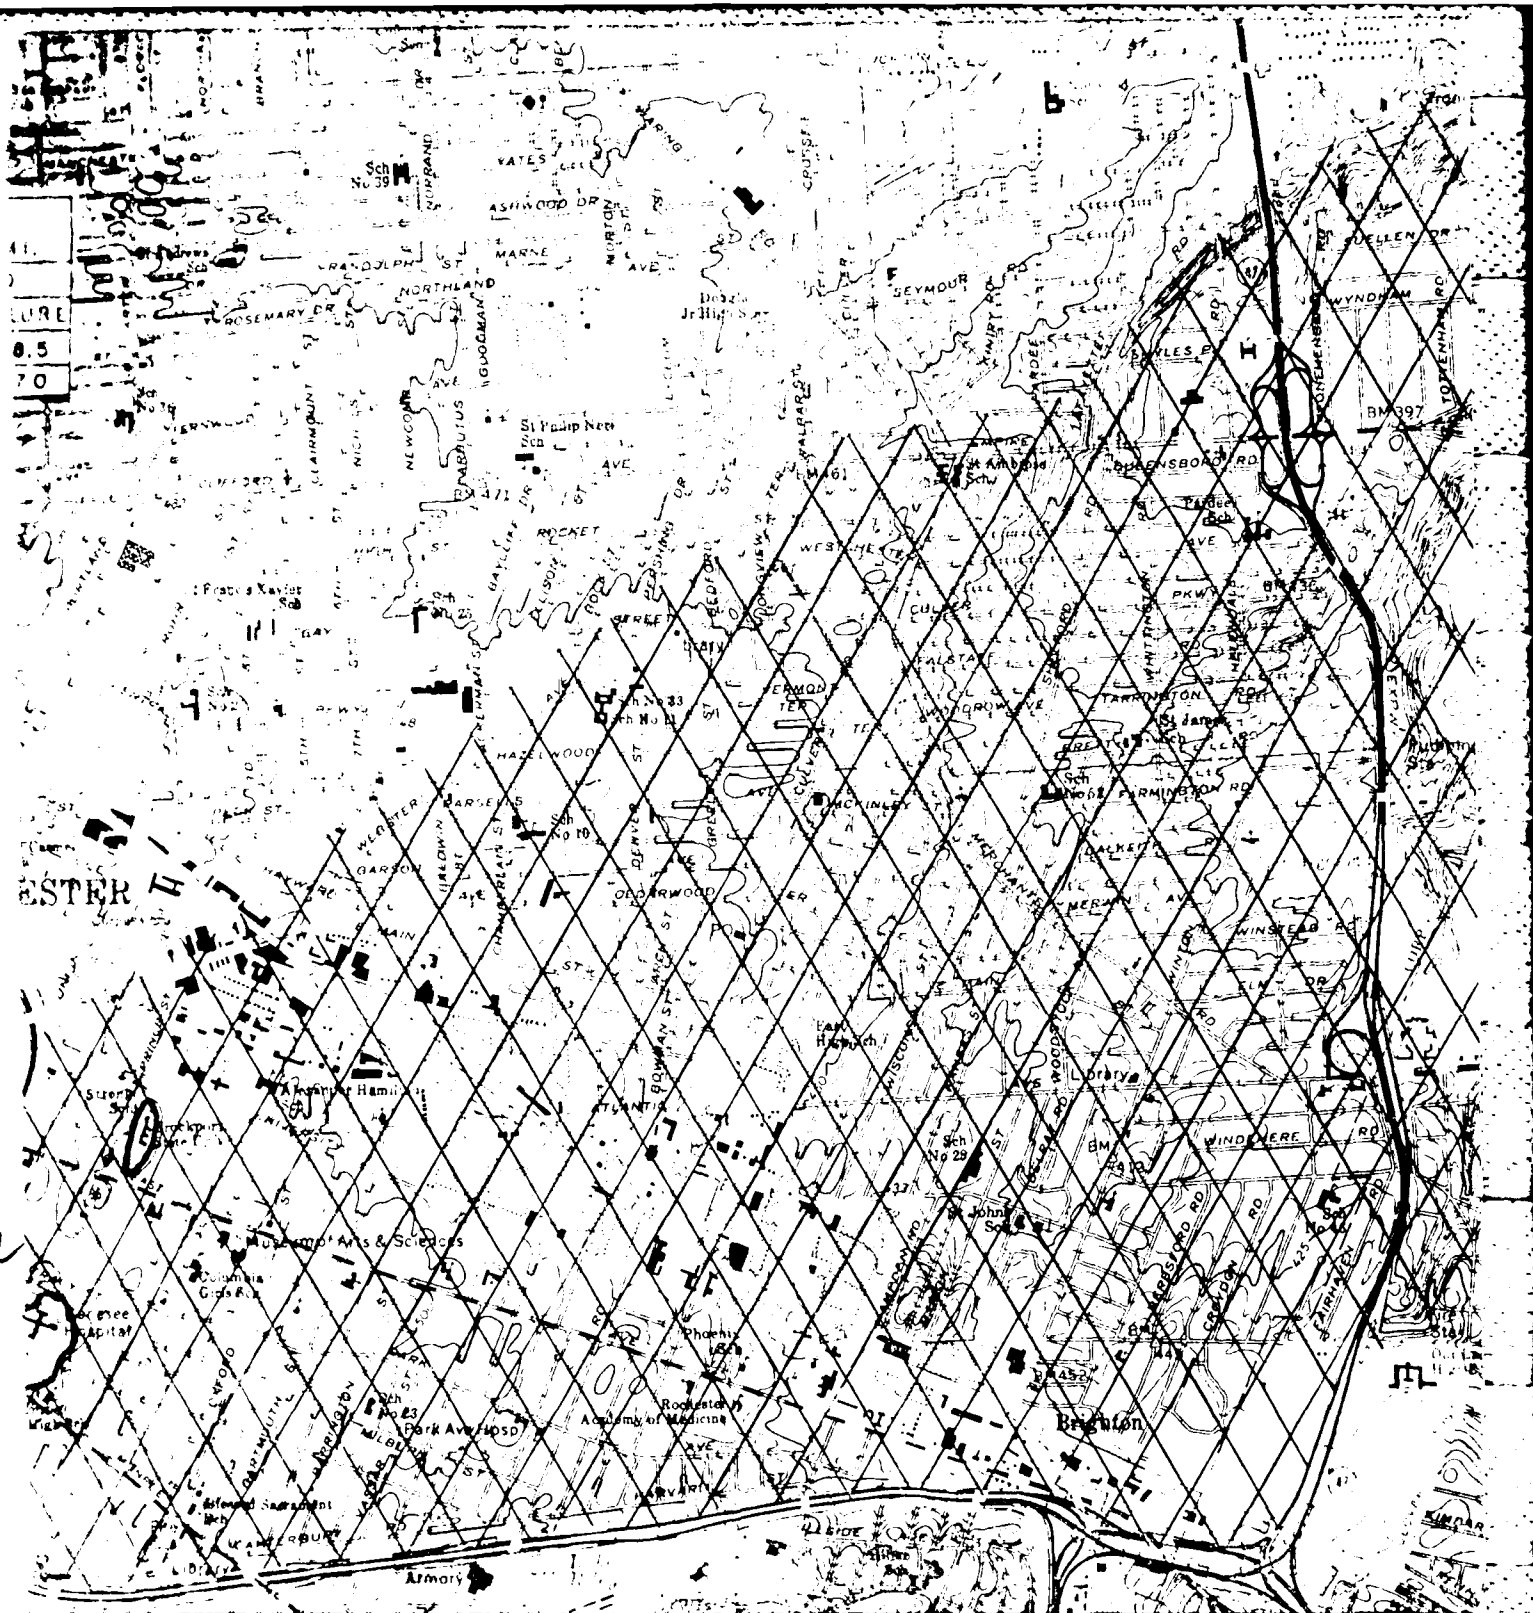
PLATE A48

PROBABLE MAXIMUM  
FLOODED AREA WITH  
DAM FAILURE.

PROBABLE MAXIMUM  
FLOODED AREA WITHOUT  
DAM FAILURE.

APPROXIMATE OVERLAND  
FLOODING FOR PROBABLE  
MAXIMUM FLOOD WITH  
OR WITHOUT DAM FAIL-  
URE.
