NRL Memorandum Report 5751

# Aircraft Carrier Flight Deck Firefighting Tactics and Equipment Evaluation Tests: Executive Summary

H. W. CARHART, J. T. LEONARD, R. L. DARWIN,\* R. E. BURNS,†  
T. J. HUGHES† AND E. J. JABLONSKI†

March 25, 1986

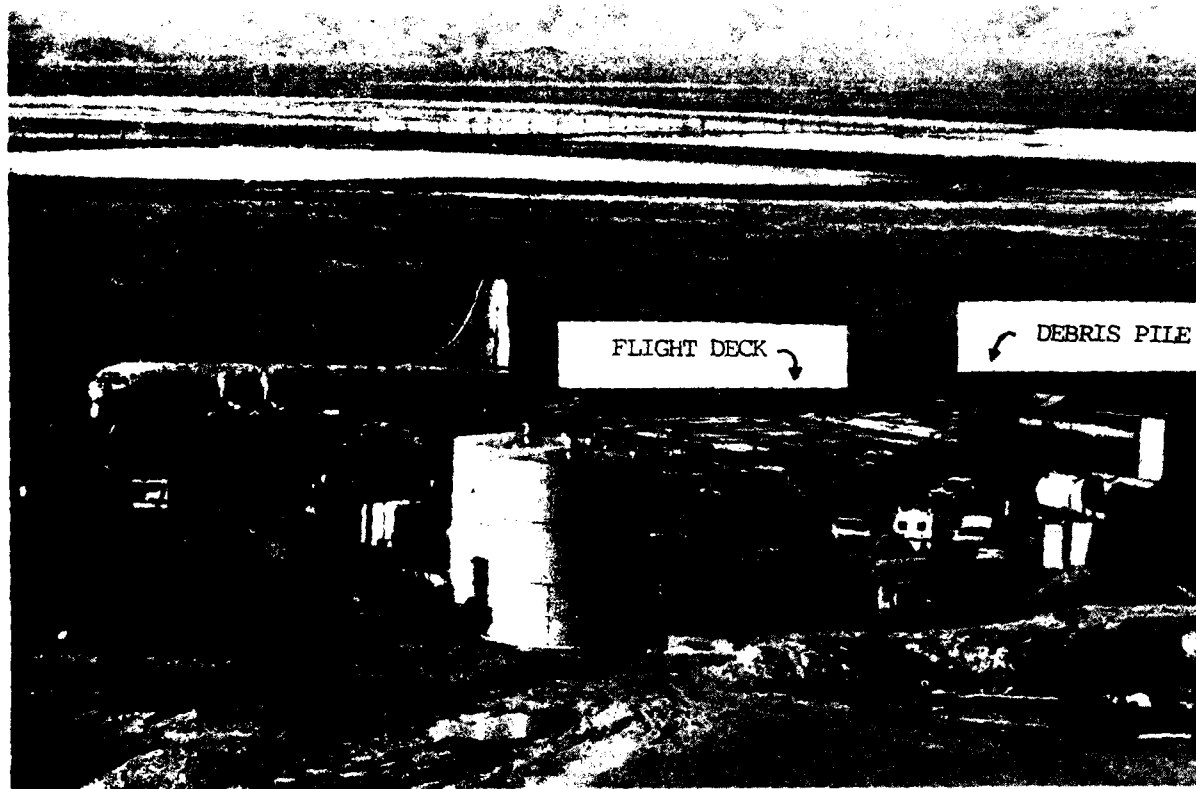
R-1253

Fig. 3 - Simulated flight deck test site, NWC,  
China Lake, CA
