11. TITLE (Including Security Classification)  
AUTEC Ocean Hauldown Dive Survey Site 1 & Site 2

Final Report  
AUTEC Ocean Hauldown Dive Survey  
Site 1 & Site 2

Site 1 & Site 2

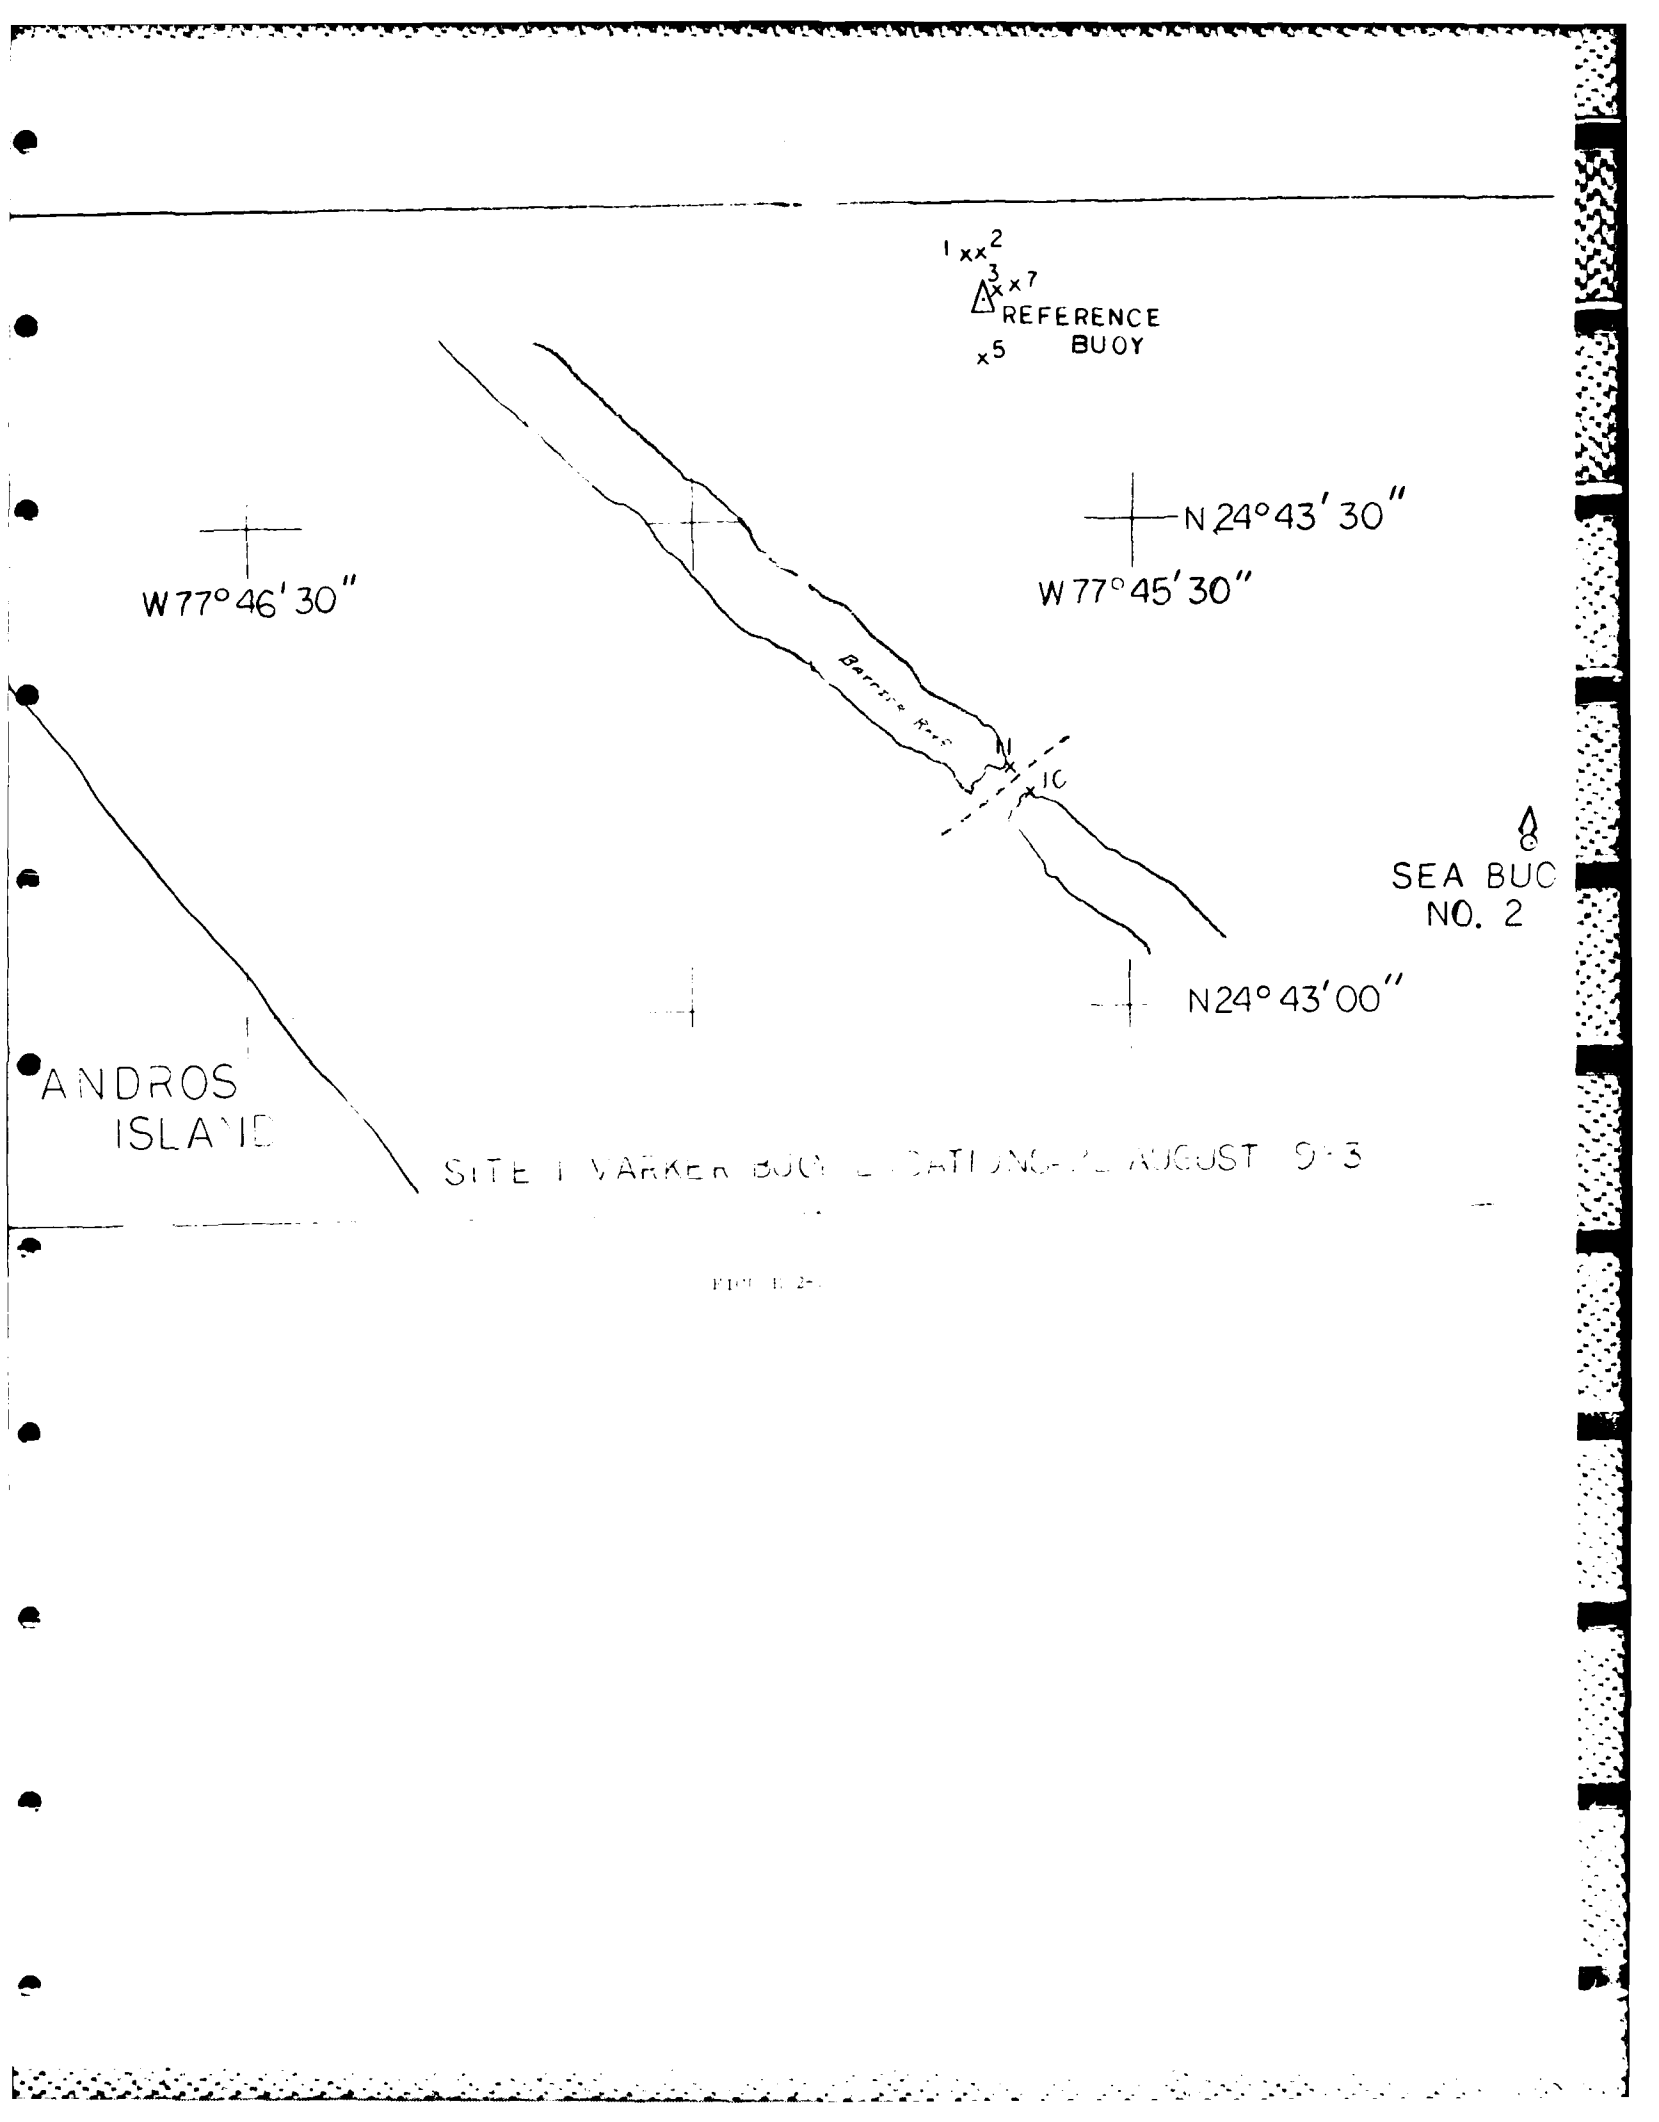
is shown in Figure 2-1. (Reference buoy anchor chain was wrapped around coral head). The survey in the vicinity of the buoy indicated several areas of interest and small marker buoys numbered 3, 7, 2, 1, and 5 were placed to delineate these areas.

Buoys #10 and 11 were placed in a shallow reef cut to define a possible cable route to shore which is shown as a dashed line on Figure 2-1. They are located in approximately 10 feet of water with coral and sand bottom. The relief is approximately 2-3 feet and clear of obstructions to shore.

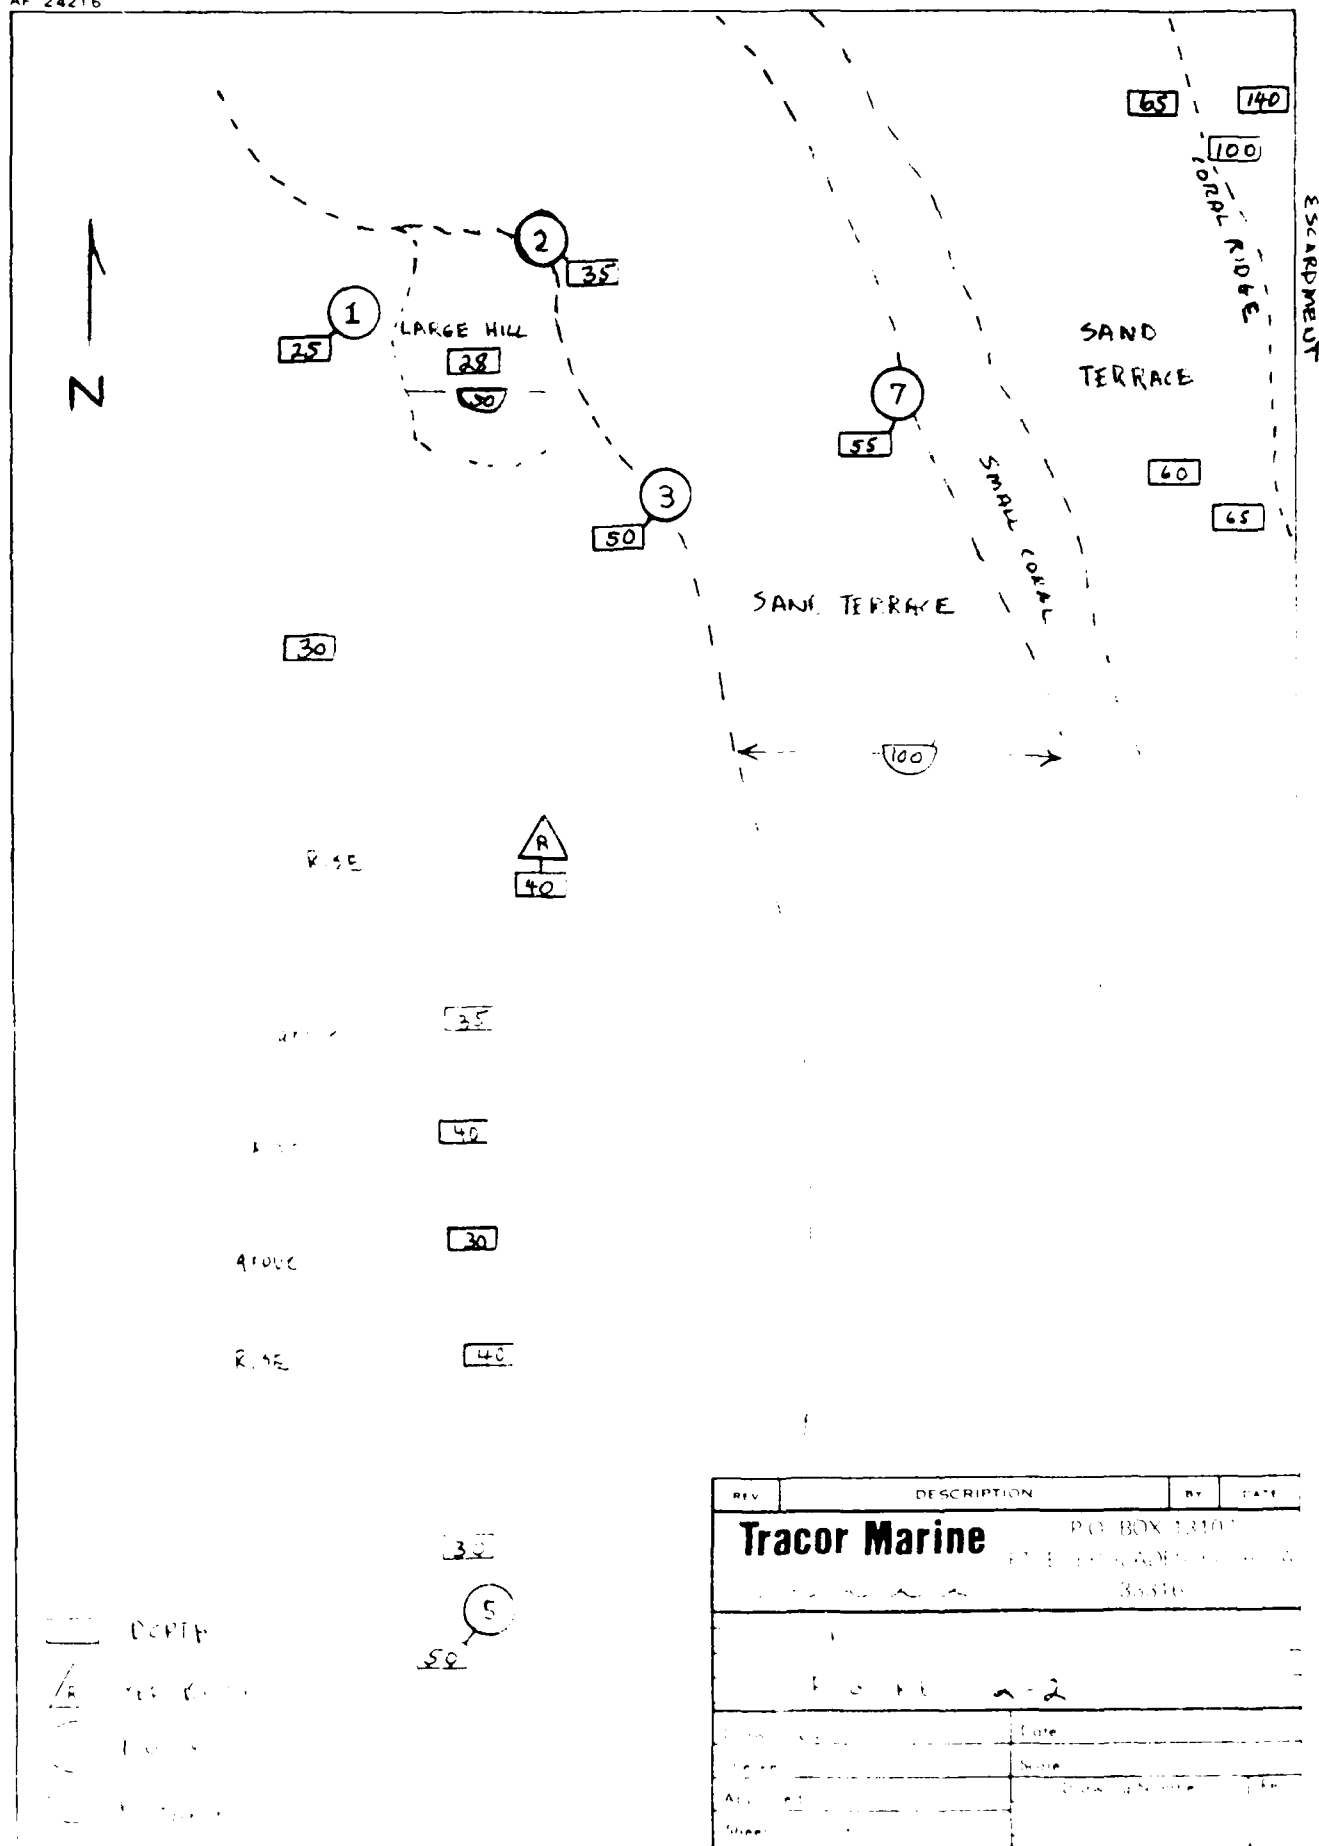
Figure 2-2 is a bottom-type chart generated from information gathered during the survey. The bottom directly east or seaward of the reference buoy is characterized by a spur and groove coral formation running east and west for approximately 50 feet. The sand trenches (grooves) have a general depth of 40 feet and the coral spurs have a relief of 4 to 6 feet. The coral spurs diminish seaward to a sand area 75 feet wide which parallels the coral line and sweeps back toward the shoreline. There is no coral in this sand area. The sand is approximately 14" thick over a coral hard ground and the depth is approximately 50 feet. Buoy #7 is located on the east side of this sand area and buoy #3 is located on the western side.

A coral bottom is again present for approximately 20 feet from buoy #7 seaward, with the normal 4 to 6 foot relief. The depth of water in this area is 55 feet.

Buoys #1 and 2 mark an area of sand of approximately 40 feet in length and at a water depth of 65 feet.

Further seaward, the sand fades into a coral bottom with a slight rise at the 65 foot depth and then falls off to approximately 80 feet with a fairly gentle slope.

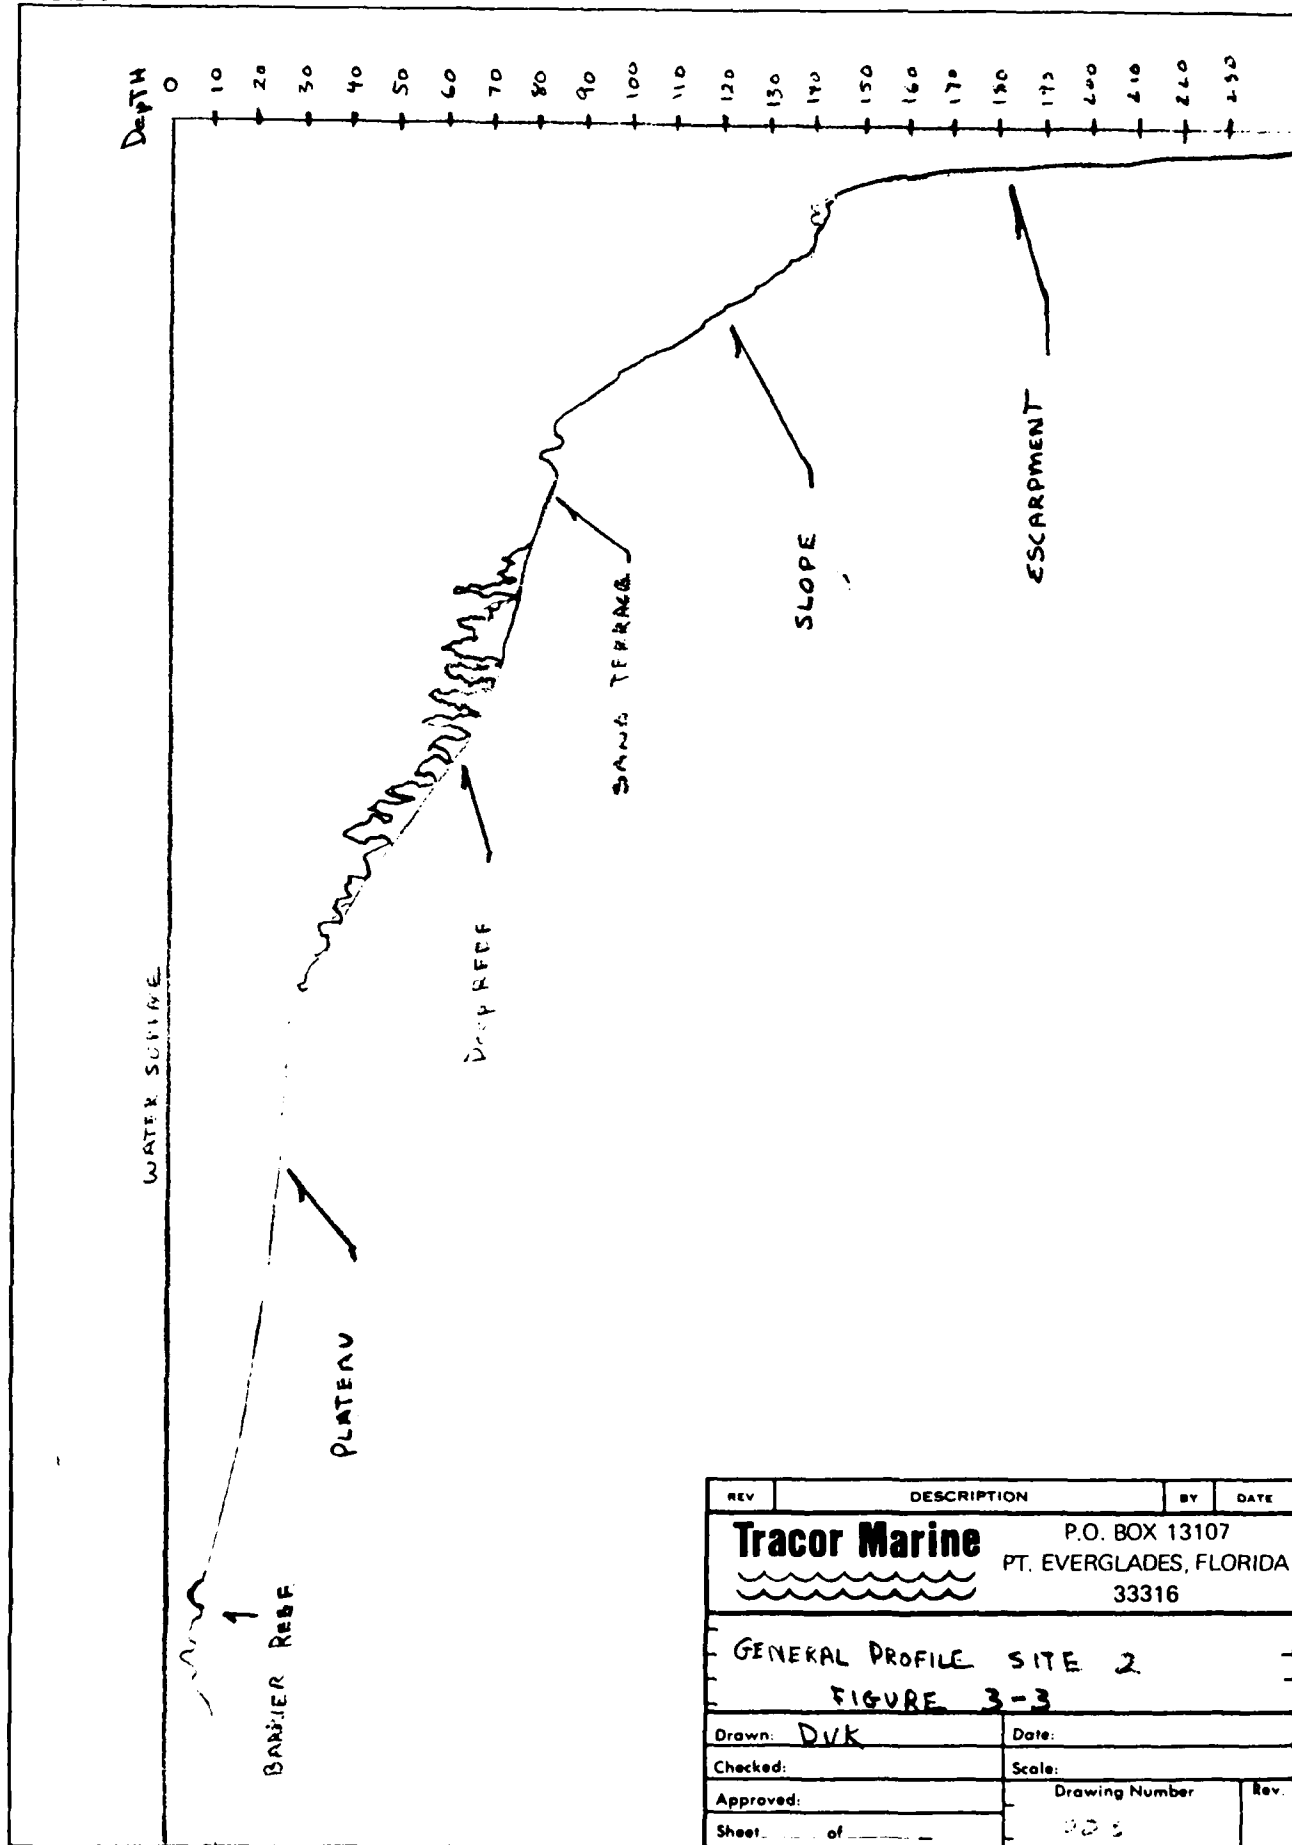
| REV | DESCRIPTION | BY | DATE |
|---|---|---|---|
| GENERAL PROFILE SITE 2<br>FIGURE 3-3 | | | |

The general profile (Figure 3-3) of the surveyed area from west to east consists of a hard coral rock plateau with small heads from the barrier reef to 100 yards west of the reference buoy. The depth of the plateau before the drop off to the deep reef is 25 feet. The deep reef begins after the drop at 45 to 50 feet and continues gradually to 70 feet where the sand terraces begin. The terraces extend from 70 to 90 ft. to the rock ridge or sill. The ridge has a slight rise of coral rock before the start of the  $45^{\circ}$  slope which extends to 140 feet. At the 140 foot level, the escarpment begins with a very sharp drop off  $80^{\circ}$ .
