**TECHNICAL NOTE**

**M R L - T N - 4 9 5**

INVESTIGATION OF A PROPELLANT FIRE AT  
MULWALA EXPLOSIVES FACTORY, JULY 1984

G. Bajinskis

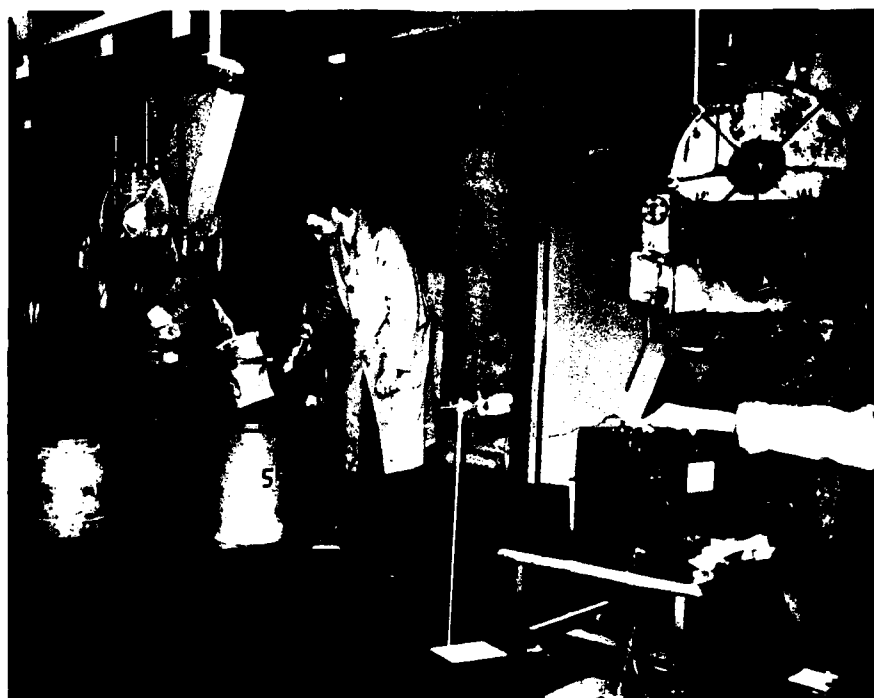
Fig. 1. Electrostatic charging tests on cut propellant in Building 234B. Photograph shows electrical discharging of cut propellant by earthing of meter input on the right of the photograph and the monitoring of surface charge by the operator prior to removal of electrode from the plastic bucket.

The potential of the cut propellant was monitored during the cutting operation with an electrostatic voltmeter linked to a probe at the bottom of the bucket. For measurements on fibre and metal buckets the probe was isolated from the base of the bucket with a thin sheet of plastic slightly larger than the probe electrode. The bucket was centrally placed on an earthed metal plate under the flow of cut propellant as shown in Figs. 1 and 2.
