Plastic instability of platinum modified and
unmodified aluminide coatings during 1100 C
cyclic testing

PLASTIC INSTABILITY OF PLATINUM MODIFIED AND
UNMODIFIED ALUMINIDE COATINGS
DURING 1100 C CYCLIC TESTING

MASTER OF SCIENCE IN MECHANICAL ENGINEERING

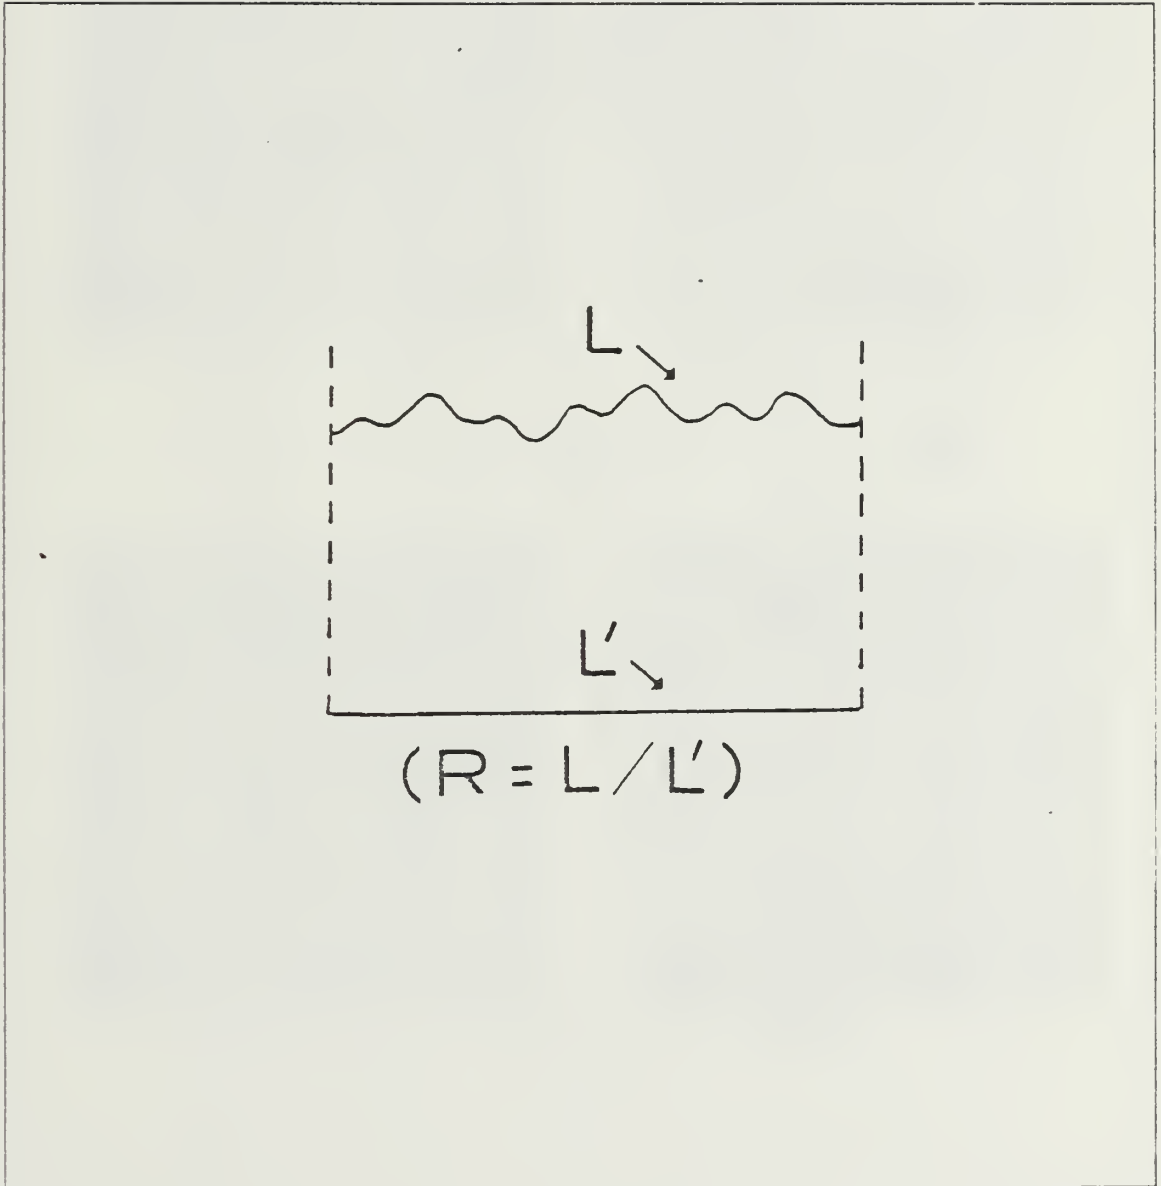
Figure B.1 Lineal Surface Roughness Measurement.

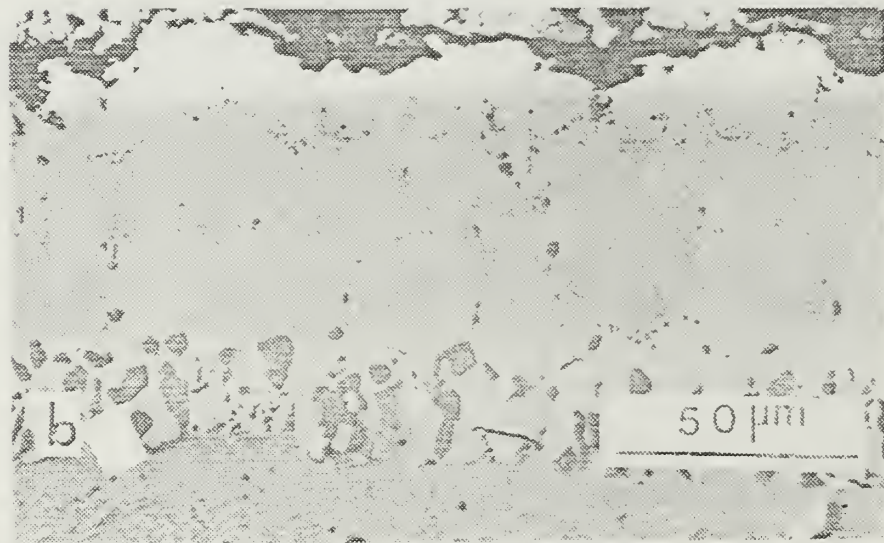
Figure B.22 Cross-section Microstructural Comparison of An Initial and Thermally Cycled Platinum Aluminide Coating, (650 ×): a) 4HAT, 0 cycles, b) 4HAT, 150 cycles.
