TECHNICAL REPORT BRL-TR-2812

# NITROGUANIDINE MORPHOLOGY IN EXTRUDED GUN PROPELLANT

ROBERT J. LIEB

JUNE 1987

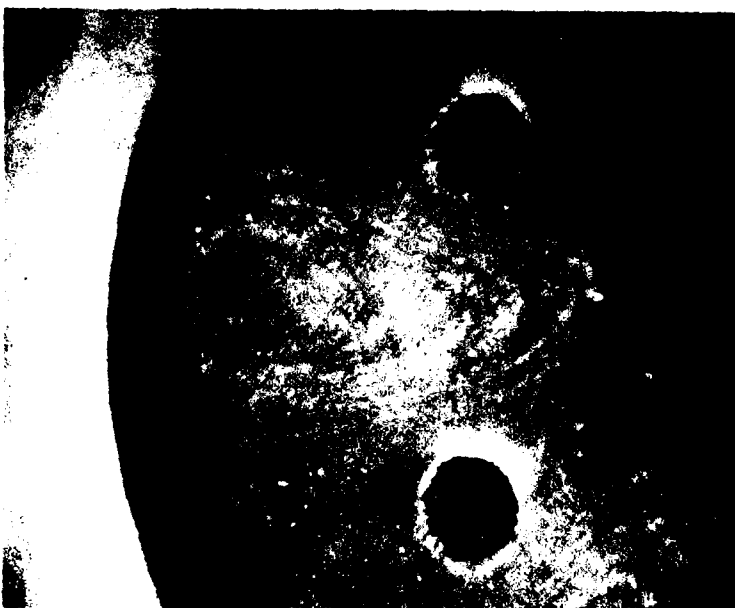
a. The Entire Grain End

b. Detail of Figure 1a.

Figure 1. Optical Photograph of M31A1 Lot 07077 Showing the Ring Structure between the Outer Perforations

The M31A1 specimen shown in Figure 1 was prepared for investigation using a scanning electron microscope (SEM). Figure 2 shows the resulting SEM photograph, and demonstrates the morphological nature of the rings. The long sweeping arcs are the result of machining required to flatten the end surfaces for testing. Higher magnification photos showed that each ring seemed to be a path formed by a series of voids. Since it was difficult to determine if the apparent porosity was intrinsic to the grain or generated by the preparation procedure, this grain was prepared for further investigation by being cold fractured along a line from midweb to midweb, through the middle of the ring structure and middle perforation. Fractures, such as this one, running through the center of opposite ring structures will subsequently be referred to as a Type A Fracture, which is illustrated in Figure 3. Cold fracturing is achieved by slowly cooling the grain in dry ice. A cold razor edge is then placed along a line defining where the crack is to begin, and a hammer strike initiates the crack propagation. The resulting crack exposes new surface that is neither stretched nor torn and, due to the brittle nature of the low temperature fracture, the inner structure of the material is revealed with little disturbance.

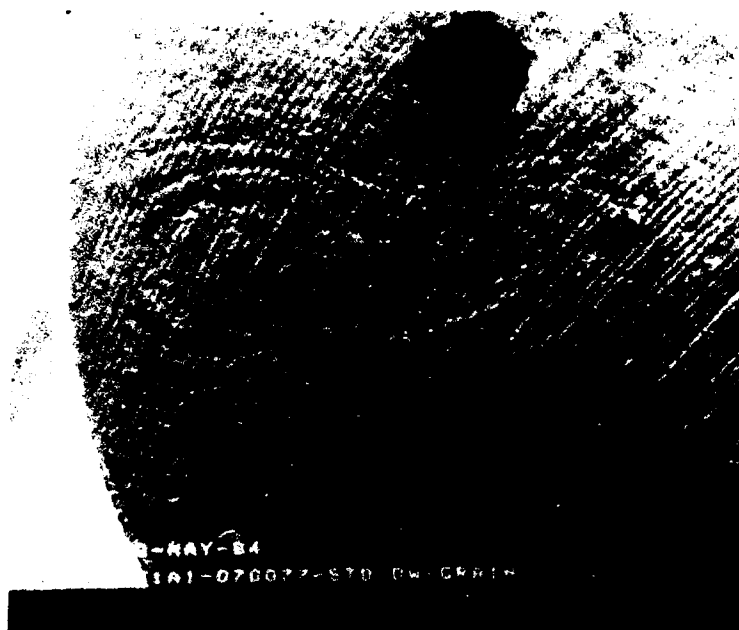
Figure 2. SEM Photograph of M31A1 Showing the Ring Structure
