MTL TR 87-28

# WELDABILITY OF 2219-T851 AND 2519-T87 ALUMINUM ARMOR ALLOYS FOR USE IN ARMY VEHICLE SYSTEMS

THOMAS D. WOLFE and STEVEN A. GEDEON

June 1987

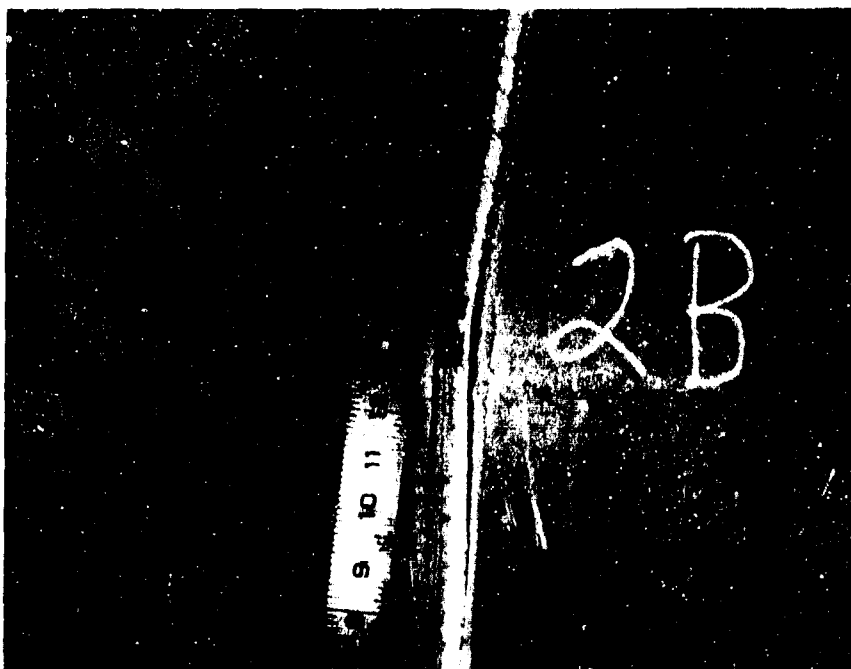
Figure 11. Closeup of reverse side of Figure 10 showing crack in fusion zone.

The offset-vee butt welds of both alloys fractured along the fusion line with crack lengths ranging from 15 to 18 inches. Figure 10 shows an example of the impact side of one of the four butt welds tested. Figure 11 is the reverse side of the same place showing the fracture and opening. Since no experimental data exists for the crack length as a function of velocity, it is not known if these plates would have passed (i.e., experienced 11 inches of crack rather than 14) had the impact velocity been slightly less.
