THE MECHANISM OF ELECTRICAL EROSION OF METALS

S.L. Mandel'shtam, S.M. Rayskiy

Source: Izvestiya Akademii Nauk SSSR, Seriya Fizicheskaya,  
Vol. 13, Nr. 5, 1949, pp. 549-553; 1 Un. Nr.;  
555; 557-561; 563-565; pages 554, 556 and 562  
missing in foreign text.

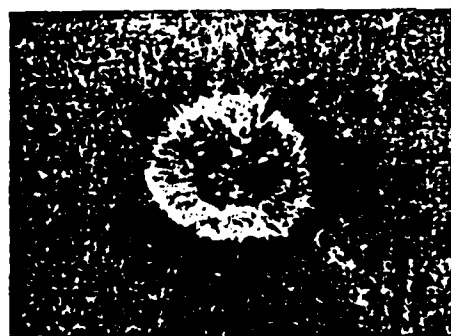
Fig. 16. Damage to a steel plate by a flare escaping from a copper wire cathode placed in a capillary tube; single discharge: a - the plate was located at a distance of 1 mm from the opening of the capillary; b - the plate was located at a distance of 0.5 mm from the opening of the capillary; c - the plate was located at a distance of 0.2 mm from the opening of the capillary; d - damage to a plate by a flare from copper wire not enclosed in a capillary tube at a distance of 1 mm between the plate and the wire; e - damage to a plate by the same flare, but at a distance of 0.2 mm.

Damage of the steel electrode proved just as severe as in experiments without a capillary tube with close positioning of the two electrodes. Figure 16 shows photographs of the damage to a steel plate by a flare escaping from a copper wire cathode enclosed in a capillary tube at different distances between the end of the capillary and the steel plate: a - approximately 1 mm; b - approximately 0.5 mm; c - 0.2-0.3 mm. (We remind the reader that the wire fails to reach the end of the capillary tube by 3-4 mm.)

Photographs of steel plate surfaces damaged by a flare from copper wire directly without a capillary tube at different distances between the wire and the plate are presented in the same figure for comparison: d - 1 mm; e - 0.1-0.3 mm.

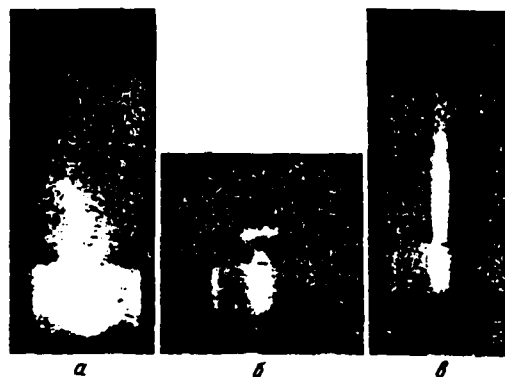
Fig. 18. Photographs of a flare escaping from a capillary tube at different discharge power values: a - at high discharge power values, the flare is unstable; b - a high discharge power values, taken with an exposure of  $2 \mu\text{s}$ ; the beginning of the exposure is  $2.4 \mu\text{s}$  after breakdown of the spark gap; c - with a decrease in the discharge power, the flare is stable.

A photograph of such a flare is presented in Fig. 18, a. This photograph was obtained by the normal method, without limiting the exposure (the flare was photographed from the beginning of its luminescence to ceasing of luminescence). In Fig. 18, b, we present a photograph taken 2.4  $\mu$ s after the beginning of a discharge with an exposure of 2  $\mu$ s. This photograph makes it possible to judge the rate of the process of expansion and propagation of the flare and the unique form taken on by the luminescent parts of the flare.

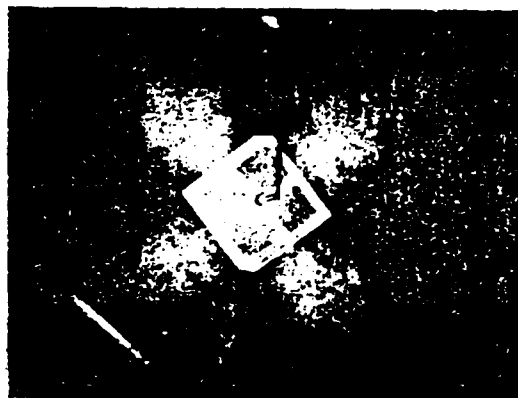
Fig. 19. Photograph of 4 flares escaping simultaneously from 4 capillary tubes differing somewhat in diameter and surface preparation in a discharger, with a high discharge power; all the flares are unstable.

regularity of the surface areas of their side walls, all the flares will have the same form generally, which can be seen, for example, from Fig. 19.
