Annual Report  
Grant No. N00014-85-K0179  
September 1, 1986 - September 30, 1987

INVESTIGATION OF MICROSTRUCTURAL FACTORS THAT  
CAUSE LOW FRACTURE TOUGHNESS IN SILICON  
CARBIDE WHISKER/AL ALLOY COMPOSITES

Report No. UVA/525398/MS88/102  
September 1987

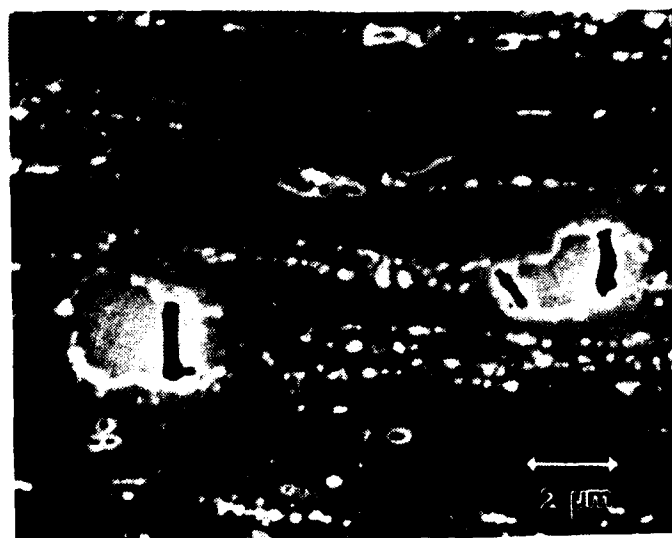
Figure 3. TEM of Al-Cu Containing Particles in 2124 Tensile Specimen 1211.

Figures 2 and 3 depict the brittle nature of large precipitates in 2124 Al specimens which were prepared by identical powder metallurgy techniques as the composite, and tested in tension [21]. Although the surrounding matrix is relatively underformed, large cracks are clearly seen to propagate through the particles. Energy dispersive spectroscopy (EDS) has revealed Mn and Fe content in these precipitates.

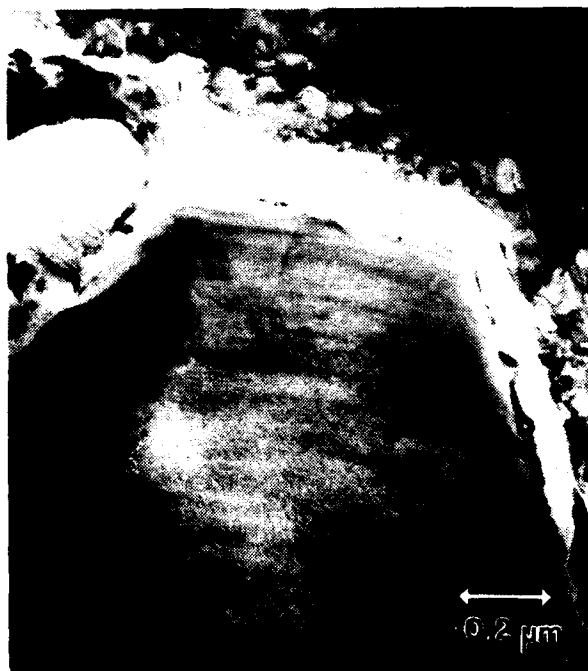
Figure 6. SEM Showing Cross Section of Whisker  
With Interfacial Failure [21].

Fracture studies by Wawner [21] clearly show the importance of the interface. Tensile fracture specimens of 2124-SiC<sub>w</sub> composites were examined with TEM (Figures 7 and 8). Cavities are found to form at whisker tips and along the interface. The same phenomenon of cavity formation was also reported by Nutt and Duva [29]. Any weak bonding between matrix and whisker can cause premature crack initiation in these areas. Correlation of mechanical properties with microstructure in investigations such as these can lead to strengthening theories. However, many fracture studies have not provided detailed microstructural characterization of test specimens, and so application of general theories is difficult [30].

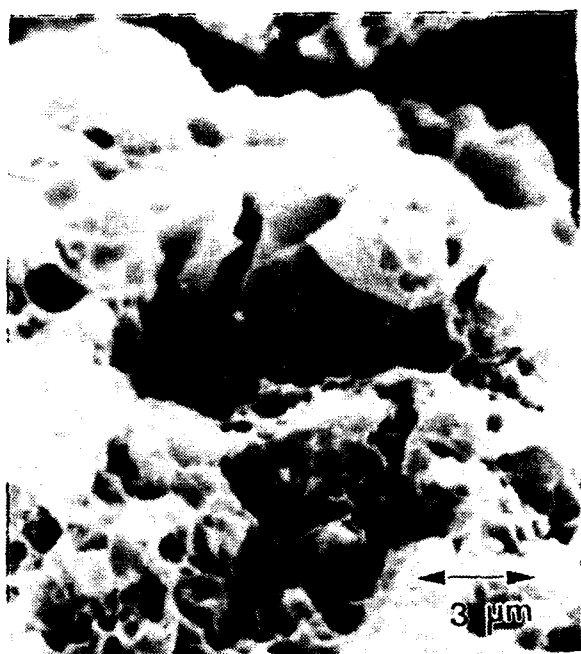
Figure 15. Brittle Intermetallic in 2124-SiC<sub>w</sub> Composite and Corresponding X-Ray Spectrum

Past microstructural studies have indicated that constituent particles in the 3-5 micron size range dominate failure in the present composite systems of interest (i.e. SiC/2124 and SiC/6061). These particles, identified through x-ray analysis as:  $\text{Al}_2\text{CuMg}$ ,  $\text{Al}_{20}\text{Mn}_3\text{Cu}_2$ , and  $\text{FeCuMnAl}_6$  [38], influence fracture toughness since they generally are brittle and form in critical locations such as whisker-matrix interfaces or along grain boundaries. These particles are also found to form in areas where whiskers are in contact, as shown in Figure 13. This figure is a TEM micrograph of a precipitate formed at the contact area of two whiskers in a 2124 matrix composite. Figures 14 and 15 show SEM micrographs of typical particles on the fracture surfaces of this material. Included is an energy dispersive x-ray spectra indicating that Cu, Fe, and Mn are found in these particles. The particles exhibit cleaved surfaces compared to the ductile appearance of the surrounding matrix. Also seen in Figure 15, is a crack passing through the particle. Pore formation can also be seen.

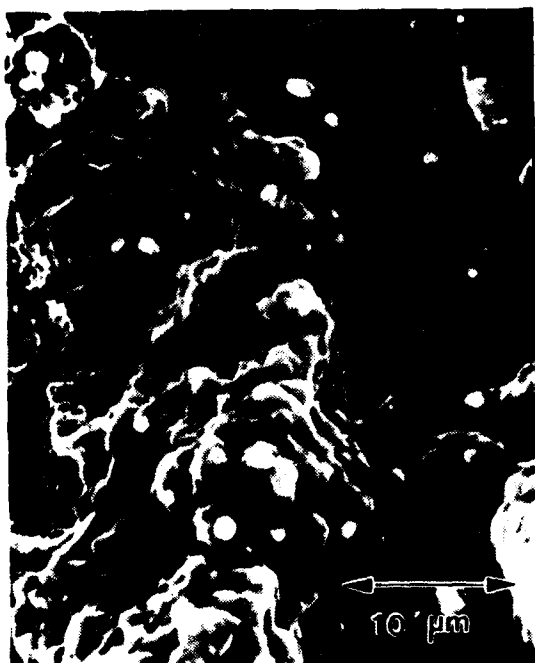
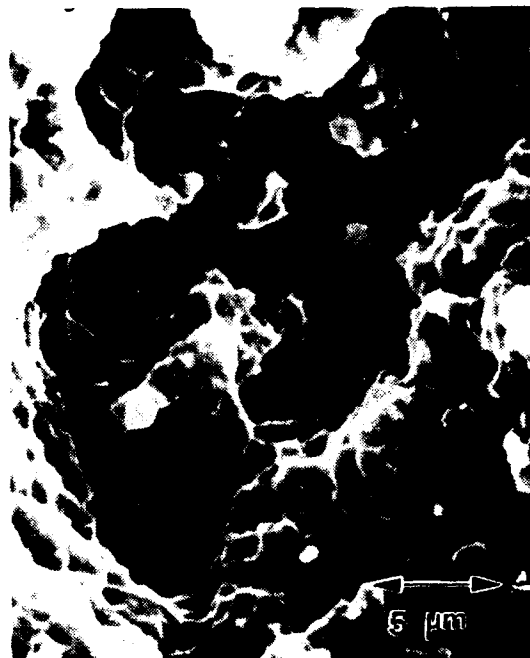
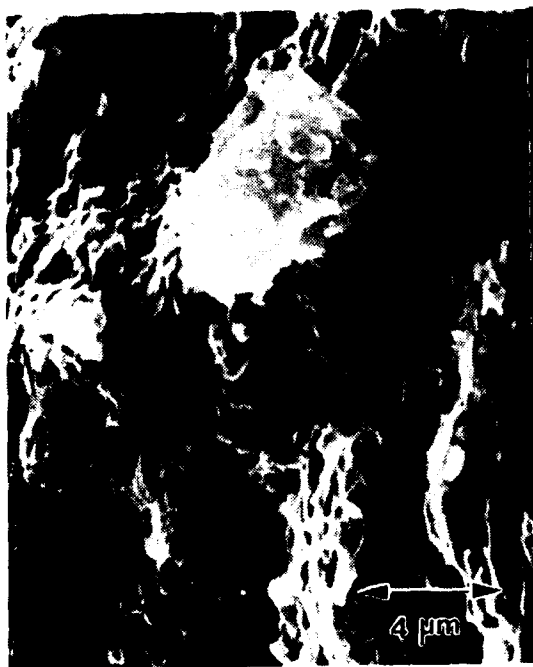
Transverse and longitudinal fracture surfaces of hot-rolled 2124 are shown in Figure 28. These micrographs can be compared to Figure 24, which shows the same material in the unrolled state. Transverse fracture surfaces, before and after rolling appear similar. The longitudinal surfaces also have similar appearances, but there is an unusual observation in the hot rolled surface [Figure 28(a)]. The area pictured, which was a common occurrence across the surface, does not exhibit the usual dimpled structure. Instead, areas of apparent localized incipient melting at a free surface (pores) are found. This melting phenomenon could have taken place during the hot-rolling process. The transverse surfaces again show the pulling away of fiber-matrix conglomerate, as seen previously. The fracture surfaces for 55% rolling reduction do not show any definite microstructural reasons for the observed strength decreases, but it is suspected that some interfacial damage must be incurred during the rolling process.

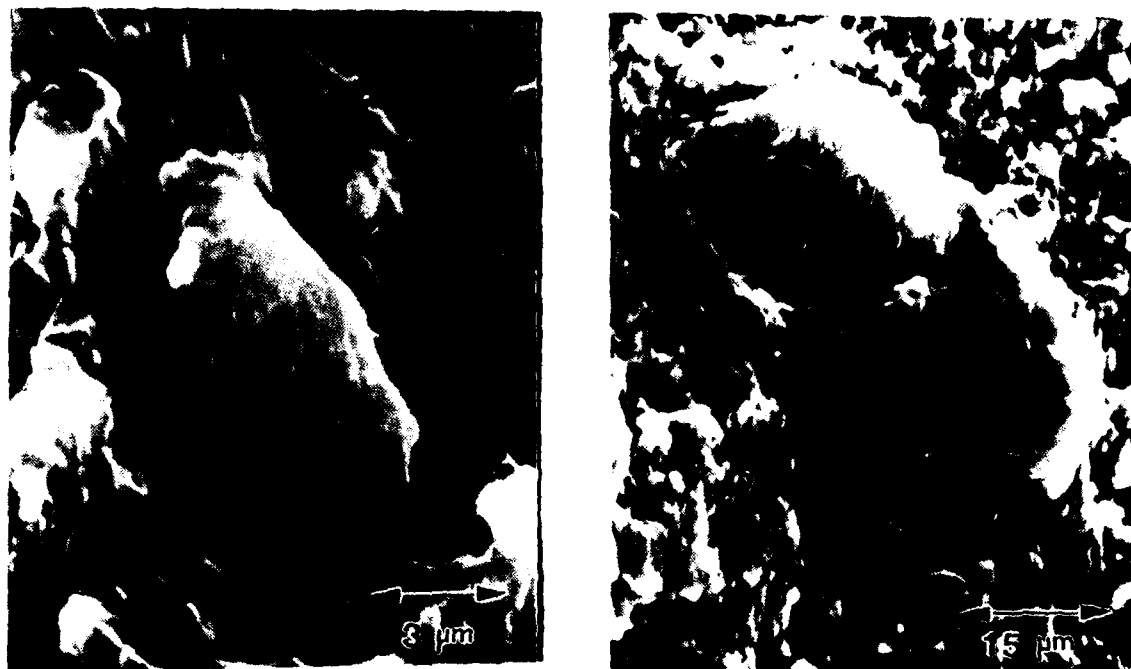
Figure 35. Fracture in 2124 Composite After 270°C Exposure and Corresponding X-ray Spectrum

It is interesting to compare the  $270^{\circ}\text{C}$  treated surface with the  $270^{\circ}\text{C}$  treated surface pictured in Figure 35. Scattered areas of localized heating were found across the surface. There are also the x-ray spectra differences. The heated areas in the  $270^{\circ}\text{C}$  material have much higher Cu content relative to the Al content than does a similar area

of T6 surface. These Cu-rich areas of apparent localized melting are a probable cause of the poor strength properties of the 270<sup>0</sup>C treated material.

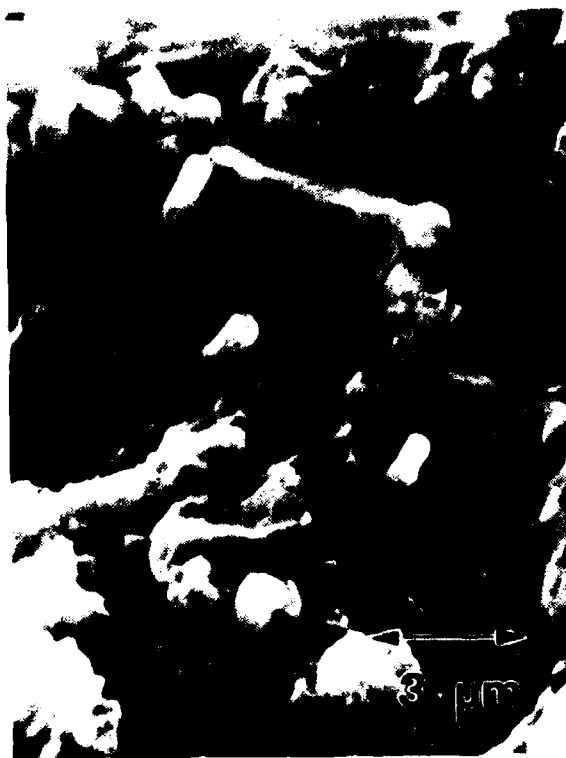
Figure 2. Fracture surface of a rolled 1100/20 v/o SiC<sub>w</sub> composite

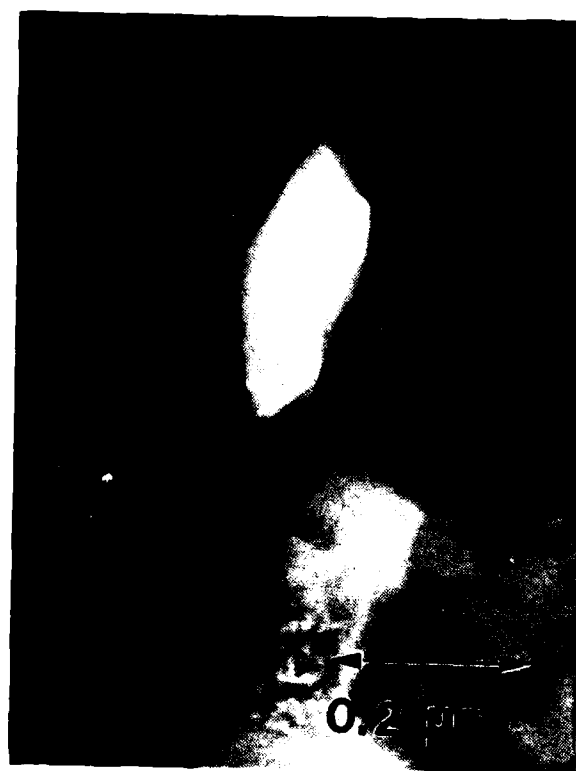
Figure 4. TEM of void at interface caused by rolling
