MTL TR 87-48

# FUSED SALT ELECTRODEPOSITED TiB<sub>2</sub> COATINGS ON HIGH-SPEED STEEL TWIST DRILLS

WILLIAM S. RICCI and JAMES L. WONG  
PROCESSING TECHNOLOGY DIVISION

September 1987

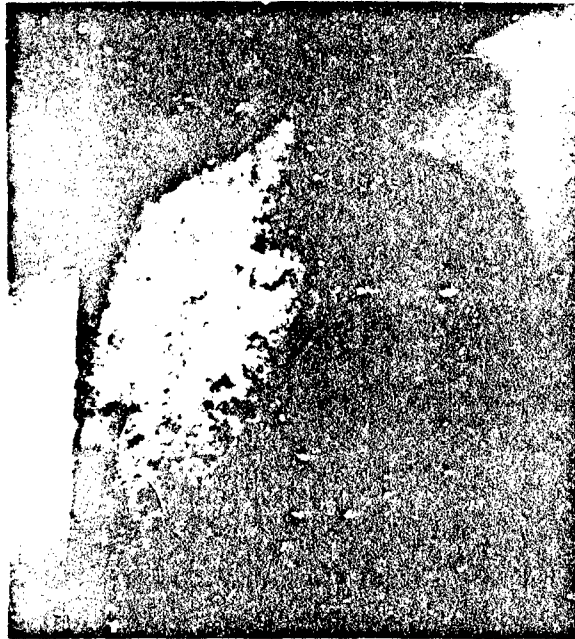
a. The 0.0005 inch  $\text{TiB}_2$  coating thickness, drill A

b. A typical 0.001 inch coating thickness, drill B

Figure 1. Photographs showing a higher concentration of surface discontinuities (Mag. 7.5).

Four heavy web, 0.25 inch diameter, M33 high speed steel twist drills with a crankshaft ground design and 135° point angles were coated with  $TiB_2$ . Principal coating parameters and resultant coating thicknesses are shown, as reported by HTC Industries, in Table 1. The adhesion and integrity of the 0.0005-inch-thick  $TiB_2$  coating was inferior to that of the 0.001-inch-thick coating as shown in Figure 1. This, however, could be the result of inadequate surface preparation prior to plating.

The total number of holes made with each tool when drilled to failure is shown in Table 2. Erosion of the coating at the chisel edge, land, and flute surfaces was noticed after the first hole was drilled with each tool. Land wear of failed tools, both coated and uncoated, was nearly identical (see Figure 3). However, wear in the flute near the lip of coated tools was not similar. Figure 4, which shows the flute wear patterns of drills that failed after 6 and 160 holes, documents the general trend that the extent of flute wear is a function of holes drilled or the total exposure time of the flute to chip flow. Figure 5 shows that coating irregularities, such as those previously shown in Figure 1, were not found to significantly affect flute wear.

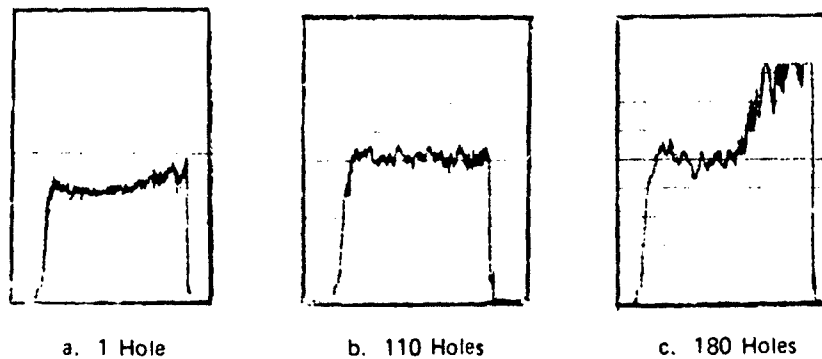
Figure 2. Cutting force traces for drill A after 1, 110, and 180 holes were drilled (Scale: 50 lb/div).

Cutting force and torque about the spindle axis were monitored by a dynamometer during all experiments. Drills were considered to have failed or to have been significantly worn when the thrust force of the drill into the workpiece, required to maintain a constant feed rate, doubled its initial value to ~ 400 lbf, Figure 2.

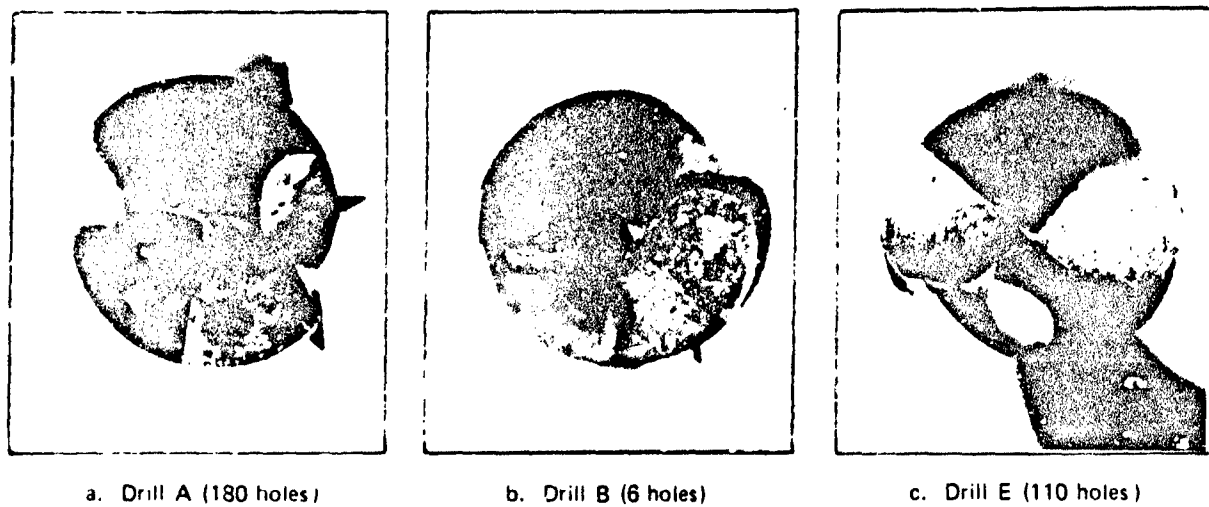
Figure 3. End view of drills showing land wear (Mag. 7X).

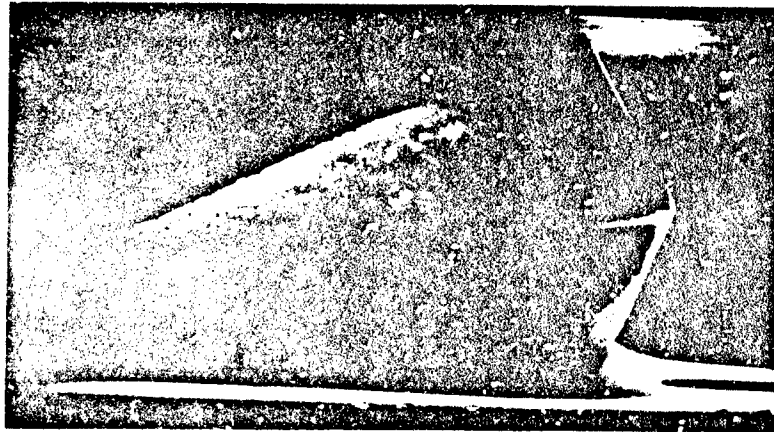
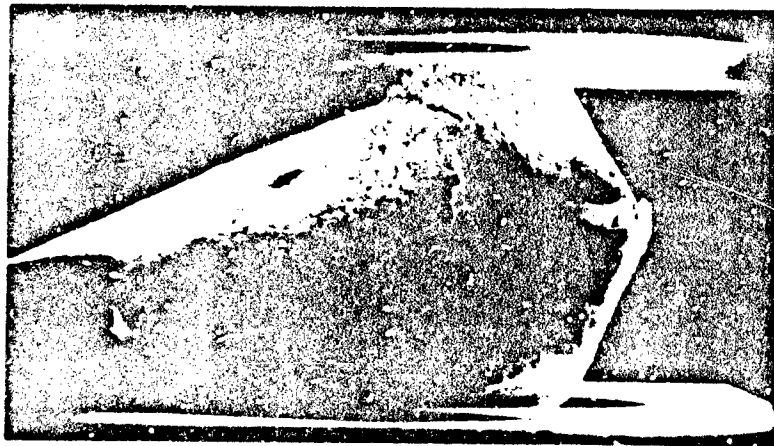
a. Drill B

b. Drill D

Figure 4. Flute wear patterns shown by scanning electron micrography (Mag. 10X).

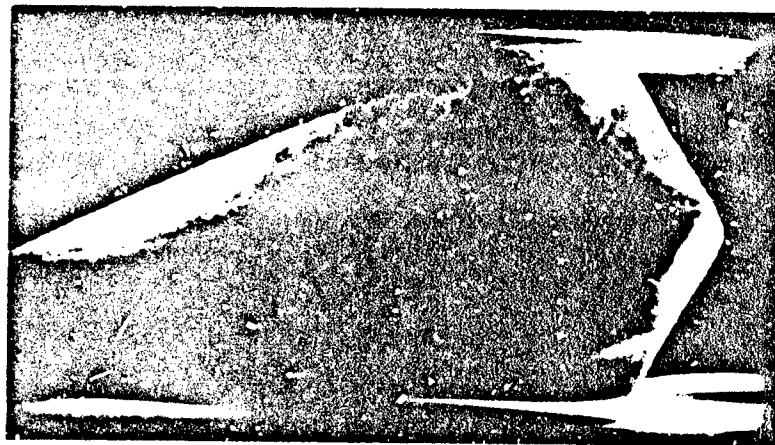
Figure 5. Flute wear pattern of drill A after tool failure, SEM (Mag. 10X).

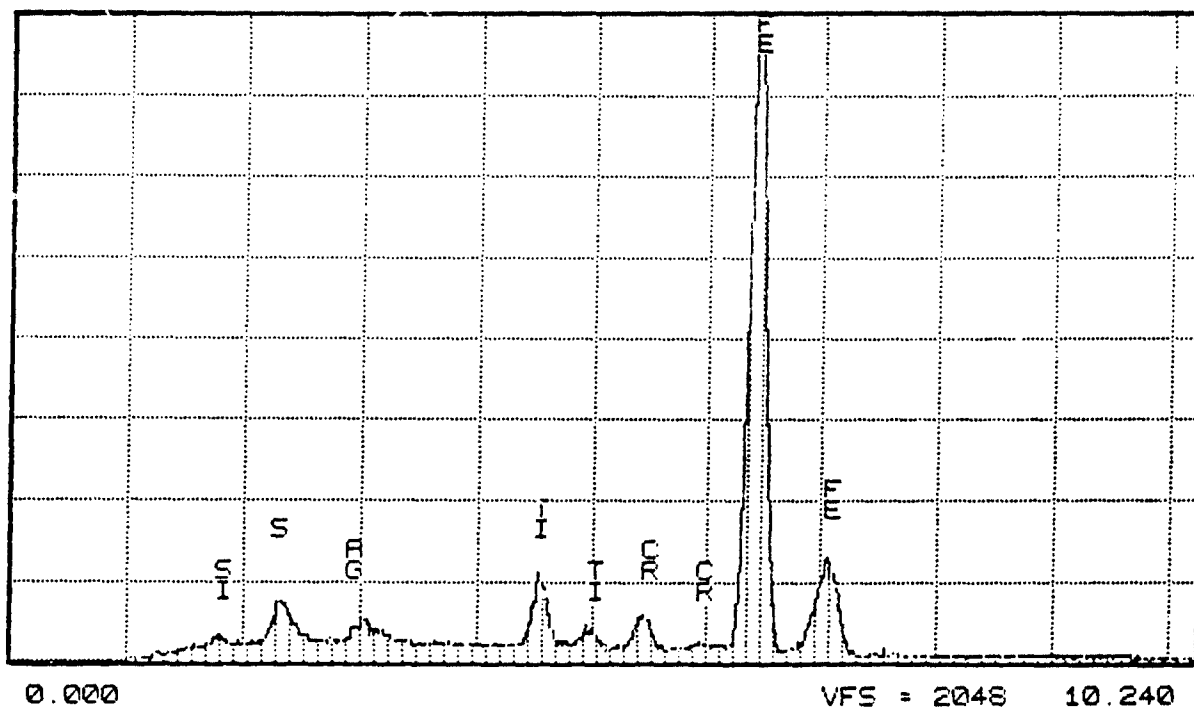
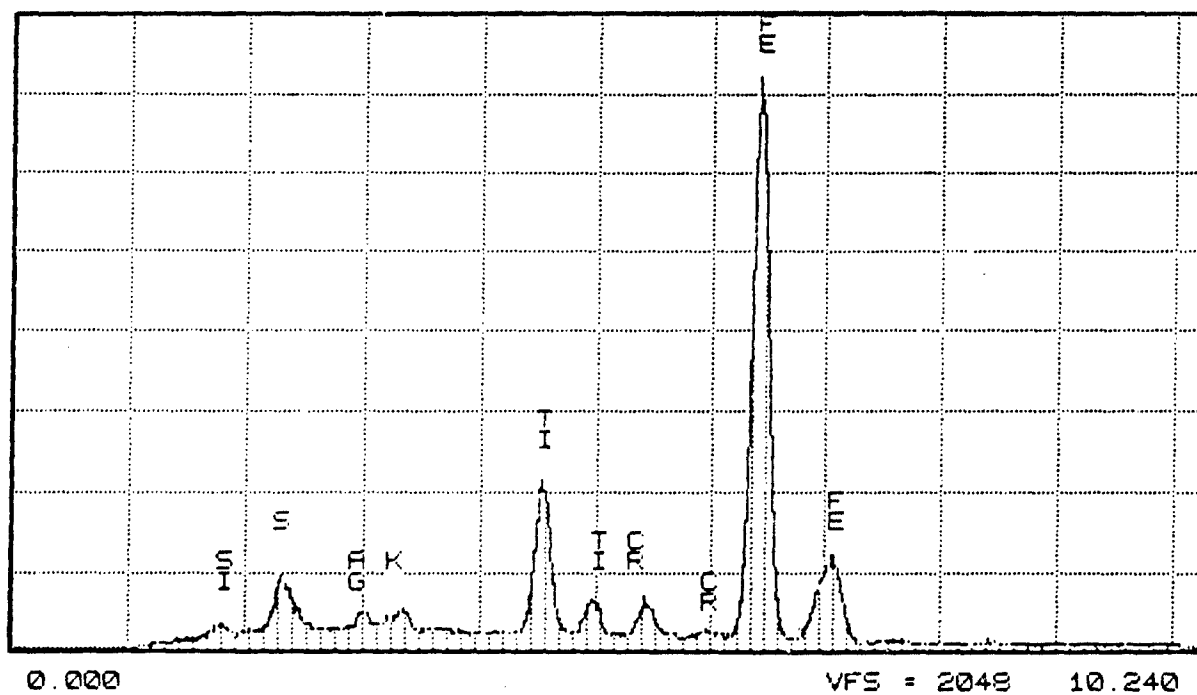
Figure 6. Qualitative element identification in the flute wear zone.

Residual traces of the coating were found in the flute wear zone. Figures 6 and 7 show qualitative element identifications for drills A and B after tool failure in the flute wear zone in the flute, but 1.5 inches from the chisel edge, respectively.

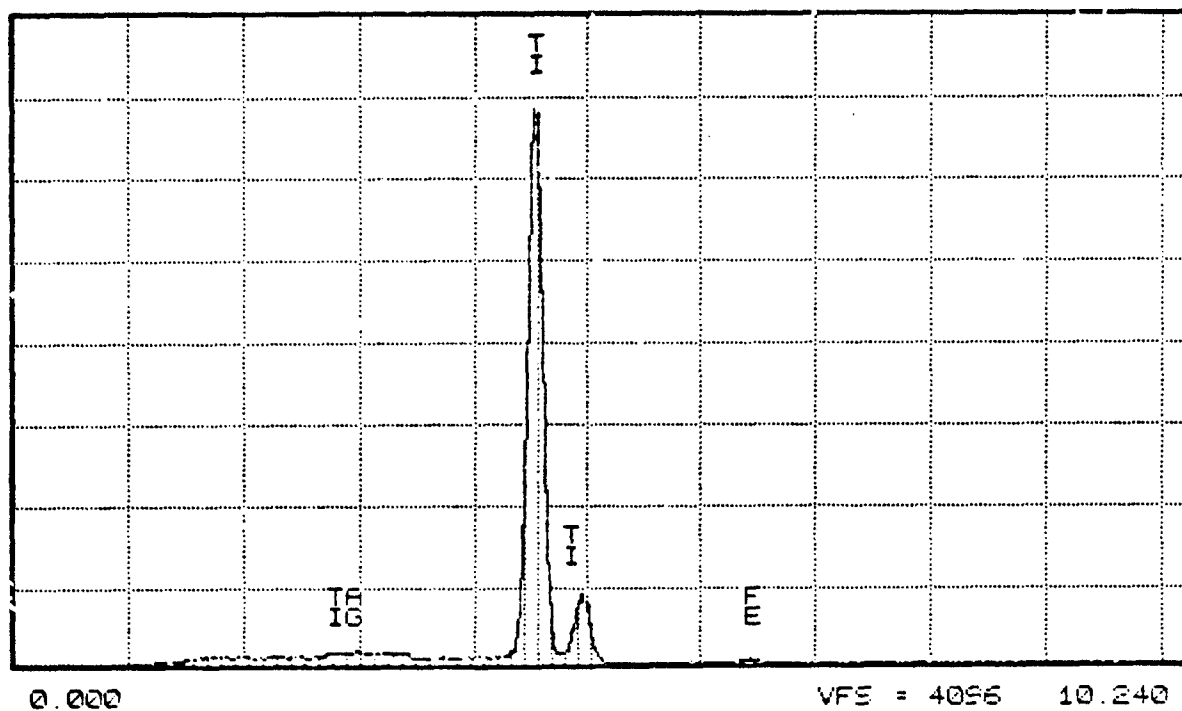
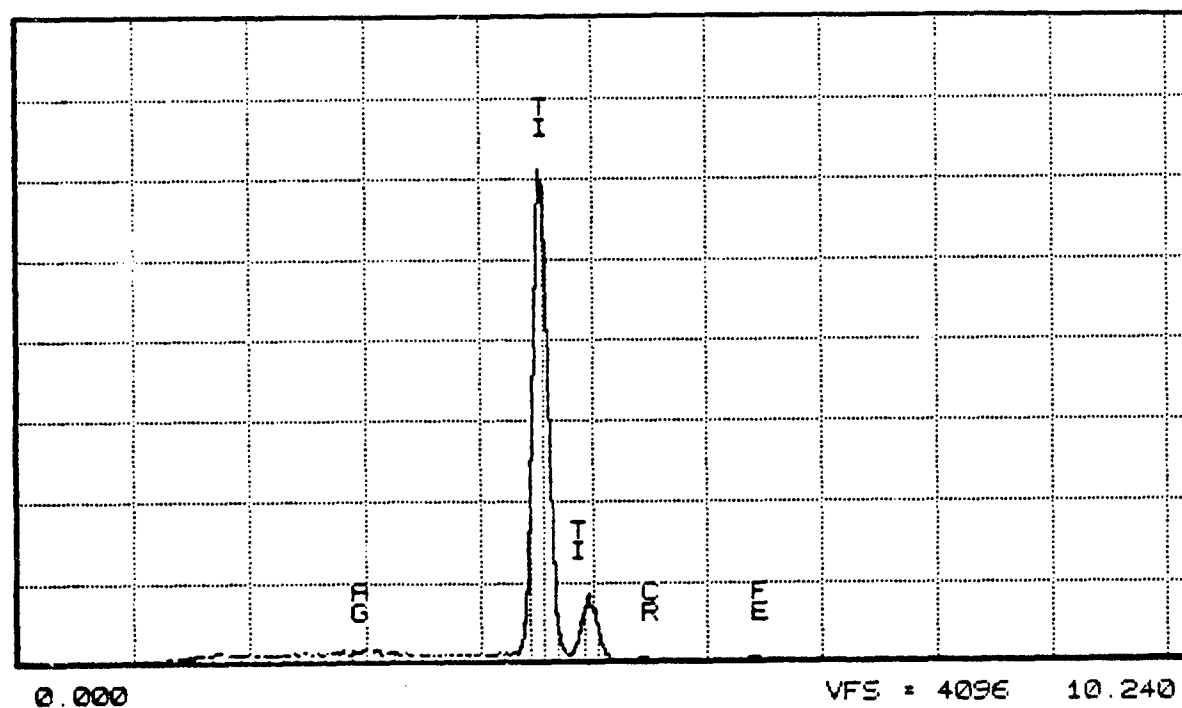
Figure 7. Qualitative element identification in the unaffected flute area.

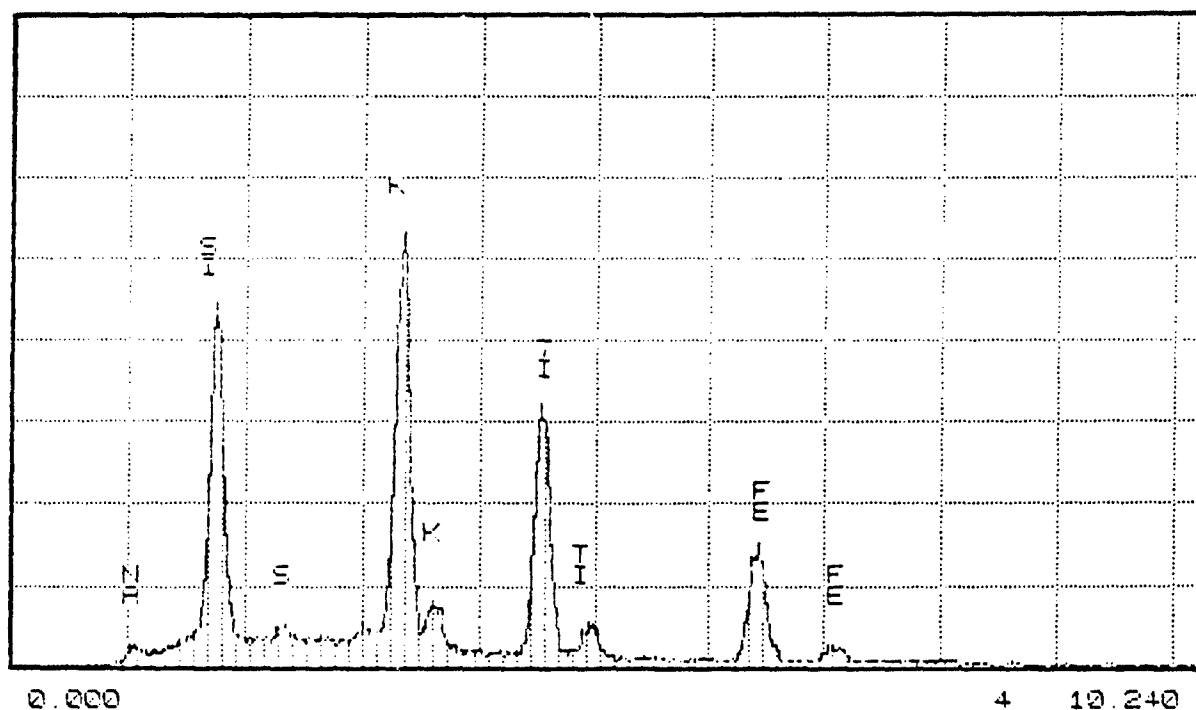
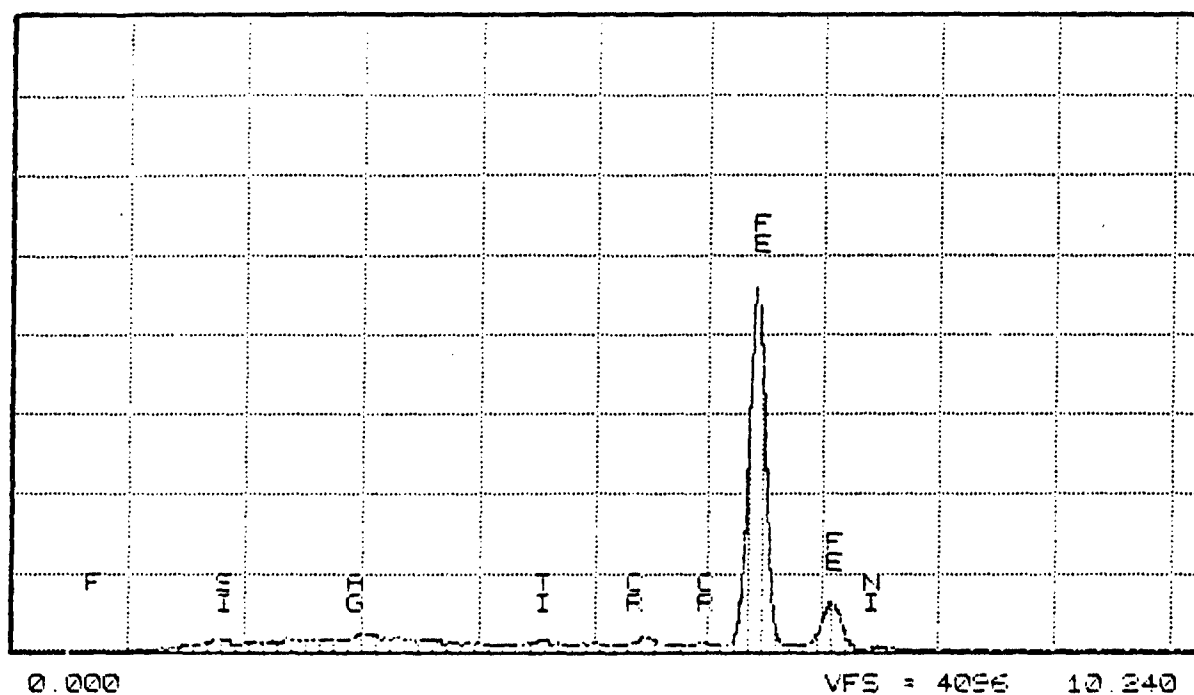
a. 1.5 Inches from chisel point

b. The flute wear zone

Figure 8. Qualitative element identification for drill D.

Figure 8 shows a similar trace for drill D and the presence of K, Na, and Si can be seen in the unaffected coating. Since the electrolyte employed is nominally the eutectic of lithium-, sodium-, and potassium-fluorides, the presence of K and Na is expected. The source of Si cannot be explained. In addition, from the relative Ti/Fe line intensity ratios it appears that in this section the TiB<sub>2</sub> coating is thinner.

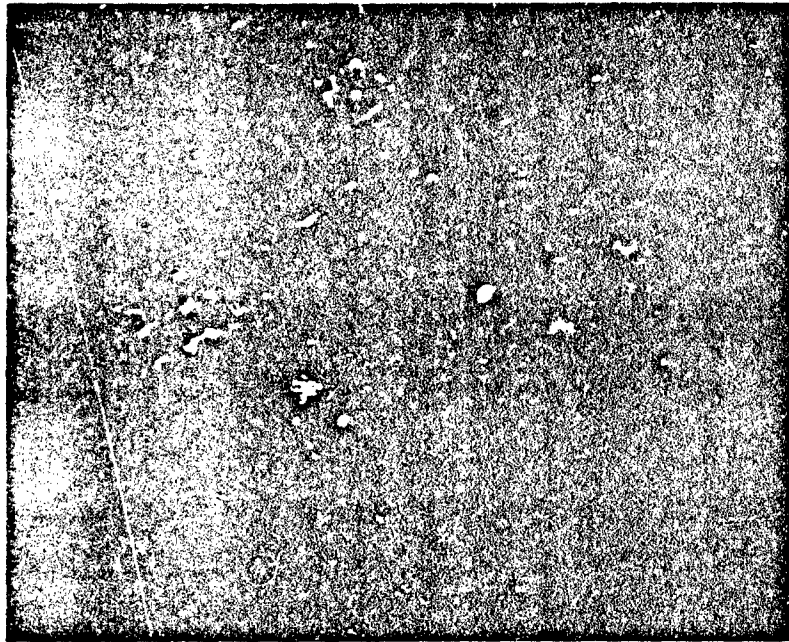
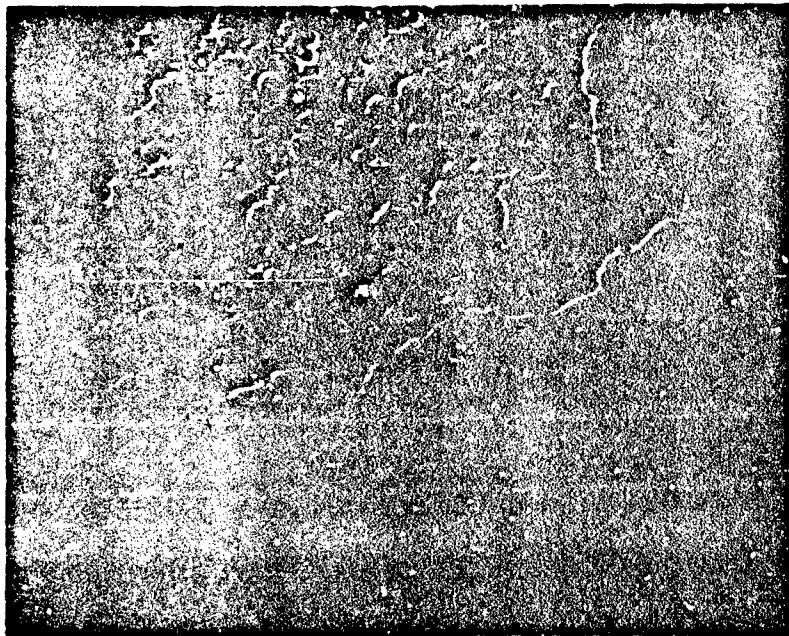
a. Away from the cutting edge of drill A

b. Close to the cutting edge of drill A

Figure 9. SEM photographs (Mag. 1000X).

Figures 9 through 12 show SEM photographs of the coatings for drills A through D, respectively. For drills A through C, coating roughness and electrodeposited particle size increased with increasing current density. The overall smoother morphology of the deposited particles and overall adherence of the coating on drill D appears to be superior to that of the others, possibly due to different salt and coating chemistries. High points of deposited particles or asperities in the coating appear to have fractured preferentially, as can be seen in samples taken progressively closer to the cutting edge.

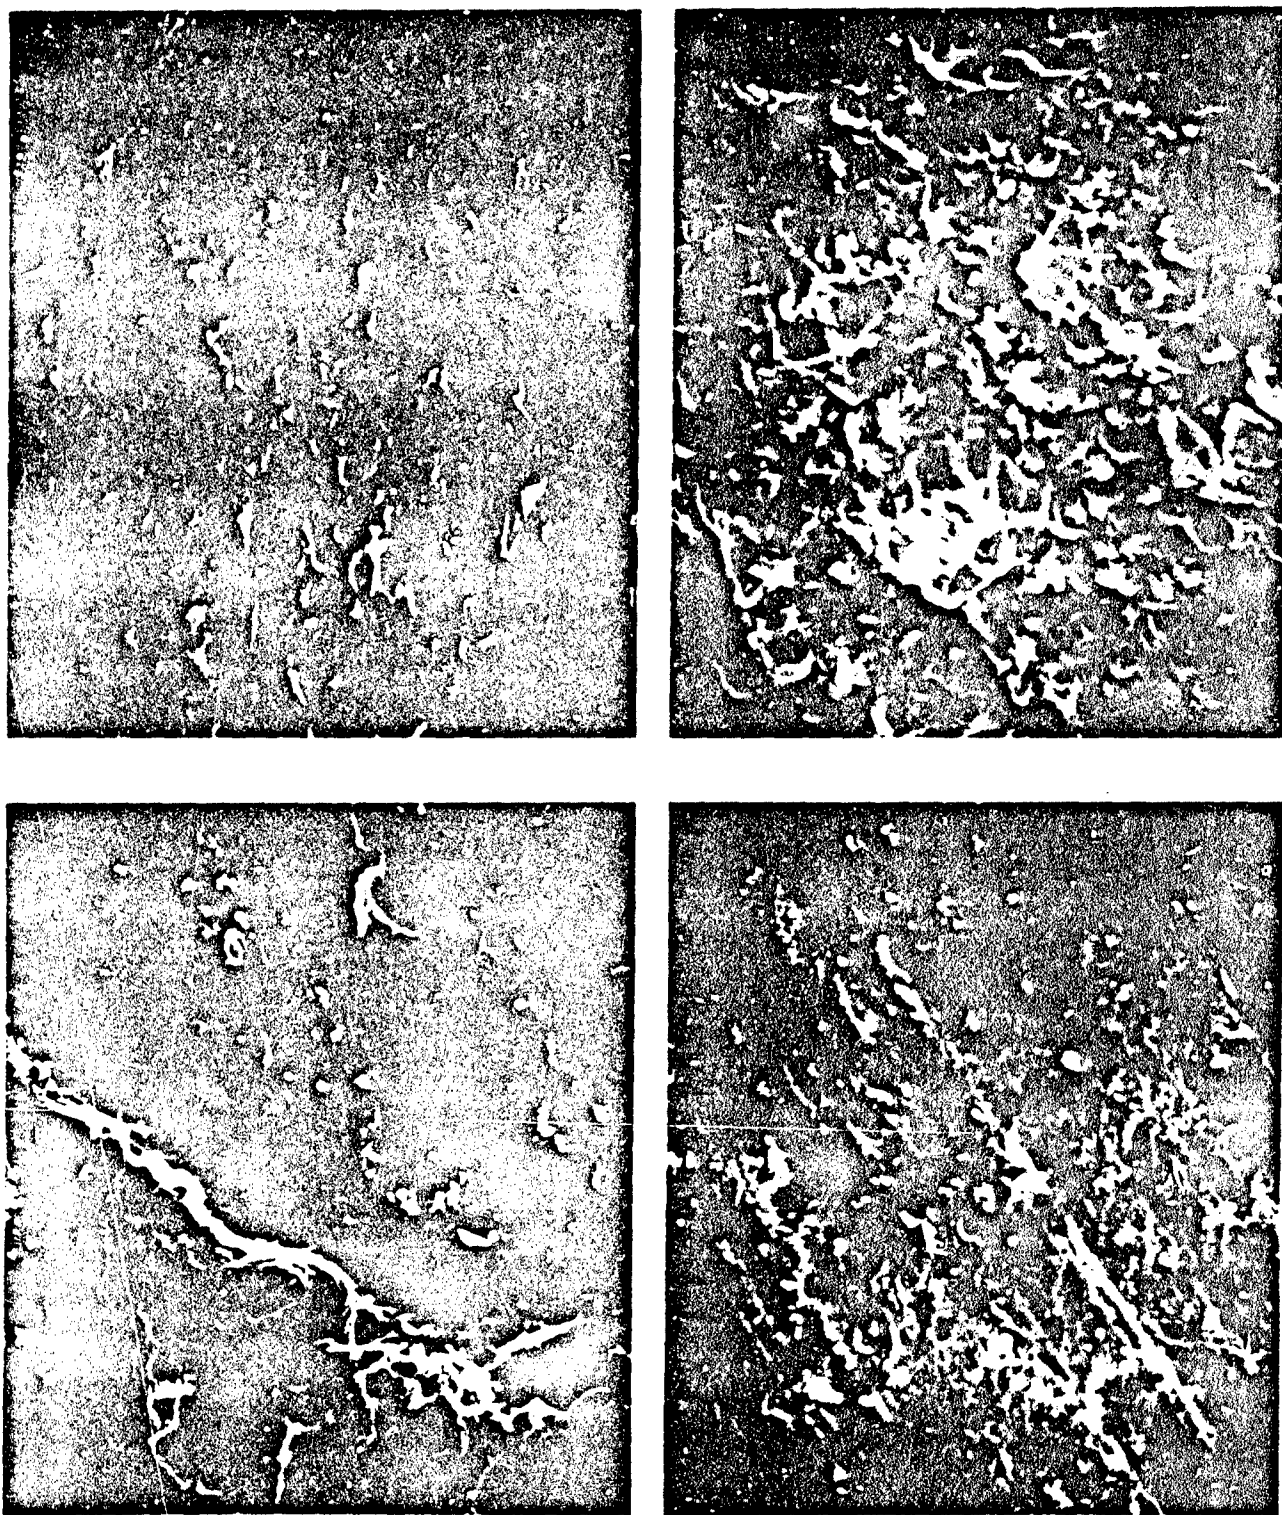
Figure 10. SEM photographs of the TiB<sub>2</sub> coating taken progressively closer to the cutting edge of drill B (Mag. 1U00X).

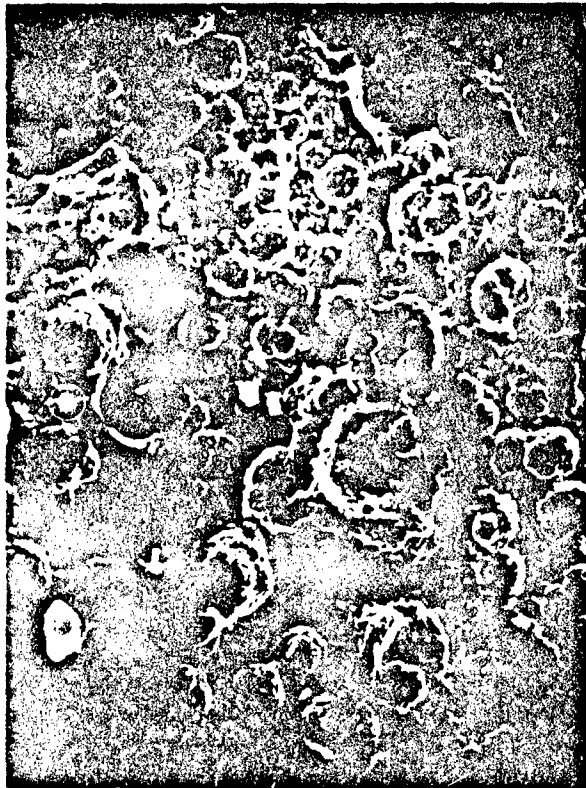
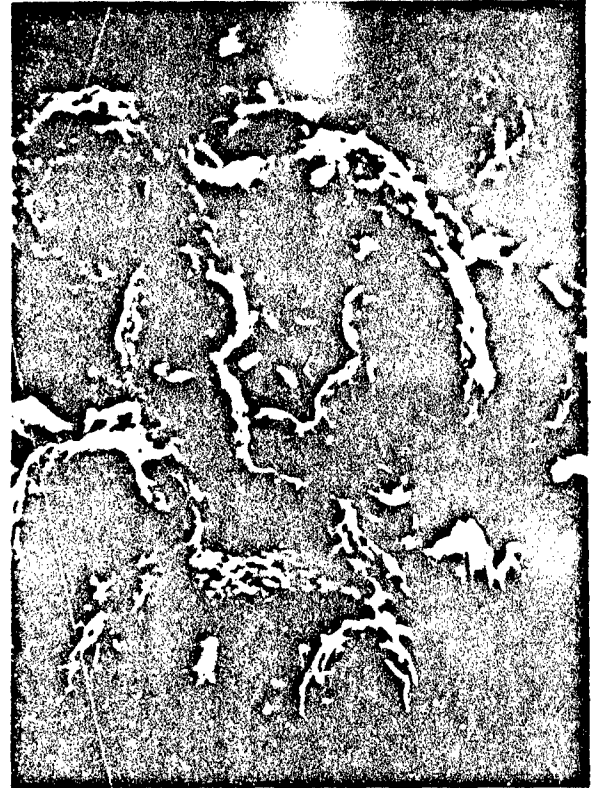
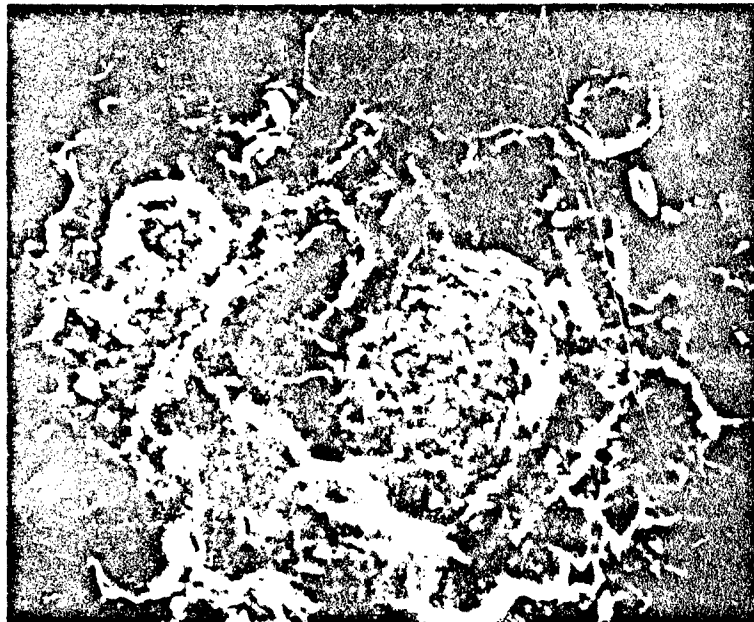
c. An area closer to the cutting edge where asperities of the coating have fractured on drill C (Mag. 1000X)

Figure 11. SEM photographs of the unaffected coating.

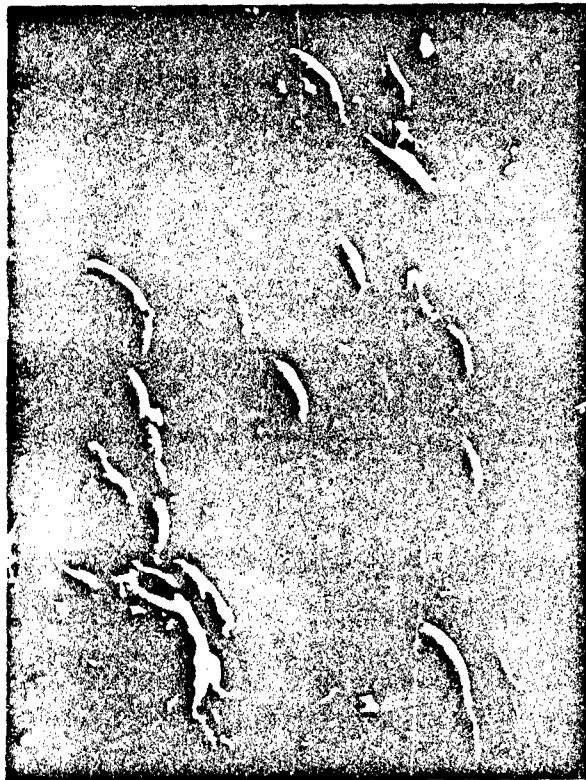
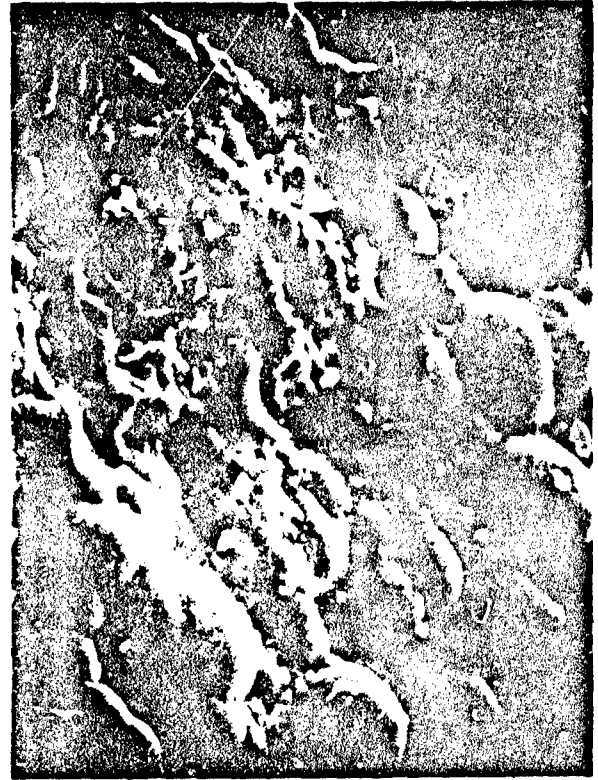
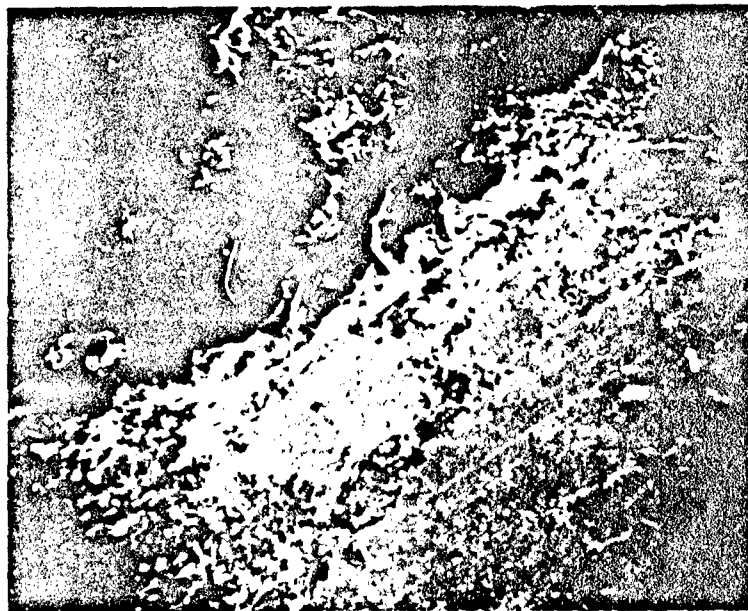
Figure 12. SEM photographs of the coating of drill D progressing towards the cut edge (Mag. 1000X).

The lower inclination angle of deposited particles on drill D contributed to the superior performance of this drill. Low inclination angles not only indicate good adherence but also reduced stress concentrations, which act as initiation sites for coating failure.
