AST-1150R-100-87

6 February 1987

FEASIBILITY REPORT: OPERATION OF LIGHT AIR CUSHION VEHICLE  
AT MCMURDO SOUND, ANTARCTICA  
BY J. STEPHEN DIBBERN

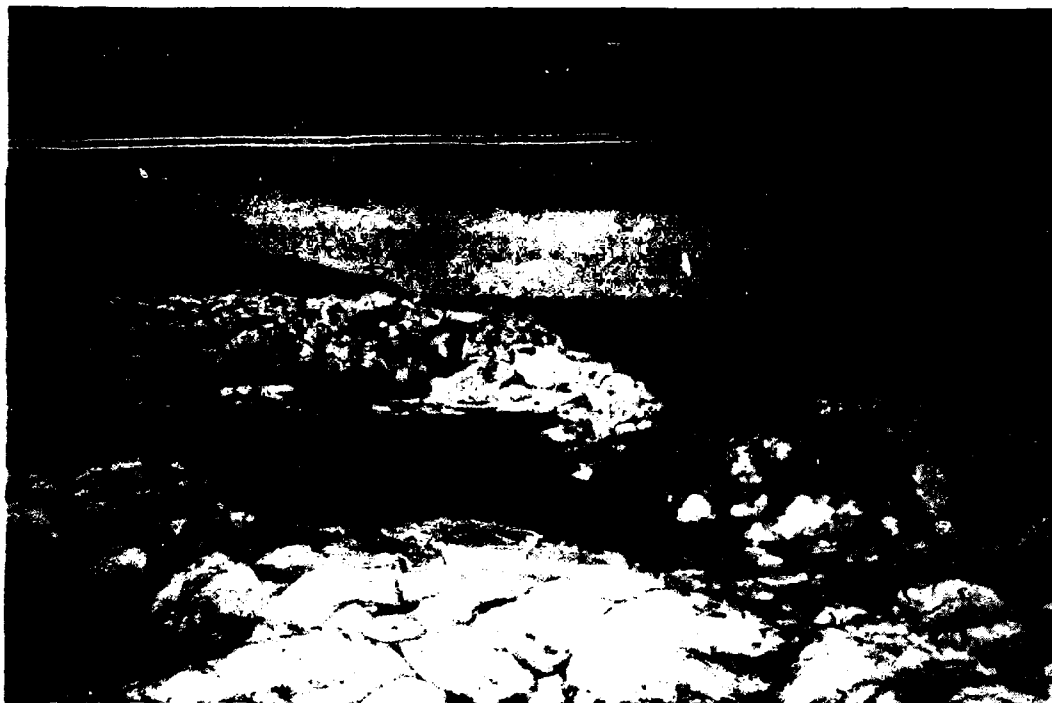
Figure 7. Waters Edge at Cape Bird. Weddell seal  
is approximately 7 feet long.
