# Decontamination of fast reactor hulls and properties of immobilised waste forms

P Biddle, P E Brown and J H Rees

Chemistry Division  
Harwell Laboratory, Oxfordshire OX11 0RA

October 1986

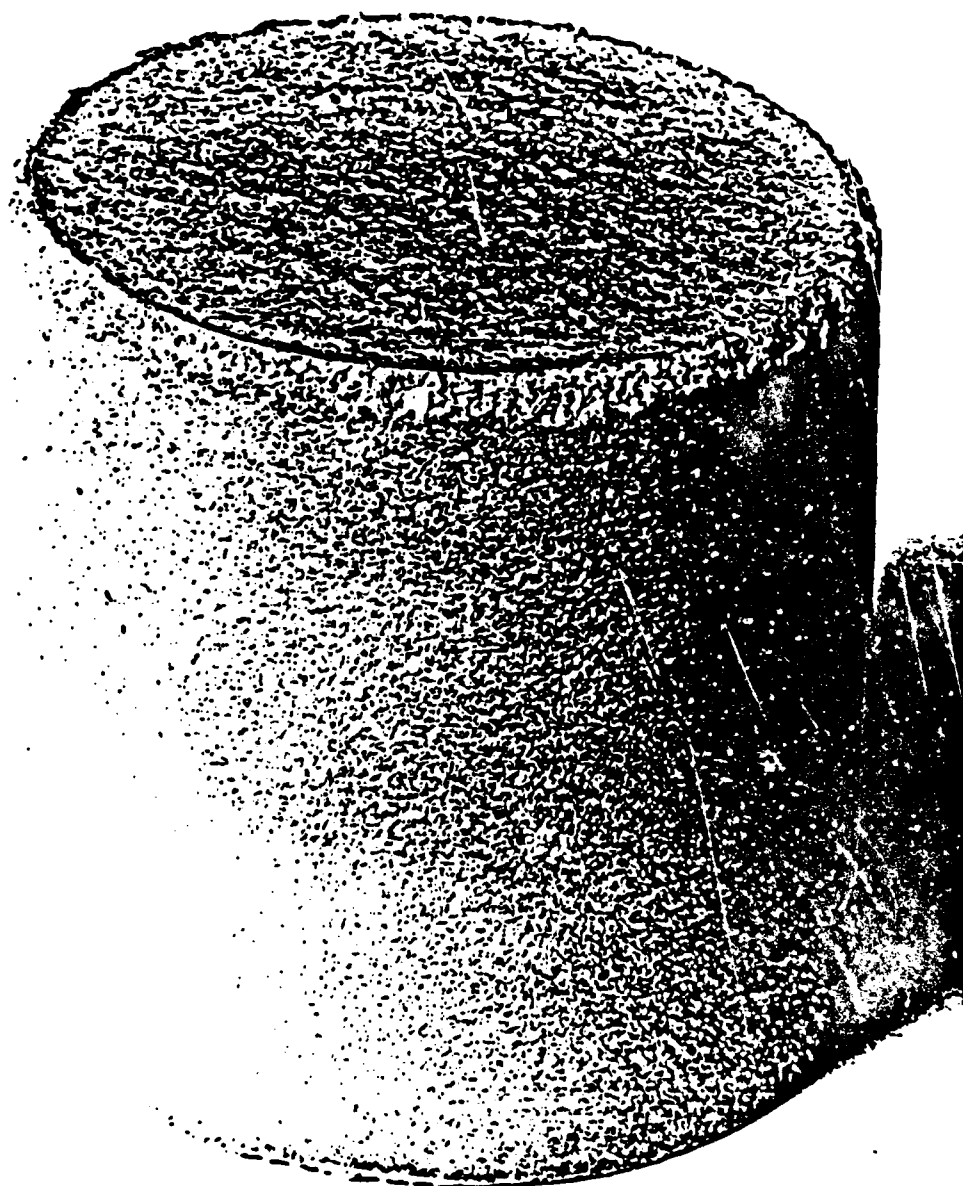
Fig. 6  
Stainless steel hulls incorporated in sand/OPC/water

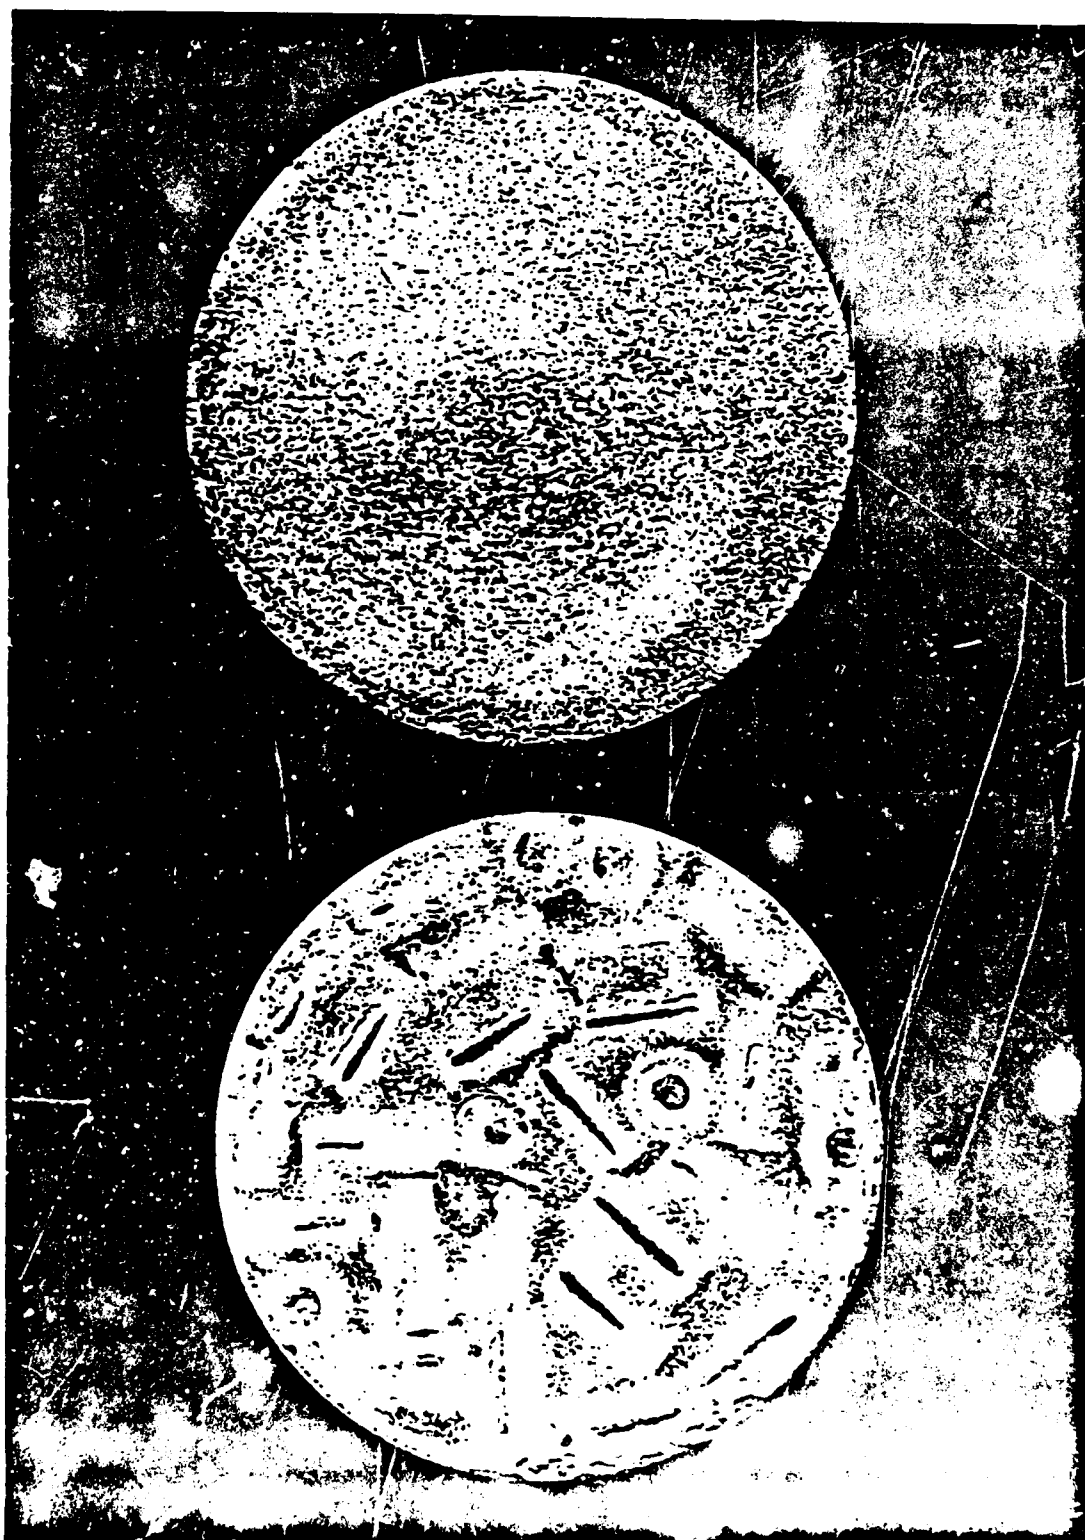
Fig. 18  
Stainless steel hulls immobilized in  
top sand OPC bottom BFS OPC
