AFWAL-TR-88-3008

**AUTOMATED EARLY  
FATIGUE DAMAGE  
SENSING SYSTEM**

Grumman Aerospace Corporation  
Bethpage NY 11714-3582

May 1988

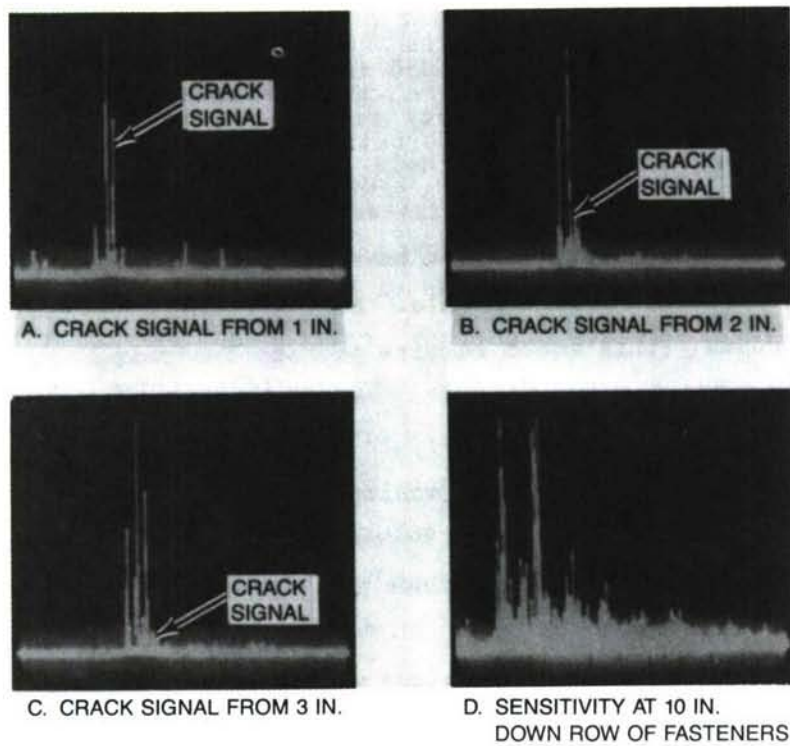
Fig. 2 Ultrasonic System Sensitivity

An ultrasonic array was coupled to a specimen using glycerine. It was manually manipulated to pick up an echo from a 0.050-in. crack propagating from the first hole in the specimen. At a distance of 1 in. from the edge of the hole, the array readily produced a 50% screen height (see Fig. 2A). Range select was set at 5 in. with no damping or reject in use. As the array was pulled back from the cracked hole, the signal accordingly diminished in screen height and shifted to the right, along the baseline. However, the signal from the hole did not drop as fast as that of the crack. As the distance to the array increased, the signal to crack signal ratio changed; maintaining that the screen height for the crack caused the hole baseline signal to rise above it (see Fig. 2B). At about 3 in., the array-to-hole crack signal became lost in the noise of the baseline (see Fig. 2C).

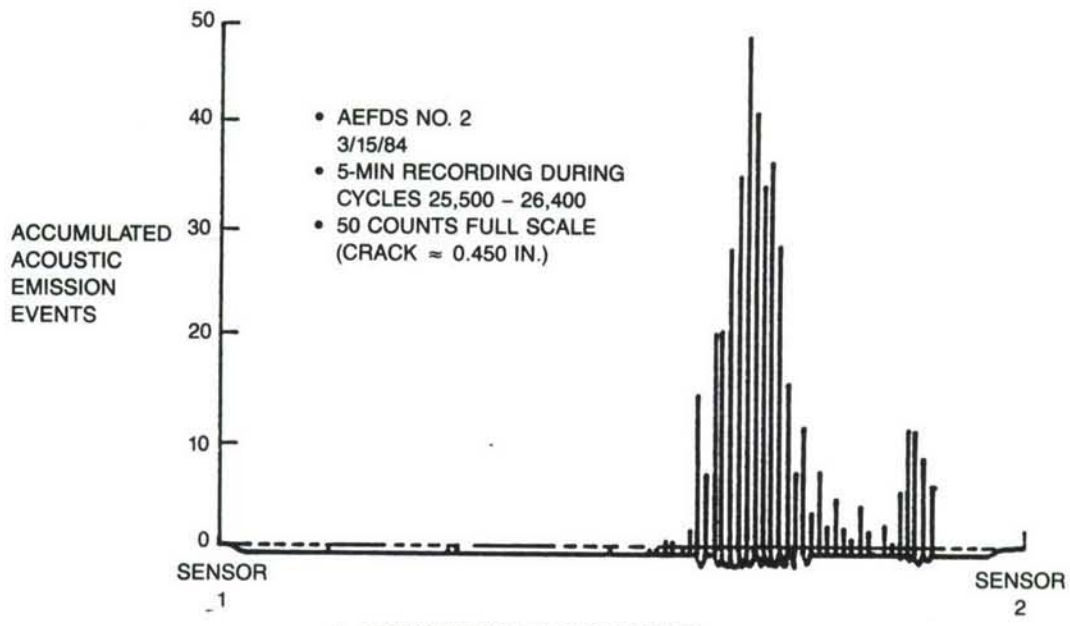
Fig. 5 Acoustic Emission Vs Electro-Optics: 0.450 In.-long Crack

A. ACOUSTIC EMISSION LOCATION

B. NONCUMULATIVE ELECTRO-OPTICAL LOCATION:  
FIRST ARRIVAL

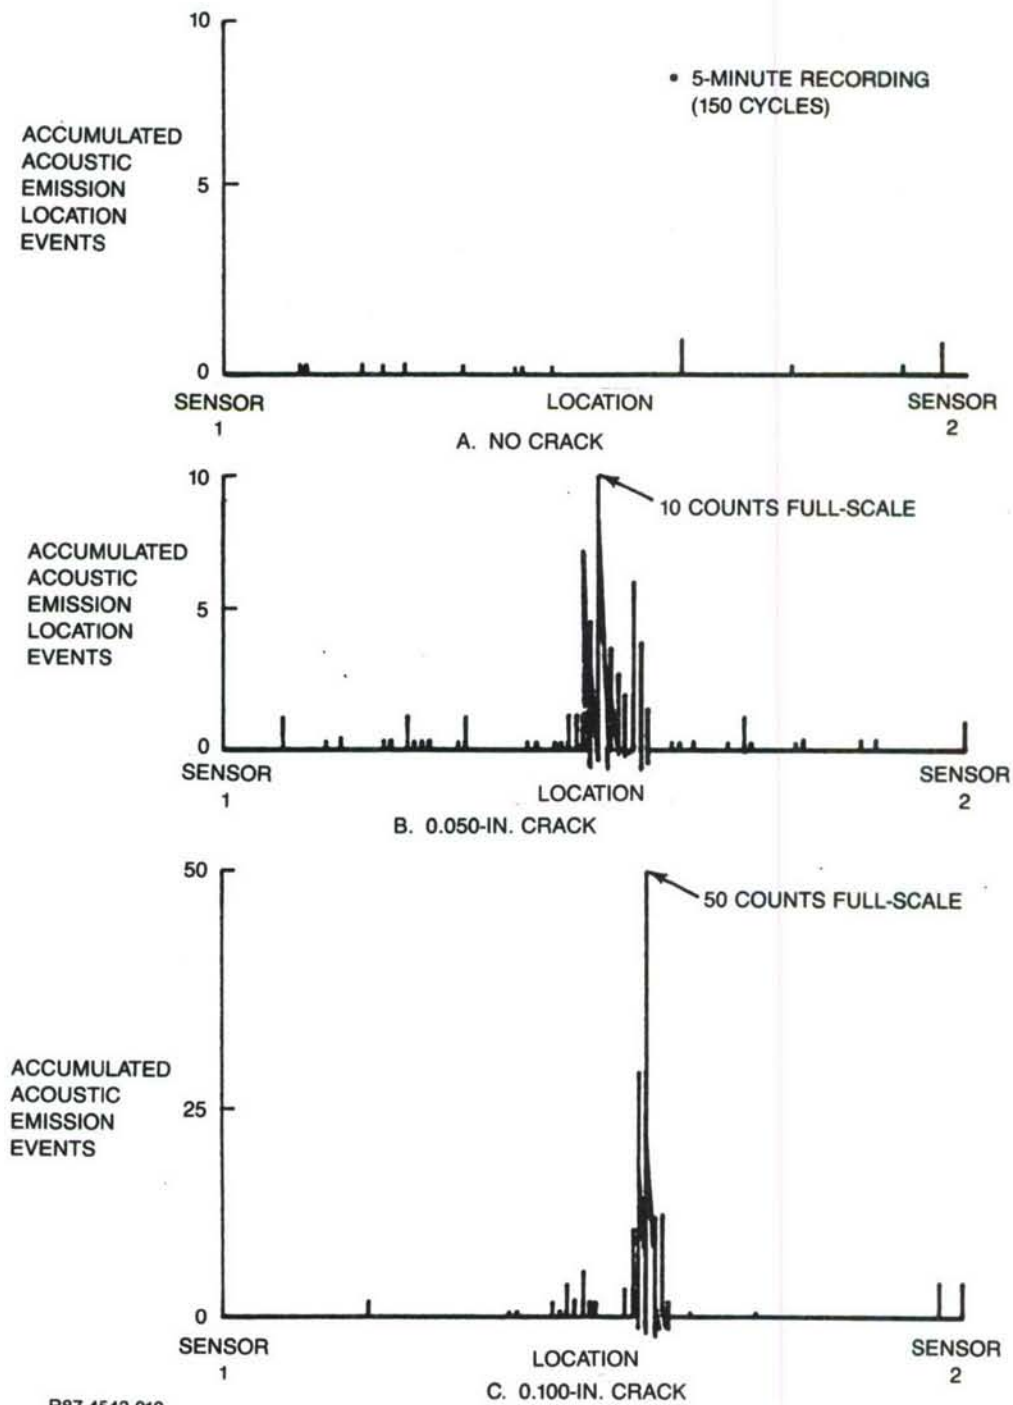
Fig. 9 Typical Acoustic Emission Data for Aluminum

A total of 12 simple dog-bone specimens were tested. Typical data for aluminum Specimens 3, 4, and 5 are shown in Fig. 9, for steel Specimens 7, 8, and 9 in Fig. 10 and for titanium Specimens 10, 11, and 12 in Fig. 11. The noise-free displays shown are indicative of the many recordings taken periodically until AE location events appeared on the screen.

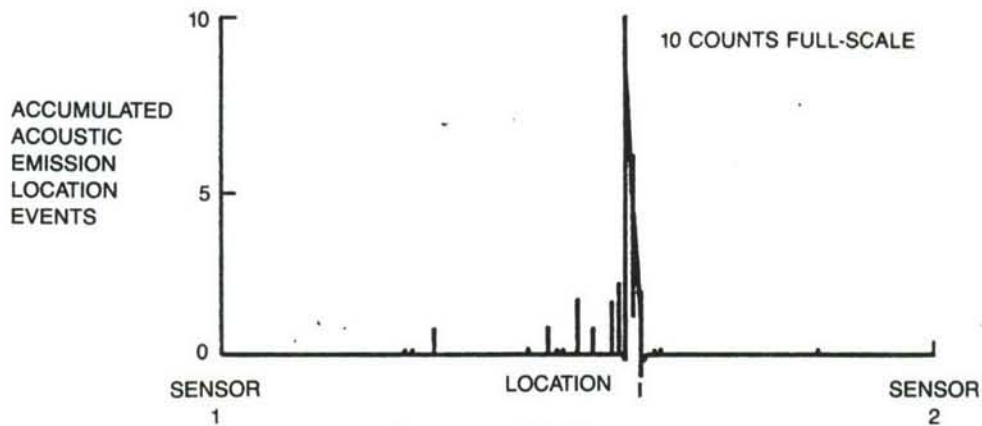
Fig. 10 Typical Acoustic Emission Data for Steel

A. NO CRACK

B. 0.050-IN. CRACK

C. 0.100-IN. CRACK

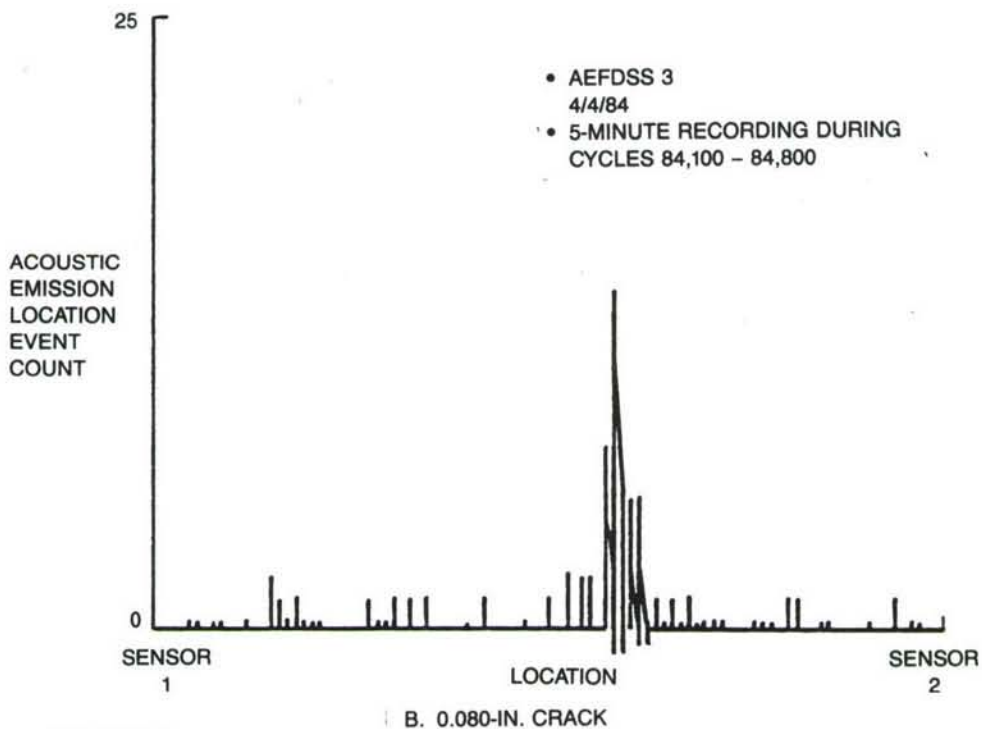
Fig. 12 Data for Specimen 3

Specimen 3 was tested at a load level of 27.5 ksi and cycled at a cycle rate of 2.5 cycles/sec. AE location events started to appear rapidly during the 5-min recording from cycles 84,100 to 84,800 as shown in Fig. 12. The test was stopped and inspection revealed a 0.080-in. crack at the hole site. The test was continued to demonstrate the effectiveness of the AE monitoring system in

detecting larger cracks. AE location events increased rapidly until cycle 88,000, when the test was stopped. The crack was inspected again and measured 0.250 in.

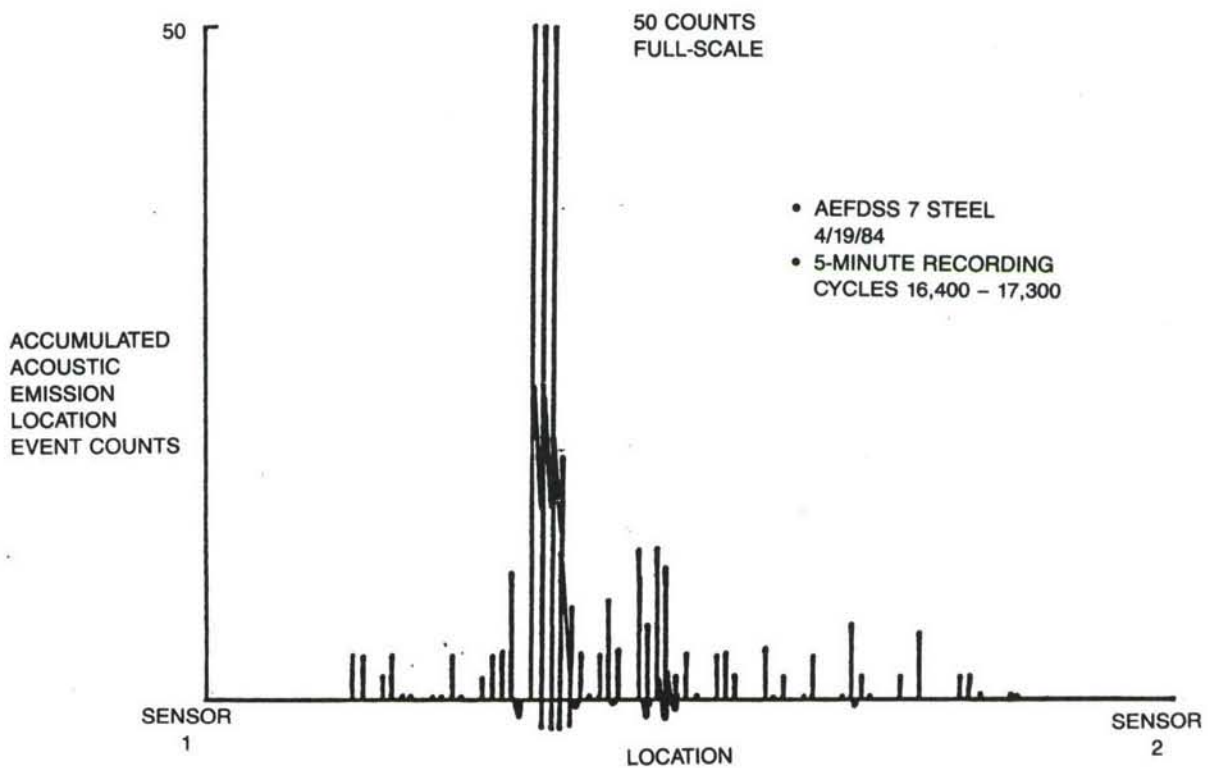
Fig. 16 Data for Specimen 7: Signal Increase

with eddy current techniques revealed no crack indications. An increase in AE activity is shown during cycles 14,800 to 15,700. The AE locations shown in Fig. 14 show an increase in AE activity with scattered locations. An inspection revealed two cracks in the hole measuring 0.080 in. and 0.040 in. Multiple cracking within the area is the cause for the scattered locations shown. Figure 16 shows the definitive location of the two cracks during cycles 16,400 to 17,300. Many AE signals are accumulating at the location to the left while a few signals are still accumulating in the original location to the right. The crack on the left grew from 0.040 in. to 0.090 in. (0.050-in. growth) while the crack on the right grew only 0.020 in.

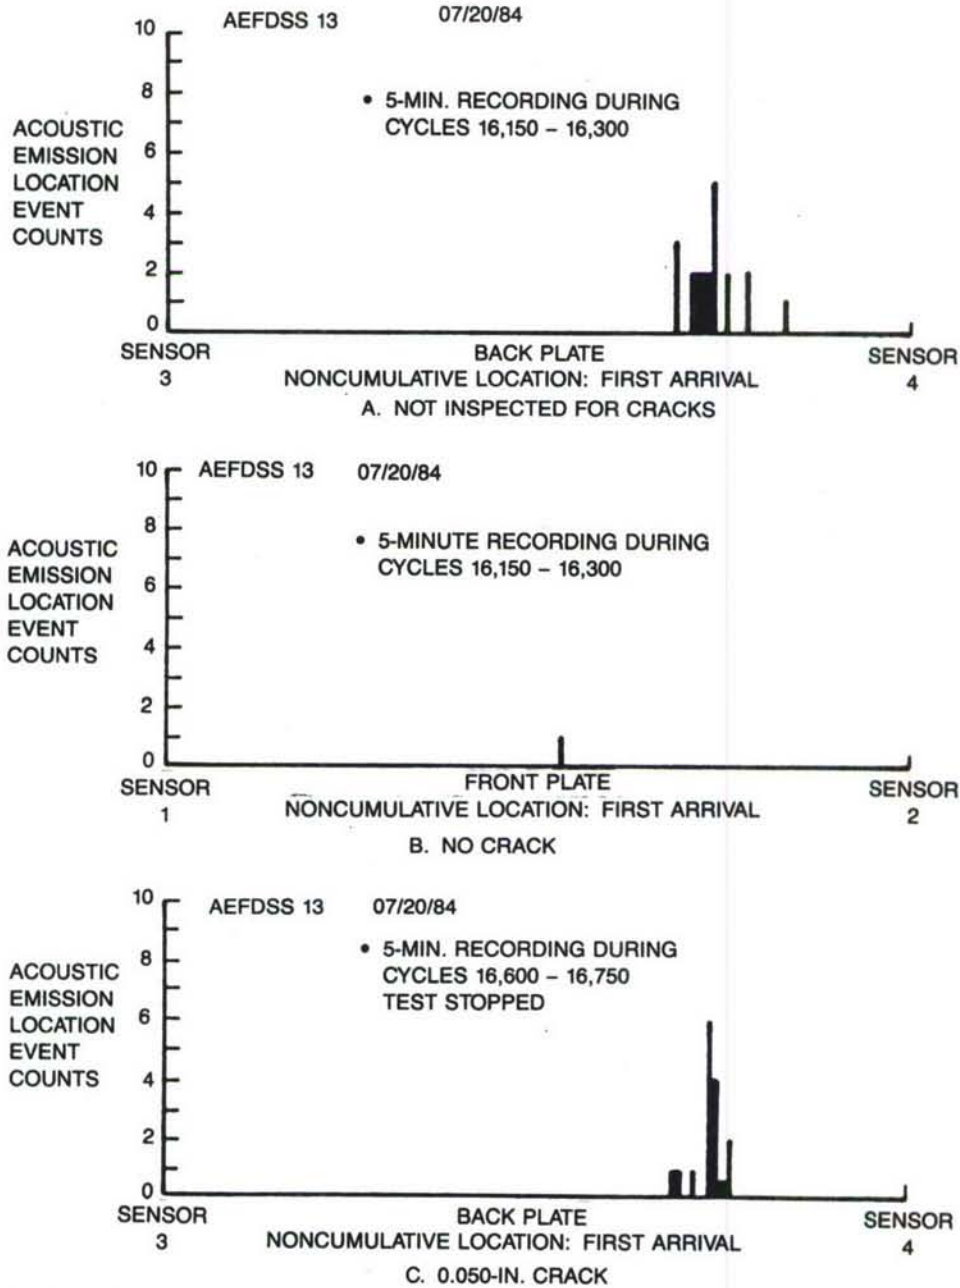
Fig. 21 Data for Specimen 13

The configuration was designed to simulate typical airframe construction, and the specimens were constructed out of aluminum to minimize construction costs. Data for Specimens 13 through 17 are shown in Fig. 21 through 27.

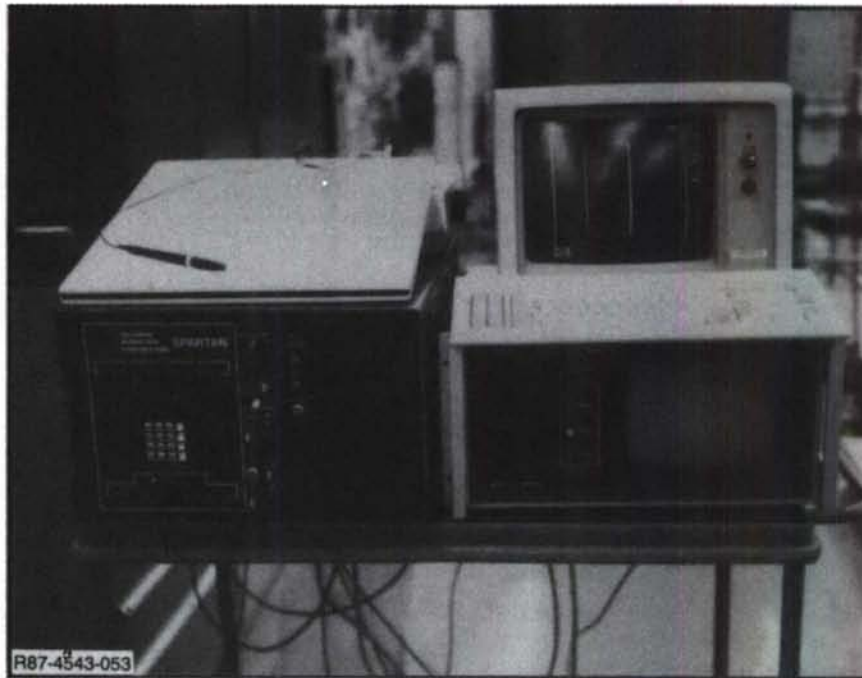
Fig. 35 Fully Configured System Showing Digitizer and Data Acquisition, Computer Display, and Keyboard

A series of final demonstration tests were conducted using the fully configured system (see Fig. 35 and 36). The decision to conduct dedicated testing on specially designed test specimens was based on the non-availability of ongoing structural tests and the need for precise correlations. The dedicated test permitted cycle interruptions immediately following first event detection, which enabled initial crack size measurements. The dedicated test also per-
