USAFOEHL REPORT

**Evaluation of Polyurethane Resins Used for  
Rapid Runway Repair Operations,  
Tyndall AFB FL**

**April 1988**

**Final Report**

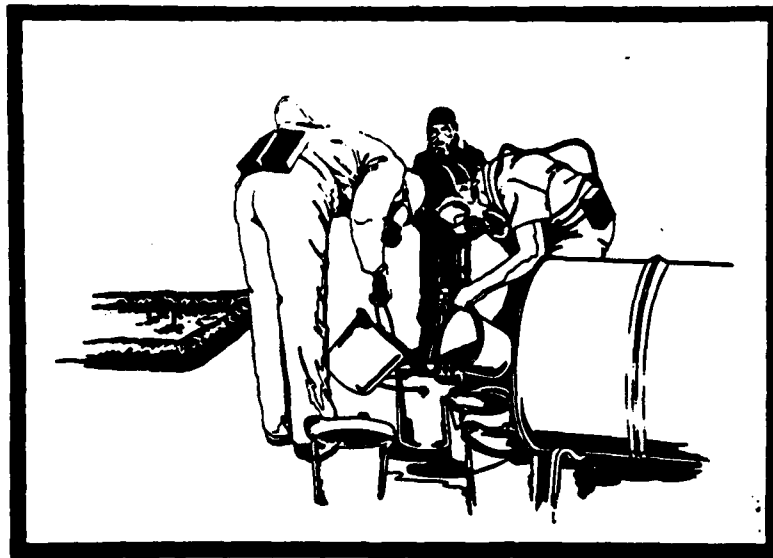
**Figure 1. Mixing Operation. Equal volumes of component A and component B of each resin were mixed in a bucket.**

Equal volumes of component A and component B of each resin were mixed in a bucket (Figure 1). Each mixture was thoroughly mixed for approximately 30 seconds then poured into a spall (or crater) filled with aggregate (Figure 2). If properly catalyzed, the mixture hardens in one or two minutes (Figure 3). The test consisted of filling approximately twenty spalls with each resin during indoor and outdoor tests. The training session lasted approximately 40 minutes. Indoor and outdoor personal and area air samples of chlorinated hydrocarbons, methylene bisphenyl isocyanate (MDI), and aromatic hydrocarbons were collected. Refer to Table 1 for sampling protocol.
