MTL TR 88-20

# FLAME CUTTING TEXTURED STEEL ARMOR

June 1988

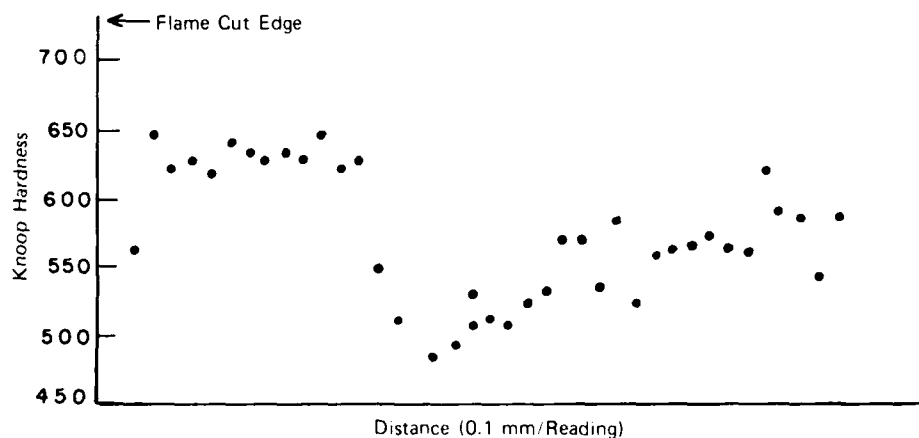
The cutting parameters used produced high quality cuts with square kerf edges and minimum dross and serration depth. Results from a hardness traverse across a flame cut edge in a plate cut without preheat are shown in Figure 1.

Figure 1. Hardness traverse across a flame cut edge in a plate cut without preheat.
