AEFA Project No. 84-16

## AH-1F INSTRUMENT METEOROLOGICAL CONDITIONS (IMC) FLIGHT EVALUATIONS

February 1988  
Final Report

AVIATION ENGINEERING FLIGHT ACTIVITY  
Edwards Air Force Base, California 93523-5000

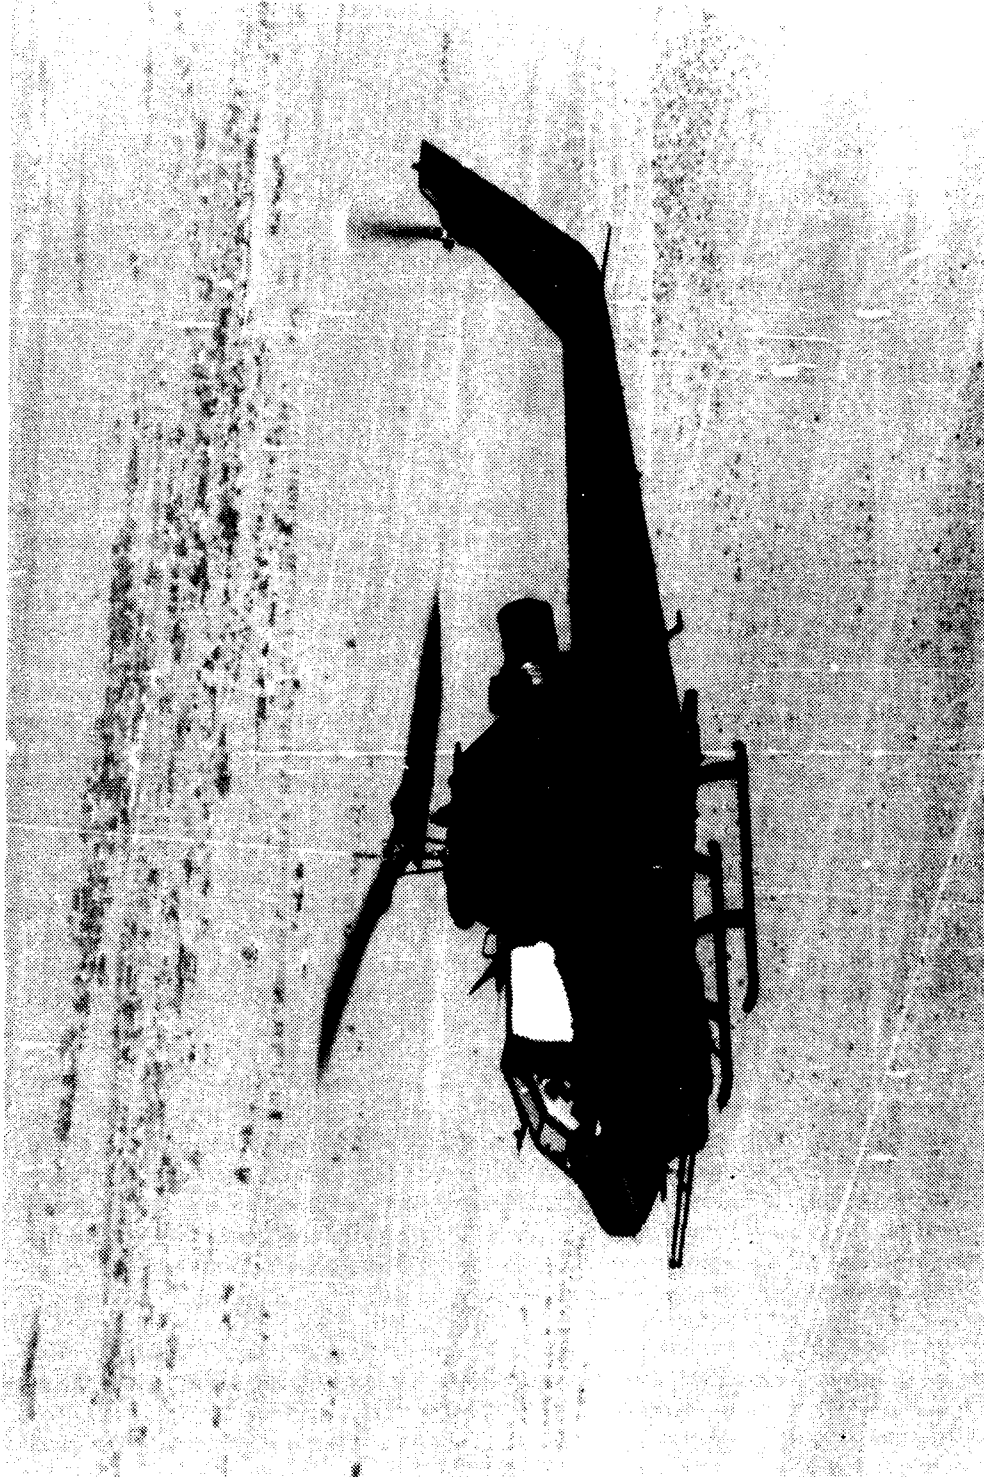
Figure B-1. Test Aircraft

4. Removable curtains were installed in the aft cockpit during conduct of simulated IMC flight as shown in figure B-1. These curtains were fabricated using white muslin target cloth and were attached to the interior of the window frames on the pilot's door and the pilot's jettisonable (left) window, and to the canopy frame forward of the pilot station and above the instrument panel, using velcro strips. The pilot's overhead window was obscured using a cardboard panel. The curtains were effective in emitting ambient light while obscuring the pilot's outside visual references without limiting peripheral vision.
