ENGINES FOR MINI-RPV XM-1A

This memorandum records the experience and test results gained at Weapons Systems Research Laboratory (WSRL) on small engines from its mini-RPV programme conducted during 1975 to 1981.

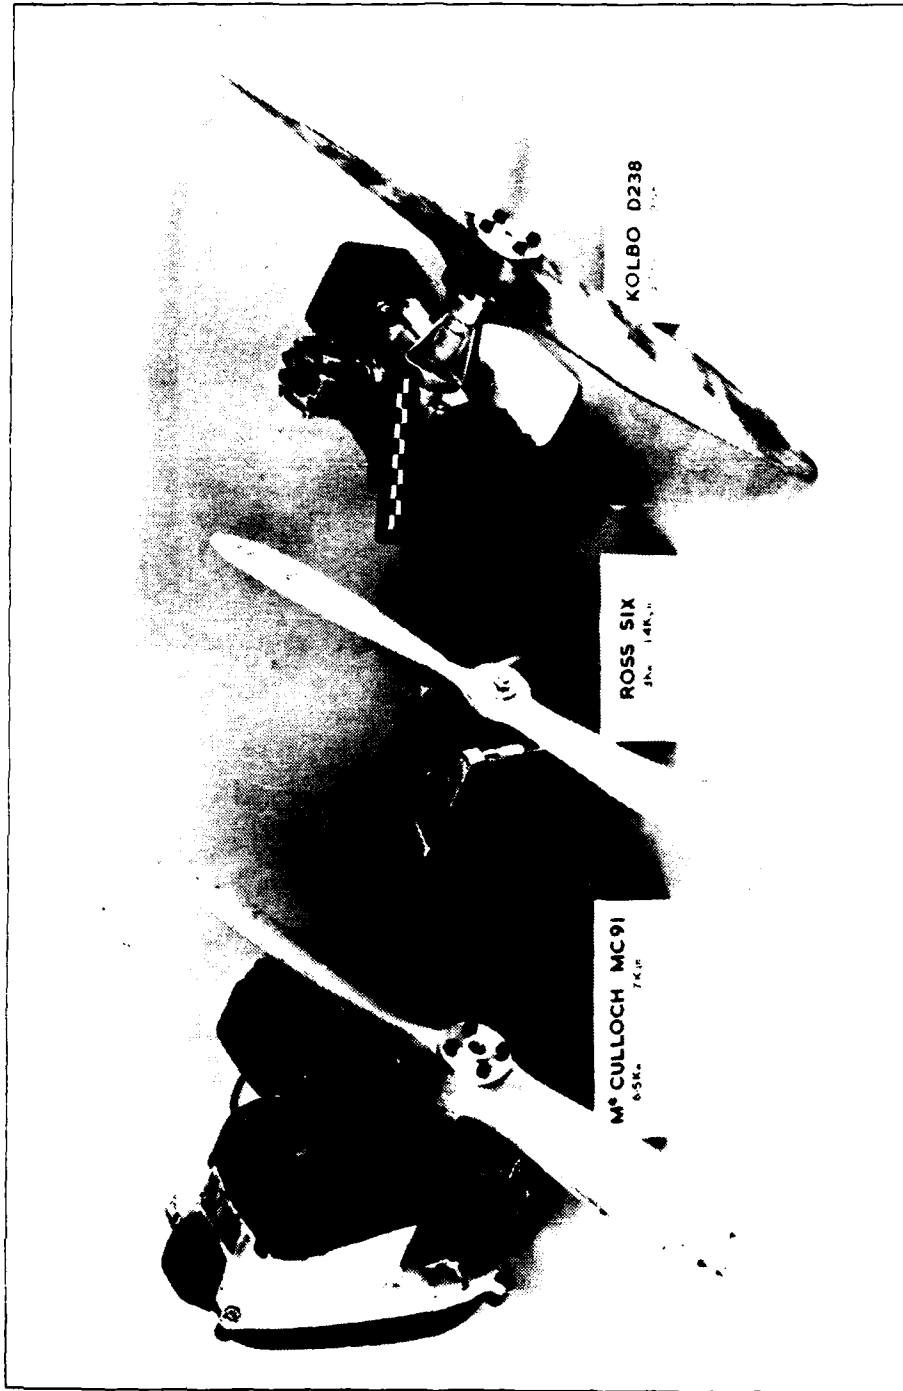
Figure 2. McCulloch MC91, Ross Six and Kolbo D238 2-stroke engines (N77/1730)

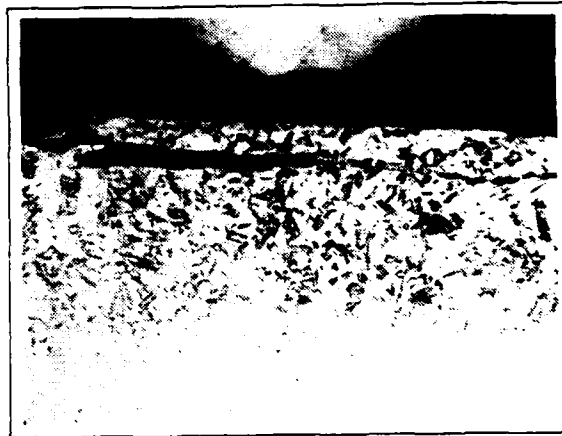
Figure V.6 Typical failure of nitrided crankshaft journal, times 170

An investigation of a failure of a Kolbo engine (no serial number) showed that one of the needle bearings in the connecting rod big-end had broken. A piece of this very hard steel had been sucked through the fuel transfer port and wedged between the piston head and the cylinder wall, causing a deep score up the cylinder. The crankshaft was examined by AEL Foundry Section and the result is given in Attachment V.3. Measurements of the shaft, which had been produced by AEL, showed considerable ovality and surface pitting on the bearing contact area (up to 0.3 mm ovality for 10 h total running time). The crankshaft had been machined from Bohler Ace steel and nitrided to provide hard, wear-resistant bearing surfaces and to improve fatigue resistance. Micro-examination by the AEL Foundry Heat Treatment Section (Attachment V.4), revealed 'sub-surface cracking, parallel to the surface, typical of a type of failure common to anti-friction bearings where the stresses are caused by pure rolling. This type of sub-surface cracking is generally attributed to the presence of non-metallic inclusions, in this case iron nitride'. Tests showed that the surface hardness was about 1000 HV with an effective case depth of 0.2 mm.

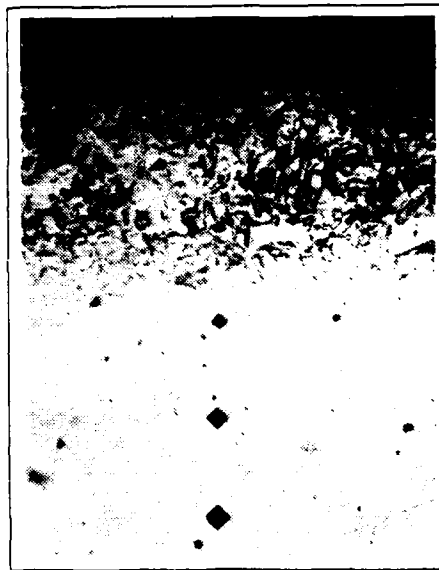
Figure V.7 Undamaged surface of crankshaft journal, times 170

Figure V.7 depicts an undamaged section of the surface which has been etched to reveal the total case depth. The hardness values corresponding to the indentations appearing in figure V.7 appear in graphical form at figure V.8.
