TECHNICAL REPORT REMR-GT-3

# GEOTECHNICAL ASPECTS OF ROCK EROSION IN EMERGENCY SPILLWAY CHANNELS

## Report 2 ANALYSIS OF FIELD AND LABORATORY DATA

September 1988

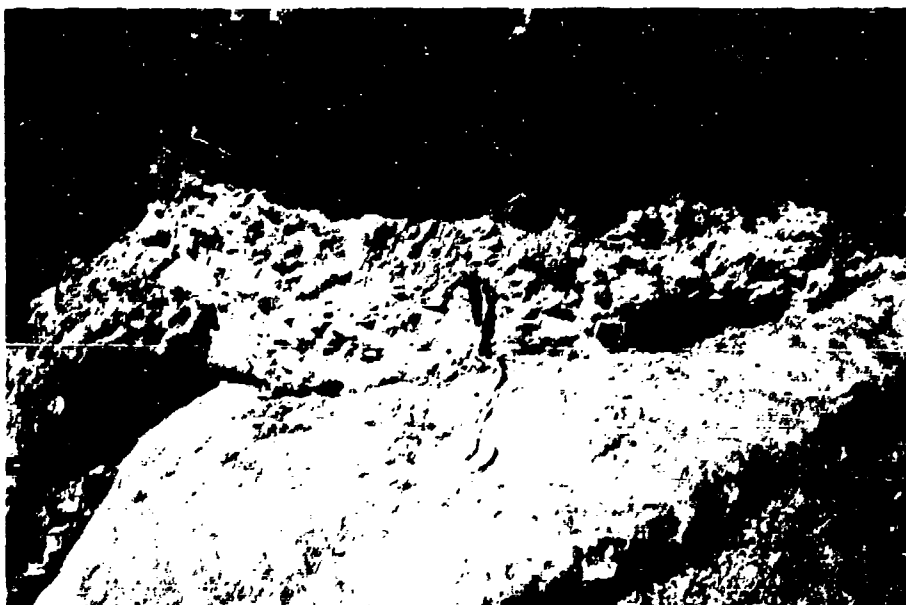
Figure 4. Weathering and the effects of scour during flows in 1983 and 1986 removed fissure fillings of clayey weathered basalt and mudstone from joints and fractures in basalt forming the downstream terminus of the Black Butte (US Army Engineer District, Sacramento (SPD)) spillway channel

19. Joint spacing (i.e. the perpendicular distance between joints of a given set) can be highly variable, with intervals in the range of hundreds of feet down to only a few feet. Where the joint separation is only a fraction of an inch, the term "fracture cleavage" is most appropriate. Joint fissures are the actual fractures which separate the rock. Joint fissures may be tight and filled with mineral-bearing material (clays, crushed rock fragments, sand-like gouge, calcite, gypsum, etc.), particularly in the subsurface, but are often open in the surface and shallow subsurface weathering regimes (Figure 2). The size of the fissure opening (aperture size), or joint-block separation, is often a function of proximity to the surface and slope of the ground or free-air surface. For example, field investigations at the Saylorville, Iowa, emergency spillway showed that the joint fissures in the hard competent sandstone bed forming the floor of the upstream portion of the channel exhibited progressive opening as the downstream terminus of the bed is approached (Figure 3). A similar situation is present at the Black Butte, California, spillway where the fissures in jointed basalt have been opened at the downstream falls by both erosion of fissure fillings and downslope movement of the blocks during flow events (Figure 4).

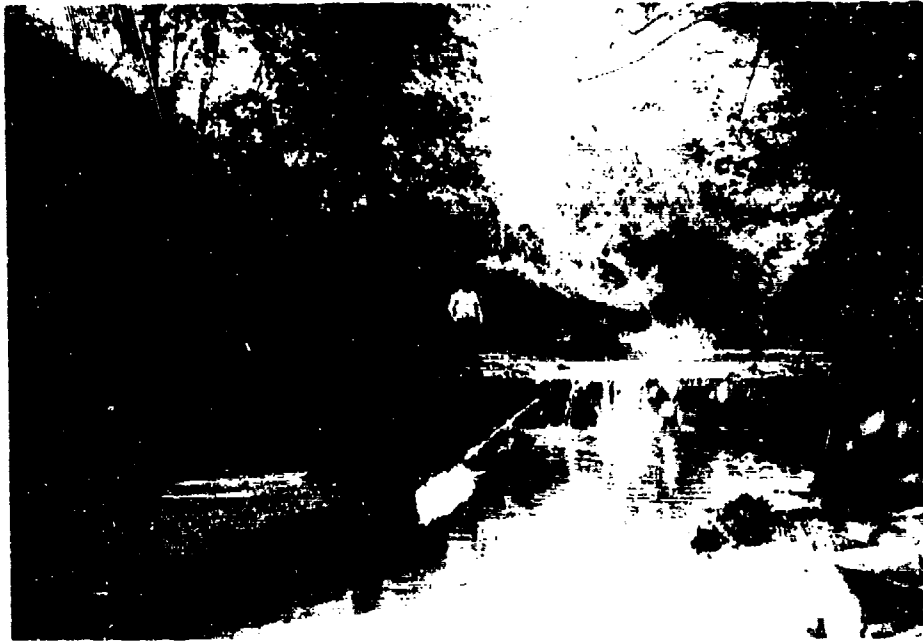
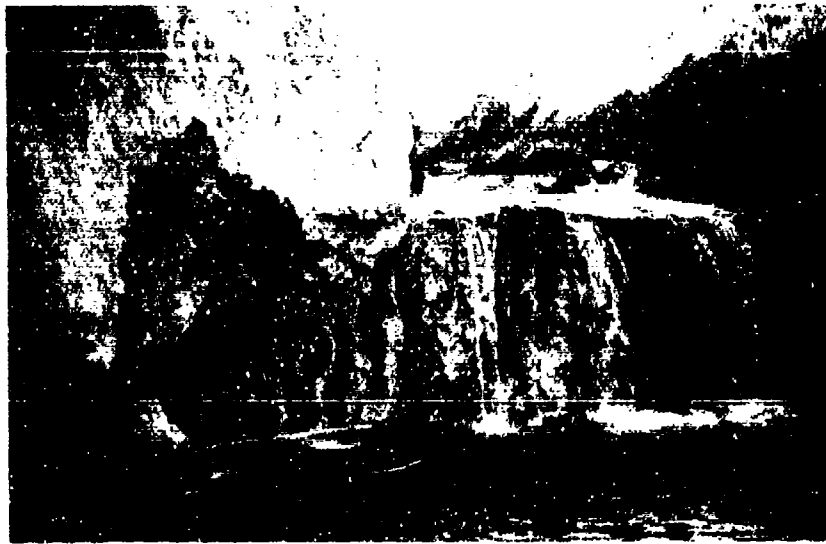
a. Hotopha Creek

b. Tillatoba Creek

Figure 5. Photographs showing natural stream channel knickpoints, Yazoo Basin Uplands, Mississippi (after Whitten and Patrick 1981)

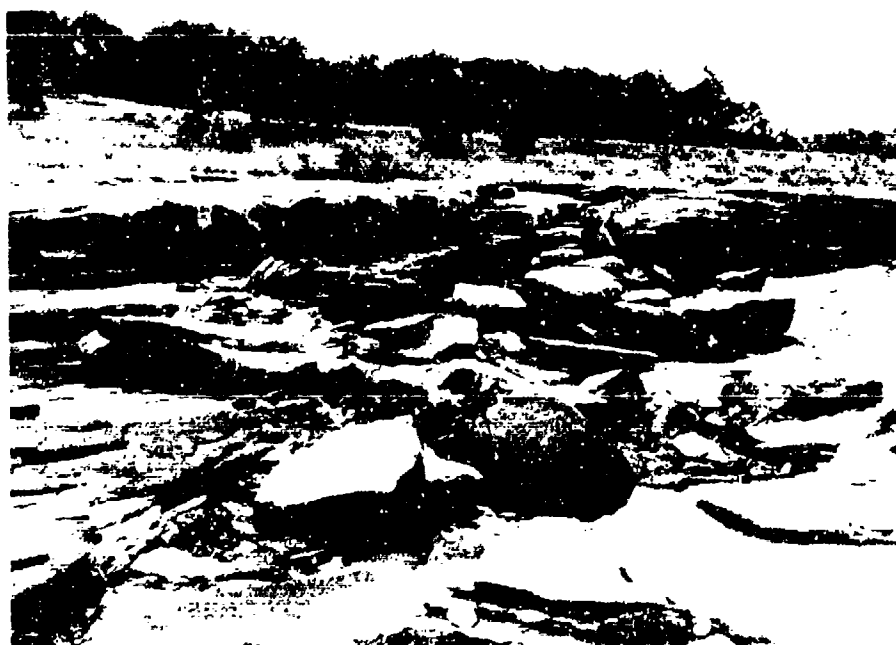
a. Upstream view

b. Downstream view

Figure 7. Photographs showing severe erosion in the emergency spillway channel at Saylorville after the 1984 overflow event. Note stairstep erosional pattern (after Cameron et al. 1986)
