INSTALLATION RESTORATION PROGRAM  
PHASE II—CONFIRMATION/QUANTIFICATION  
STAGE 2

MOODY AIR FORCE BASE,  
GEORGIA

FINAL REPORT  
NOVEMBER 1988

FINAL REPORT  
FOR  
MOODY AIR FORCE BASE, GEORGIA 31601

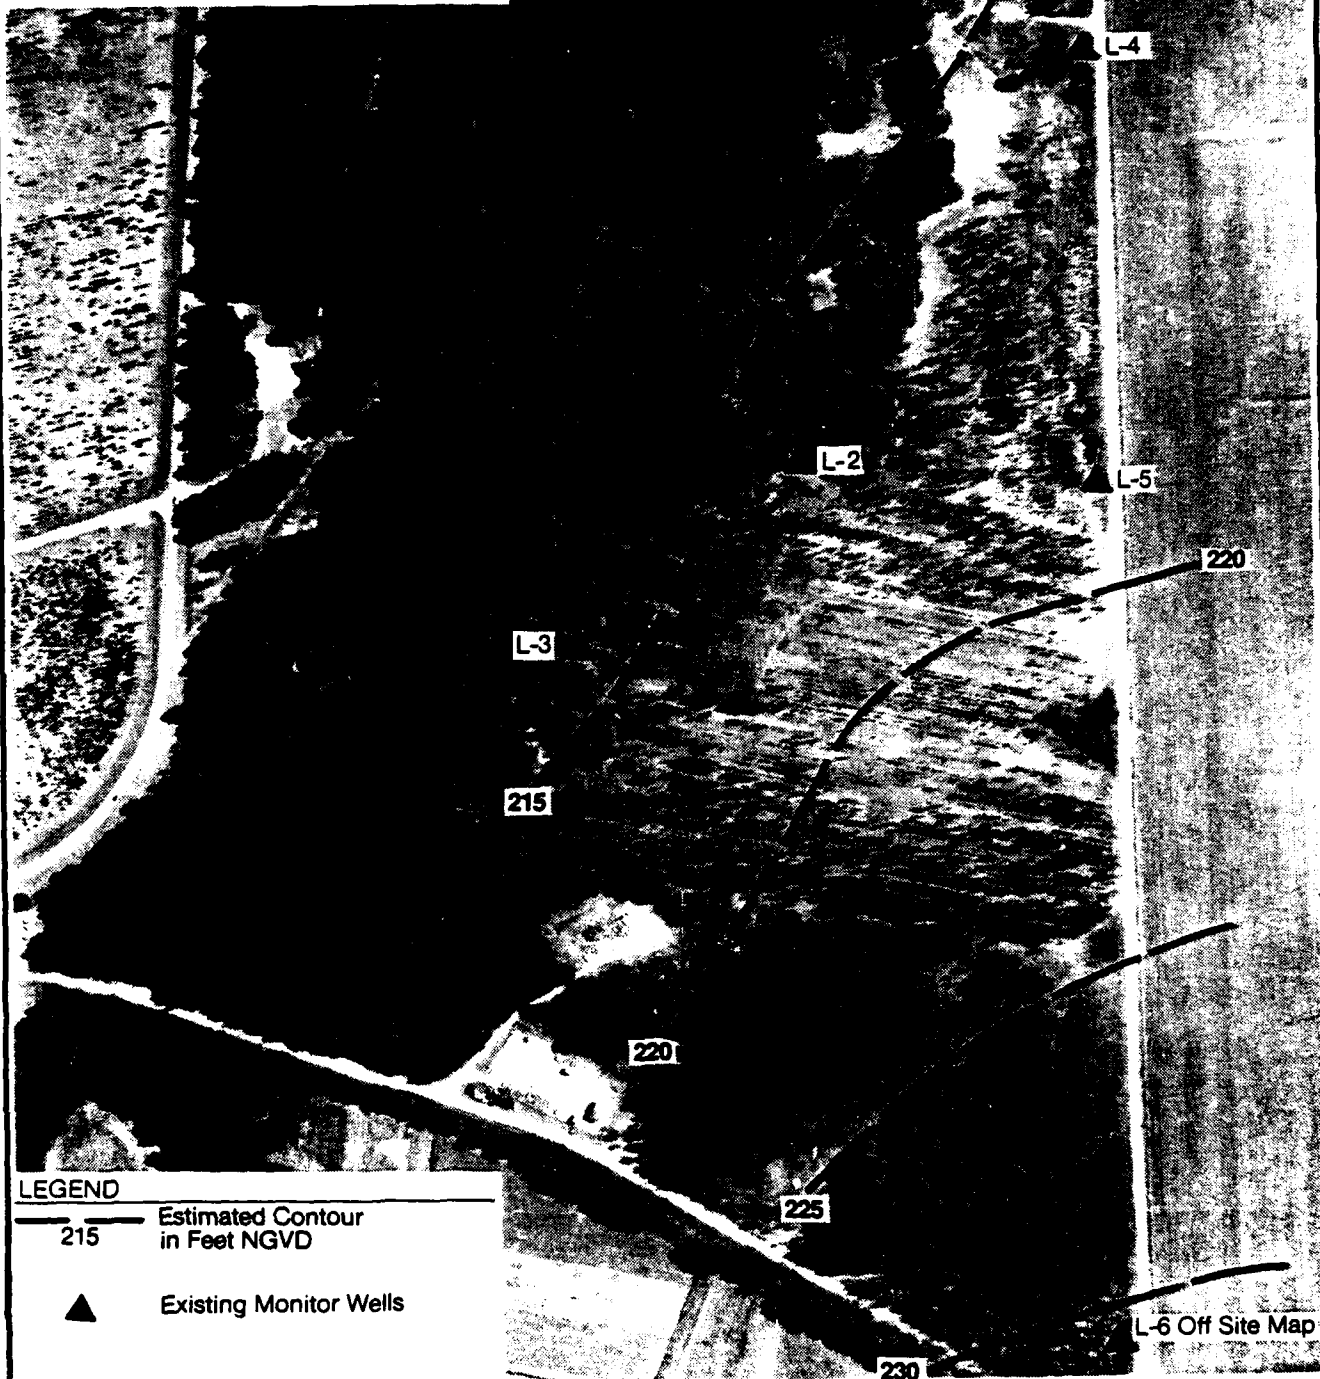
**FIGURE 23.**  
Approximate Shallow Groundwater Elevations,  
Site 1, Southwest Landfill, April 1984, Moody AFB, Georgia.

The estimated shallow groundwater elevations at Site 1 during April 1984, September 1984, and January 1987, are shown in Figures 23, 24, and 25, respectively. Available groundwater measurements are summarized in Table 8. WAR conducted the 1984 measurements during the previous Phase II Stage 1 investigation. CH2M Hill also measured the water levels in December 1986 before obtaining water quality samples; however, data from some wells known to be upgradient reflected water levels that were depressed or recovering and were not considered representative. Water level contours were estimated by linear interpolation between available data points and should be considered accurate only to the degree implied by the method used.

The water level maps indicate that shallow groundwater at Site 1 generally moves in a northeasterly direction towards the Mission Lake drainage system. Based on available data, it appears that shallow groundwater in the western base area

Note: Contours indicated approximate average NGVD elevations and are best estimates of spatial variations throughout the site. Actual levels may vary point to point due to local changes in hydrogeologic or other influences.
