TECHNICAL REPORT O-89-1

AN EVALUATION OF THE HARDENED DIGITAL RECORDING SYSTEM

Robert J. Dinan

Instrumentation Services Division

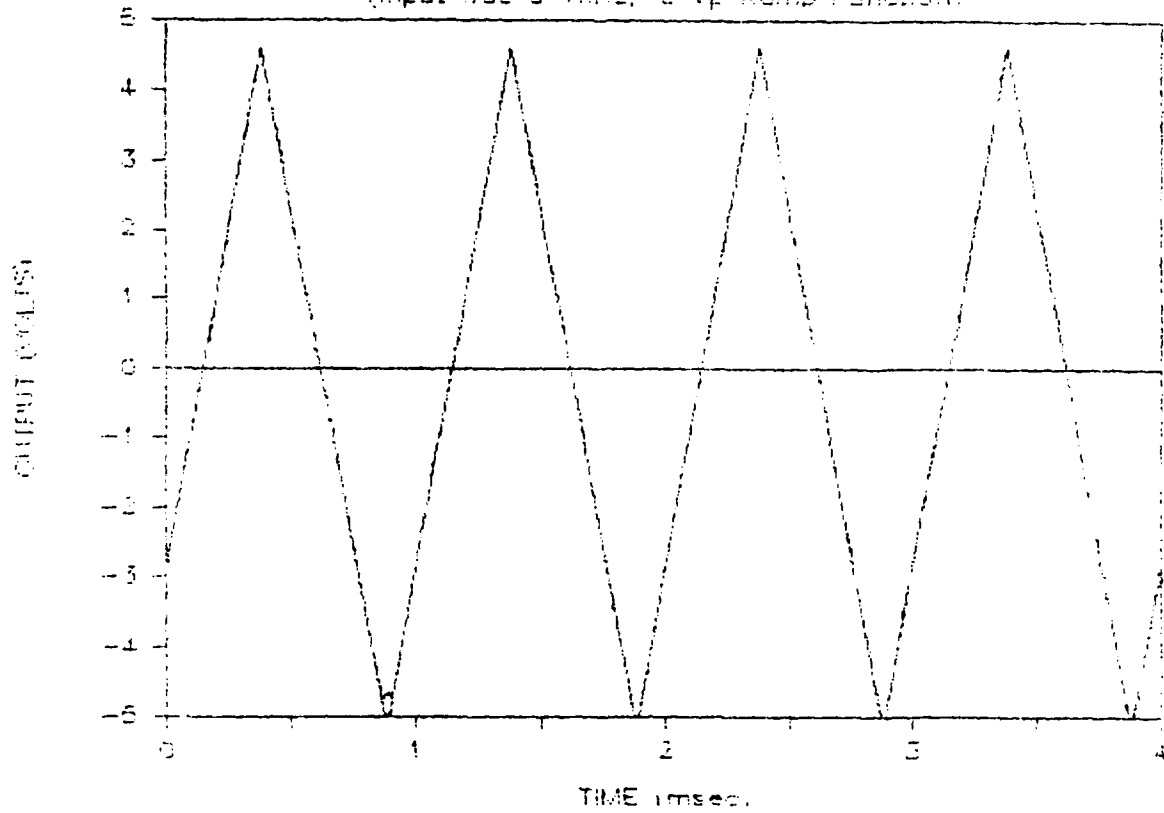
Figure 3. Recorder No. 5 with Ramp Input.

FSC #5 RAMP FUNCTION OUTPUT

(Input was a 1kHz, 5 Vp Ramp Function)

9. Communication with Recorder No. 4 was unreliable at first, then became impossible. It no longer responded to any attempt to communicate. The reason for this failure was not determined. Figures 1, 2, and 3 show the results of the procedure with a ramp function input to Recorder Nos. 1, 3, and 5. These recorders seemed to be working properly except for the intermittent trigger operation of Recorder No. 5. The cause of the 0.25V DC offset is undetermined. All A/D inputs were zeroed prior to testing. This offset may be

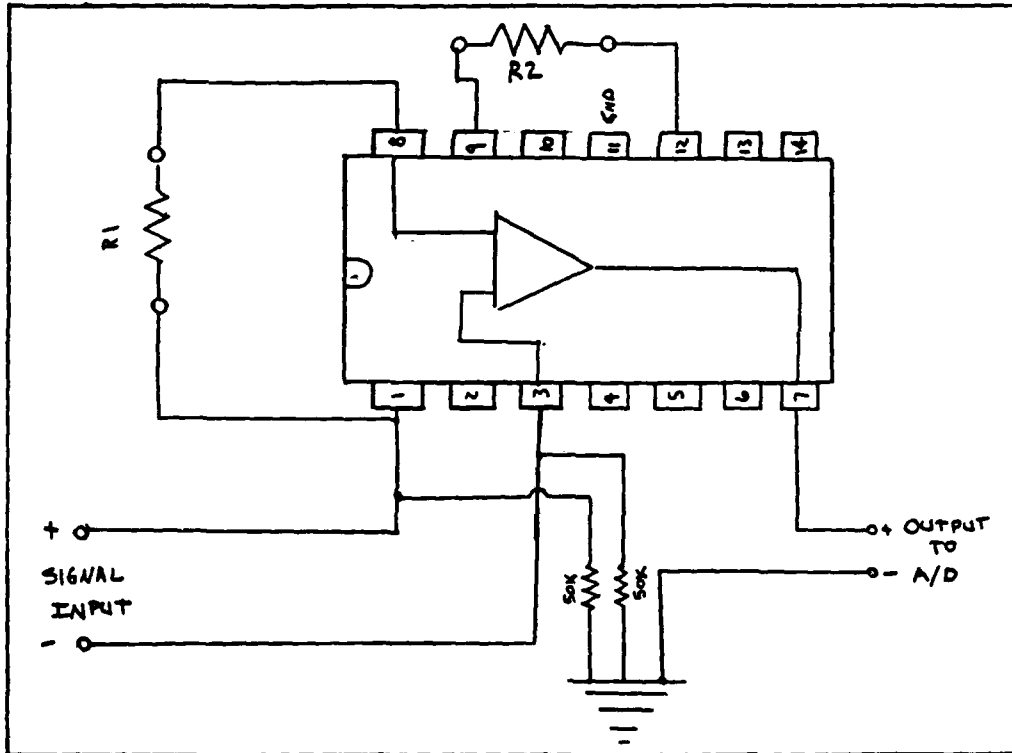
APPENDIX A. SCHEMATIC

Schematic of modified KSC SDRS signal conditioning board showing location of R1 and R2 for gain adjustment.

d. Use the following formula to determine the resistance values which achieve the desired gain for the instrumentation amplifier. See Appendix A for schematic diagram of the signal conditioning circuit to determine the location of R1 and R2.

$$G = R2/R1$$
