TECHNICAL REPORT ARCCB-TR-89001

**MACHINE TOOL DYNAMIC MEASUREMENTS  
AND DIAGNOSTIC SYSTEM**

**R. K. WHARTON**

**T. P. VINCENT**

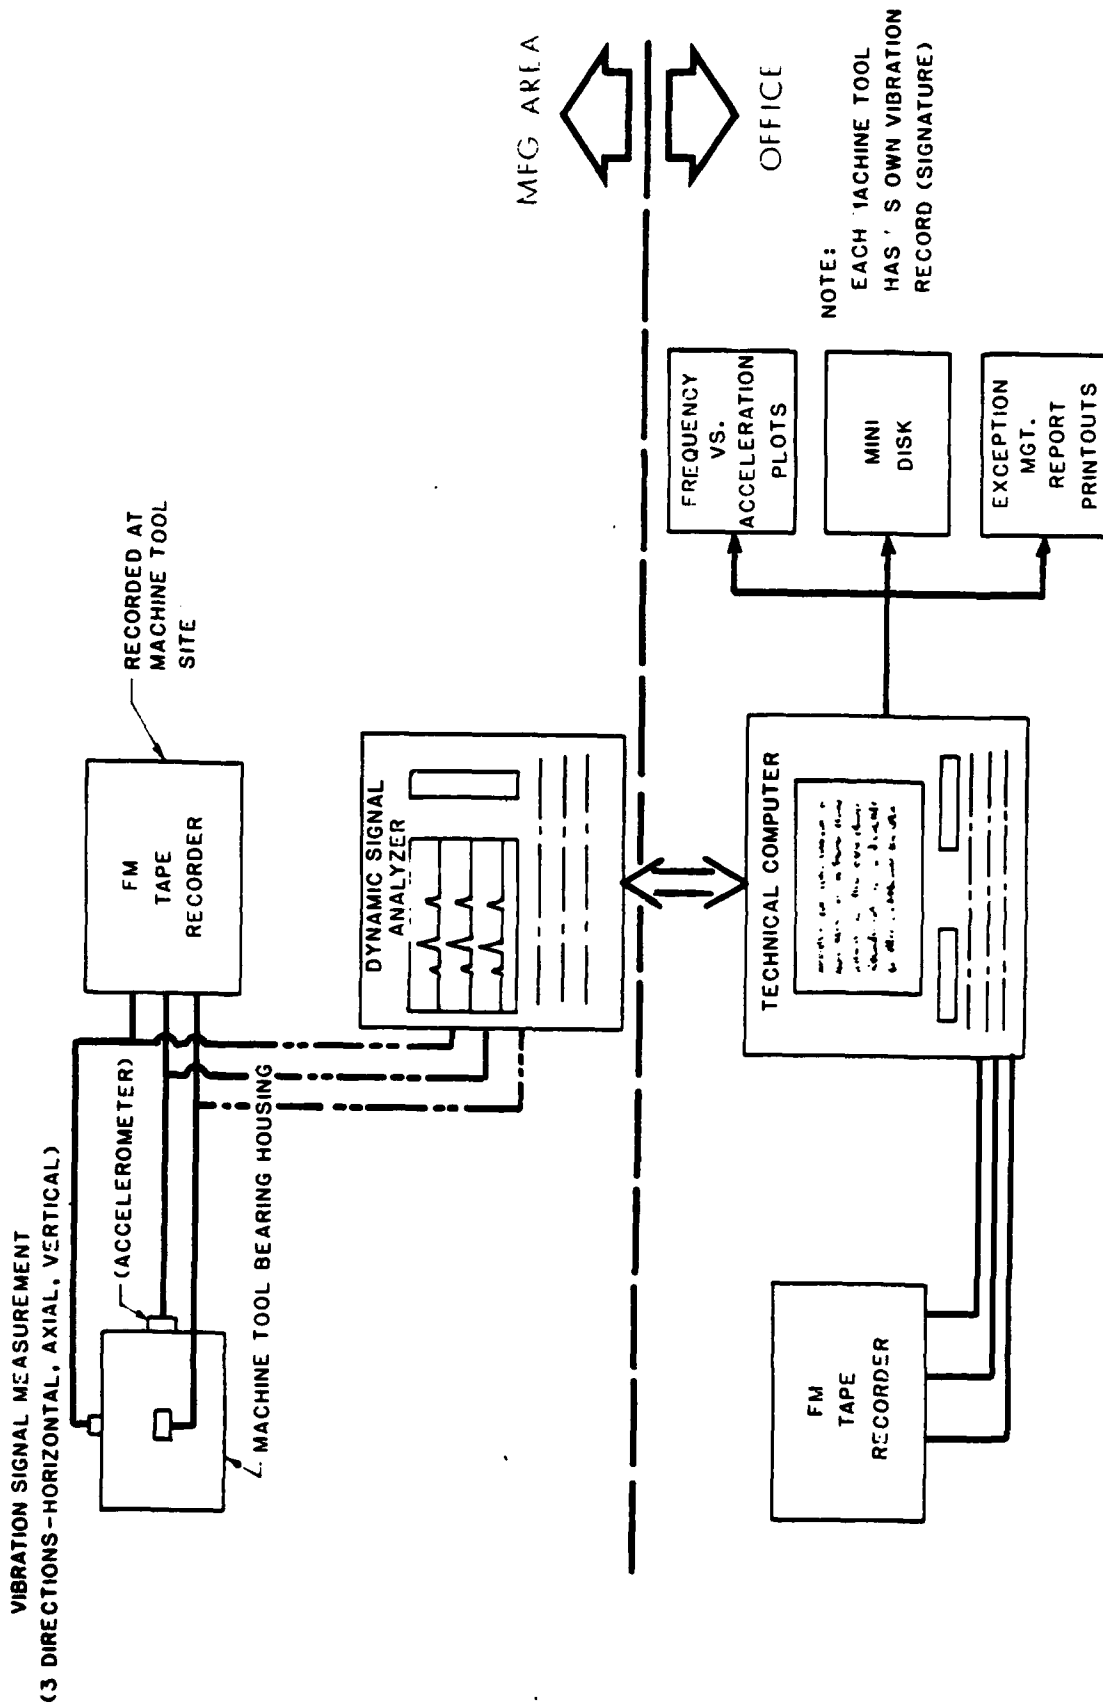
CONFIGURATION  
FIGURE 1

MACHINE TOOL DYNAMIC MEASUREMENTS AND DIAGNOSTIC SYSTEM

Nomenclature - MACHINE TOOL DYNAMIC MEASUREMENTS AND DIAGNOSTIC SYSTEM

Real-time Analyzer - Model 3561A - Single Channel - Range 125 $\mu$ Hz - 100 KHz

Tape Recorder - FM-4 Channel - Brue1 & Kjaer - Model 7006

Accelerometers - ICP Quartz - PCB Co.

Vibration Envelope Detector - Shaker Research/MTI - Model 223A

The Machine Tool Dynamic Measurements and Diagnostic System consists of four separate subsystems: sensors (accelerometers), FM four-channel tape recorder, real-time dynamic signal analyzer, and computer hardware/software. The total system monitors, detects, measures, and analyzes vibration spectra. Figure 1 is representative of the total system concept.

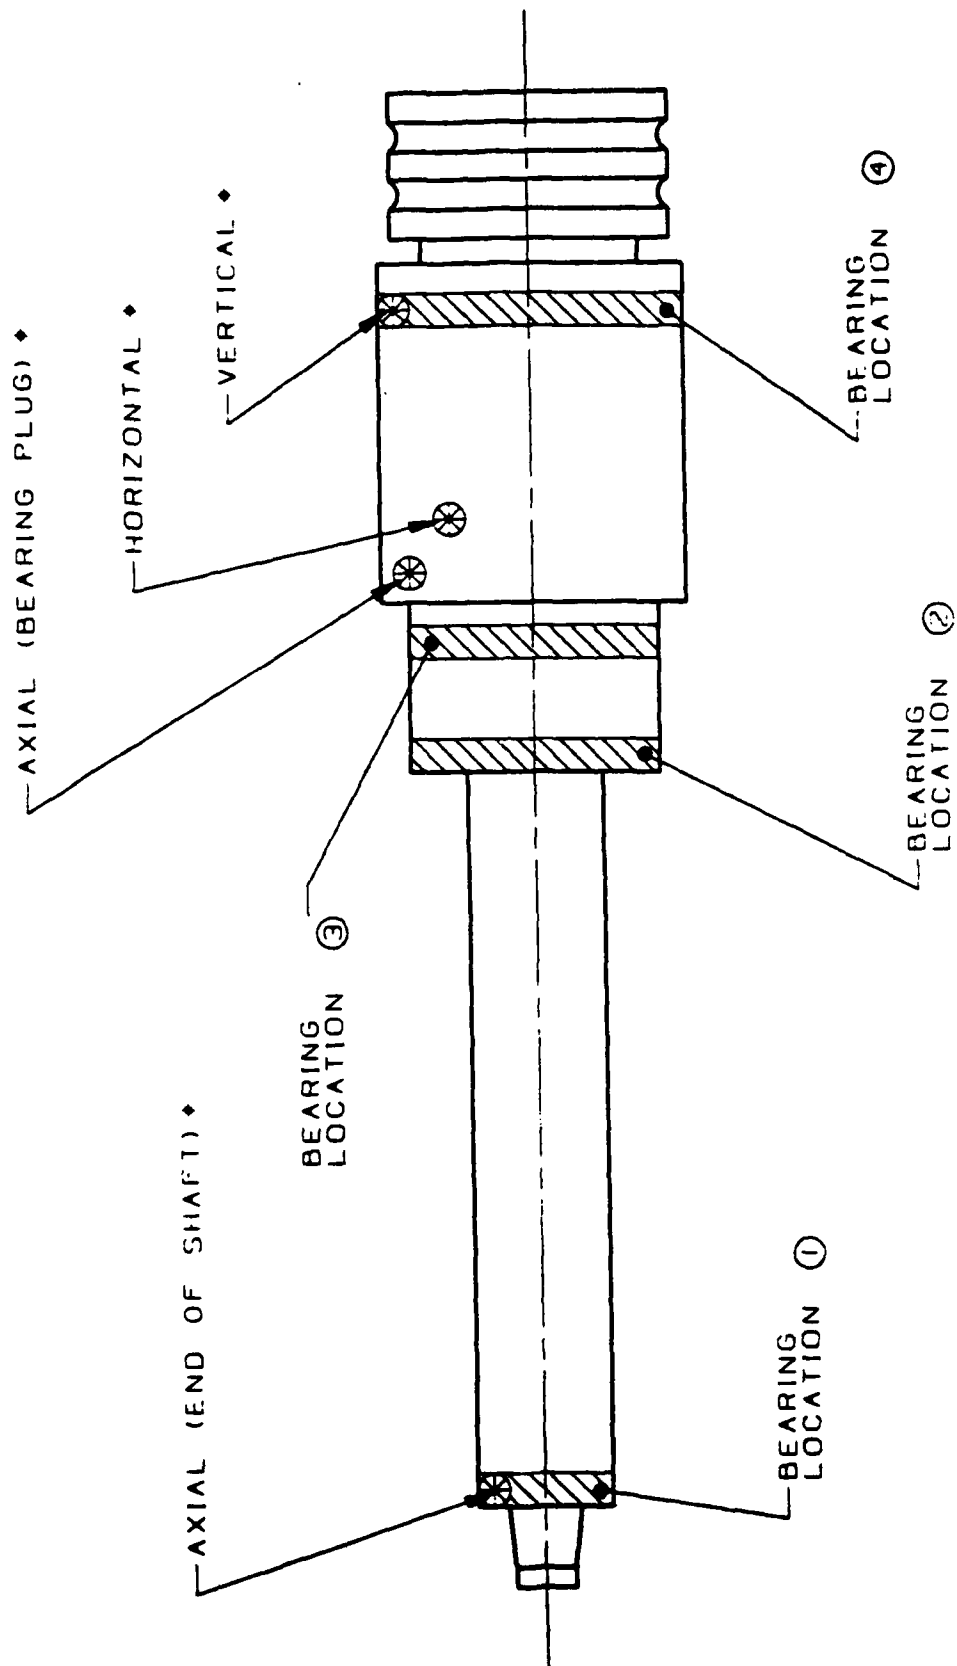
FIGURE 2

# (ACCELEROMETER) AND BEARING LOCATIONS SPINDLE

♦ ACCELEROMETER

A closer look at one machine tool's spindle vibration measurements also revealed the presence of additional mechanical faults. The defect calculations in Appendix A for ball bearing assemblies, Figure 3, suggest that two bearing assemblies on the same spindle register defects at 815 Hz and 805 Hz. These frequencies are associated with the outer race of bearing at spindle location No. 1, and inner race of bearing at spindle location No. 4, respectively.

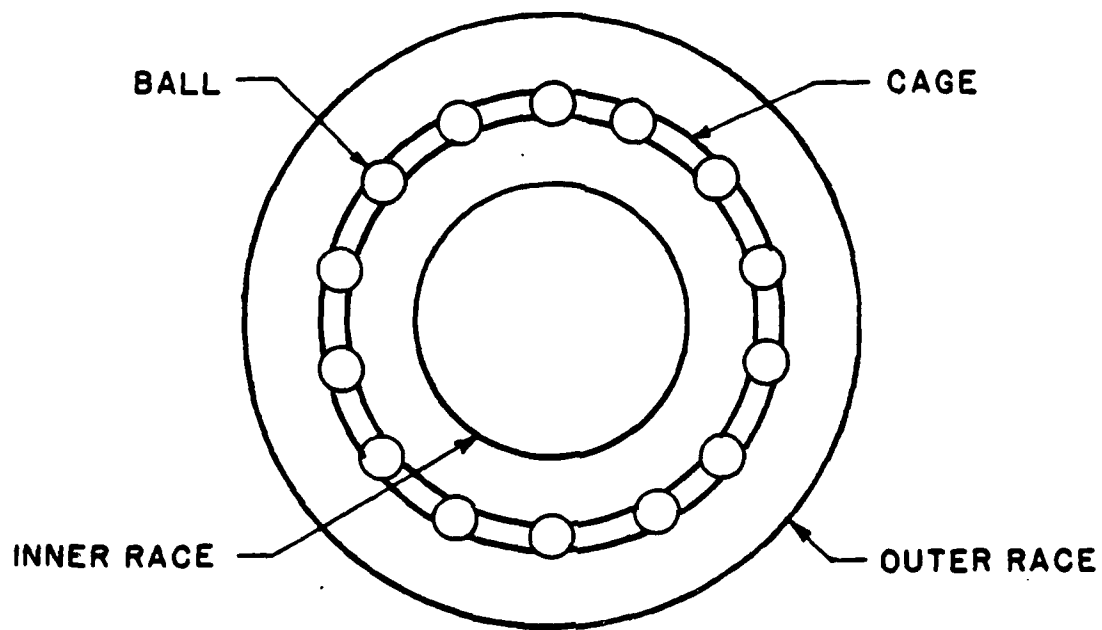
FIGURE 3

## BALL BEARING ASSEMBLY

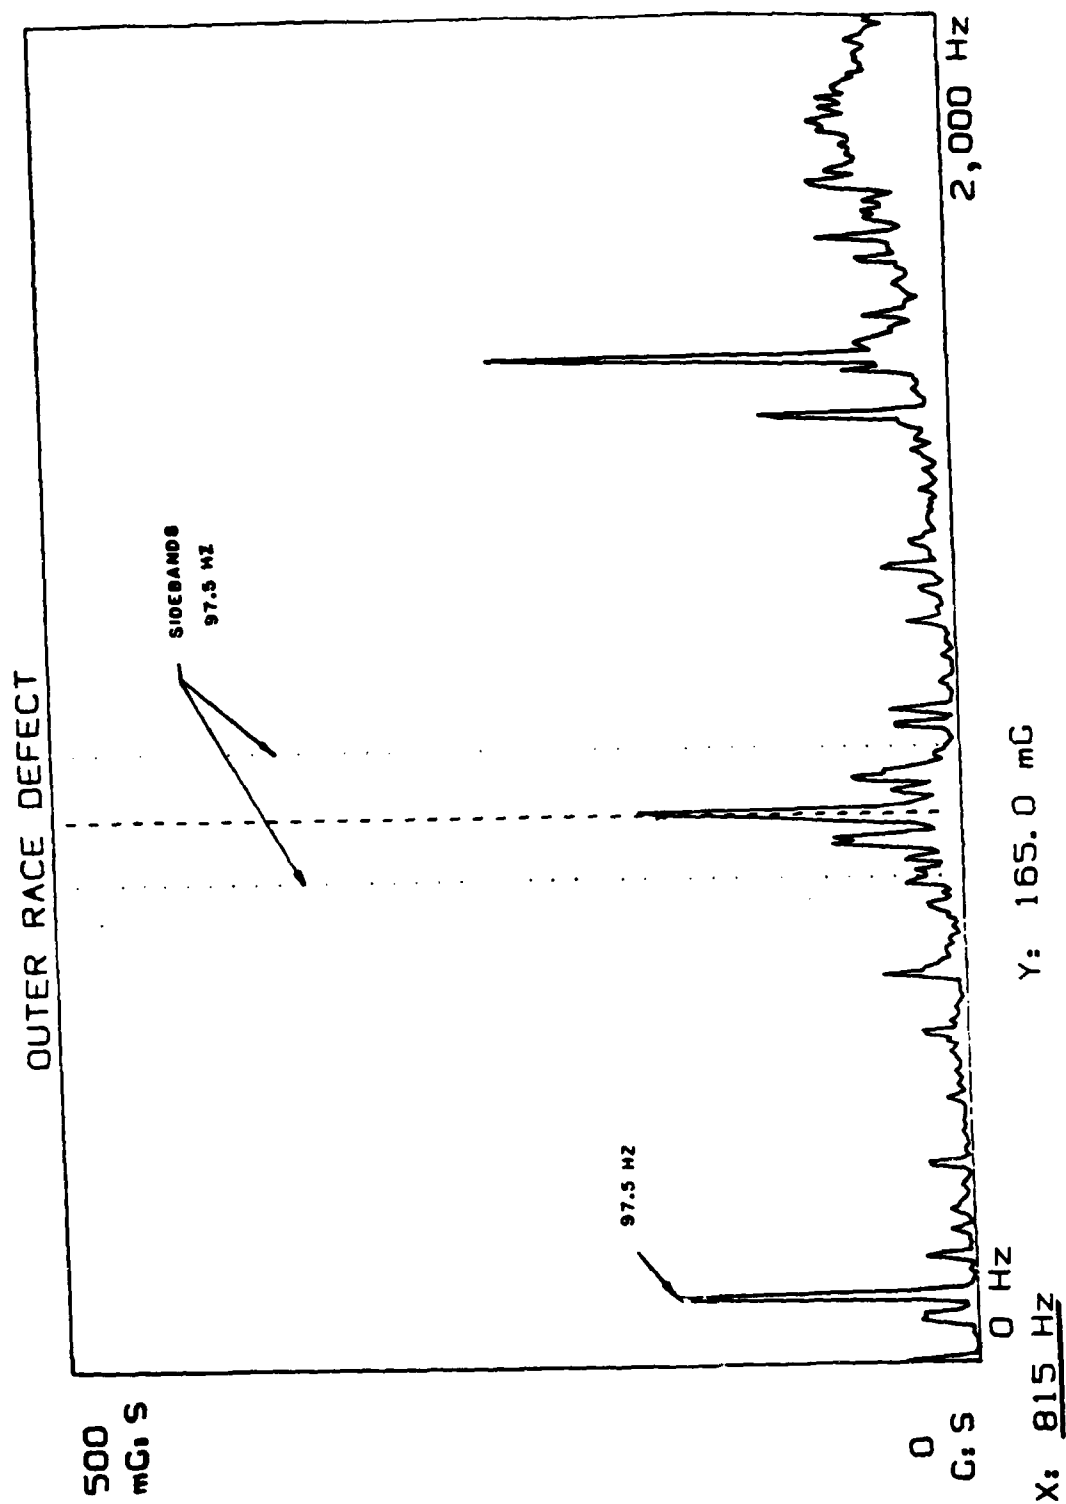
FIGURE 4

GRINDER — INTERNAL CONTOUR  
ACCELEROMETER LOCATION—HORIZONTAL (Analog Vibration Spectra)

16-microinch surface finish was obtained. Analog waveform plots for these defect frequencies are shown in Figures 4 through 6. The capability afforded by the digital signal analyzer influenced the spindle manufacturer to redesign his spindles and employ real-time analysis criteria for future balancing of spindles. The remainder of the spindles were tested and balanced as the example stated.

\* SEE FIGURES 4, 5, and 6

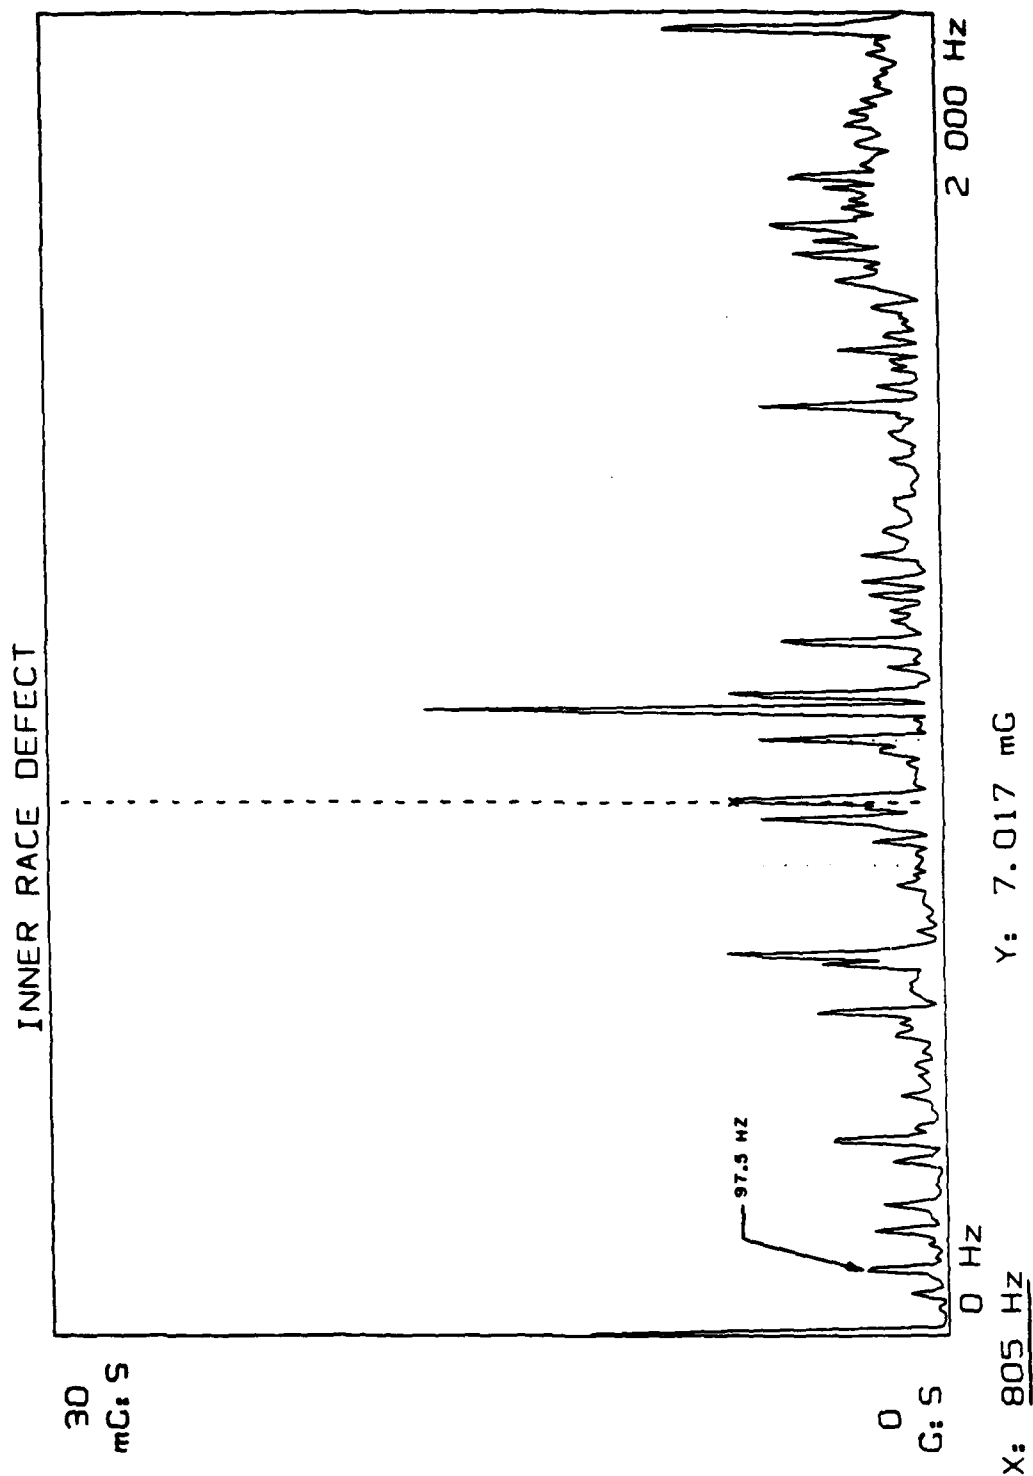
FIGURE 5

**GRINDER—INTERNAL CONTOUR**  
**ACCELEROMETER LOCATION—VERTICAL** (Analog Vibration Spectra)

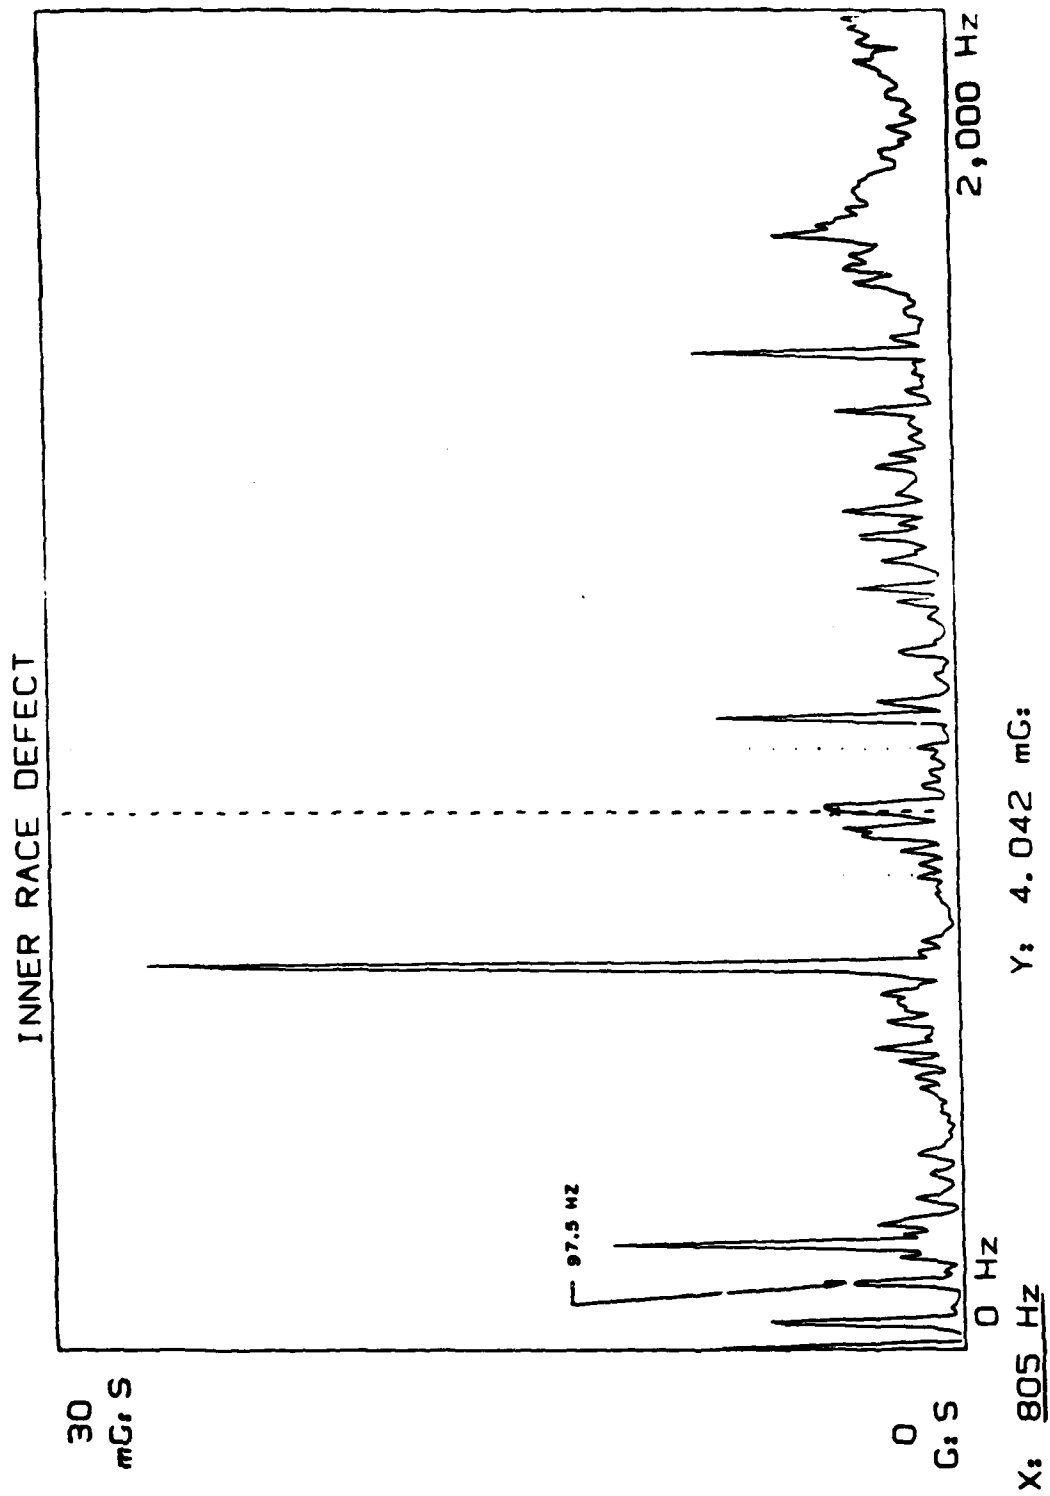
FIGURE 6

# GRINDER — INTERNAL CONTOUR

ACCELEROMETER LOCATION — AXIAL (Analog Vibration Spectra)

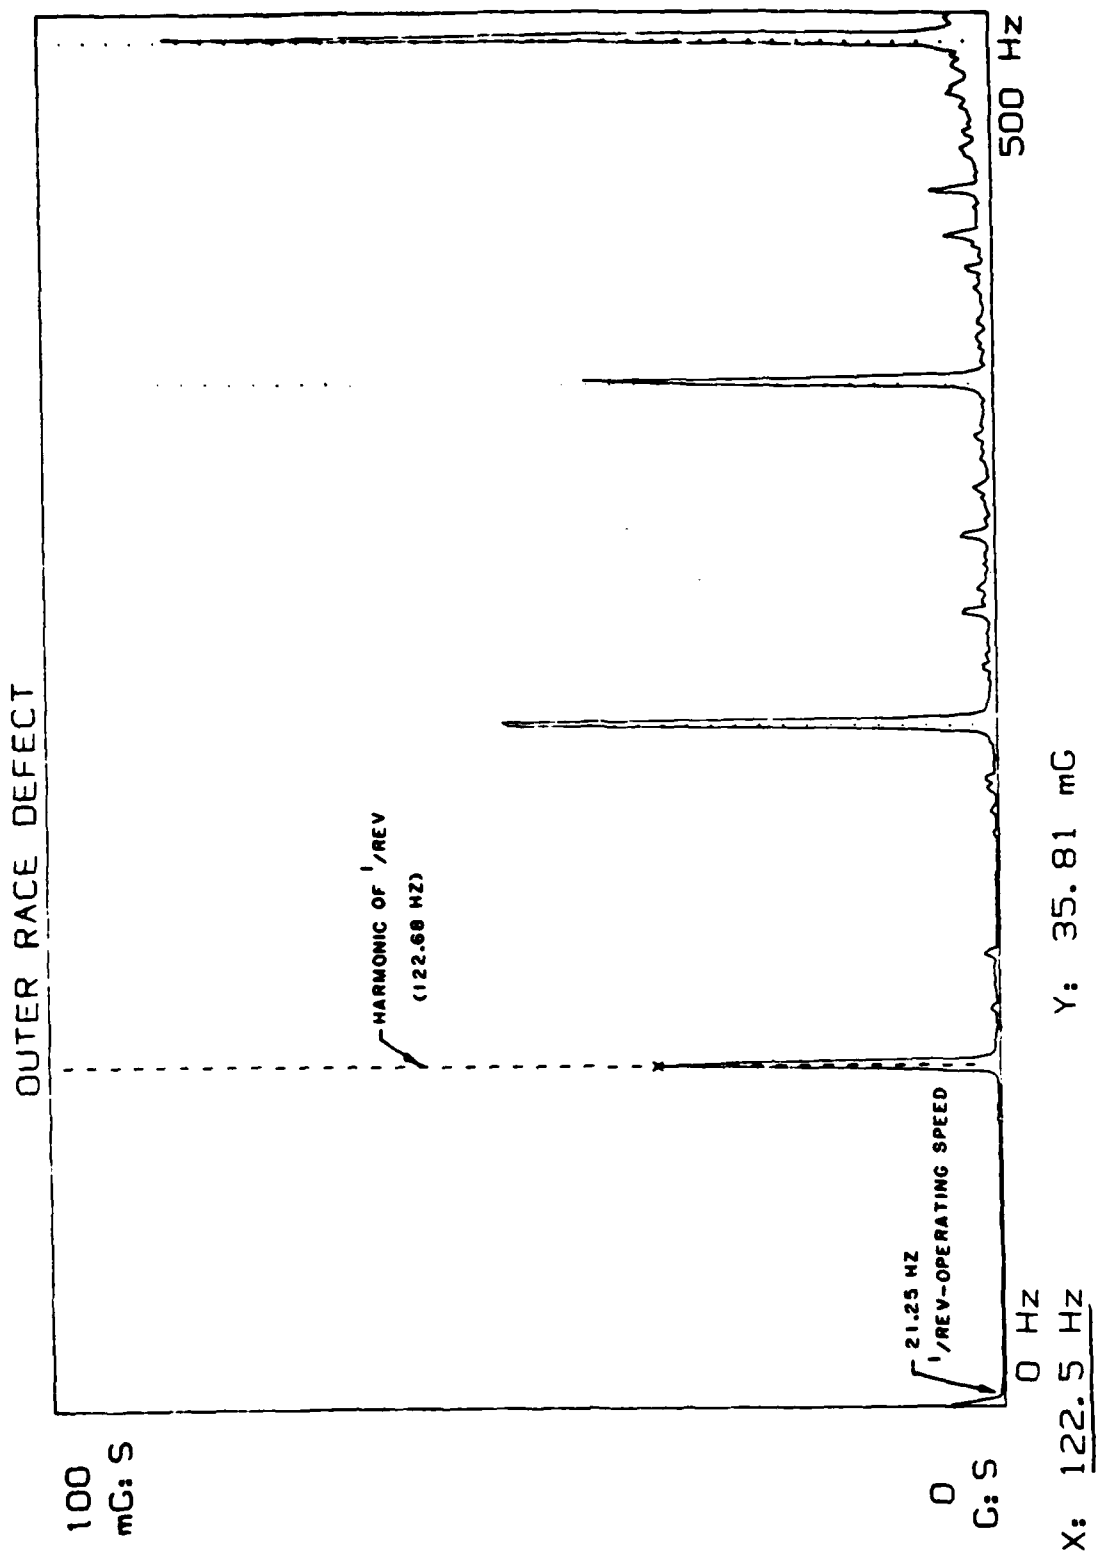
**EXTERNAL SURFACE GRINDER  
ACCELEROMETER LOCATION-VERTICAL (Analog Vibration Spectra)**

In the second case, during the fabrication of repair parts and gauges (105-mm, 120-mm, 155-mm, and 8-inch ordnance systems) a surface grinder was producing an undesirable 32-microinch surface finish. The (with contact) defect equations in Appendix A and real-time digital signal analysis methodology again were employed. A computed frequency of 122.68 Hz suggested that due to excessive vibration chatter, component wear had occurred in the spindle's ball bearing outer race assembly. The analog waveform plot of this defect is shown in Figure 7. On this occasion, the magnitude of g'levels necessitated removal of the spindle from the grinder for examination and replacement of the ball bearing assembly. Following reassembly of the spindle in the grinder, rebalancing was performed and the required 16-microinch surface finish was attained.

\* See Figure 7

\* SEE FIGURE 7

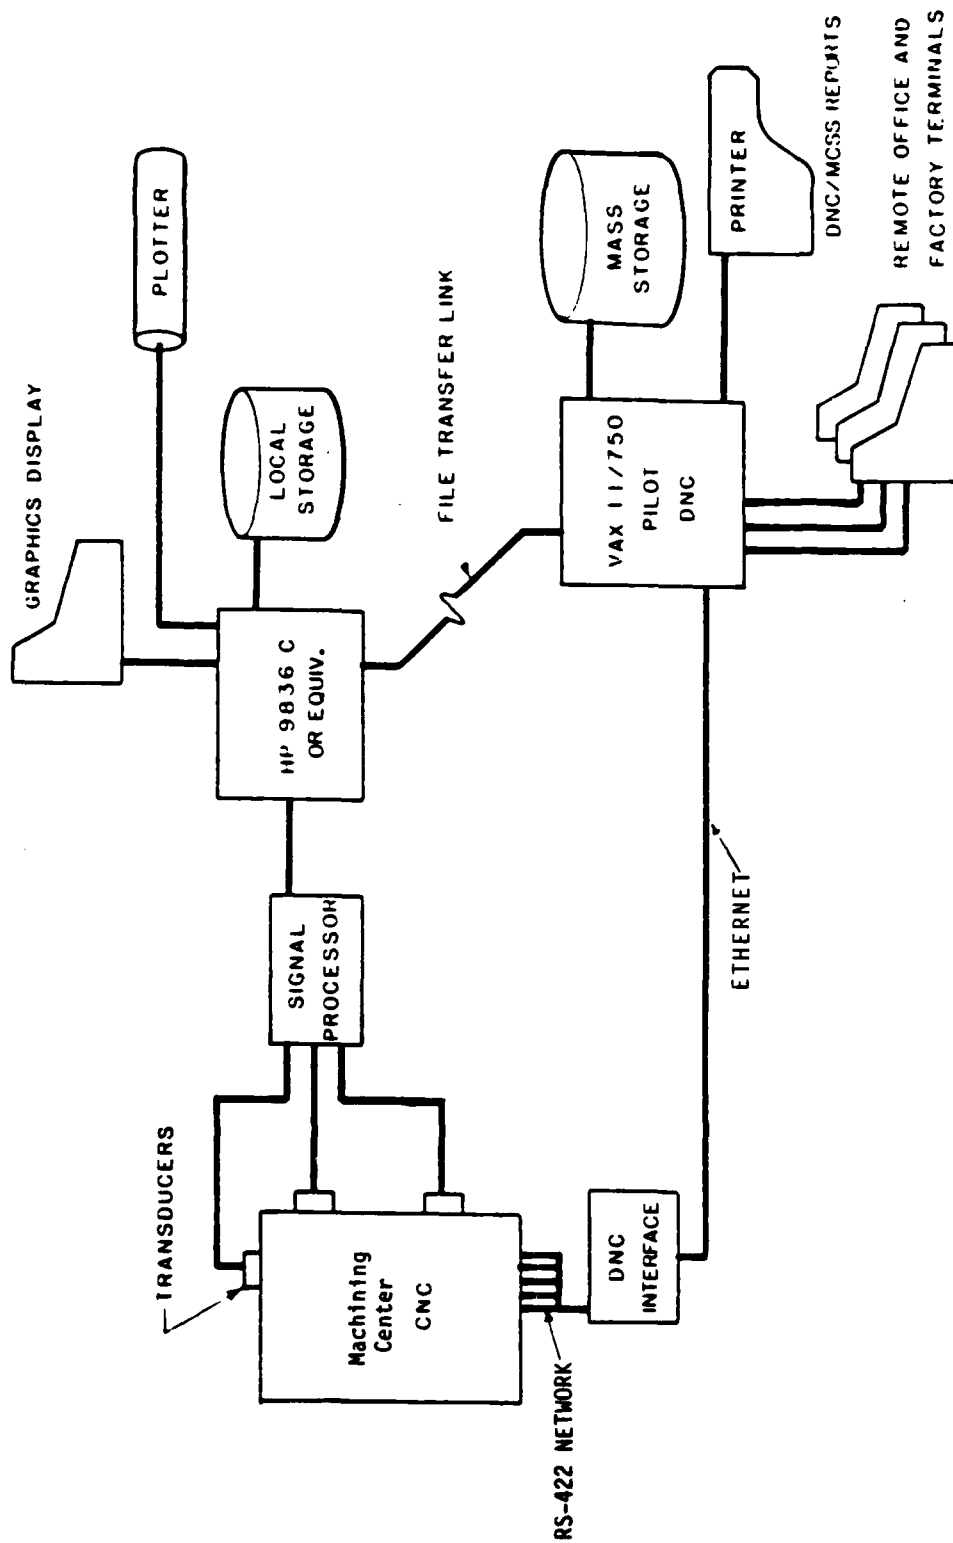
FIGURE 8

# MACHINERY CONDITION SURVEILLANCE SYSTEM (MCSS) PROPOSED PILOT SYSTEM CONFIGURATION DNC/MCSS LINK

The system is the forerunner of the pilot on-line MACHINERY CONDITION SURVEILLANCE SYSTEM (Figures 8 and 9), and will function as a backup for the plant-wide application.

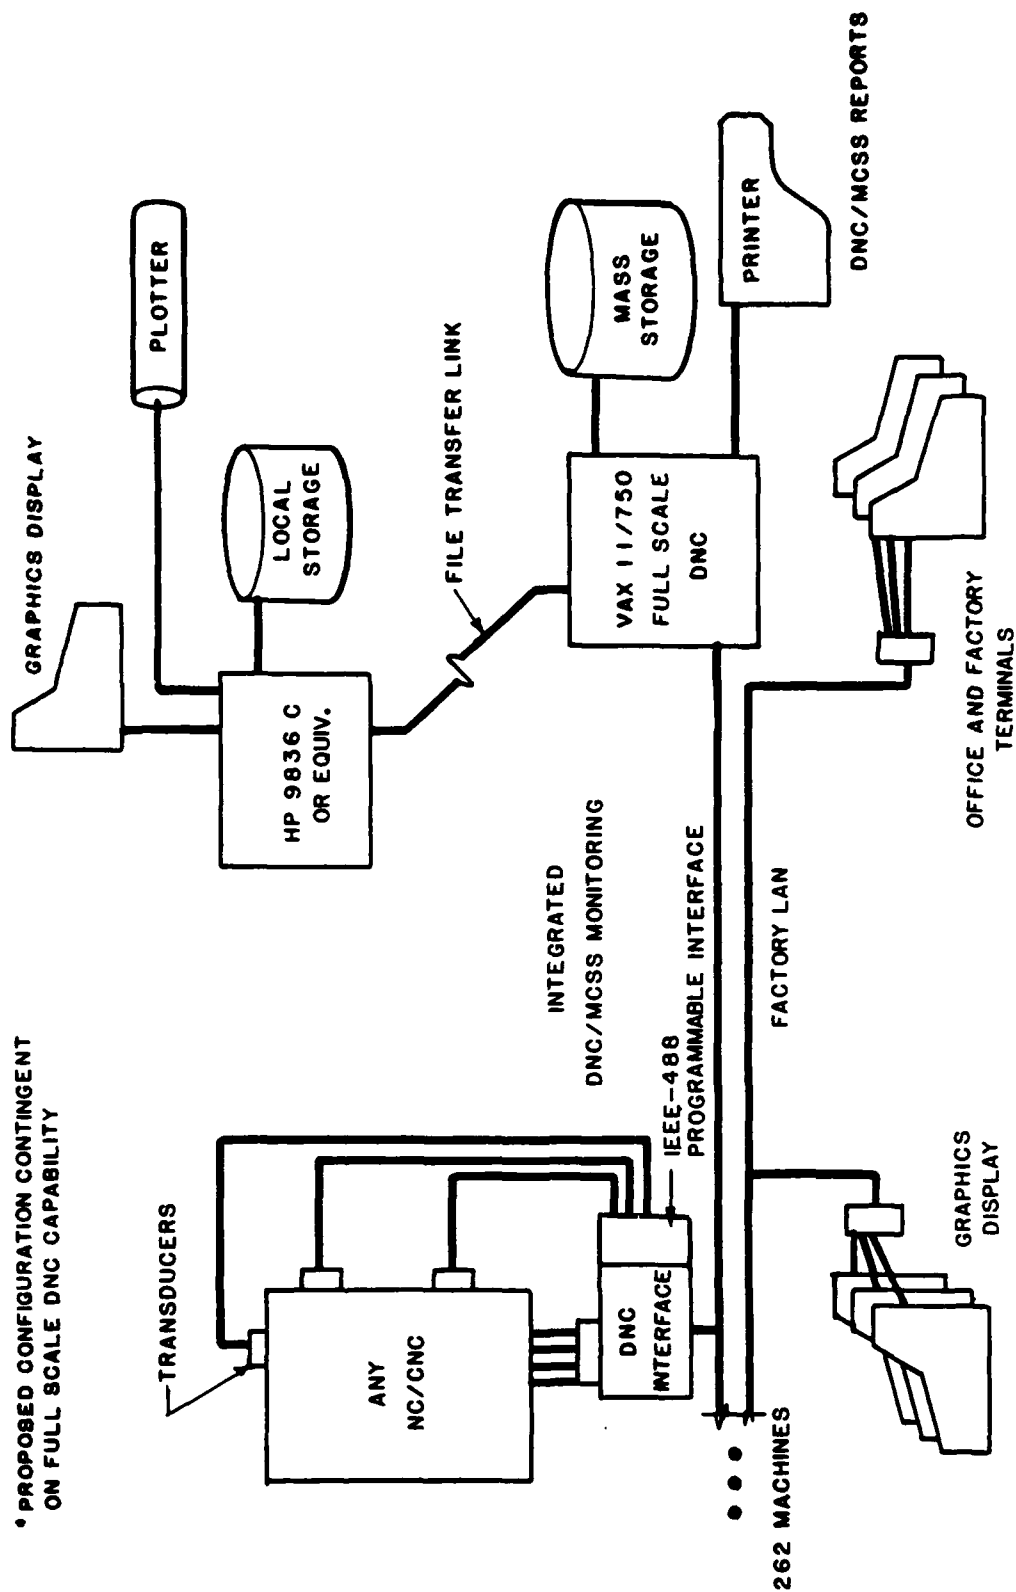
FIGURE 9

# **MACHINERY CONDITION SURVEILLANCE SYSTEM (MCSS) PROPOSED FULL SCALE SYSTEM CONFIGURATION DNC/MCSS INTEGRATION\***

\* PROPOSED CONFIGURATION CONTINGENT  
ON FULL SCALE DNC CAPABILITY
