MISCELLANEOUS PAPER CERC-89-2

# THE COLONIAL BEACH, VIRGINIA, DETACHED BREAKWATER PROJECT

Coastal Engineering Research Center

January 1989  
Final Report

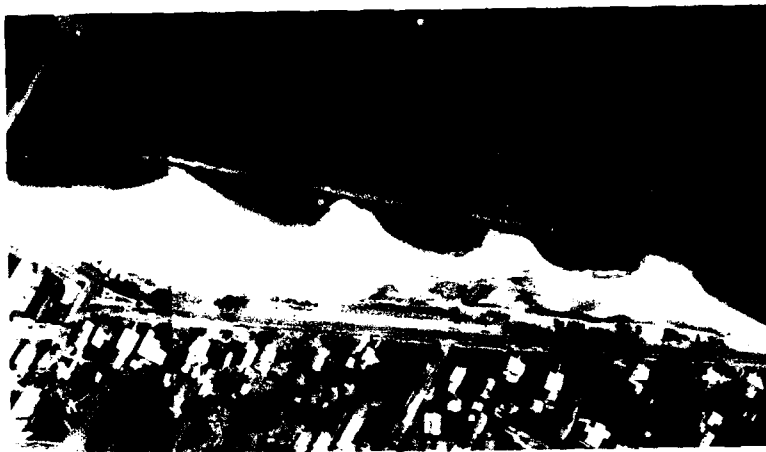
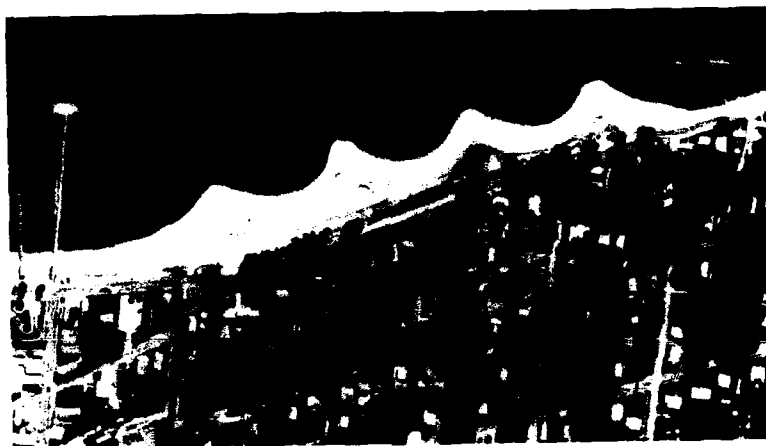
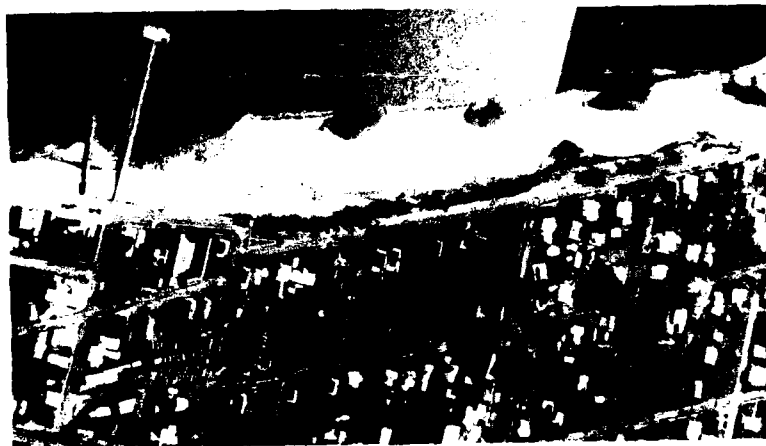
a. Uncontrolled vertical, March 1983

b. Controlled vertical, June 1984

c. Controlled vertical, February 1985

Figure 3. Central Beach aerial photographs

18. Central Beach aerial photographs are presented in Figure 3, and Castlewood Park Beach aeriels are included in Figure 4. The darker zones toward the back beach of both sites in the photographs consisted of finer sized sediment, and the zones occasionally were filled with water and vegetation. Originally the beach fill was built to +3 ft mlw, but on occasions when an extra-tropical low barometric pressure system (i.e., a water level setup and storm waves) occurred simultaneously with an astronomical high tide, the back beach areas became inundated. The waves were able to break on the reveted and nonreveted banks, resulting in scouring at the base of the revetment and bluff erosion. A sinuous beach berm formed, mirroring the diffraction pattern of the breakwater. When the water level returned to normal, water was ponded in the back beach area leaving the sinuous berm as a narrow beach offshore (Figure 5).

19. The back beach depression apparent in the March 1983 aeriels (Figures 3a and 4a) had become more pronounced by November 1983 (Figure 6). In October 1984, 3,000 cu yd of beach fill with a median grain size of 0.5 mm was placed in the low back beach region at Central Beach, raising the entire beach elevation to +4.0 ft mlw.

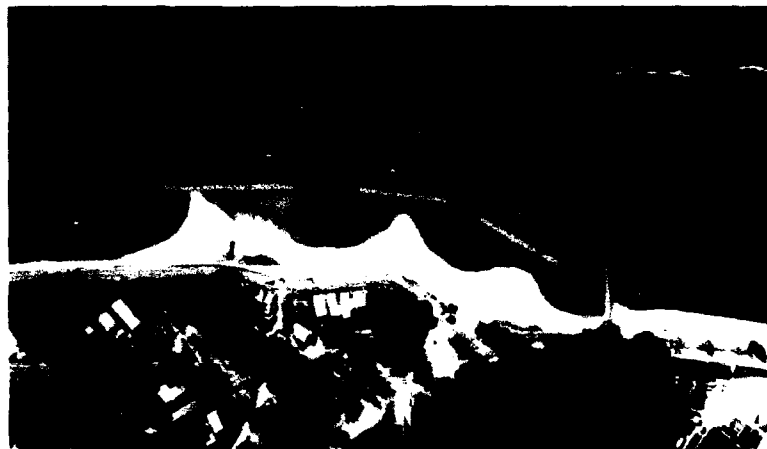
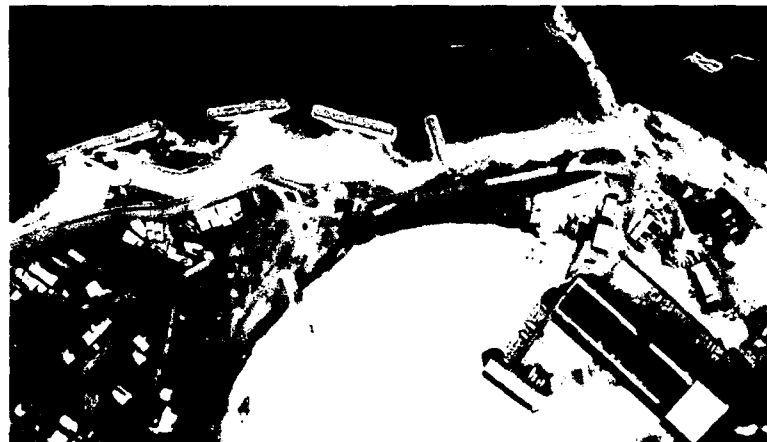
a. Uncontrolled vertical, March 1983

b. Controlled vertical, June 1984

c. Controlled vertical, February 1985

Figure 4. Castlewood Park Beach aerial photographs

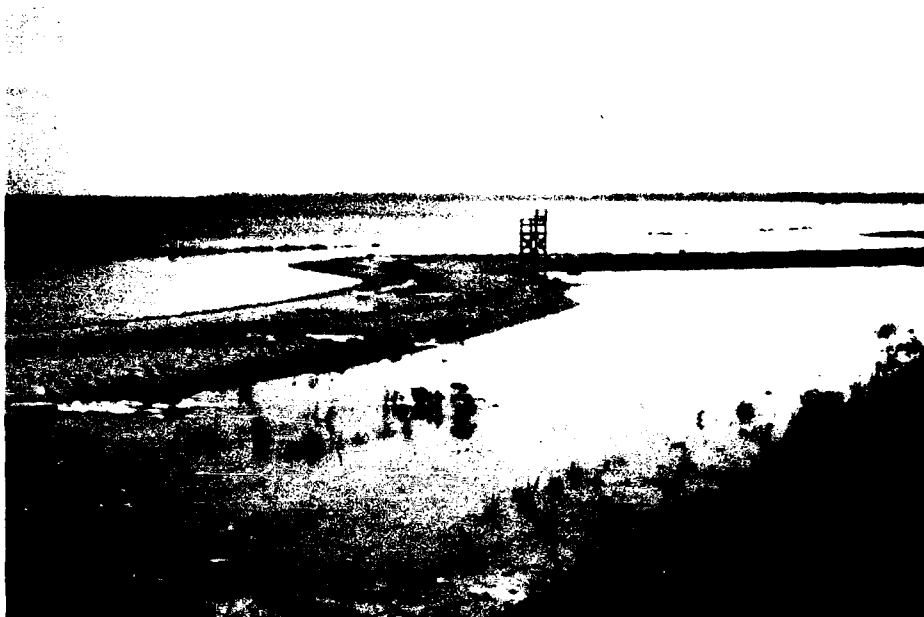
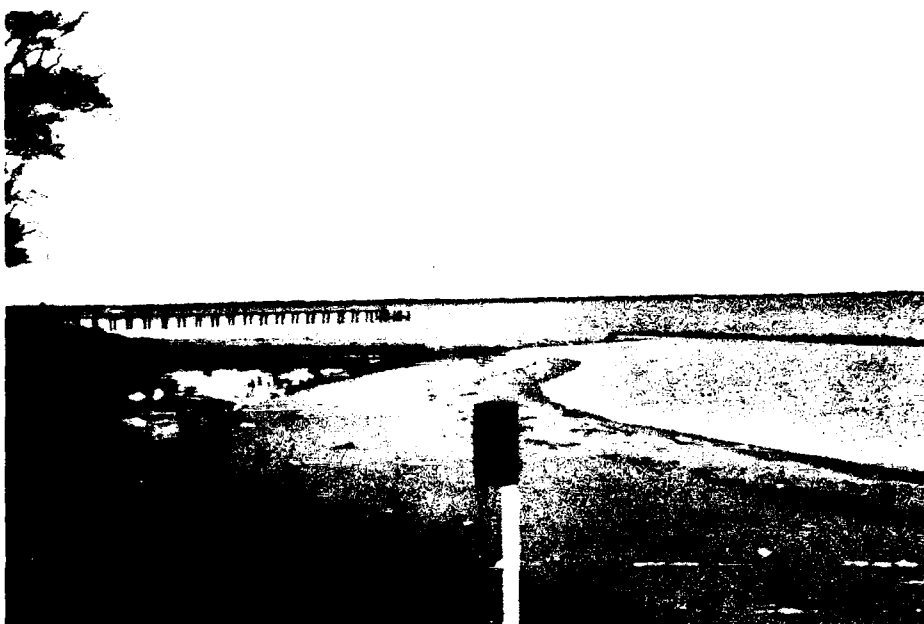
a. Central Beach

b. Castlewood Park Beach

Figure 6. Low back beach areas filled with water,  
September 1983
