REPAIR, EVALUATION, MAINTENANCE, AND  
REHABILITATION RESEARCH PROGRAM

TECHNICAL REPORT REMR-CS-20

# EVALUATION OF VINYLESTER RESIN FOR ANCHOR EMBEDMENT IN CONCRETE

February 1989

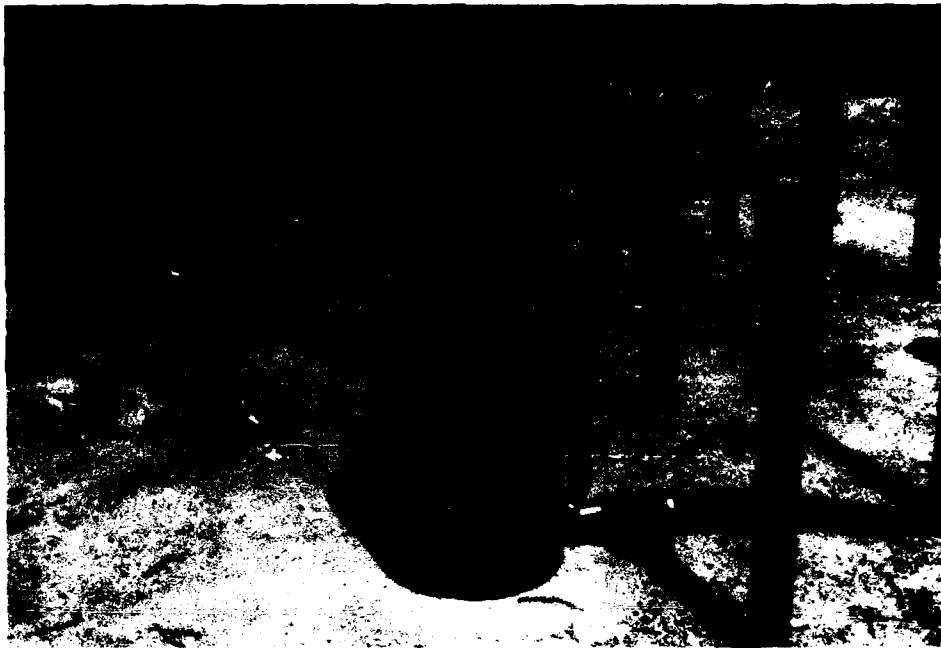
Figure 7. Pullcut tests in progress

a. Closeup view

b. Overall view

15. In the pullout tests, the hydraulic ram was positioned over the anchor to be tested and secured with a nut threaded onto the end of the anchor (Figure 7). A mechanical dial gage was positioned on the end of the anchor to measure displacement of the anchor relative to the concrete surface. The loading rate in the pullout tests was approximately 3,350 lb-ft/min with 3-min intervals at each increment of load. Generally, three-load increments of 2,000-psi gage pressure each were initially applied to anchors installed in dry holes. Smaller increments were applied beyond 6,000 psi depending on the magnitude of anchor displacement. Two initial-load increments of 1,000 psi each were applied to anchors installed under submerged conditions with smaller increments applied beyond 2,000 psi.

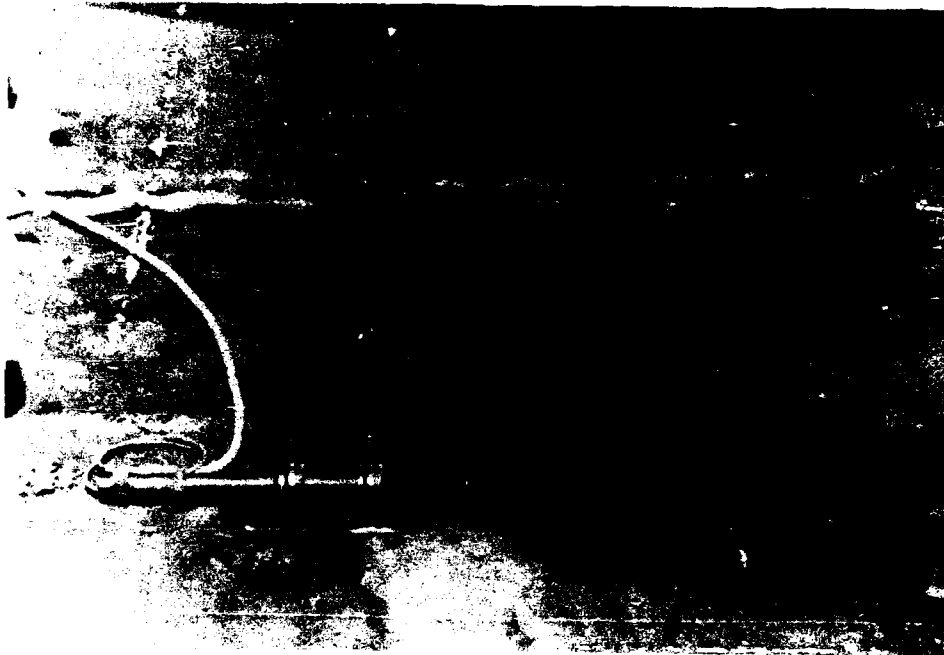
Figure 8. Arrangement of shear test equipment

a. Closeup view of collar and LVDT gage

b. Overall view

16. Horizontal shear loads were applied to the anchors through a donut-shaped steel collar positioned around the anchor (Figure 8). A high-strength steel rod was used to transfer load from the hydraulic ram through the collar to the anchor. Grouted anchors were used to mount a reaction beam on the sides of the concrete block. A linear variable differential transformer (LVDT) gage was positioned against the collar opposite the load transfer rod to monitor horizontal movement of the anchor near the surface of the concrete block. Shear loads were applied continuously at a rate of approximately 6,700 lb-ft/min, up to failure of the anchor.

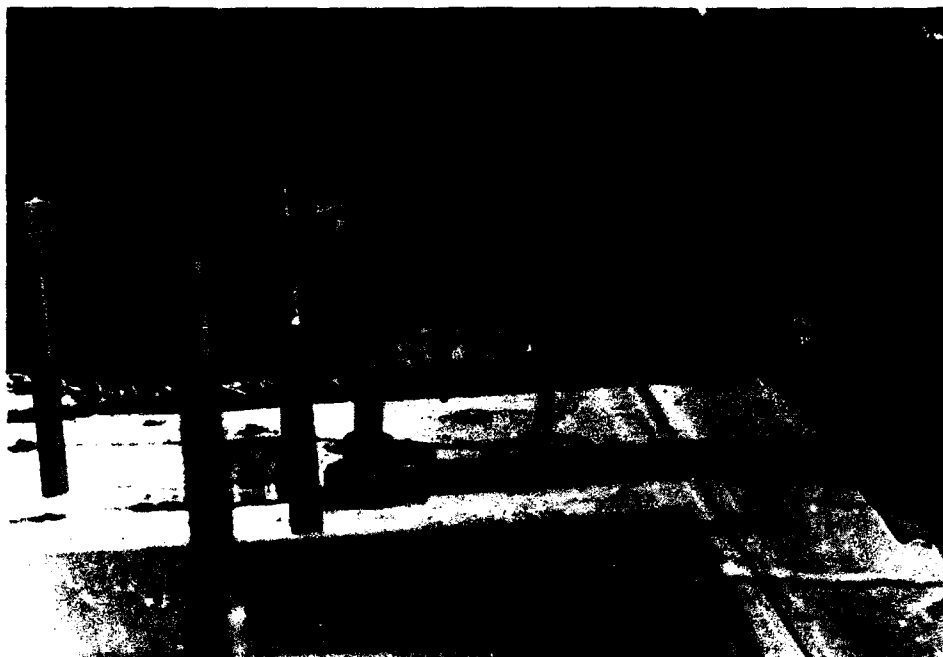
Figure 26. Typical results of shear testing

a. Bending of anchor during test

b. Typical shear failure

30. Some bending of the anchors occurred during the shear tests (Figure 26) as a result of localized failure of the grout and concrete near the top of the holes. The extent of bending appeared to be influenced by the strength of the grout and the distance between the anchor and the edge of the drill hole. Although this bending probably caused some error in the test data, the results are considered to be a satisfactory estimate of the relative shear capacity of anchors installed under the various conditions.
