AEFA Project No. 83-01

**VERIFICATION OF U-21 CLOUD PARAMETER MEASUREMENT  
EQUIPMENT AND COMPARISON OF NATURAL AND ARTIFICIAL  
ICE ACCRETION CHARACTERISTICS ON ROTOR BLADE  
AIRFOIL SECTIONS**

Final Report

**AVIATION ENGINEERING FLIGHT ACTIVITY**  
Edwards Air Force Base, California 93523-5000

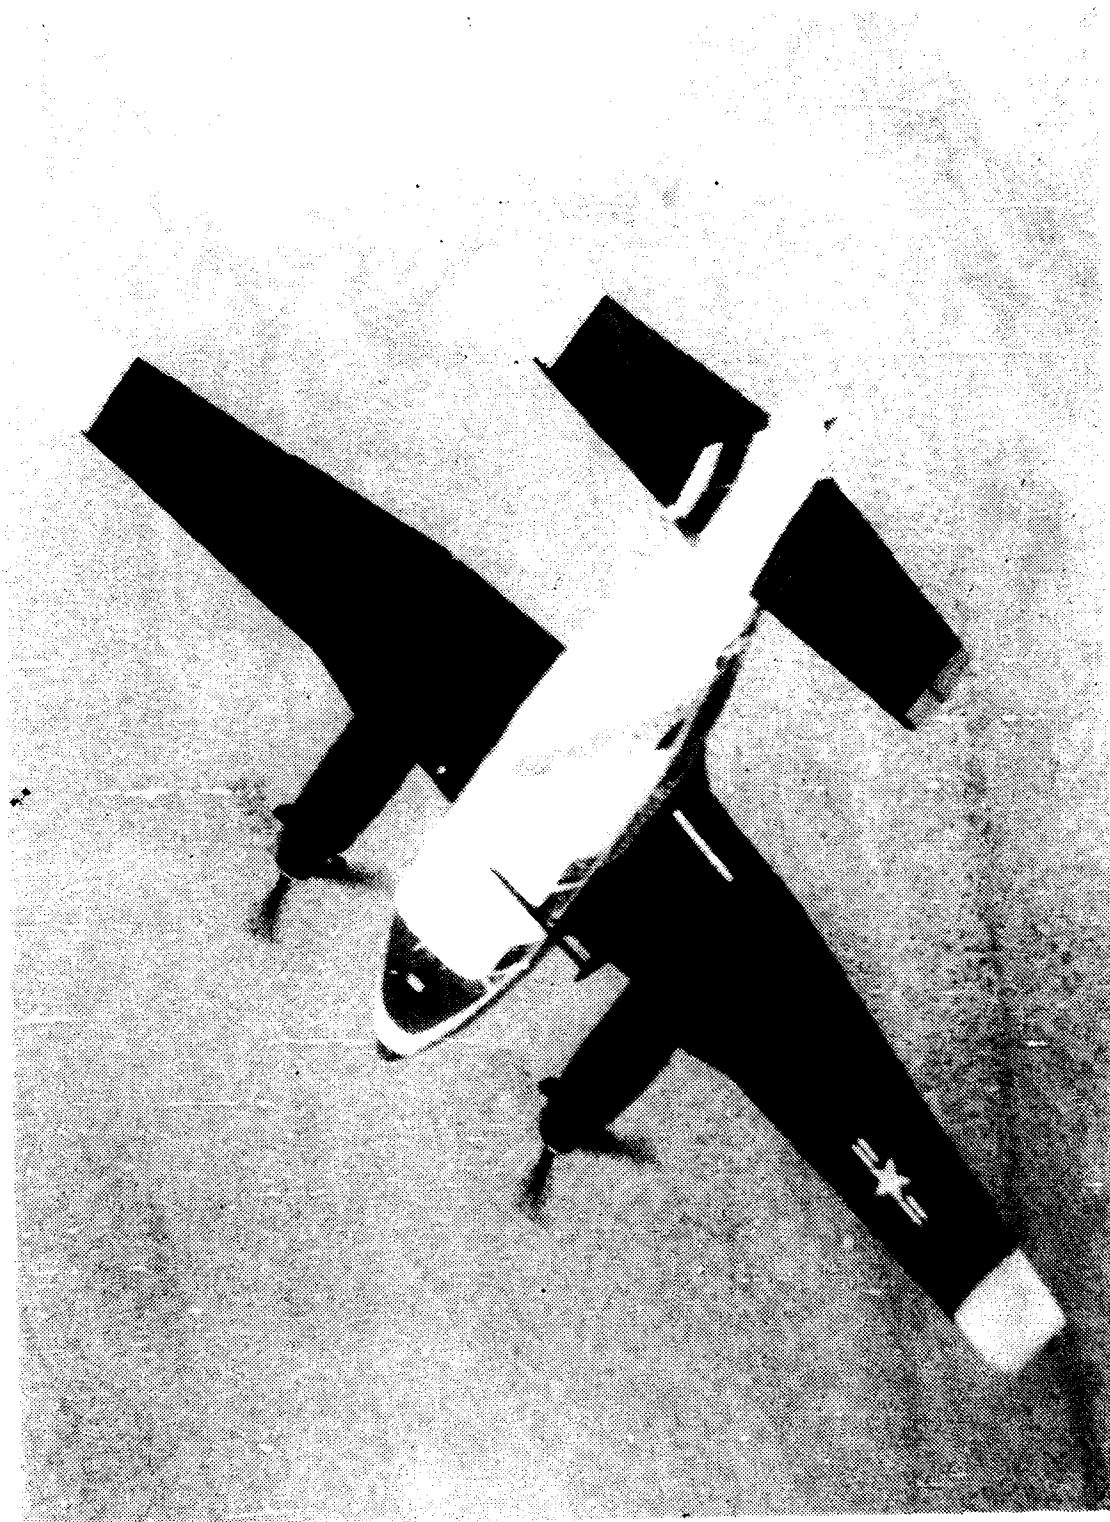
4. A US Army JU-21A aircraft (S/N 66-18008) made by the RAC and fitted with cloud measuring equipment served as the project test bed. Shown in figure 1, it is an unpressurized, low-wing, all metal, twin turboprop airplane with tricycle landing gear with a maximum takeoff gross weight of 9650 lb. The aircraft incorporates various ice protection systems and is certified for flight into moderate icing conditions.

Figure 1. JU-21A Aircraft S/N 66-18008

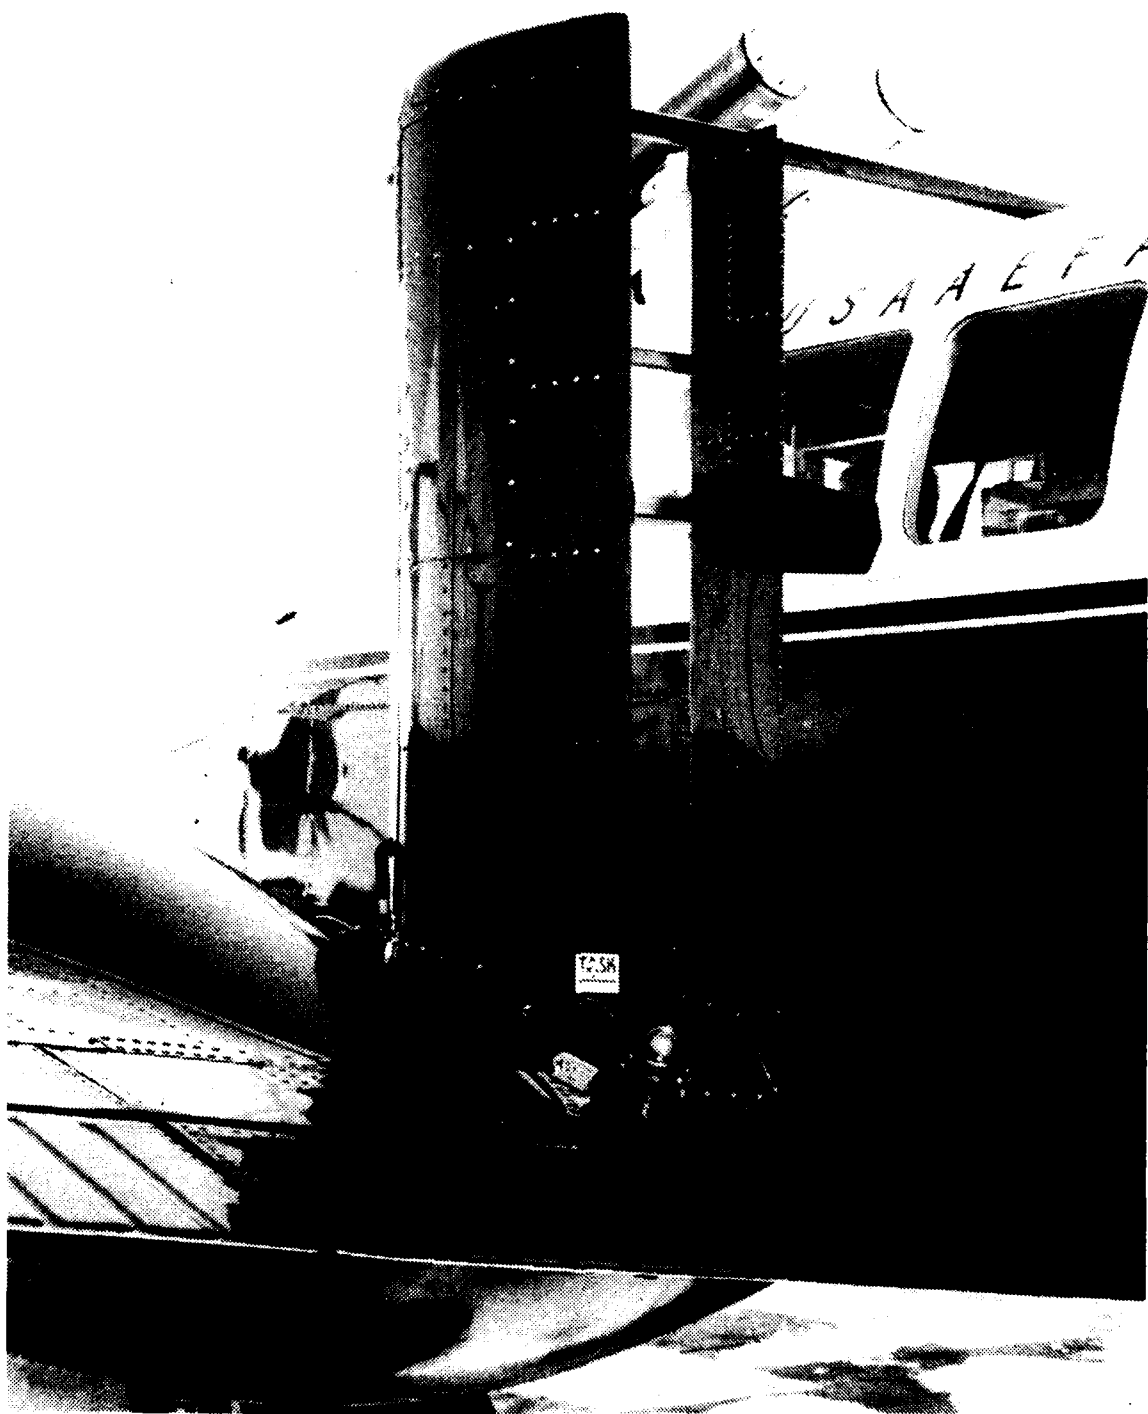
Figure B-4. ASA Assembly, Quartering View

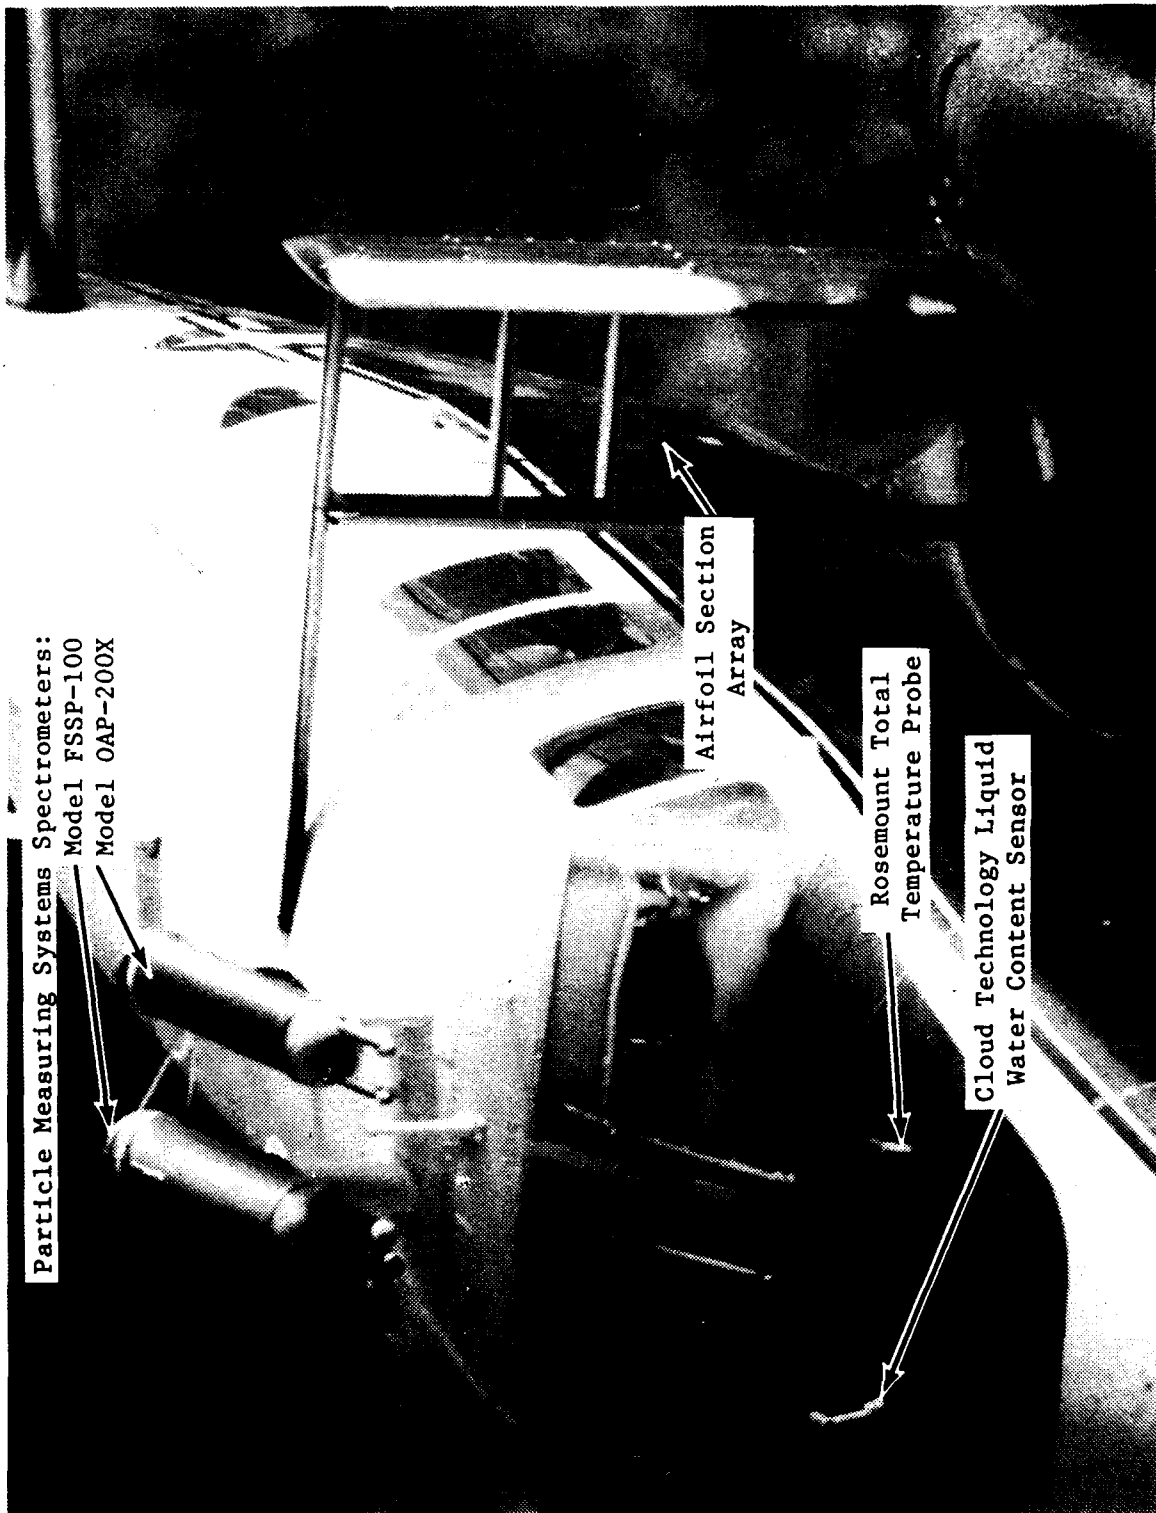
Figure C-1. Cloud Measuring Instrumentation on JU-21A

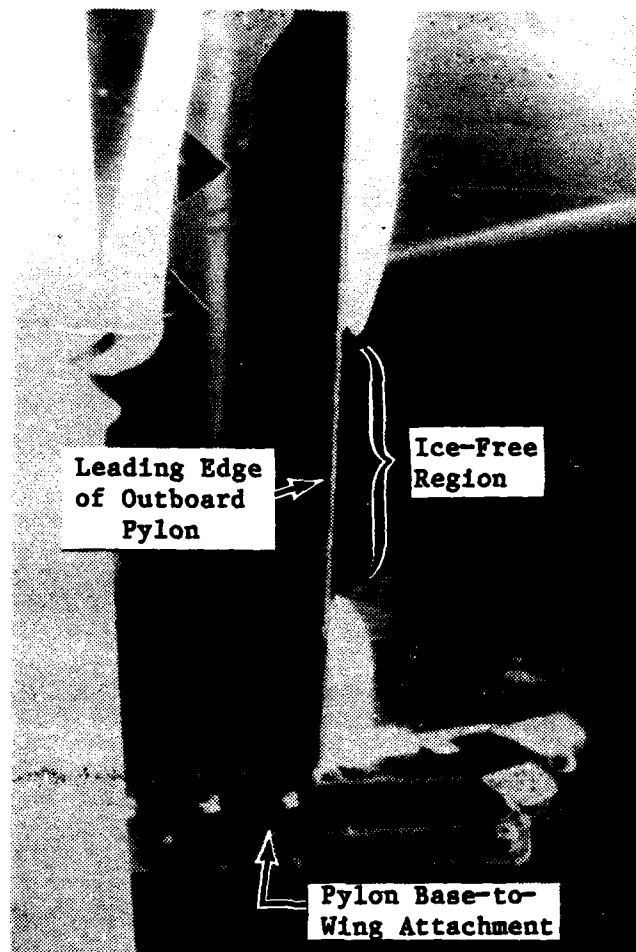
Figure F-11. Ice-Free Region on ASA  
Outboard Pylon

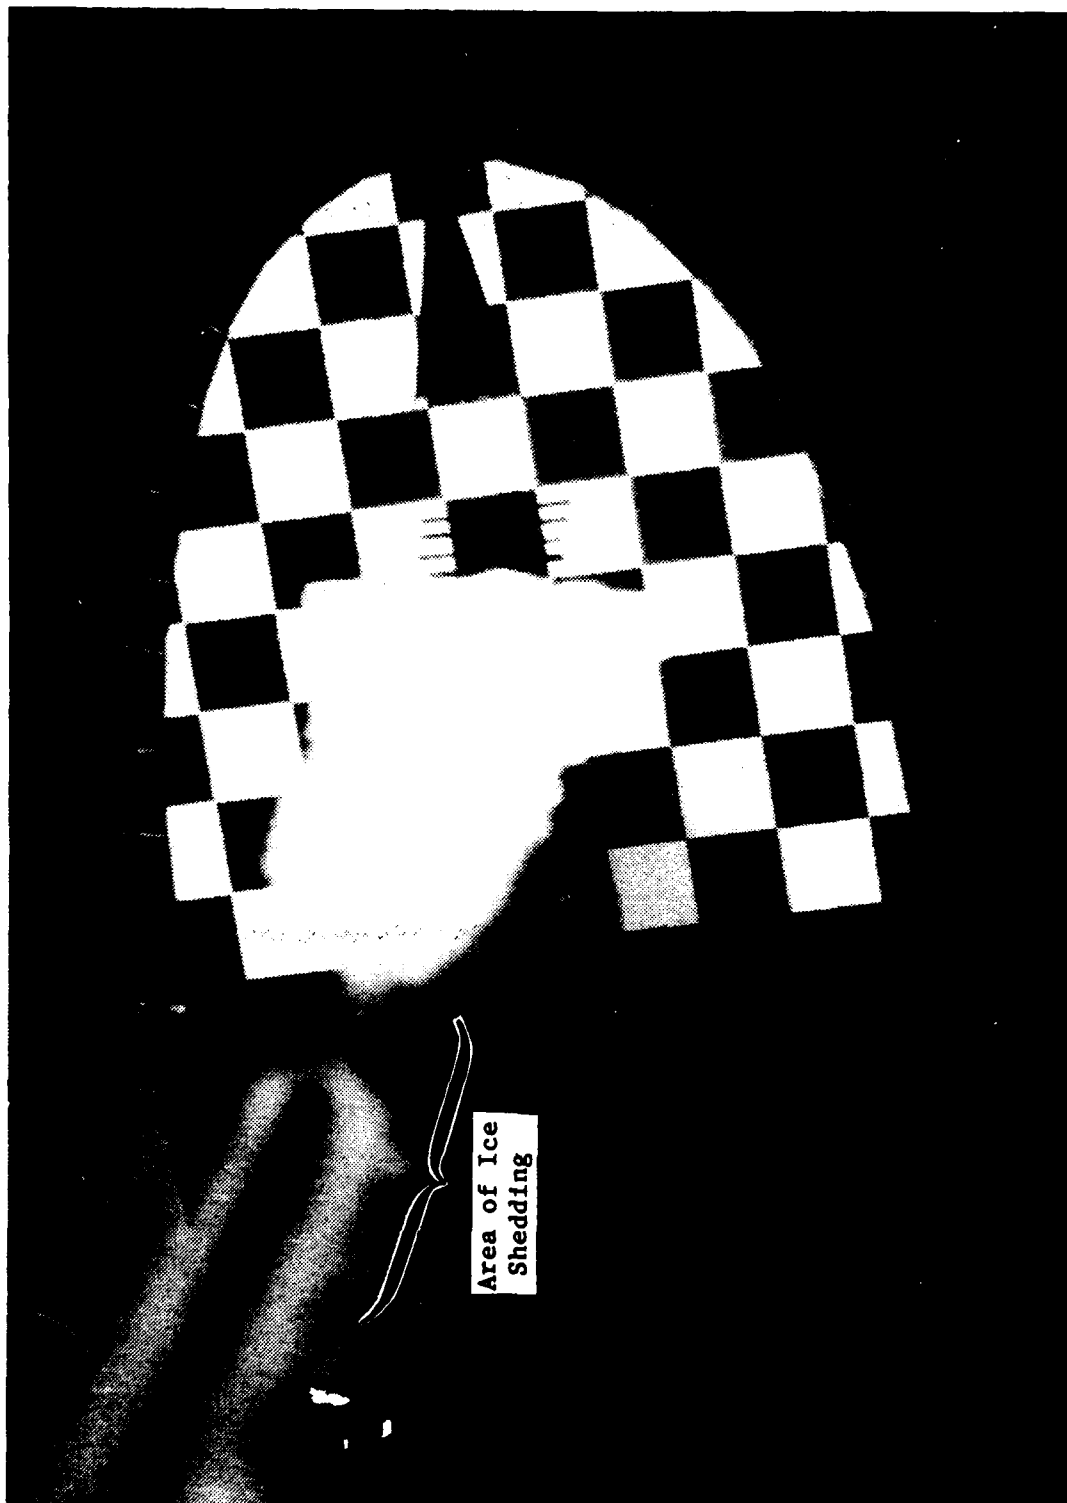
Figure F-19. Ice Section Shed from Small  
Airfoil During Immersion
