# Hazardous Materials Technical Center

INSTALLATION RESTORATION PROGRAM  
PRELIMINARY ASSESSMENT  
GRANITE MOUNTAIN RADIO RELAY STATION, ALASKA

April 1989

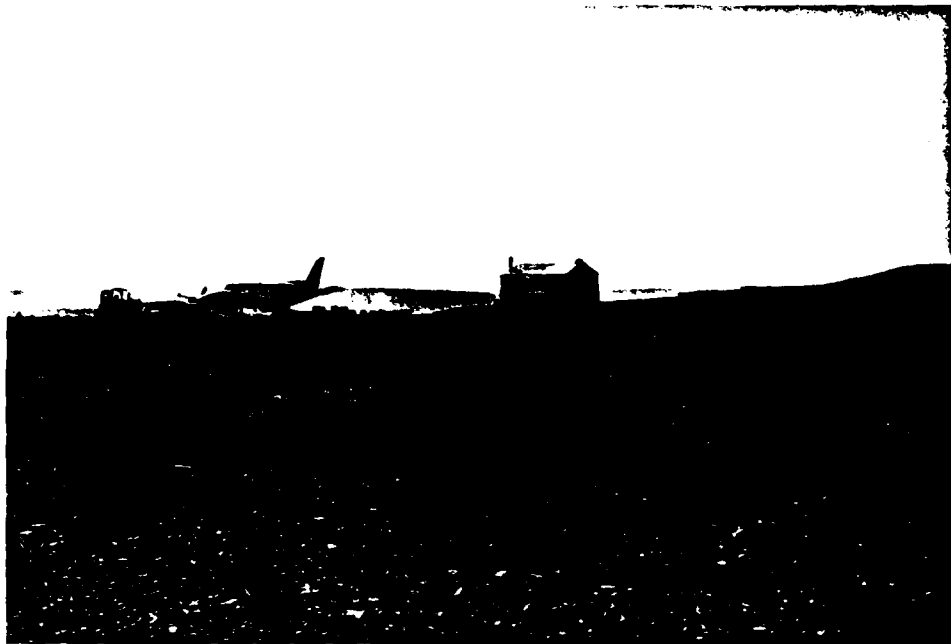
- Approximately 25 55-gallon drums were stored east of the Temporary Auto Storage Building. These drums appeared to be intact and no spillage was observed (see Photos 1, 2, and 3, Appendix E);

- The Temporary Air Terminal was inaccessible and, therefore, it could not be inspected;
- An abandoned bulldozer was observed southeast of the Temporary Auto Storage Building (see Photo 1, Appendix E);

Photo 1. Temporary Air Terminal, Temporary Auto Storage Building, 55-gallon drums (behind aircraft), and abandoned bulldozer viewed southwest.

according to state and Federal regulations. Removal of any remaining 55-gallon drums around the runway facilities is also recommended. Temporary fuel storage equipment and fueling operations should be managed to ensure that fuel spills do not occur. Abatement of any asbestos remaining within the buildings is also recommended.

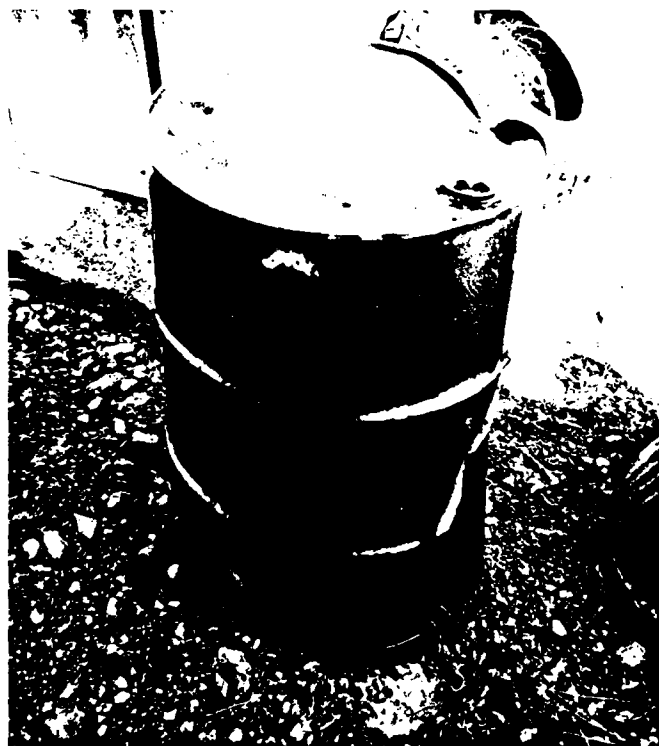
- One 55-gallon storage tank labeled "Lube Oil" was observed between the Temporary Auto Storage Building and an adjacent storage building east of the Temporary Auto Storage Building (see Photo 4, Appendix E);

Photo 4. 55-gallon drum located between the Temporary Auto Storage Building and the storage building viewed northeast.

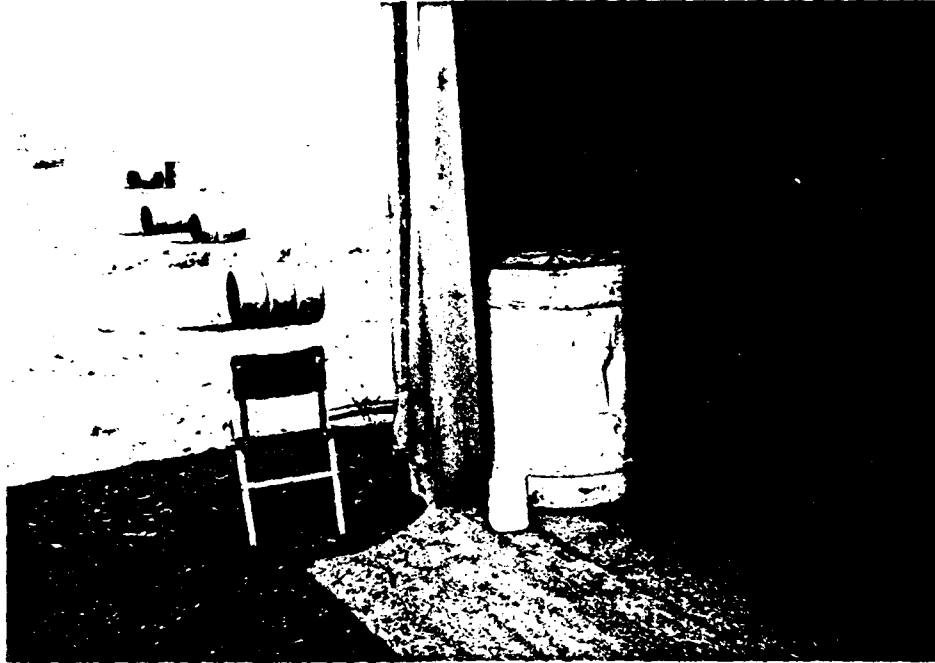
- The interiors of both the Temporary Auto Storage Building and the adjacent storage building appeared clean. Several 55-gallon drums were observed inside the storage building, however, they did not appear to be leaking (see Photo 5, Appendix E);

Photo 5. 55-gallon drums inside and outside of the storage building viewed southeast.

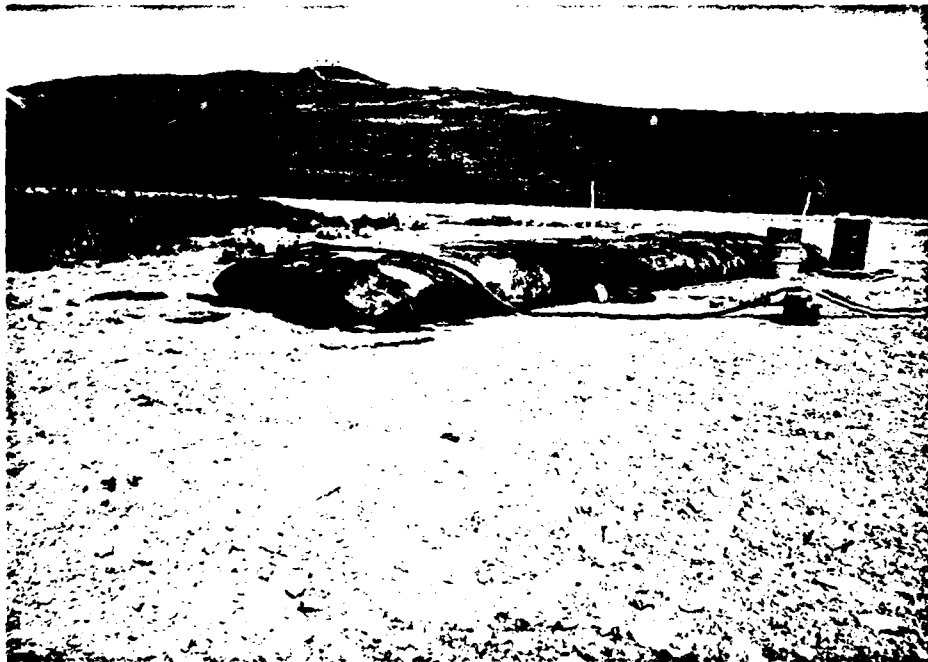
- A fuel bladder, filled with aviation gasoline, was observed at the west edge of the runway and east of the Temporary Air Terminal. During the site visit, a small, single-engine aircraft was observed transporting this fuel to a mining operation several miles away. Minor staining of the soil immediately around the bladder was observed (see Photo 6, Appendix E);

Photo 5. Fuel bladder adjacent to runway viewed northeast.

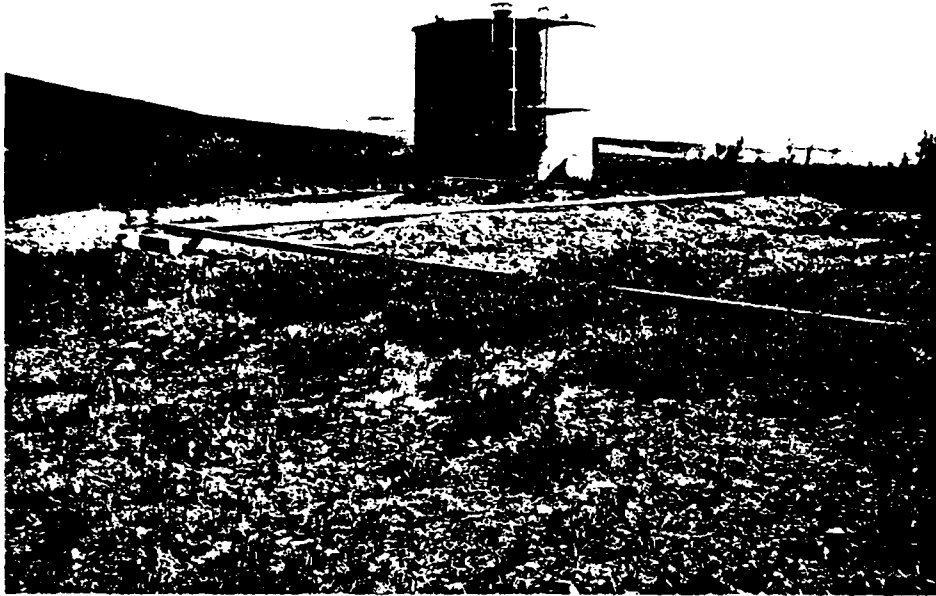
- A fuel oil tank, located east of the runway, appeared to be empty (see Photo 7, Appendix E);
- Eleven 55-gallon drums and a fuel storage tank were observed east of the runway. These items may contain aviation gasoline. No spillage was observed on the ground (see Photo 8, Appendix E);

Photo 7. Fuel storage tank and associated piping east of the runway viewed east.
